# ROAD SAFETY AUDIT

## EXISTING ROAD

McAuleys Lane, Myocum

September 2020

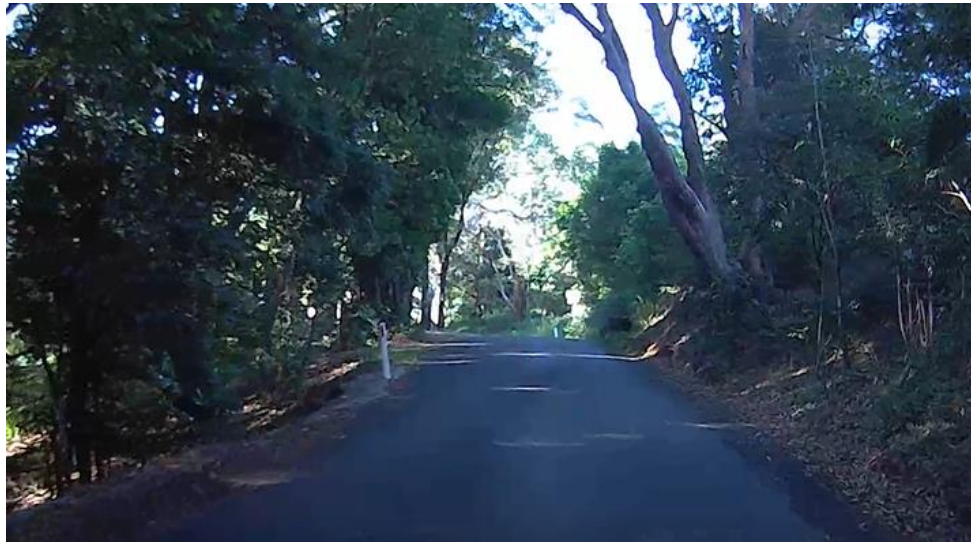
| Number | Description | Risk Rating |
|---|---|---|
| 01 | <p><b>Road Width</b></p> <p>The road width is consistently narrow for most of the length. Many sections have narrow or non-existent shoulders. Some sections are very narrow (at the “slip” – refer Finding 17 and 18), winding, and in poor condition. In some locations, cars were parked on the road shoulder/verge at the time of the inspection, further reducing the available road carriageway width.</p> <p>Due to the narrow width there is no painted centreline.</p> <p>There is a risk that drivers may not allow for the narrow road and not drive to the conditions, and lose control and collide with an oncoming vehicle or a roadside hazard.</p> <p><i>Refer to Photo 1, 2</i></p> <p><i>Location: Entire length</i></p> | <p>Frequency: Improbable</p> <p>Severity: Serious</p> <p>Risk: <b>Medium</b></p> |

**Photo 1: Example of narrow road width**

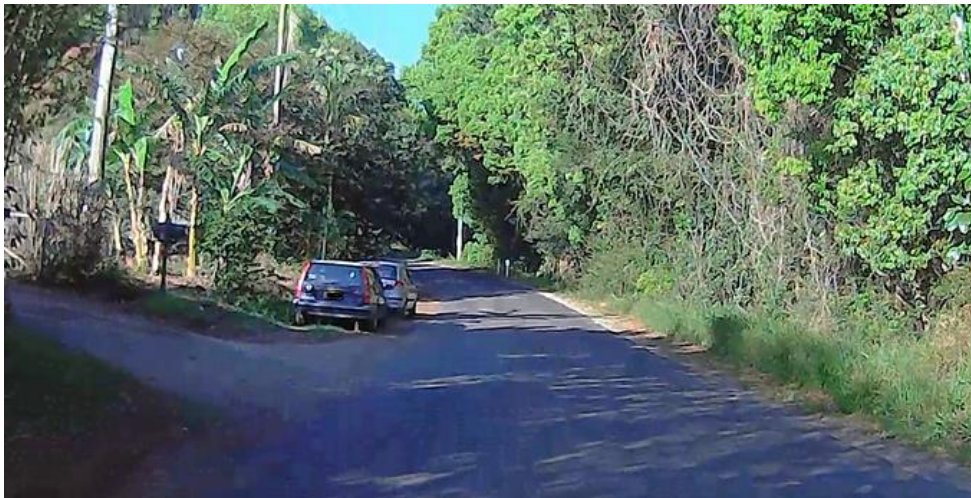
**Photo 2: Parked cars further reducing road width**

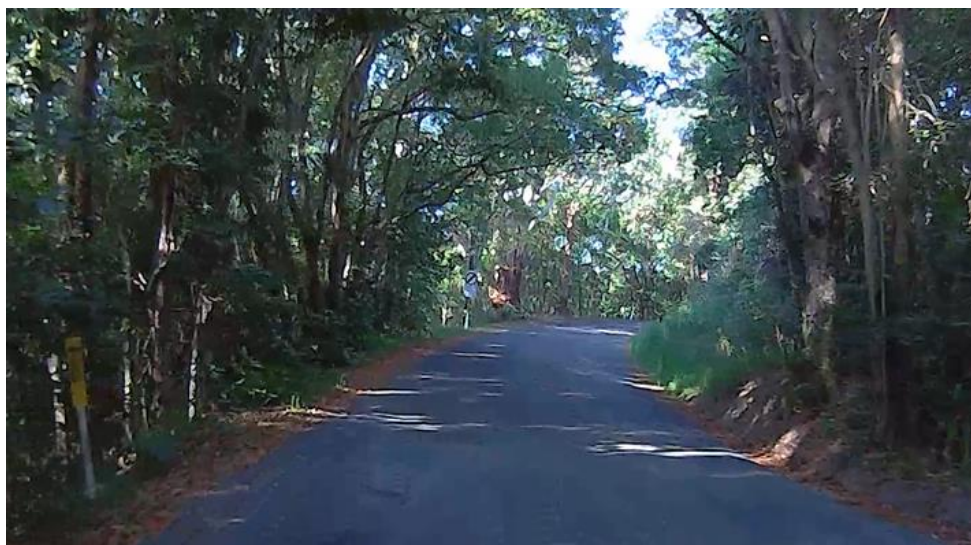
| Number | Description | Risk Rating |
|---|---|---|
| 02 | <p><b>Road Shoulders/Roadside Drainage</b></p> <p>The road shoulders are narrow or non-existent in many locations. Pavement edges are damaged. Some of the road shoulders are above the level of the road surface. Some roadside drains are silted or overgrown, or non-existent. Inadequate roadside drainage can result in water ponding or flowing on the road surface.</p> <p>Where there is no shoulder, there is no recovery area for errant vehicles or refuge for stopped vehicles. There is less room for cyclists and pedestrians.</p> <p>There is a risk that vehicles may hit the damaged road edges or water on the road edge and lose control, resulting in a collision with a roadside hazard or another vehicle. Drivers may tend to keep a distance from the shoulders, increasing the risk of a head-on collision.</p> <p><i>Refer to Photo 3, 4</i></p> <p><i>Location: Numerous</i></p> | <p>Frequency: Improbable</p> <p>Severity: Serious</p> <p>Risk: <b>Medium</b></p> |

**Photo 3: Example 1 of narrow shoulders/inadequate roadside drainage**

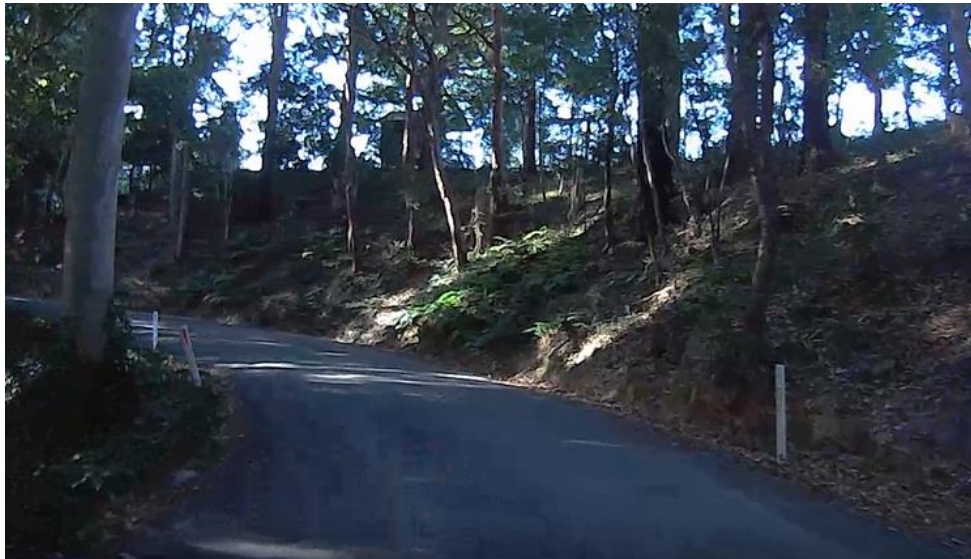
**Photo 4: Example 2 of narrow shoulders/inadequate roadside drainage**

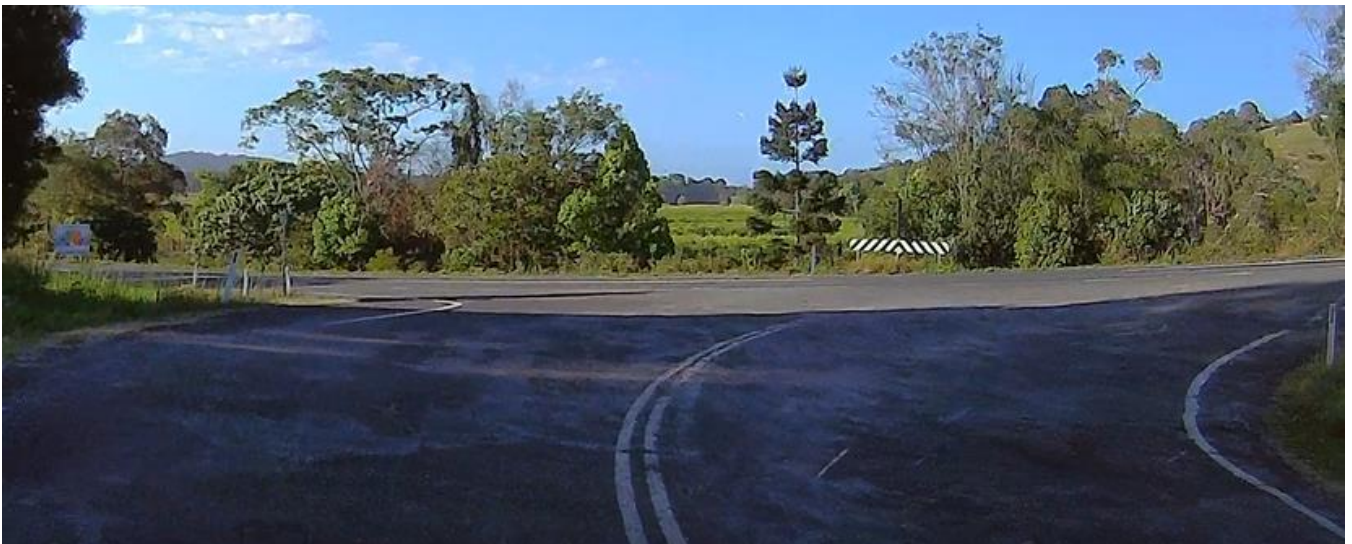
| 03 | <p><b>Poor Condition of Road Surface and Pavement</b></p> <p>The road surface and pavement is in a poor condition in many places - uneven surface, cracks, potholes, patches, shoving and rutting.</p> <p>The worst section is from Mullumbimby Road (including the intersection) to #119 McAuleys Lane (approx. Ch. 1150).</p> <p><i>(List may not include every location).</i></p> <p>There is a risk that vehicles will lose control on the damaged surface, especially on curves, resulting in a collision with a roadside hazard or another vehicle.</p> <p><i>Refer to Photo 5, 6</i></p> <p><i>Location: Numerous</i></p> | <p>Frequency: Improbable</p> <p>Severity: Serious</p> <p>Risk: <b>Medium</b></p> |

**Photo 5: Road condition at Mullumbimby Road intersection – patchy and uneven**

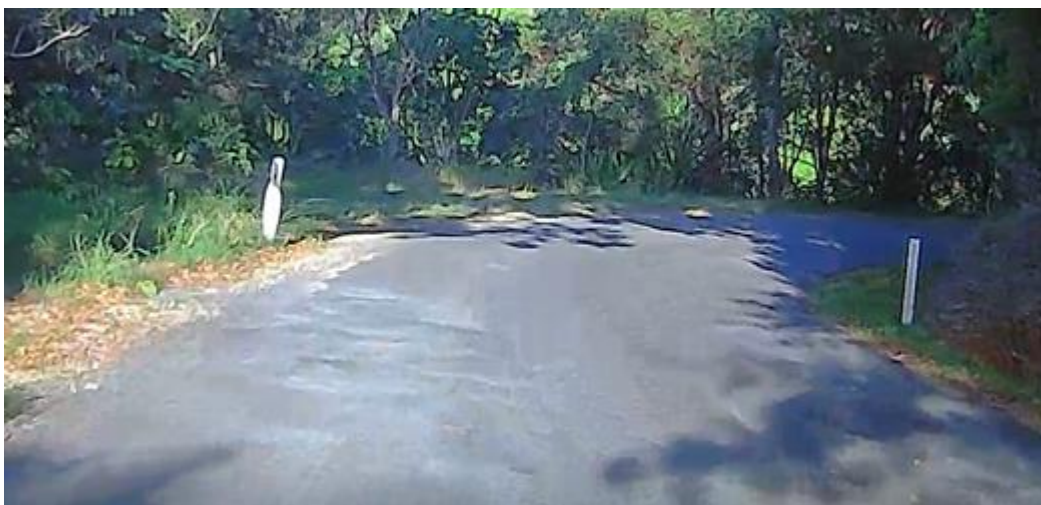
**Photo 6: Example of road condition between Mullumbimby Road and #119**

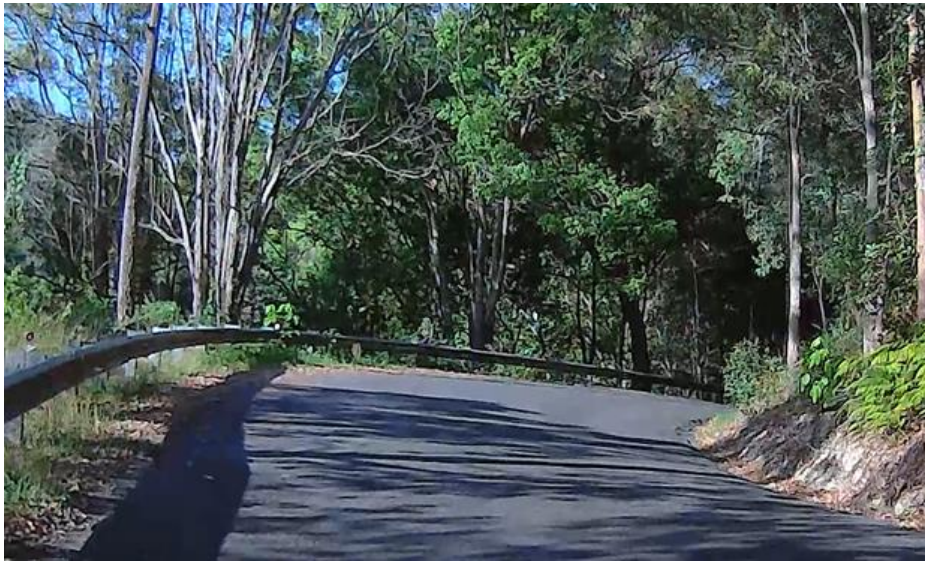
| 05 | <p><b>Inadequate Definition of Curve Alignments</b></p> <p>There are no alignment delineation devices (such as advisory signage, CAMs, guideposts, RRPMS, etc.) on many of the curves.</p> <p>The curves at Ch. 2550 and Ch. 2800 have insufficient chevron alignment markers (CAM) (minimum requirement is 4).</p> <p>These alignments could be considered hazardous without additional delineation devices.</p> <p>Without adequate delineation, there is a risk that motorists will not correctly anticipate the road's alignment, particularly at night, resulting in a collision with an oncoming vehicle or a roadside hazard.</p> <p><i>Refer to Photo 7</i></p> <p><i>Location: Numerous</i></p> | <p>Frequency: Occasional</p> <p>Severity: Serious</p> <p>Risk: <b>High</b></p> |

**Photo 7: Example of inadequate delineation of curves (no CAMs)**

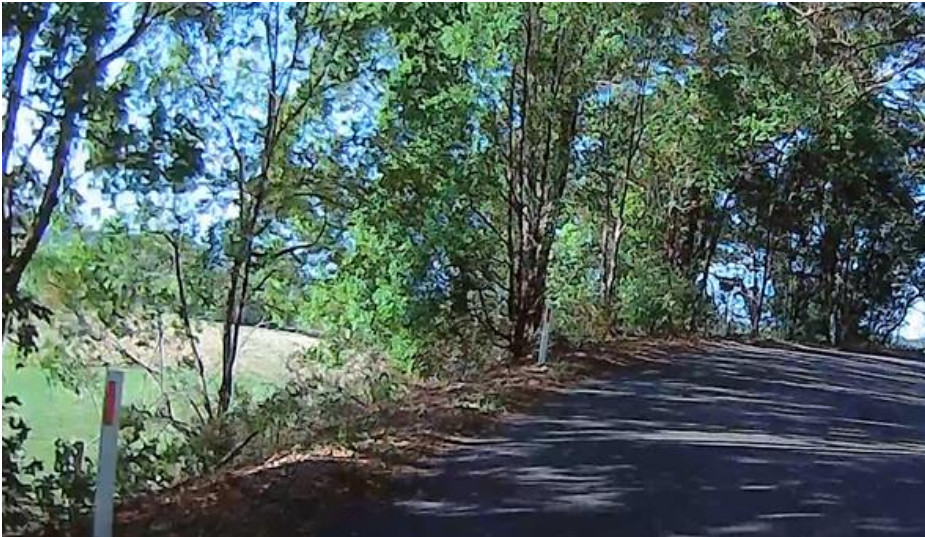
| 06 | <p><b>Roadside Hazards</b></p> <p>There are numerous roadside hazards along the road:</p> <ul style="list-style-type: none"> <li>• Large trees – too numerous to list</li> <li>• Embankment at the following chainages: 275; 425; 1200-1450; 1700; 1875; 2500; 2650-2850; 3050</li> <li>• Several poles and stays</li> <li>• Fence at Ch. 450</li> <li>• Headwall at Myocum Road intersection</li> <li>• Creek crossing (headwalls) at Ch. 2750.</li> </ul> <p><i>(List may not include every location).</i></p> <p>Some of these hazards are on the outside of a curve in the line of travel. An impact with any of these roadside hazards may increase the severity of a run-off-road crash. The provision of safety barriers may be warranted in some of these locations.</p> <p>There is a risk that an errant vehicle could leave the roadway, resulting in a collision with the roadside hazards.</p> <p><i>Refer to Photo 8, 9</i></p> <p><i>Location: Numerous</i></p> | <p>Frequency: Improbable</p> <p>Severity: Serious</p> <p>Risk: <b>Medium</b></p> |

**Photo 8: Example of roadside hazards – steep bank down from shoulder**

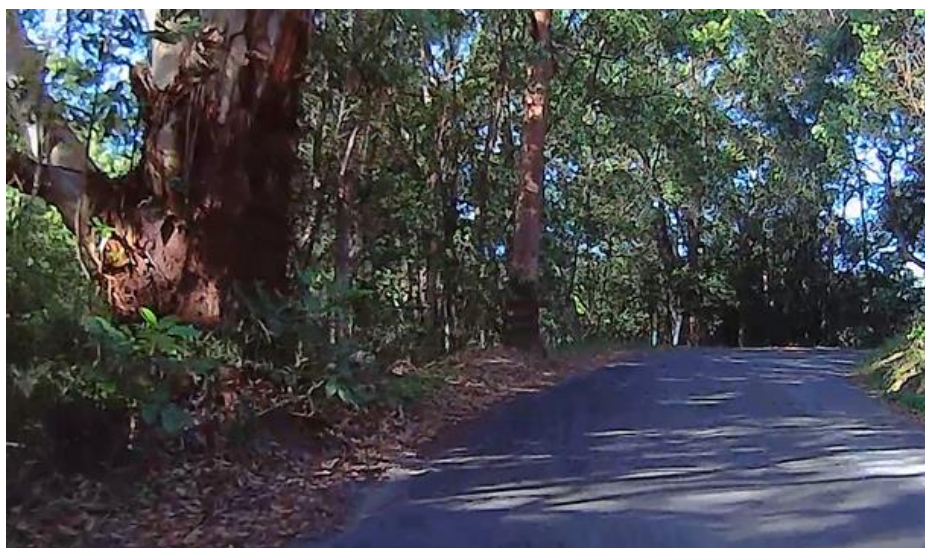
**Photo 9: Example of roadside hazards – large trees near road edge**

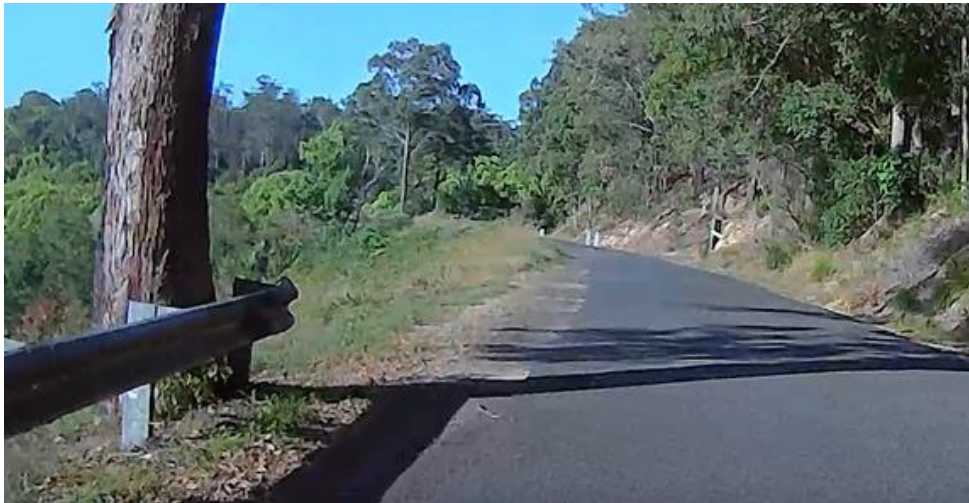
| 07 | <p><b>Safety Barriers</b></p> <p>The safety barrier end terminal at Ch. 1450 is non-compliant. The safety barrier end terminal at Ch. 1750 is non-compliant and is also against a tree. The required deflection distance is not provided between the barrier and the hazard.</p> <p>The safety barrier end terminals between Ch. 1450-1850 are not adequately delineated – no yellow/black chevrons.</p> <p>In general, the safety barriers do not have adequate reflectors for night time delineation.</p> <p>There is a risk that an errant vehicle may collide with the end of the safety barrier.</p> <p>There is a risk that an impact with the end of the safety barrier may increase the severity of a run-off-road crash.</p> <p><i>Refer to Photo 10</i></p> <p><i>Location: As listed</i></p> | <p>Frequency: Improbable</p> <p>Severity: Serious</p> <p>Risk: <b>Medium</b></p> |

**Photo 10: Safety barrier end at tree**

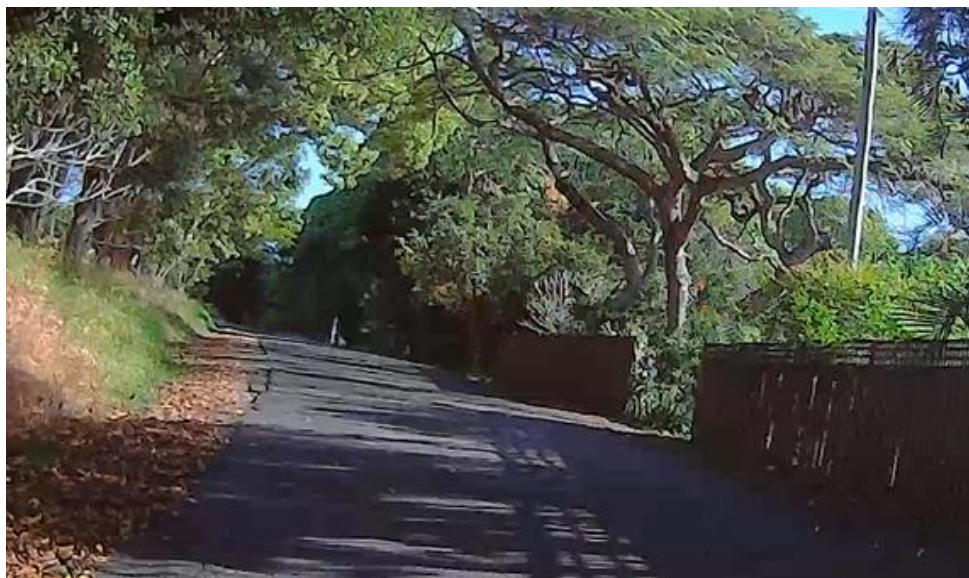
| 08 | <p><b>Concealed Driveways/Sight Distance from Driveways</b></p> <p>There are many concealed driveways along the road. Sight distances are sometimes reduced by the road alignment, roadside vegetation, or fencing. There is only one 'Concealed Driveways' sign – additional signs may be warranted.</p> <p>There is a risk that vehicles entering or leaving these driveways may be struck by through traffic.</p> <p><i>Refer to Photo 11, 12</i></p> <p><i>Location: Numerous</i></p> | <p>Frequency: Improbable</p> <p>Severity: Serious</p> <p>Risk: <b>Medium</b></p> |

**Photo 11: Concealed driveway – driveway through fence at shoulder edge**

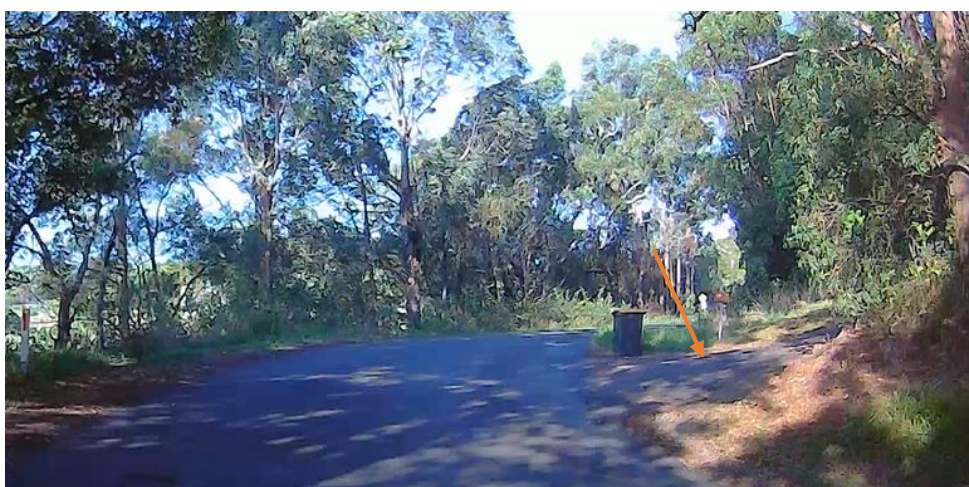
**Photo 12: Example of concealed driveway**

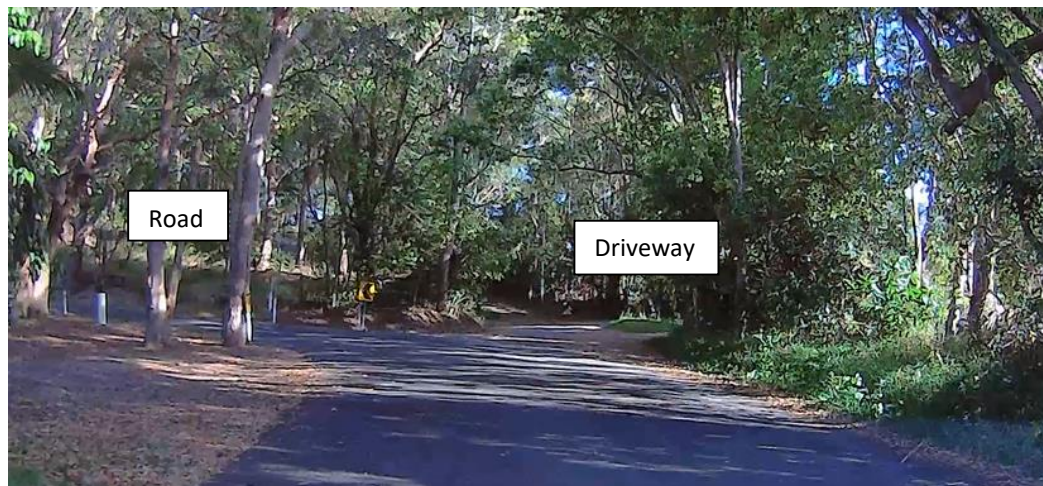
| 09 | <p><b>Confusing Road Alignment at Ch. 2575</b></p> <p>The travel path through the bend is not well defined – looks a bit like an intersection. There are several driveways on the bend. From the west the road looks like it goes straight ahead (up a driveway). Drivers may not correctly anticipate the road alignment.</p> <p>There is a risk that a driver could be confused by the layout and head up the driveway, then make a last minute correction back onto McAuleys Lane. This could result in the driver losing control and colliding with an oncoming vehicle or a roadside hazard.</p> <p><i>Refer to Photo 13</i></p> <p><i>Location: Ch. 2575</i></p> | <p>Frequency: Improbable</p> <p>Severity: Serious</p> <p>Risk: <b>Medium</b></p> |

**Photo 13: Bend approach from the west is confusing – driveway looks like road continues straight**

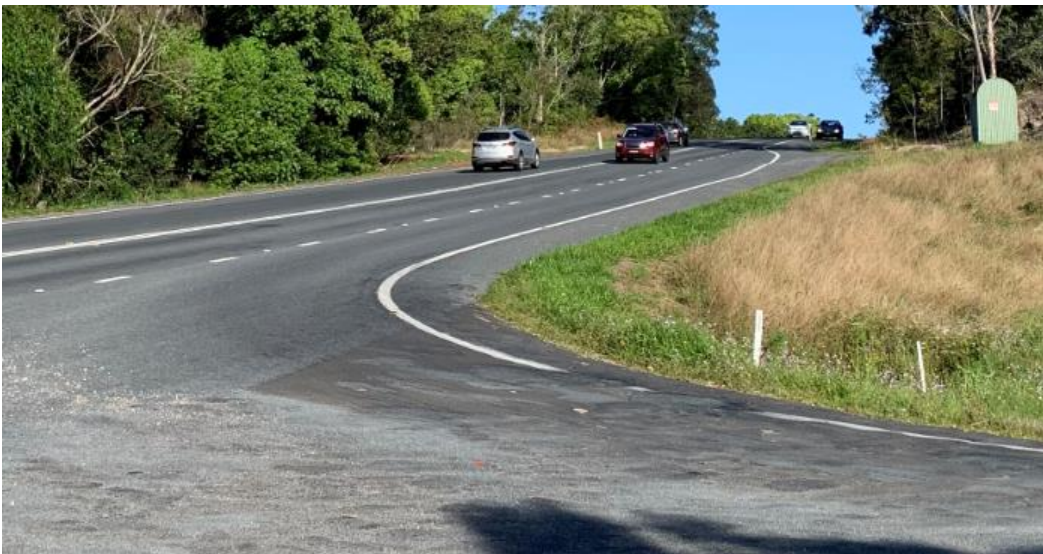
| 10 | <p><b>Sight Distances Inadequate</b></p> <p>Sight distances at the following intersections appear to be deficient:</p> <ul style="list-style-type: none"> <li>• From McAuleys Lane, looking right along Mullumbimby Road</li> <li>• From McAuleys Lane, looking left along Myocum Road</li> </ul> <p>There is a risk of a crash at the intersections due to the poor sight distances.</p> <p><i>Refer to Photo 14</i></p> <p><i>Location: As listed</i></p> | <p>Frequency: Improbable</p> <p>Severity: Serious</p> <p>Risk: <b>Medium</b></p> |

**Photo 14: Sight distance (right) at Mullumbimby Road. Note bus stop (on right) just over crest**

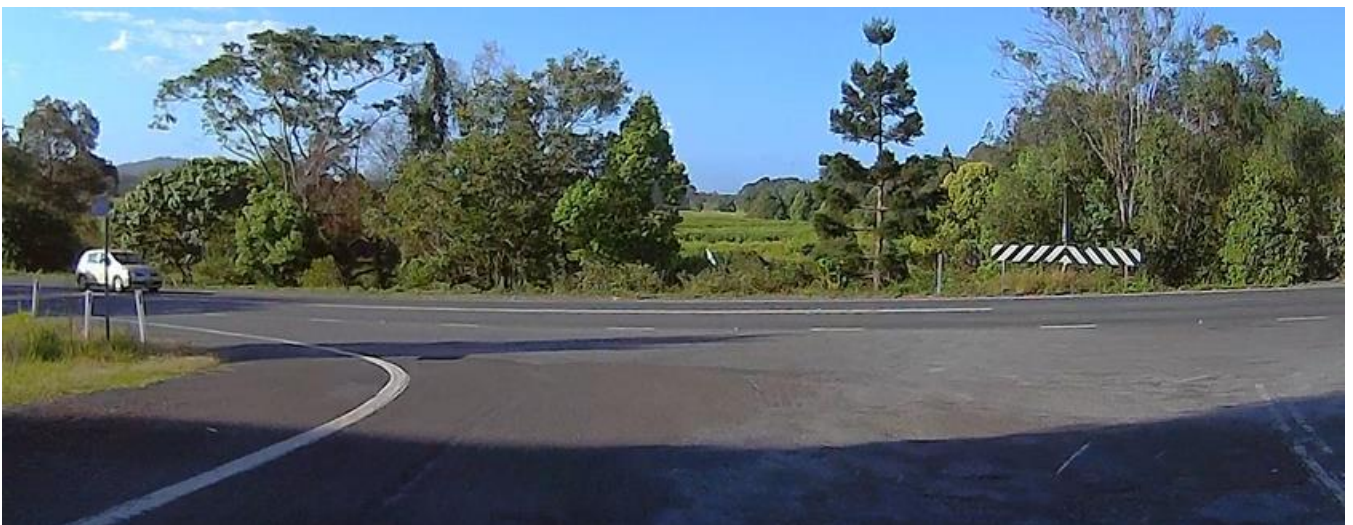
| 12 | <p><b>Lack of Intersection Signs/Lines</b></p> <p>There is a lack of relevant signs and line marking at the following intersections:</p> <ul style="list-style-type: none"> <li>• Mullumbimby Road – no ‘Stop’ or ‘Give Way’ signs or hold line.</li> <li>• Muli Court – no ‘Stop’ or ‘Give Way’ signs, no hold line, no sight board.</li> <li>• Bilin Road – no ‘Stop’ or ‘Give Way’ signs, no hold line, no sight board.</li> </ul> <p>There is a risk that drivers will misjudge the intersection controls resulting in a collision with an oncoming or turning vehicle.</p> <p><i>Refer to Photo 15</i></p> <p><i>Location: As listed</i></p> | <p>Frequency: Improbable</p> <p>Severity: Serious</p> <p>Risk: <b>Medium</b></p> |

**Photo 15: Example of lack of intersection signs/lines – Mullumbimby Road (no stop/give way sign, or hold line)**

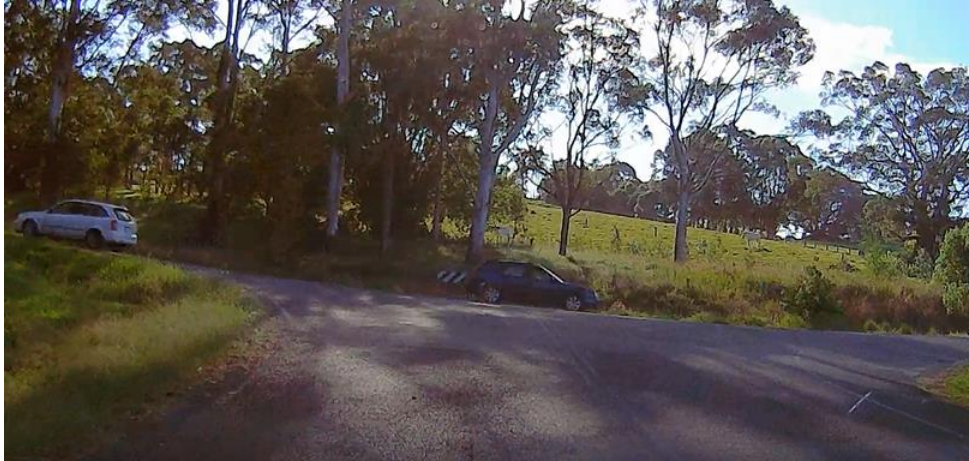
| 13 | <p><b>Line Marking at Intersections</b></p> <p>The line marking at the Mullumbimby Road and Myocum Road intersections is badly worn. There is no line marking at the Muli Court and Bilin Road intersections. There are also no RRPM’s at the intersections.</p> <p>Without adequate delineation, there is a risk that drivers may incorrectly interpret the road alignment or travel path at the intersections and cross to the incorrect side of the road, particularly at night, resulting in a collision with an oncoming vehicle.</p> <p><i>Refer to Photo 16</i></p> <p><i>Location: As listed</i></p> | <p>Frequency: Improbable</p> <p>Severity: Serious</p> <p>Risk: <b>Medium</b></p> |

**Photo 16: Condition of line marking at Myocum Road intersection (note: no stop/give way sign, or hold line)**

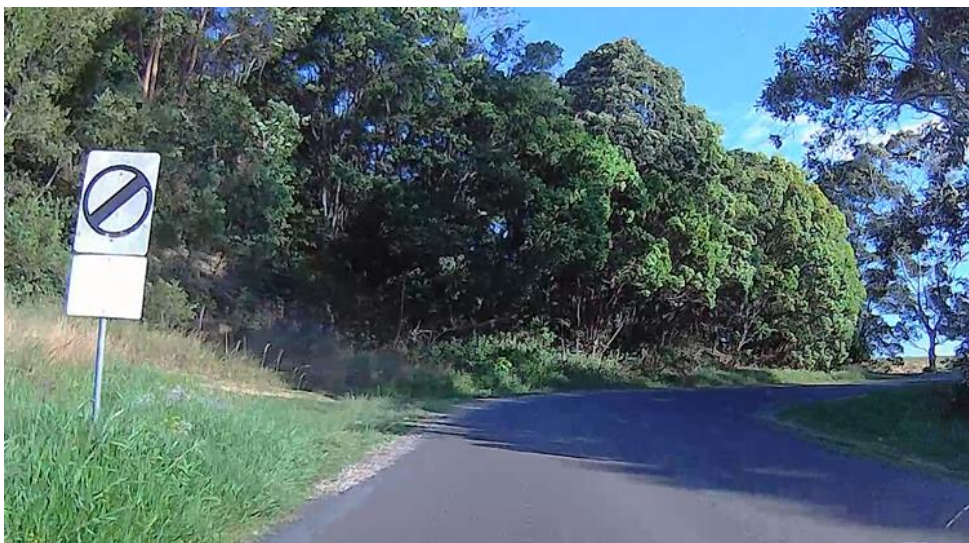
| 22 | <p><b>Signposting of Speed Limits</b></p> <p>McAuleys Lane is incorrectly signposted as a “derestricted” speed zone. This sign is no longer in use and should be replaced. As the intersecting roads at each end (Mullumbimby Road and Myocum Road) are 80km/h roads, the correct signage on entering McAuleys Lane at each end is the ‘End 80’ sign. Due to the road conditions, the sign should be supplemented with a ‘Reduce Speed to Conditions’ sign.</p> <p>At each end of McAuleys Lane, an ‘80’ sign should be installed to indicate a return to an 80km/h speed zone on the intersecting roads. An ‘80’ painted on the road pavement adjacent to the signs may also be warranted.</p> <p>There is a risk that a driver will not adequately perceive the correct speed limit and travel too fast along the road.</p> <p><i>Location: Change in speed zones</i></p> | <p>Frequency: Occasional</p> <p>Severity: Serious</p> <p>Risk: <b>High</b></p> |

**Photo 17: Superseded speed zoning sign; 'Drive to Conditions' sign is totally illegible**

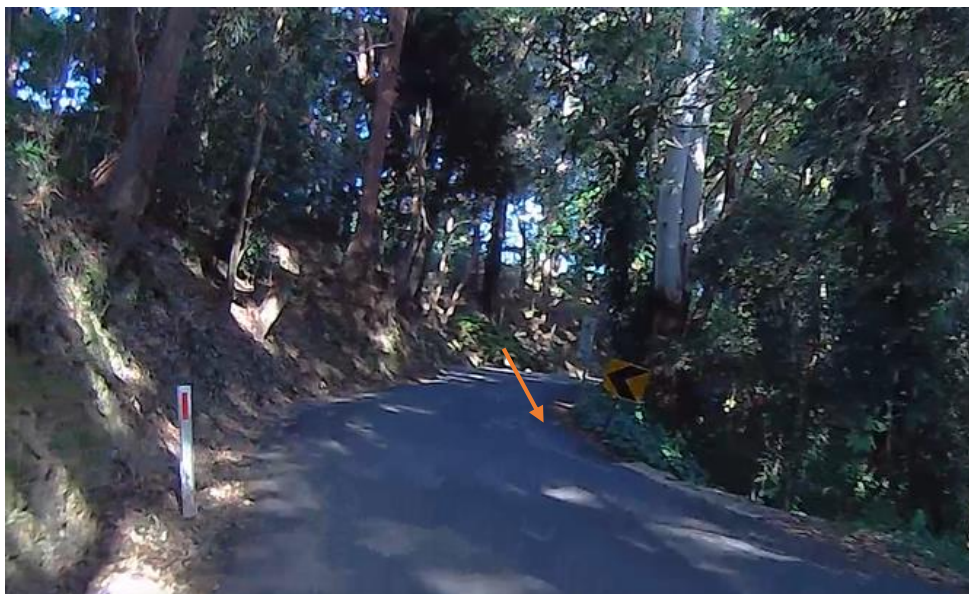
| 17 | <p><b>“Slip” at Ch. 1250 - Priority</b></p> <p>At Ch. 1250, a recent “slip” has been repaired, and the road reduced to a short section of one lane travel. The “slip” is in a narrow winding section of road, and approach sight distance to the hazard is minimal. A convex mirror has been installed for westbound traffic. A painted edge line to define the slip is barely visible.</p> <p>Eastbound traffic appears to have priority (there is a ‘Prepare to Stop’ sign for westbound traffic). However, for westbound traffic, there is no ‘Give Way’ sign (and hence no advance warning of same), and no hold line.</p> <p>Also, CAMs have been used to delineate the “slip” rather than the more appropriate unidirectional hazard markers.</p> <p>There is a risk that a westbound driver may not give way, resulting in a head-on crash, or run-off road crash into a roadside hazard. There is also a risk of a rear end collision when a vehicle is stopped to give way.</p> <p><i>Refer to Photo 18</i></p> <p><i>Location: Ch. 1250</i></p> | <p>Frequency: Improbable</p> <p>Severity: Serious</p> <p>Risk: <b>Medium</b></p> |

| 18 | <p><b>“Slip” at Ch.1250 – Sight Distance</b></p> <p>It is not possible to see oncoming traffic at either end of the restricted passing zone at the “slip”, almost until traffic meets.</p> <p>This may result in oncoming or following vehicle collisions, vehicles passing at the narrow section, or vehicles having to reverse to provide room to pass.</p> <p><i>Location: Ch. 1250</i></p> | <p>Frequency: Improbable</p> <p>Severity: Serious</p> <p>Risk: <b>Medium</b></p> |

**Photo 18: The "slip" at Ch. 1250 – one lane; faded edge line; incorrect use of CAMs**

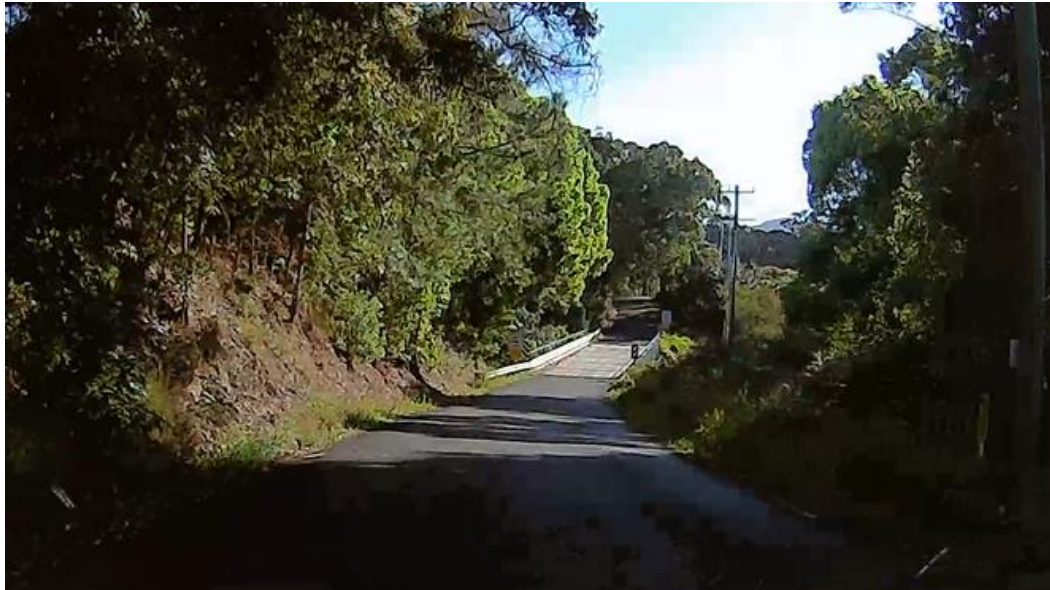
| 19 | <p><b>No Advance Warning of Narrow Bridge</b></p> <p>The width of the rail overbridge at Ch. 2375 is approximately the same as the road approaches. However, the safety barriers have a “walling” effect making the bridge appear narrower.</p> <p>There are no advance warning signs (‘Narrow Bridge’) and no advance ‘No Overtaking or Passing’ signs in the approaches.</p> <p>There is a risk that two vehicles may collide on the bridge, or an approaching driver may lose control and collide with an oncoming vehicle or a roadside hazard.</p> <p><i>Refer to Photo 19</i></p> <p><i>Location: Bridge at Ch. 2375</i></p> | <p>Frequency: Improbable</p> <p>Severity: Serious</p> <p>Risk: <b>Medium</b></p> |

**Photo 19: Westbound approach to rail overbridge**

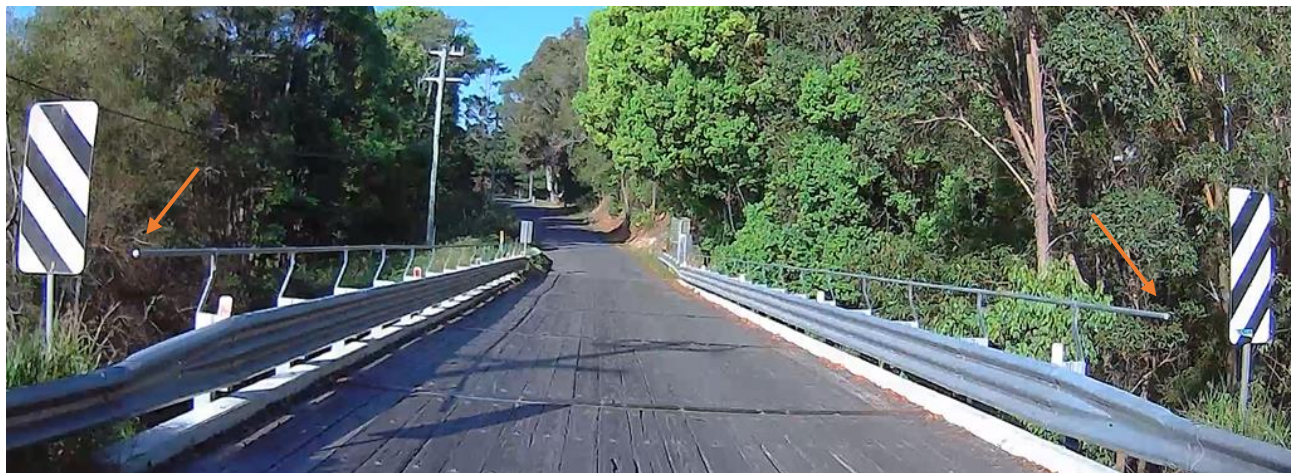
| 20 | <p><b>Possible Spear Hazard from Upper Rail on Bridge at Ch. 2375</b></p> <p>There is a thin tubular rail located above the bridge safety barrier. The rail ends are unprotected. An impact with the end of this rail during a crash may increase the severity of the crash.</p> <p>There is risk of a driver or passenger being “speared” by the rail during a run-of road crash.</p> <p><i>Refer to Photo 20</i></p> <p><i>Location: Bridge at Ch. 2375</i></p> | <p>Frequency: Improbable</p> <p>Severity: Serious</p> <p>Risk: <b>Medium</b></p> |

**Photo 20: Potential spear hazard?**

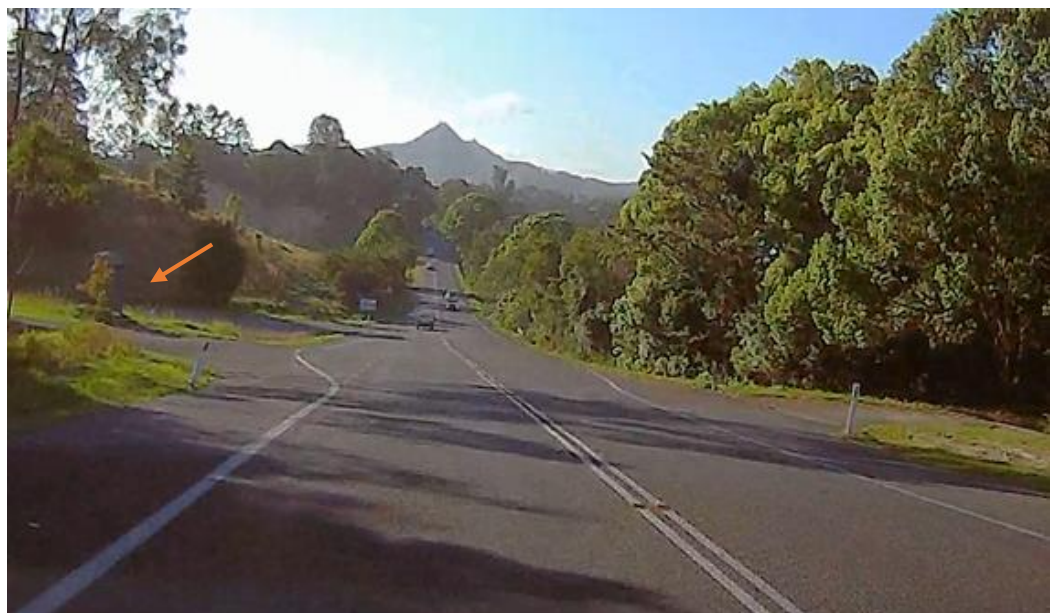
| 23 | <p><b>Bus Stop on Mullumbimby Road</b></p> <p>There is a bus stop on Mullumbimby Road, approx. 70m east of the intersection. For westbound traffic on Mullumbimby Road, the bus stop is just over a crest. There is no advance warning of the bus stop, and sight distance is limited.</p> <p>There is also a “short cut” from McAuleys Lane to the bus stop. Eastbound drivers on McAuleys Lane take the short cut to the bus stop to pick up passengers (observed as mainly school children), then pull out onto Mullumbimby Road (observed mainly turning left). Sight distance to the right is limited.</p> <p>There is a risk of a collision between a westbound vehicle on Mullumbimby Road and a bus pulling into or out of the bus stop. There is a further risk of a collision between a vehicle pulling out of the “short cut” and a westbound vehicle on Mullumbimby Road.</p> <p><i>Refer to Photo 21</i></p> <p><i>Location: Bus stop on Mullumbimby Road</i></p> | <p>Frequency: Occasional</p> <p>Severity: Serious</p> <p>Risk: <b>High</b></p> |

**Photo 21: Bus stop/shelter on Mullumbimby Road – westbound view from crest in road**
