**Re: Dilapidation Report  
Lots 12-14, Section 6, DP 4358, 68 Byron Street, Bangalow**

## DILAPIDATION REPORT

PROPERTY: LOTS 12-14, SEC 6, DP 4358  
68 BYRON STREET  
BANGALOW NSW 2479

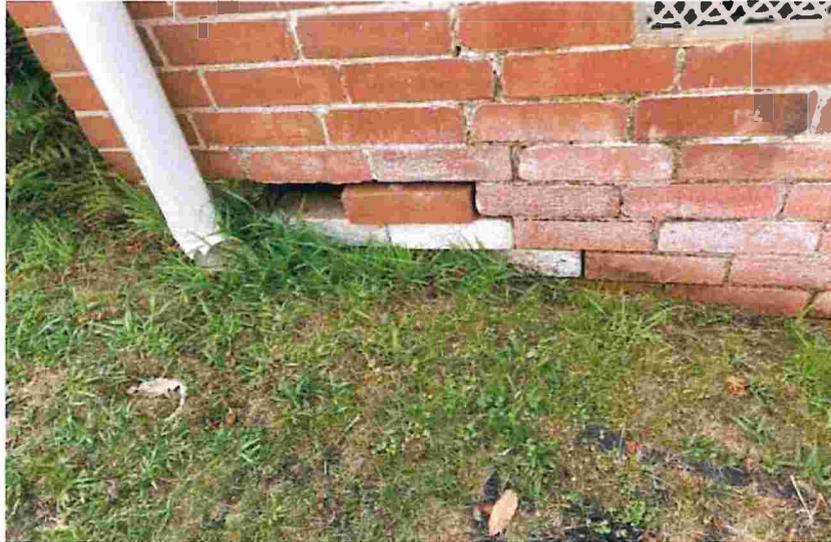
1. Repair hole in brick wall at ground level. Remove 6 bricks; 230mm x 110mm. Bricks to match existing. Mortar to match existing and mortar finish to be flush joint.

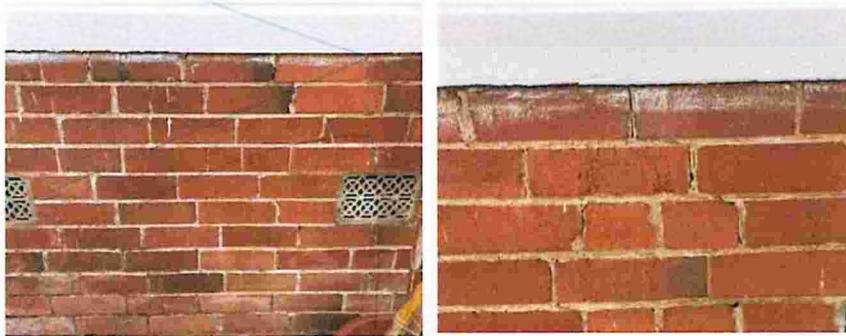
2. Mortar to brickwork; Replace mortar in subfloor brick wall; Wall dimensions 1.5m x 15m. Remove existing mortar to a depth of 20mm and repoint. Mortar colour to match existing and mortar finish to be flush with joint.

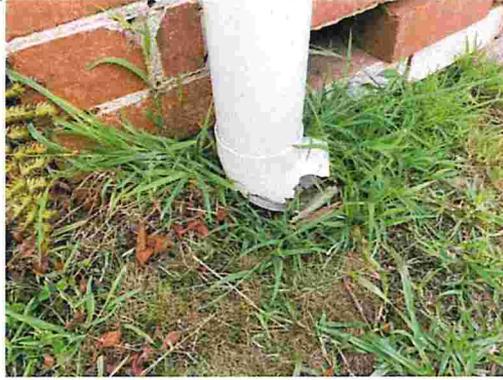
3. Damage to downpipe. Repair and connect to stormwater system. Stormwater pipe to be 100mm PVC pipe installed to a depth of 500mm and embedded in metal crusher dust to a height of 400mm. Replace existing soil over crusher dust as topside finish. Pipe to be directed to existing kerb and gutter to the rear of the lot. Pipe length 35m. Metal kerb adapter for upright kerb to be installed.

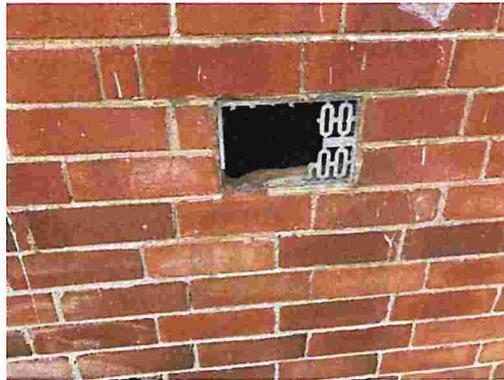
4. Replace subfloor vent 230mm wide x 150mm high. Remove existing and install with same design vent. Repoint with mortar to match existing.

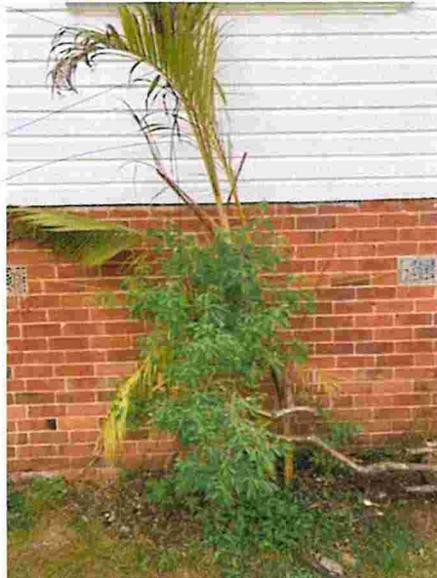
5. Remove palm tree to prevent damage to footings. Replace excavation with top soil.

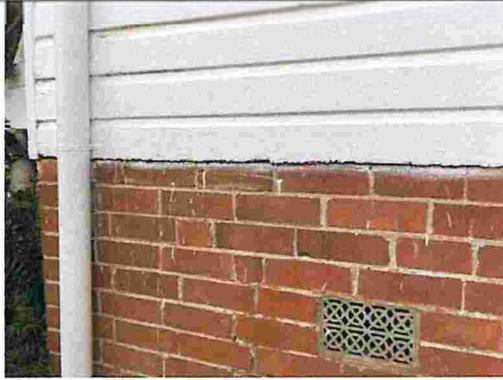
6. Remove and replace existing wet rot and timber decaydamaged chamfer board with matching board. 150mm high x 15m long. Prime board and finish with 2 coats of paint, in a colour to match existing boards.

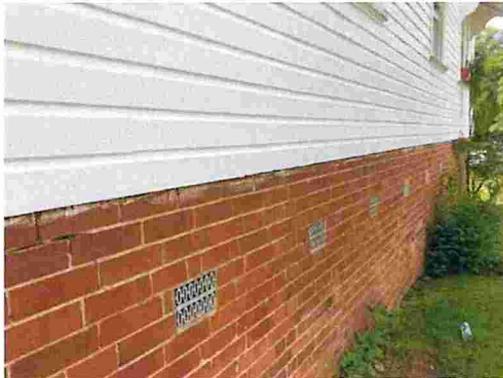
7. Timber clad wallboards to be repaired. Area 15m long x 3.6m high. Wash down wall with wall detergent wash; lightly sand and repaint with 2 coats of external paint to match existing colour.

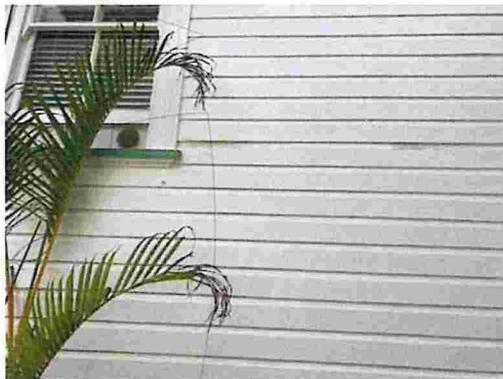
8. Windowsill. sand back and fill holes with proprietary filler or similar 4 sills 1.8m x 0.5m. Paint to match existing colour.

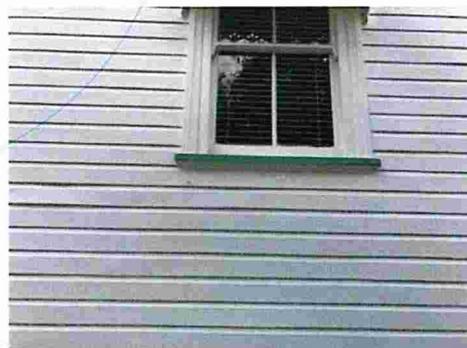
9. Remove glass putty from windows where deteriorated and replace with new window putty. Prime coat and external coat to match existing colour. Length of putty is 25m for windows in this wall.

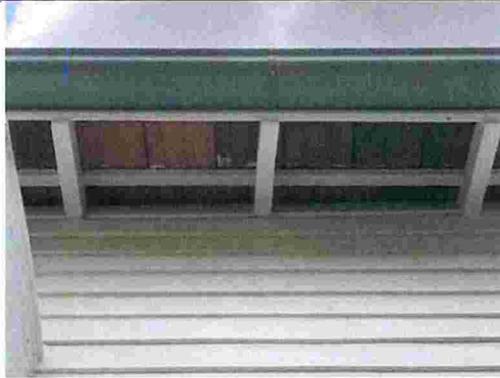
13. Fascia – remove old paint, prime (1 coat) repaint finish coat (2 coats). Colour to match existing. Timber size 25mm x 125mm x 15m.

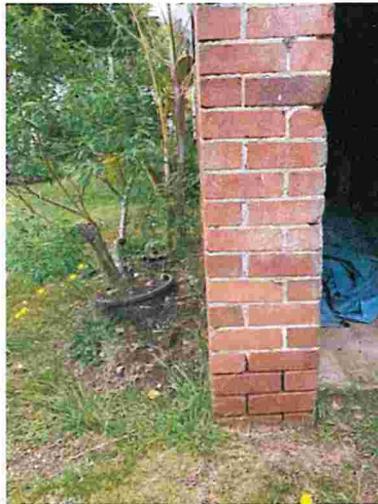
14. Mortar to brickwork; Replace mortar in subfloor brick wall pier. Pier dimensions 1.5m x 0.6m. Remove existing mortar to a depth of 20mm and ~~repaint~~ **repoint**. Mortar colour to match existing and mortar finish to be flush with joint.

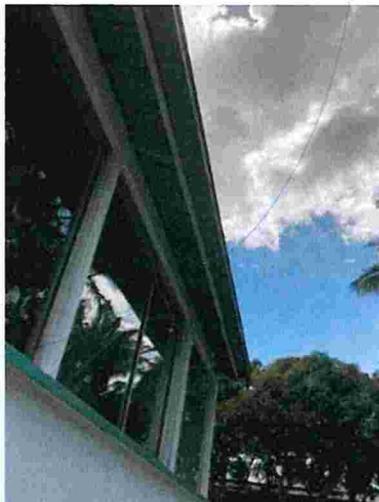
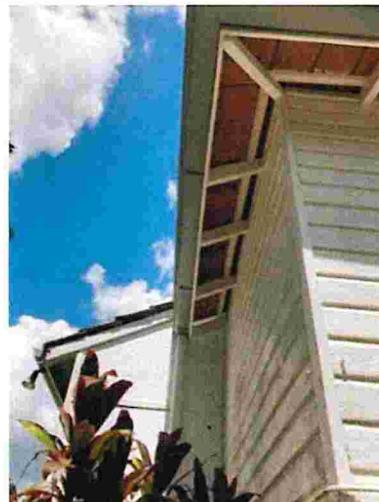
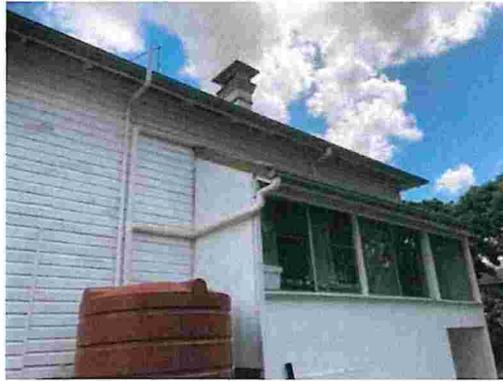
18. Exposed eave rafters to be lightly sanded and repainted 50mm x 125mm x 500mm x 18. Repaint with suitable exterior paint to match existing colours.

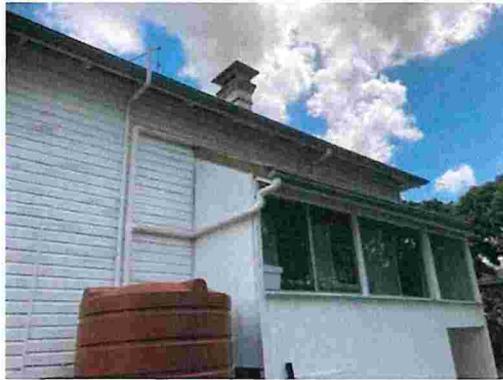
19. Replace metal barge 1.5m with barge roof tiles to match existing roof tiles (East & West ends).

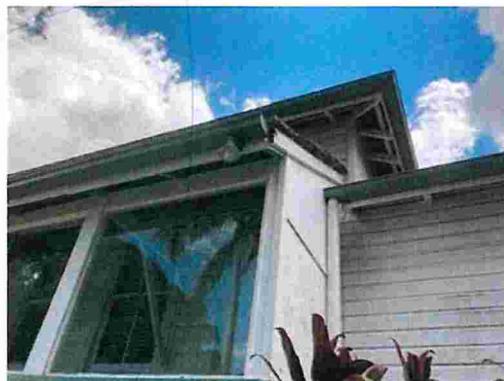
20. Replace timber rafter to awning 1.8m x 50mm x 125mm HWD. Prime coat and finish with 2 coats of external paint.

Wash down FC sheeting and timber window frame using truck wash and repaint with 2 coats of external paint.

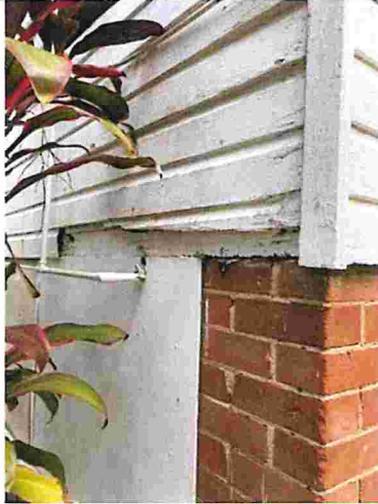
21. Replace timber wall cladding to South East corner. Cladding timber area 25m<sup>2</sup> 150 bevelled edge. Timber to match existing. Paint with 1 coat of timber primer and 2 coats of external paint to match existing colour.

Repaint FC sheet 6m<sup>2</sup> using 2 coats of external paint.

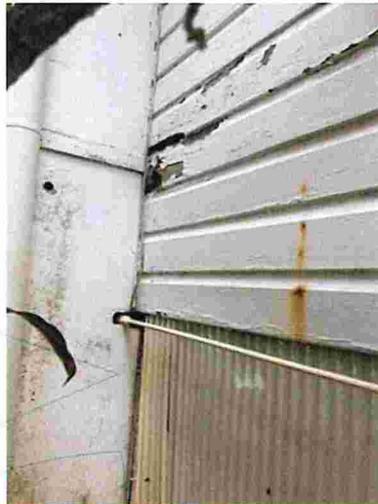
22. Replace both bearer to above wall 150mm x 100mm x 2.5m HWD and portion of stud wall behind cladding. Remove existing cladding and add 5.5m wall sarking and insulation 90mm x 45mm treated timber studs – 7 x 2.5m long.

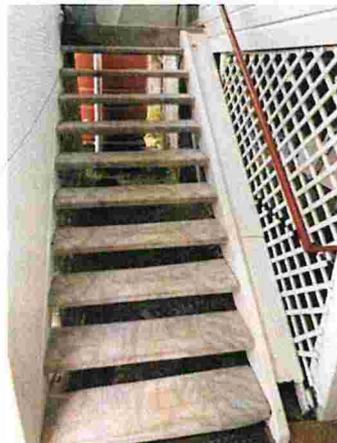
23. Undercover rear access stairs. Remove and replace existing stair construction stringers and treads. Stair size 1.2m wide x 3.0m long. Fixed to ground floor slab and timber joist at top. Tread size 450mm x 50mm. Stringer size 300mm x 50mm HWD.

Stair case to be painted with 1 coat of timber primer and 2 coats of external paint to match existing colour.

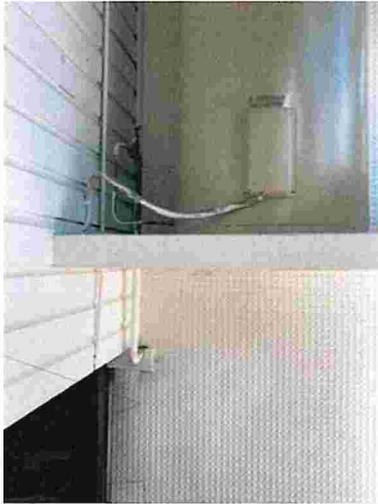
27. Hot water System – Provide copper pipe to pressure relief valve 2m overflow pipe, to be discharged at ground level and away from path of travel.

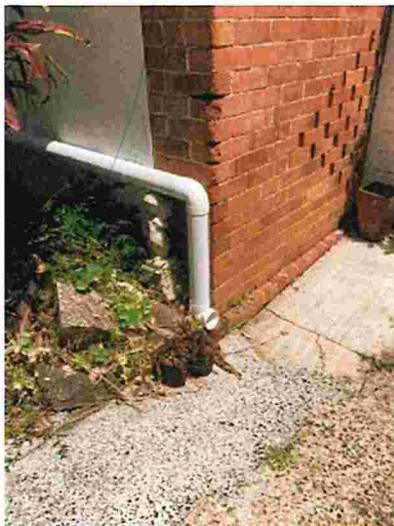
28. Connect stormwater pipe to stormwater system. Pipe to be 100mm PVC installed to a depth of 500mm and embedded in metal crusher dust to a height of 400mm. Replace existing soil over crusher dust as topside finish. Pipe to be directed to existing kerb and gutter to the rear of the lot. Pipe length 20m. Metal kerb adapter for upright kerb to be installed.

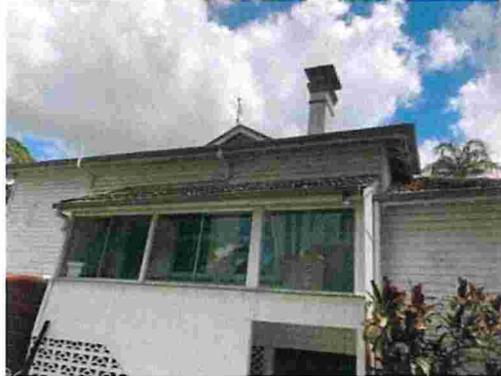
29. Replace fascia and gutter over rear entry stairs to match existing. Gutter and fascia length 5.7m. Lightly sand and repaint with 1 coat of primer and 2 coats of external paint to match existing colour. Repaint roof top gable fascia and eave 4m<sup>2</sup> with 2 coats of external paint to match existing colour.

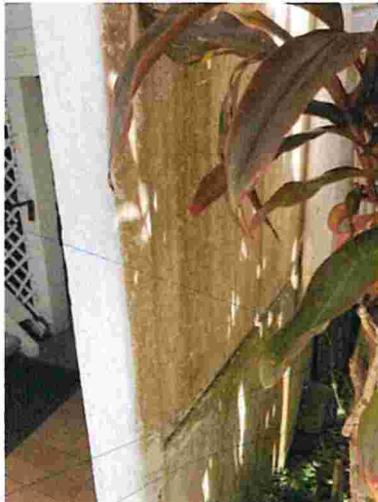
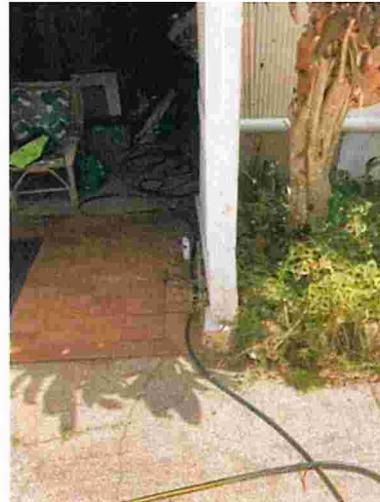
30. Remove post 90mm x 90mm x 2m high HWD. Remove and replace fibre cement adjoining wall cladding – 4m<sup>2</sup>. Paint with 1 coat of primer and 2 coats of external paint to match existing colour.

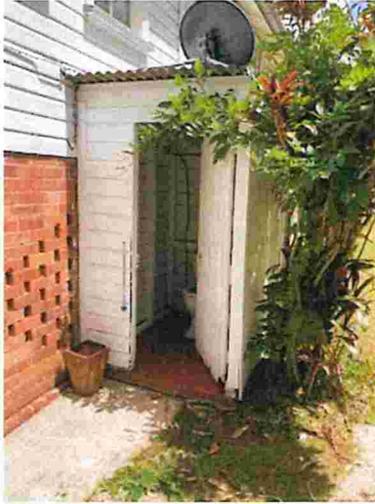
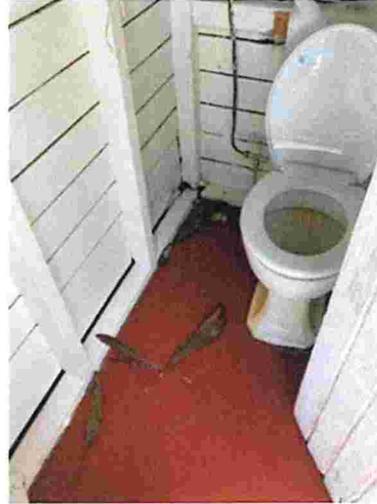
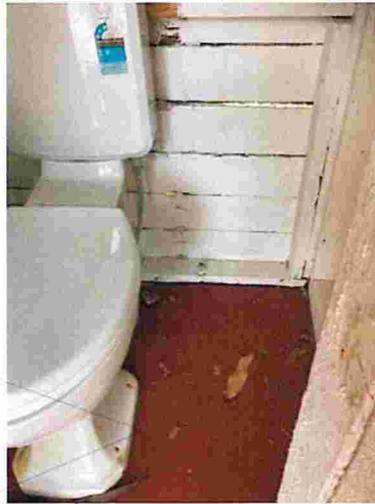
31. Remove post 90mm x 90mm x 2m high HWD. Remove and replace fibre cement adjoining wall cladding – 4m<sup>2</sup>.

Replace external water closet. Bottom plates and studs show significant decay beyond repair.

Existing WC water leak PVC pipe to rear of toilet damaged and leaking. Replace with 50mm pipe x 200mm length.

Construct 4 new walls and timber door 1.3m x 1.5m x 2.1m high.

Replace metal roof – flashing 100m x 150m, barge 150m x 150m, rear gutter 1.3m plus downpipe to stormwater pit.

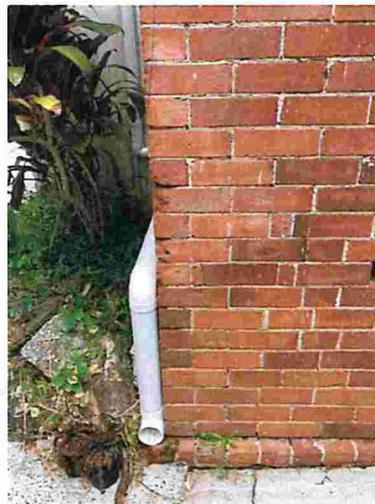
32. Replace damaged and weathered bricks to subfloor brick wall. Remove 10 bricks; 230mm x 110mm. Bricks to match existing. Mortar to match existing and mortar finish to be flush joint.

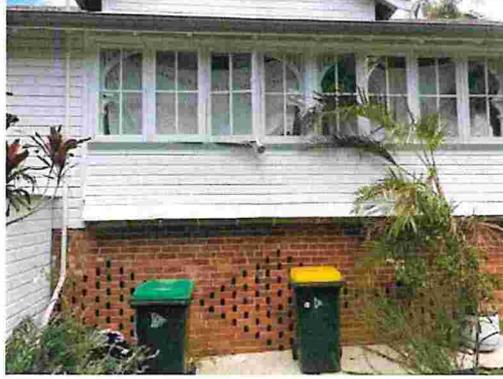
33. Timber clad wallboards (25m<sup>2</sup>) to be washed down with wall detergent wash. Lightly sand and repaint with 2 coats of external paint to match existing colour.

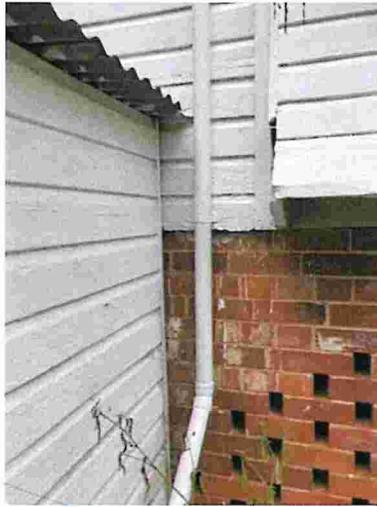
34. Replace vertical cladding adjacent to PVC pipe using 70mm x 18mm x 4.0m HWD. Paint with 1 coat of primer and 2 coats of external paint to match existing colour.

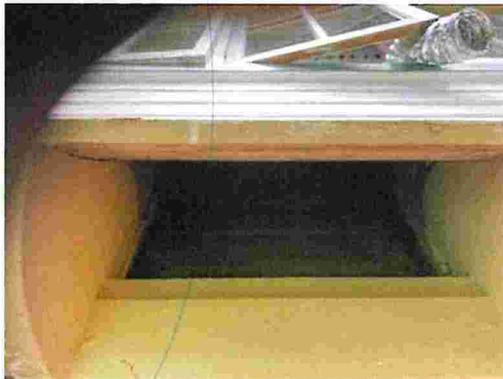
35. Wall ventilation openings – Install vermin proof mesh to prevent access to wall and roof space. Combined area 10m x 250mm. [Below image](#)

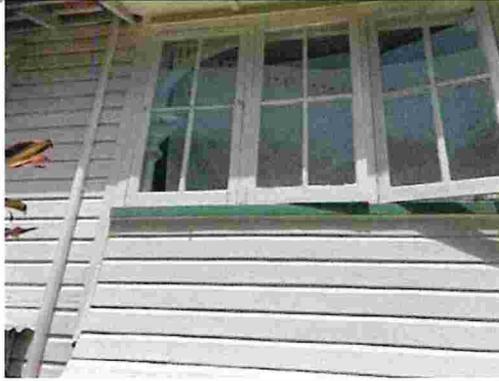
36. Window glass panes – Remove deteriorated putty and replace with new (30m in combined length).

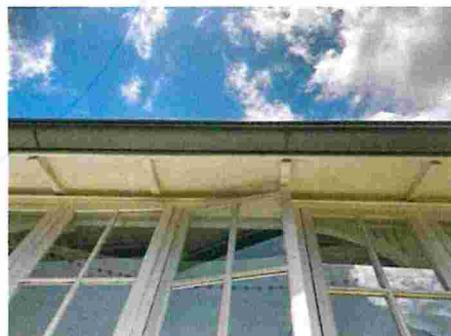
39. Eave and rafters – Lightly sand and repaint with 2 coats of external paint to match existing colour. Rafters – 75mm x 50mm x 500mm x 21 rafters. Eave area – 7m<sup>2</sup>.

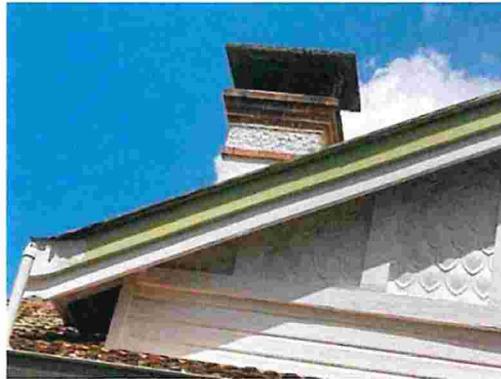
40. Fascia barge – Remove and replace metal roof barge 8m to match existing.

Protect and refurbish pressed metal sheet, treat with rust protection prior to repainting

Replace and repaint fascia gable with 1 coat of primer and 2 coats of external paint to match existing colour.

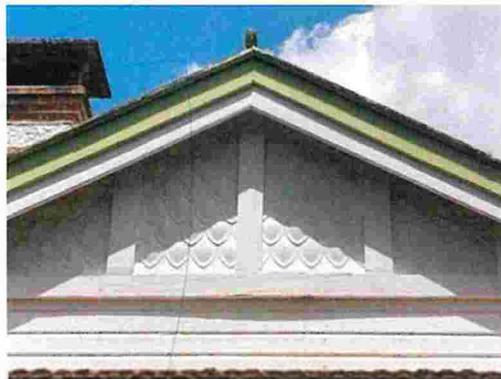
41. Gable wall lining– Remove and replace timber boards – 4.5m x 150mm x 38mm HWD.

Cladding – Remove and replace horizontal timber chamfer boards 4 x 150mm x 6m

Sarking – Install 5m<sup>2</sup> wall sarking behind cladding.

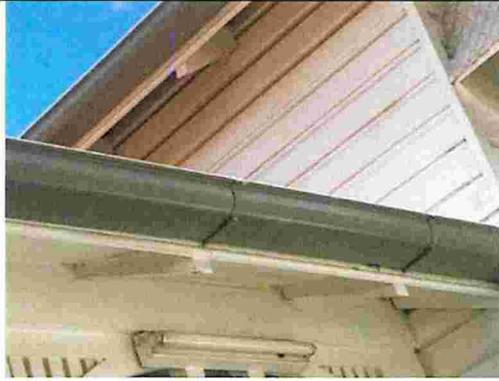
42. The inspection noted that there were no issues to the guttering to North side of property.

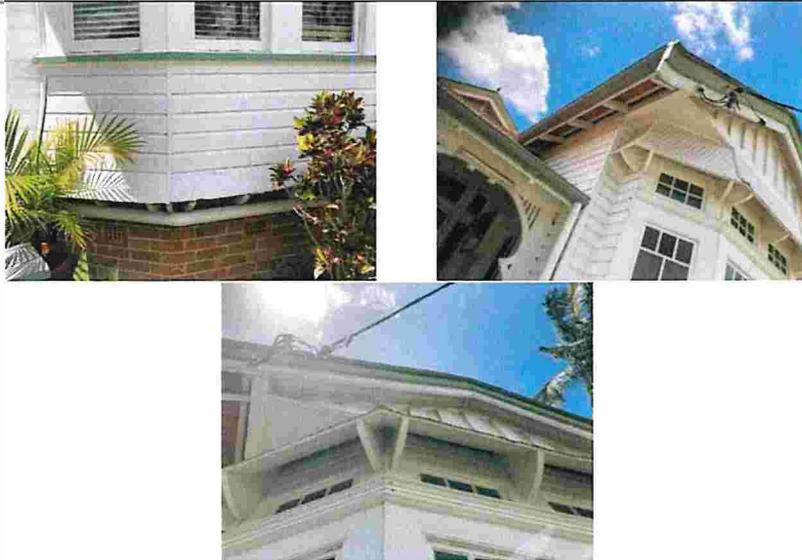
45. Cladding and verandah boards – 55m<sup>2</sup>. Wall cladding to be washed down with wall detergent wash. Lightly sand and repaint with 2 coats of external paint to match existing colour.

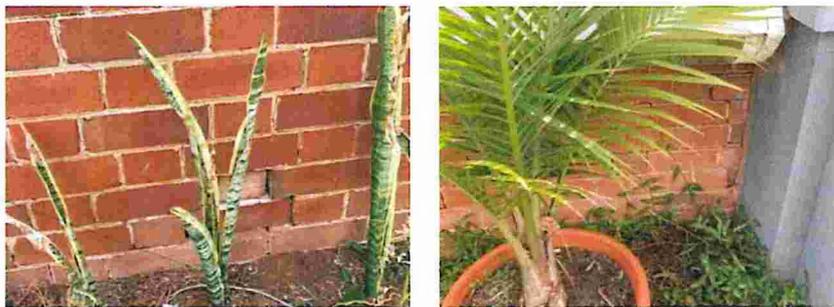
46. Subfloor brick wall – 8m<sup>2</sup>. Replace 50 bricks in subfloor brick wall to match existing. Repoint existing mortar to a depth of 20mm and repoint. Mortar colour to match existing and mortar finish to be flush with joint.

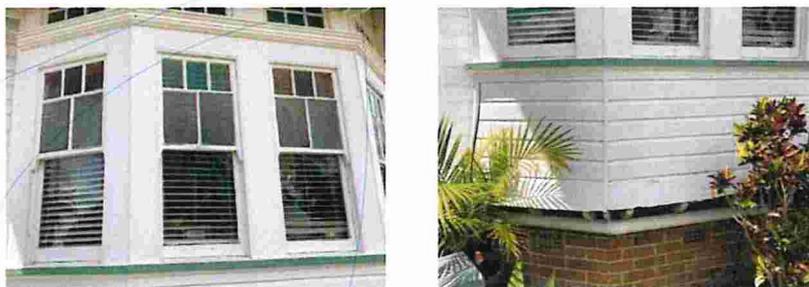
47. Window glass panes – Remove deteriorated putty and replace with new (8m in combined length).

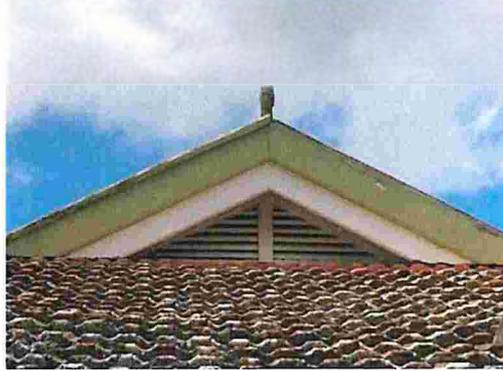
48. Fascia barge – Remove and replace metal roof barge 6m to match existing.

Replace and repaint fascia gable with 1 coat of primer and 2 coats of external paint to match existing colour. **Replace missing gable roll to match existing**

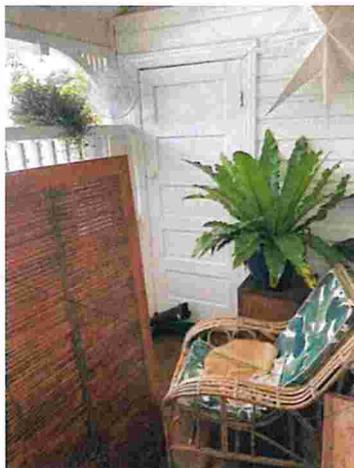
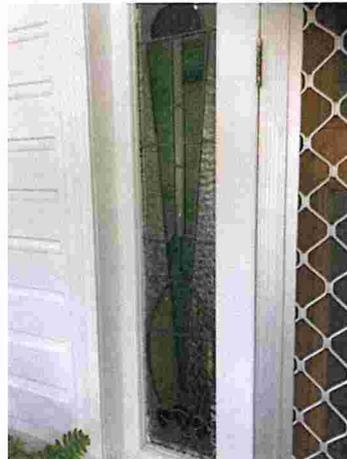
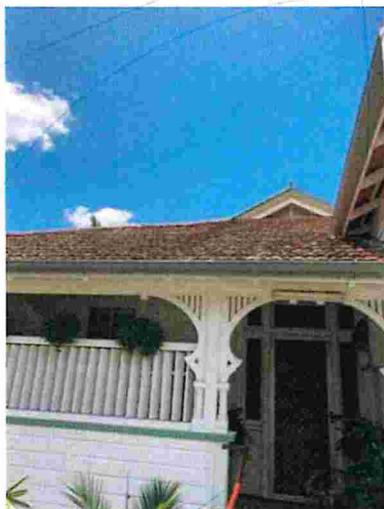
49. Leak over entry on East side and minor mould evident on ceiling adjacent to stairs. Most likely resultant from leak in roof above. To be rectified by complete replacement of roof as recommended in this report.

Repaint walls, windows and doors 60m<sup>2</sup> - Lightly sand and repaint with 2 coats of external paint to match existing colour.

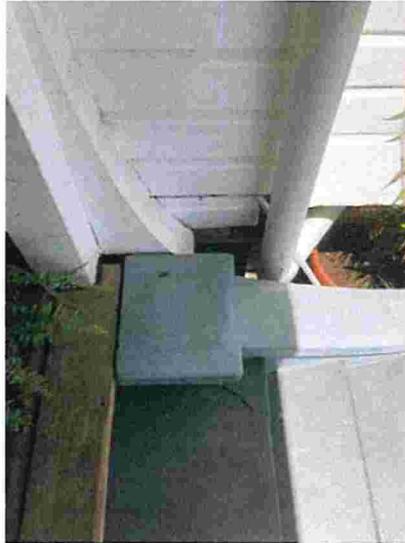
50. Remove and replace damaged concrete tread 1200mm x 500mm x 50mm to entry steps.

Remove and replace damaged chamfer board wall cladding adjacent to stairs 2m length to match existing. Paint with 1 coat of primer and 2 coats of external paint to match existing colour.

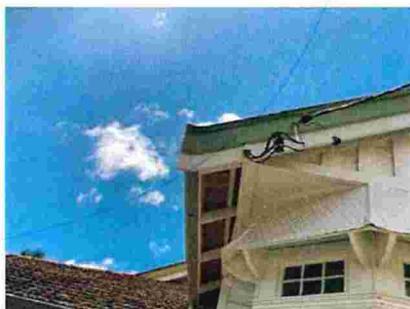
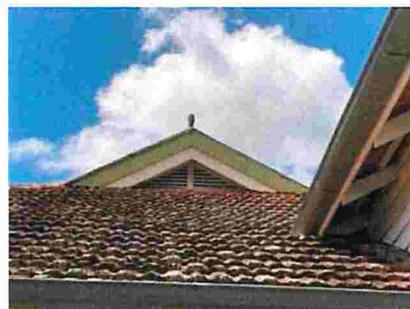
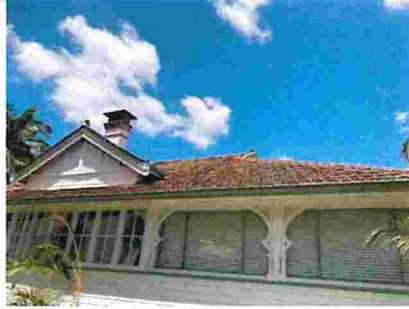
#### 51. External Tiled Roof – approximately 255m<sup>2</sup>

A thorough inspection of the tiles was not undertaken due to height work safety legislation i.e. greater than 1.8m above ground. This inspection was further complicated by advice from the tenants that recent works by an electrician resulted in damage to the tiles.

This damage was expected as the tiles are estimated to be over 80 years of age.

Visual inspection also revealed height variations within the tile landscape indicating that movement of roof timbers (rafters and battens) had caused this movement. It is considered not safe to apply physical weight load on the existing tiles.

Visual inspection within the roof space revealed a pitched timber construction. This timber construction is considered not in compliance with relevant timber framing codes and considering the age of the building, reroofing would be recommended, including Engineers advice regarding upgrading of the roof timber structure.

In addition to the above, there are several areas in the internal ceilings indicating moisture penetration and a subsequent growth of mould. Thereby indicating the existing roof structure is vulnerable to water penetration in the future.

Therefore, it is recommended that the entire tiled roof area be also retiled with heritage tiles to match existing with the inclusion of roof sarking and roof insulation to minimise risk of water leaking to the ceilings below and also enhance comfort zones to the habitable rooms below.

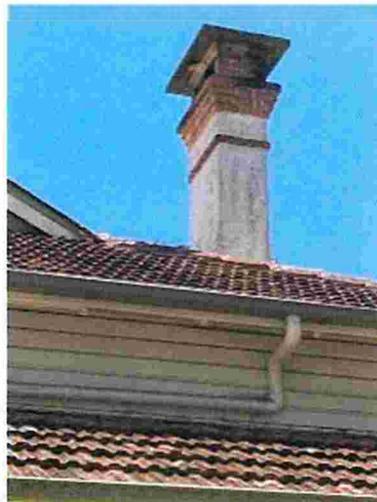
52. Chimney. A thorough inspection of the chimney was not undertaken due to height work safety legislation i.e. greater than 1.8m above ground. Please note that the tenants have been advised by the owners/agents not to use the chimney.

Inspection of this item should be undertaken by a chimney expert with regards to its state of use and recommendations for maintenance.

Inspection by structural engineer

Repoint void joints or missing mortar

Cap chimney opening with CFC sheet, fix securely

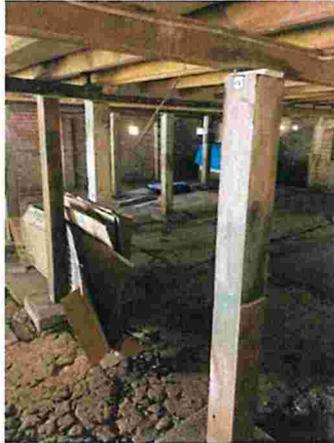
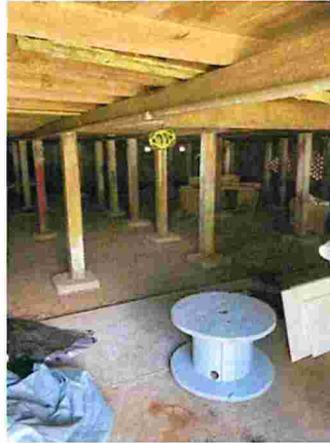
54. The inspection noted posts approximately 1.8m high, no cross bracing provided compliance with timber frame code and BCA is recommended. Structural Engineer to be engaged to provide subfloor-bracing solution.

Post missing and required to South West corner 2150mm high. 145mm x 145mm HWD with ant cap. Concrete pad on existing concrete slab 600mm x 600mm x 200mm high.

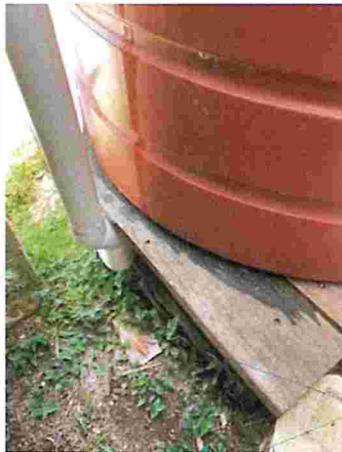
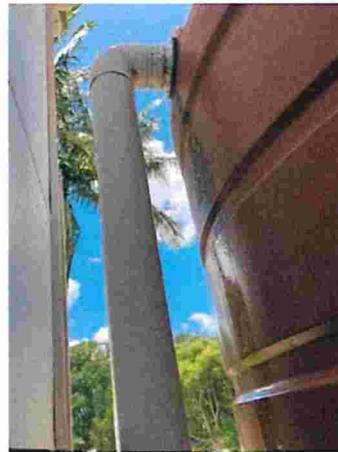
55. PVC water tank. Repair leak at outlet.

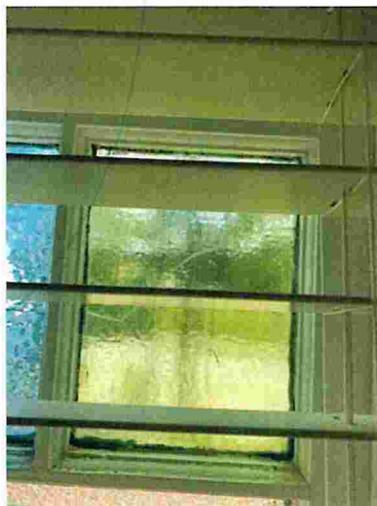
56. Cracked glass pane. Remove and replace cracked pane 150mm x 220mm glass to match existing.

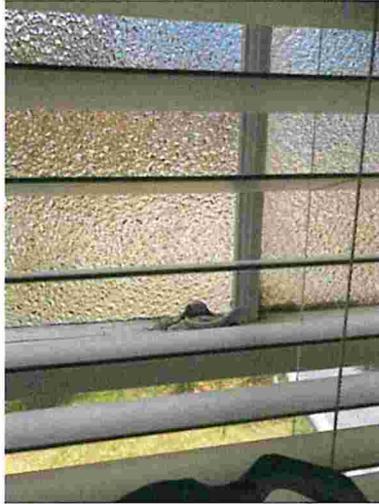
57. Maintenance to casement window rollers and latch for ease of operation.

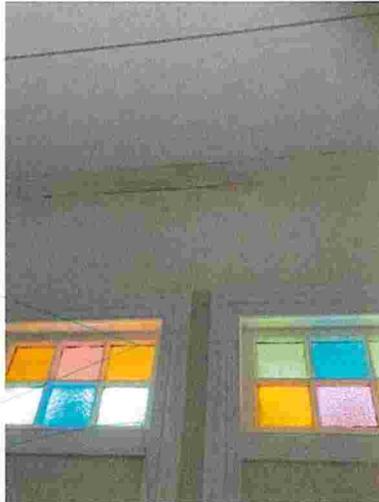
58. Stain to cornice. Replace 2m cornice and wall 2m<sup>2</sup> plasterboard. Repaint with internal ceiling paint to match existing. Replace with Fibre Cement Sheet, plaster joints - reuse existing cornice if sound.

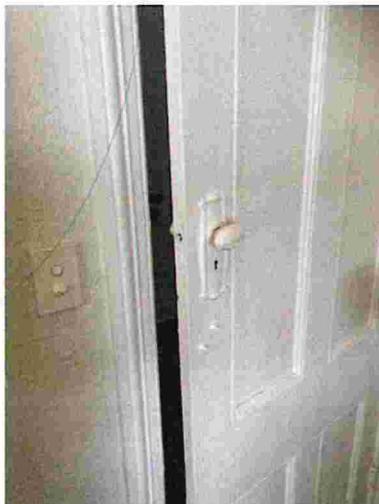
59. Ease and adjust door hinges for ease of access and so as to ensure that door closes to the latch position.

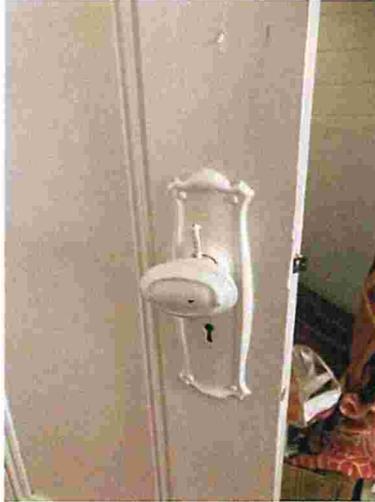
60. Replace door lock to match existing. **Repair existing door handle/locking/latch**

Limited access for inspection of walls and floor due to stored goods within room.

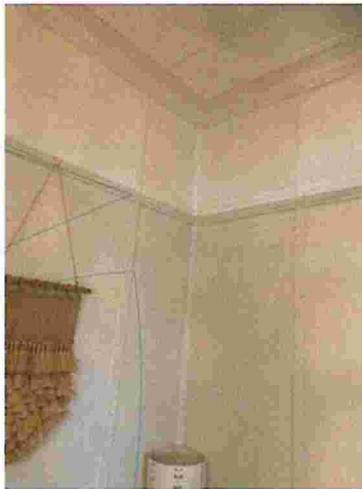
61. Remove stain approximately 1m<sup>2</sup>. Repaint ceiling with internal ceiling paint to match existing.

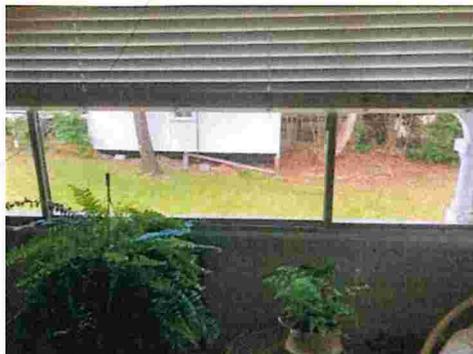
62. Maintenance to aluminium window rollers to 4 windows – 1.2m x 2.4m.

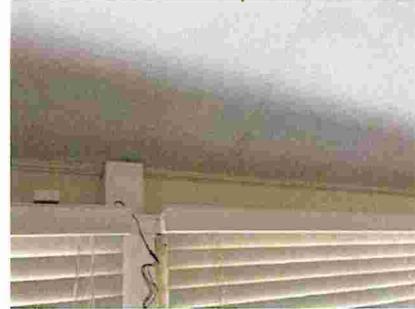
63. Stain and mould evident to ceiling. Remove stains approximately 2m<sup>2</sup>. Repaint ceiling (25m<sup>2</sup>) with internal ceiling paint to match existing. **Treat for mould and clean prior to painting add mould inhibitor to new paint.**

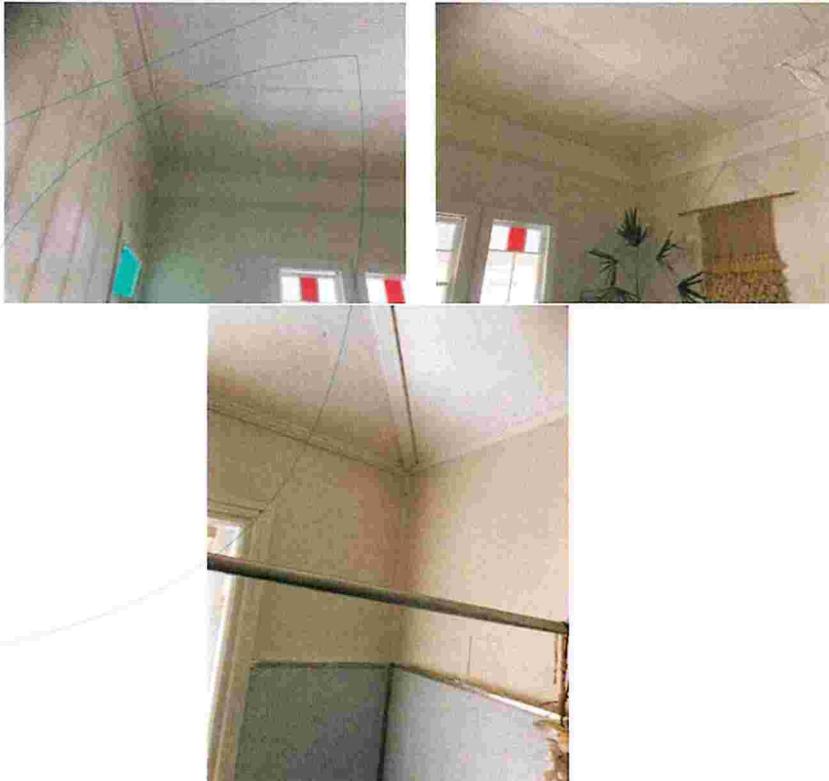
68. Remove ceiling mould and repaint ceiling with internal ceiling paint to match existing.

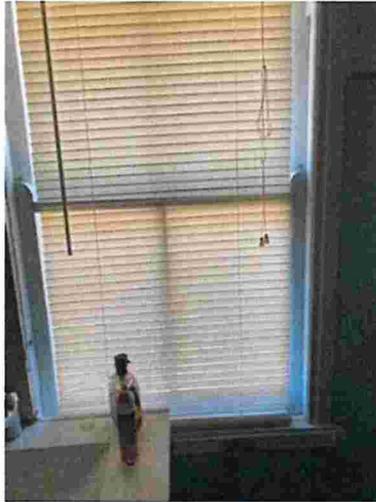
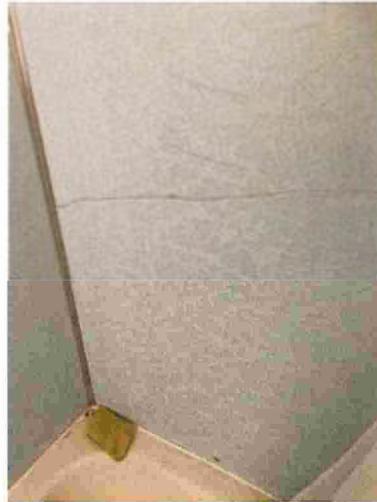
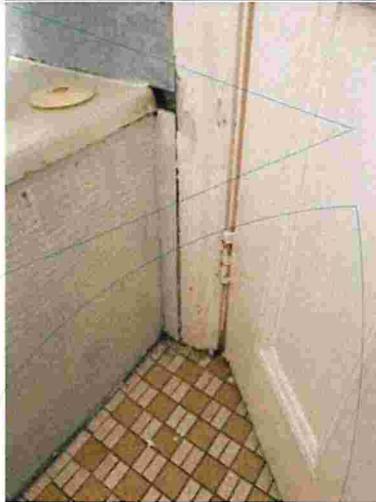
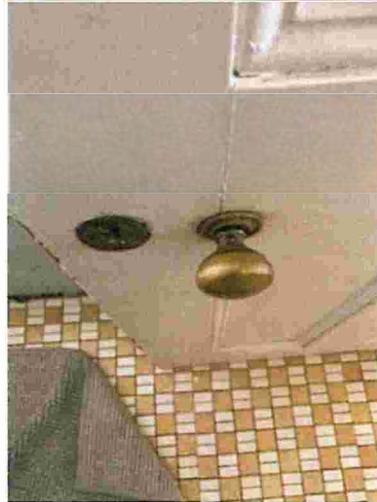
69. Cracked wall panel. Remove and replace with similar product – 1.5m<sup>2</sup>.

Patch hole adjacent to entry door – 50mm x 50mm.

Ease and adjust window for ease of access and so as to ensure that window closes to the latch position.

Ease and adjust entry door hinges for ease of access and so as to ensure that door closes to the latch position.

Replace door furniture to bathroom door. **Repair existing hardware.**

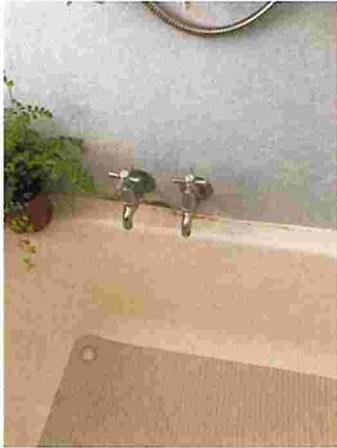
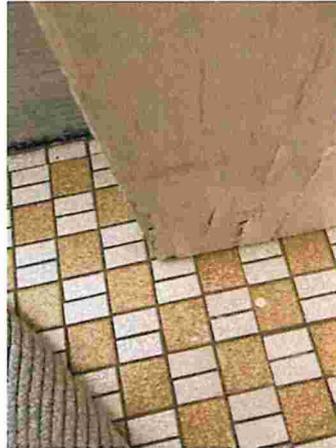
70. Seal bathtub enclosure and adjoining floor tiles using silicon – 3m.

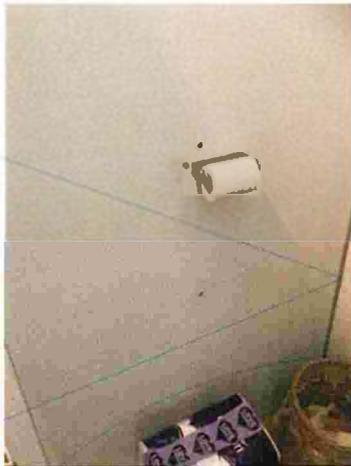
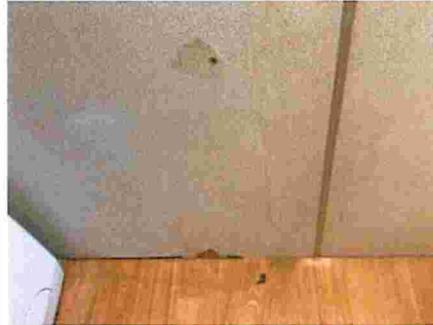
71. Dispose and replace Laminex sheet where holed and fit new paper dispenser. Area 10m<sup>2</sup>.

Provide waterproof seal to junction of wall and floor. Area 10 lineal metres.
