30 October 2017

WRL Ref: WRL2017065:DH:JTC LR20171030

## **Clarkes Beach Access**

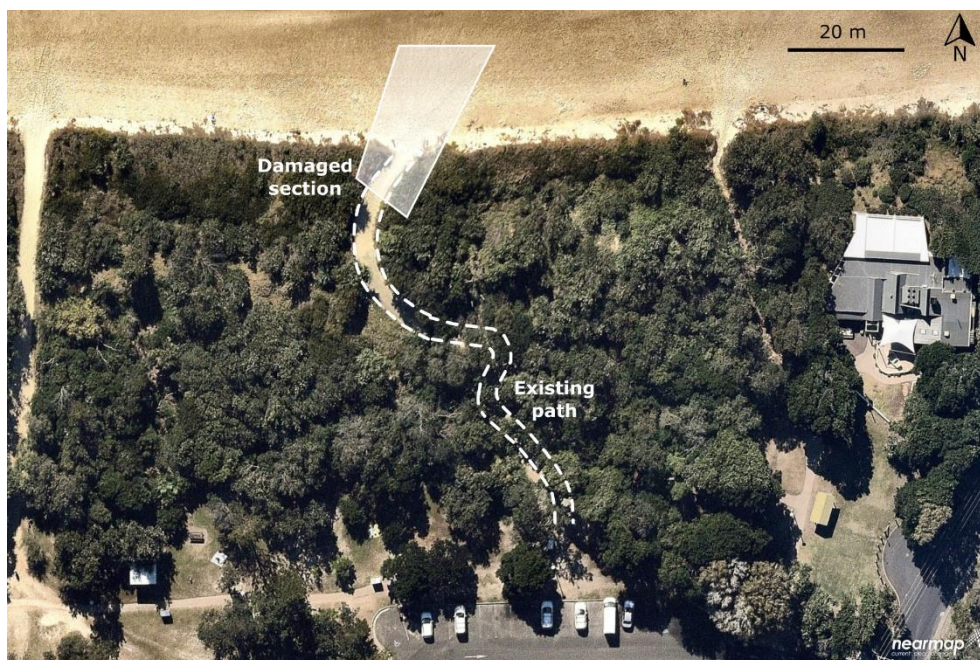
**Figure 1. Access path to Clarkes Beach (source: Nearmap/BSC)**

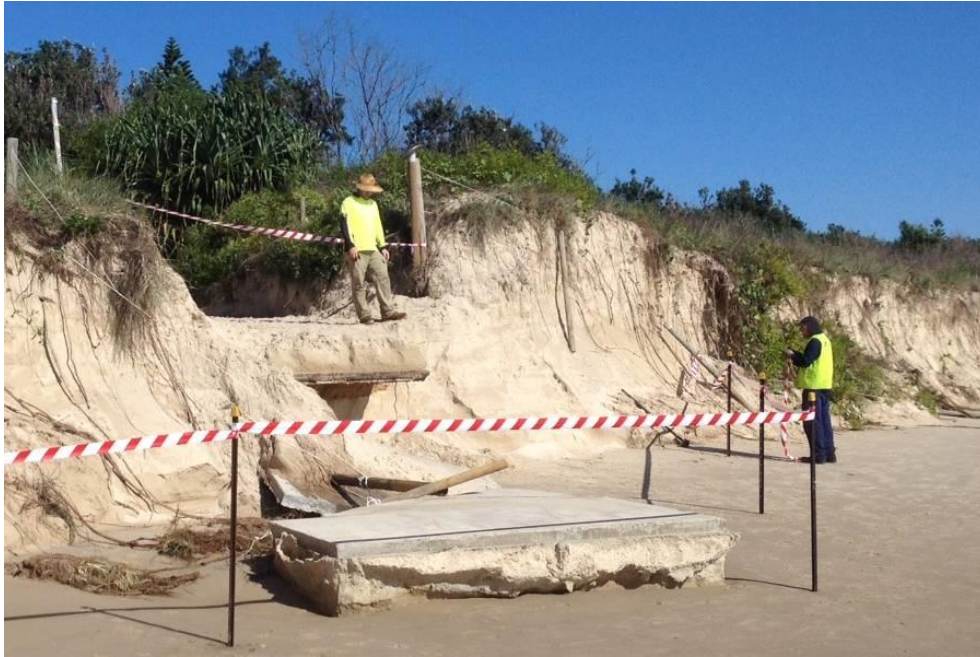
Recent erosion at Clarkes Beach has caused the seaward end of the concrete beach access path to collapse (Figure 1, Figure 2). The Water Research Laboratory (WRL) of the School of Civil and Environmental Engineering, UNSW Sydney has been commissioned by Byron Shire Council (Council) to investigate options for reinstating beach access.

**Figure 2. Damaged section of access path (source: BSC)**

The remaining portion of the existing beach access consists of a concrete slab on ground. The erosion hazard assessment indicates that larger erosion events than recently experienced are possible and therefore part of the remaining path could be vulnerable to further undermining. It may be acceptable to leave this vulnerable remaining portion intact provided that if undermined, it does not cause the collapse of newer seaward portions.

- Landward of the 100 year ARI erosion zone:
  - Any option can be pursued, noting that elevated structures can allow vegetation growth and fauna passage;
- Between the 100 year ARI and 10 year ARI erosion zone:
  - A rigid option founded on piles will allow the continuation of a planar ramp with only occasional interaction with coastal processes. Such piles will need to be founded on bedrock or designed with sufficient foundation friction.
- Seaward of the 10 year ARI erosion zone:
  - A board and chain structure with a maximum gradient of 1V:4H is recommended.
  - Minor local beach scraping and adjustments to the boards will be needed to retain beach access following storm erosion events.

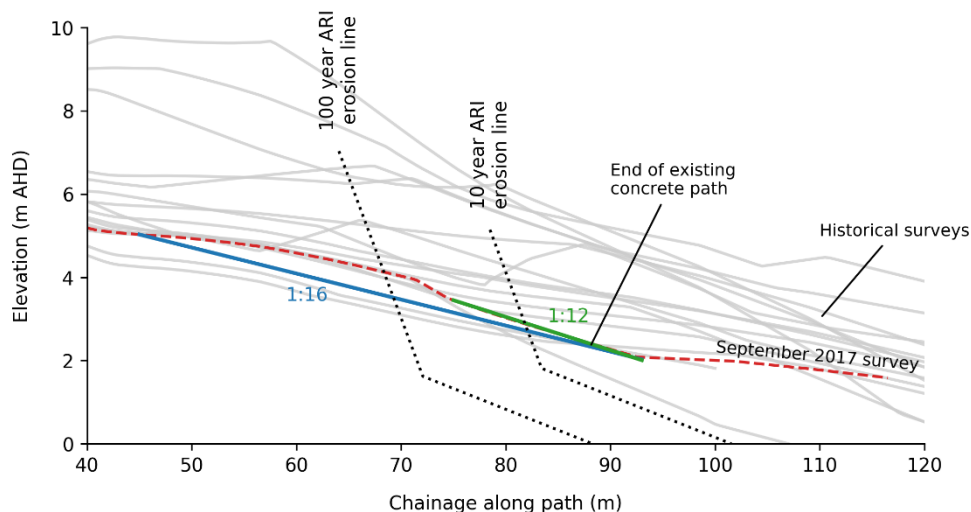
Depending on the final design of the beach access path, it may be exposed to waves and/or dune reshaping from storm events. This section of Clarkes Beach is active, and the historical photogrammetry beach profiles show large variation in the past 70 years (Figure 3). The access path is within the 100 year ARI erosion hazard line (Figure 4). Erosion hazard lines for this study are based on the "zone of slope adjustment" calculated using the Nielsen (1992) method, on the 1999 surveyed beach profile, with erosion volumes based on guidance from Gordon (1987).

**Figure 3. Elevation profile of existing path and historical beach surveys**

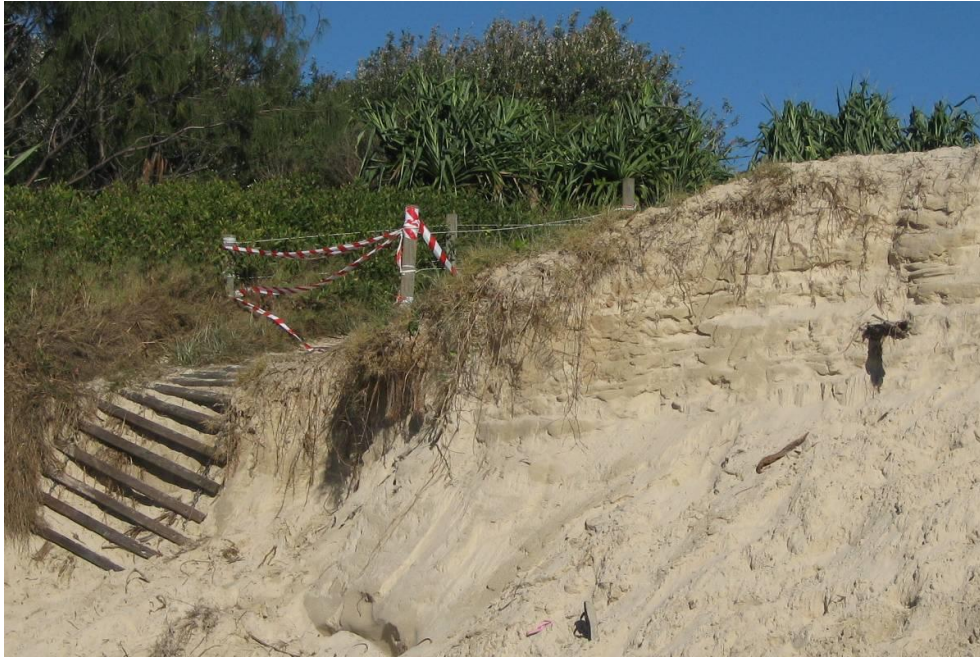
- Must be manually re-established after major erosion to dunes (Figure 6);
- Corrosion of galvanised bolts and chains (stainless steel fittings could be used but these may then substantially exceed the life of the timber);
- Decay of timbers;
- Potential for splinters; and
- Can be difficult to negotiate if timbers are too narrow and too widely spaced.

**Figure 6. Destabilisation of board and chain path after dune erosion (source: J Carley, WRL)**
