# BYRON BAY

## TREE SERVICES

On Monday the 7<sup>th</sup> May 2018 I attended a site to inspect 2 trees with a "Tree House" between them adjoining private property 77 Massinger Street Byron Bay. Both trees were located and inspected and their current condition documented. Both trees are located on council land, the first (tree 1) was identified as being a Forest Red gum (*Eucalyptus tereticornis*) with a diameter at breast height (d.b.h) of 400mm, estimated height of approx. 16m and would be classed as semi mature. The second was a Grey Ironbark (*Eucalyptus siderophloia* Benth.) d.b.h 370mm estimated height of 13-14m.

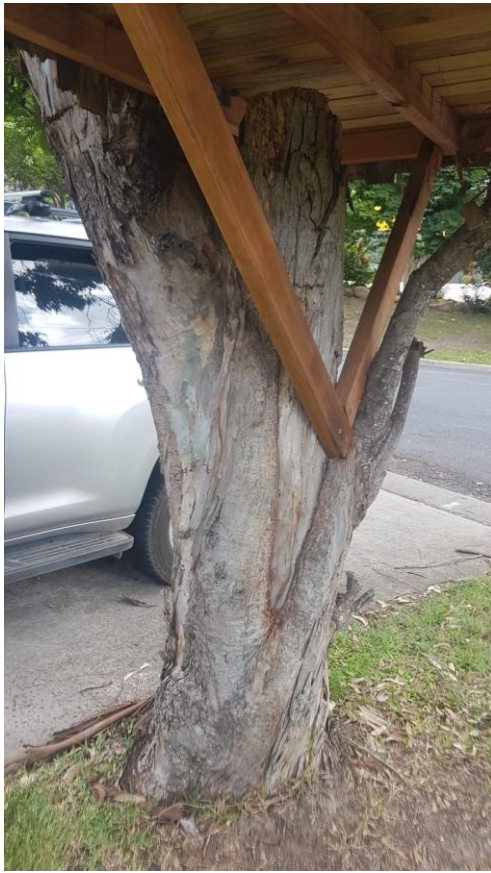
Roots are girdling around the base of the tree in the Southern sector and are now occluding the concrete driveway. Attachment of the tree house is by way of a prop attached to the dead tissue of the trunk with roofing screws, and a chain (since been removed) was wrapped around the apical stem.

Pic 1 showing bracing/ propping of the tree house and attachment points

Ongoing inspection of the trees is recommended every 12- 24 months by a qualified cert V arborist. Further detailed Inspection of the dead section of tree1 in 24 months is strongly recommended as this would appear to be one of the major loading points of the structure.

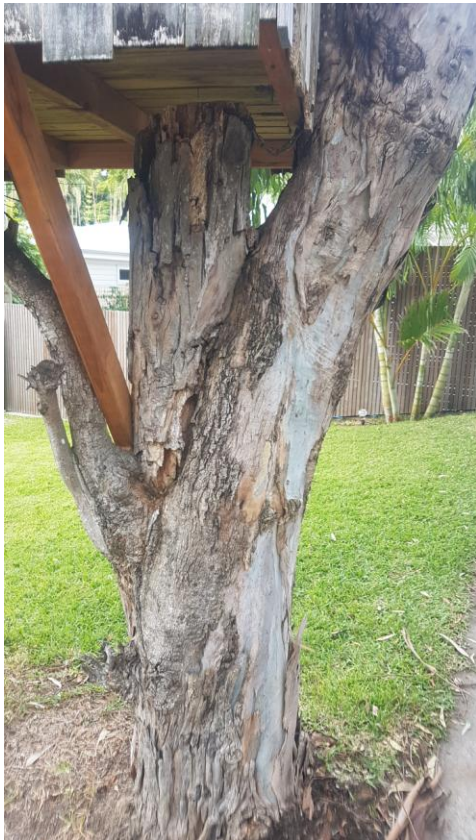
Tree 1 Forest red gum, is located North of the concrete driveway between the property boundary and the road. It consists of one primary apical dominant stem growing in the Southern sector, this stem is healthy, growing vigorously. Its growth is a direct response to the removal of the original central apical trunk, estimated to have occurred approx 10-15 years ago. The central "lopped" trunk is dead at approx 1.8m above ground level and is now in a state of decay, with wounding from approx 300mm from ground level to the top. Wound wood development is fair to average for a tree of this age and its given environment. There is a small stem growing to the north which has recently died.

The dead wood was sounded using a plastic hammer and resonance indicates the trunk is not sound wood.

Pic 2 showing Decaying central stem and marks left by chain(recently removed).

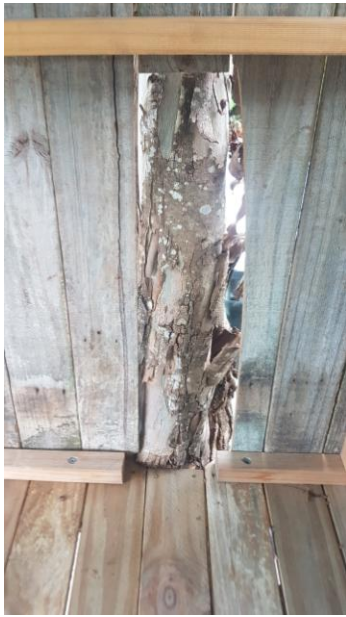
Pic 3 showing branch rubbing on the floor of the tree house. Pannel has been removed to allow for growth.

1. Chains wrapped around the trees should be loosened to allow for trunk expansion.
2. Nuts attached to the threaded rod should be loosened and joists will need to be moved away from the trunk to allow for trunk expansion. If these joists are not moved the tree will eventually push them apart and snap them.
3. Floor boards and roof should be cut to allow a gap of approx 25mm or more again to allow for trunk expansion.

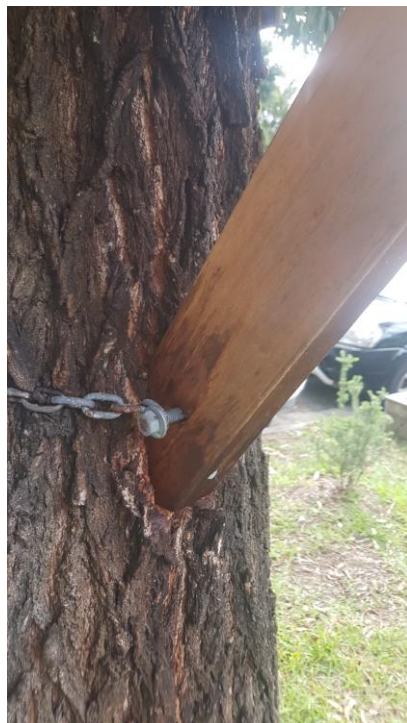
the prop attachment would have caused minor wounding during installation but impact would be very minor. The chain around the trunk is the greatest concern. During secondary wall expansion in the tree the chain if not loosened will be included into the tree.

Pic 4 attachment of Prop to trunk.

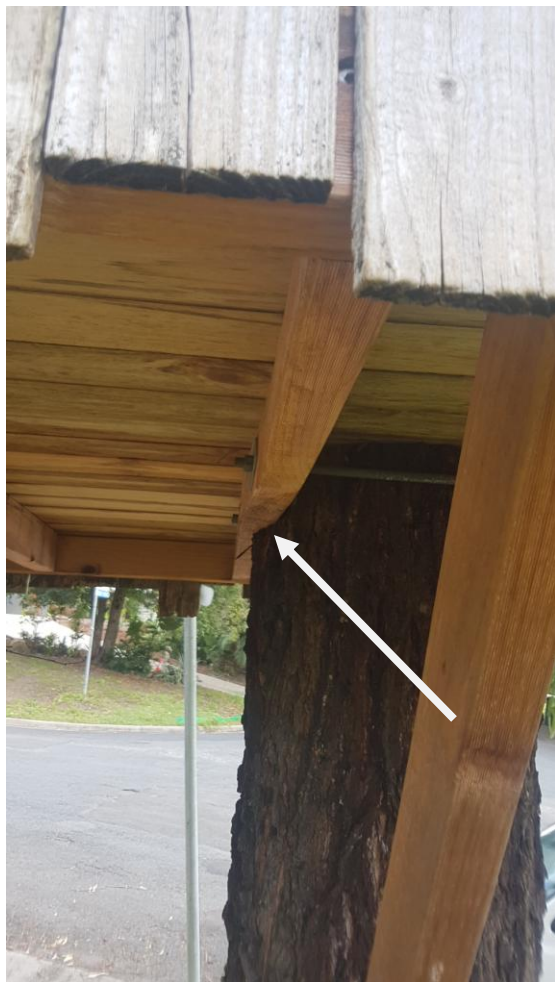
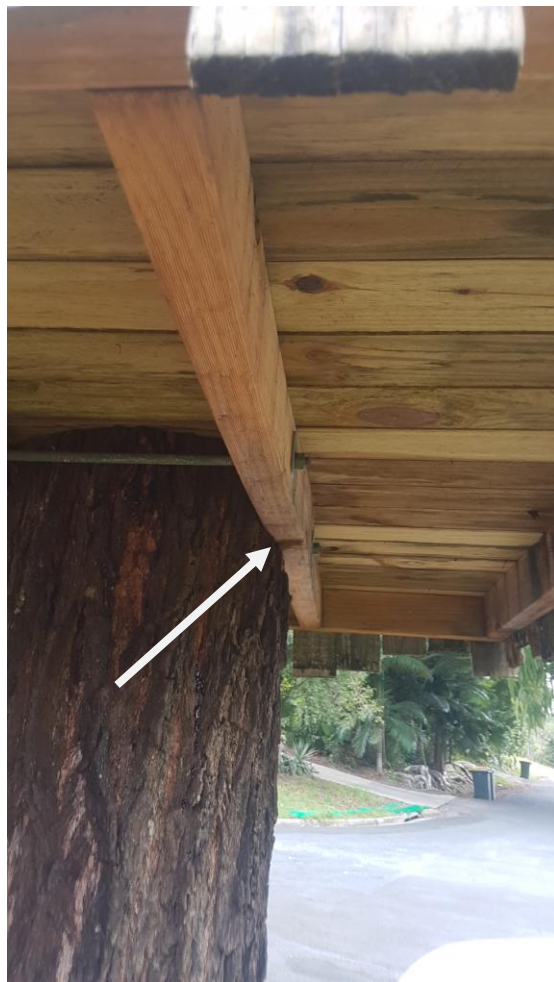
Pics 5 and 6 above indicate expansion of the trunk since installation of the tree house and subsequent movement of the joists and threaded rod effectively sandwiching the tree house to the tree.

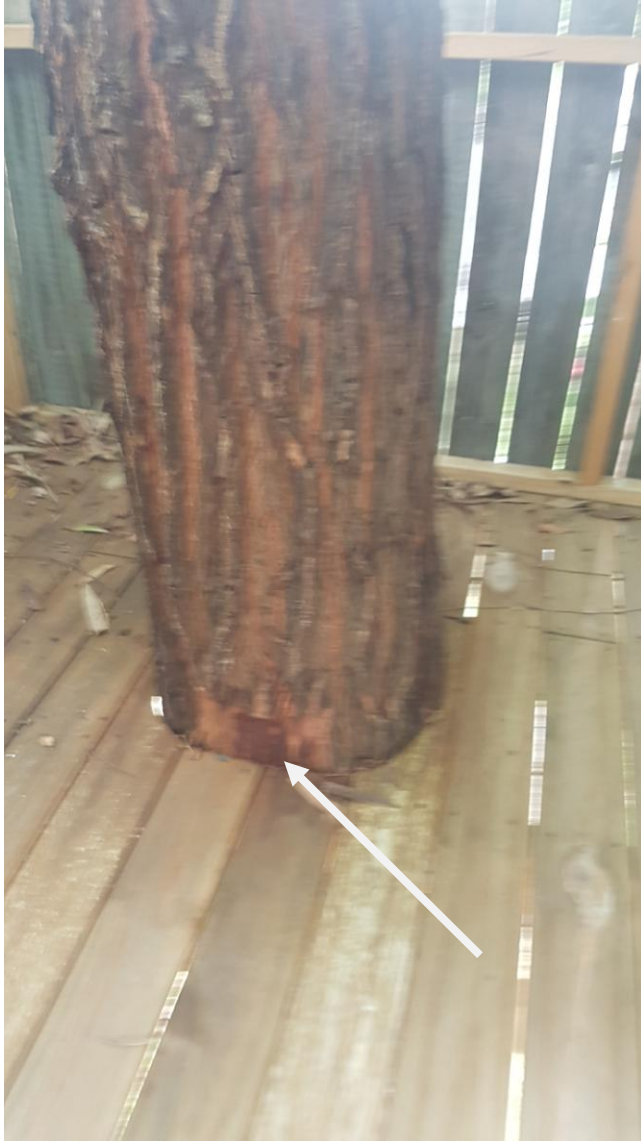
Pic 7 shaving of the bark to allow for floor

The Ironbark truck grows through the floor and the roof of the house and it was noted that there was rubbing from the floor and in 1 section the bark had been shaved to allow for the joist below.

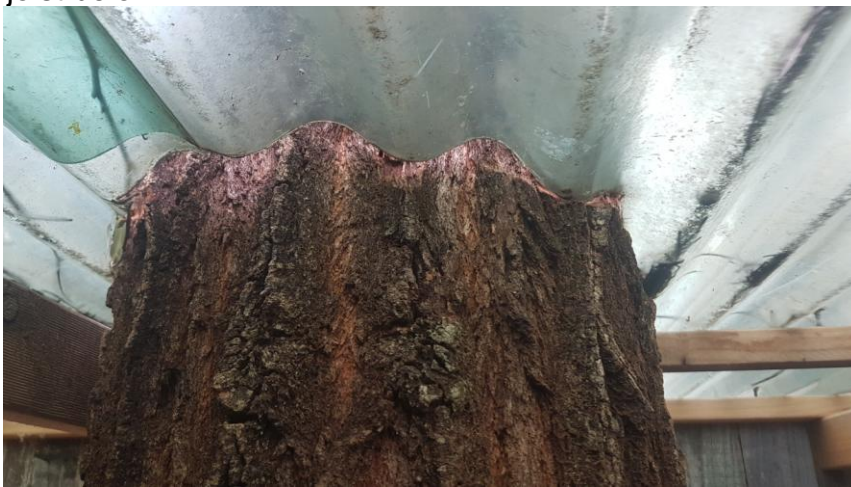
Pic 8 above shows roof sheeting rubbing on the bark.
