Northern Tree Care

16th February, 2018.

Re: Inspection of trees at Tyagarah Airport

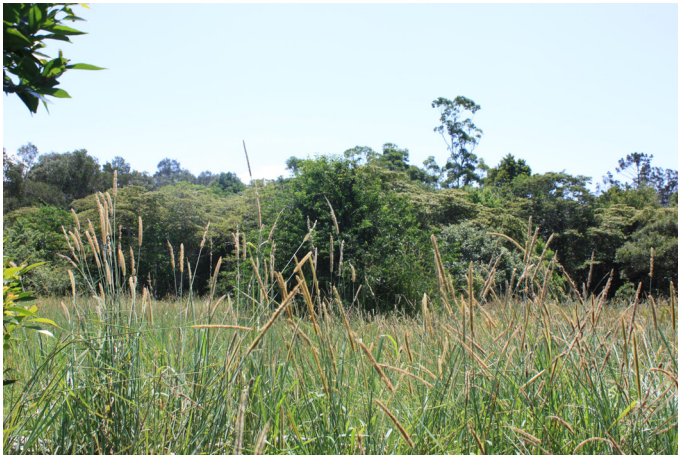
Several trees were identified that had been cut down in the open area to the east of the main runway at Tyagarah Airport. One of the trees is a mature aged Hard Quandong *Elaeocarpus obovatus* [see Photo 1] and the other trees are Casuarina species [see Photo 2]; (Harden et al 2004). The Hard Quandong has a decurrent form with 3 main stems arising from the ground between 200 and 350 mm in diameter. The tree had been lopped at approximately 1.5 m from the ground. The pruning cuts are consistent with having been cut with a chainsaw [see Photo 3]. The tree has produced a large number of epicormic shoots and from their growing extension and size it is estimated that the tree was lopped 3 or 4 years ago. The new growth is in good condition and the tree is expected to survive and grow into the future.

Photo 1.
Hard Quondong Tree.

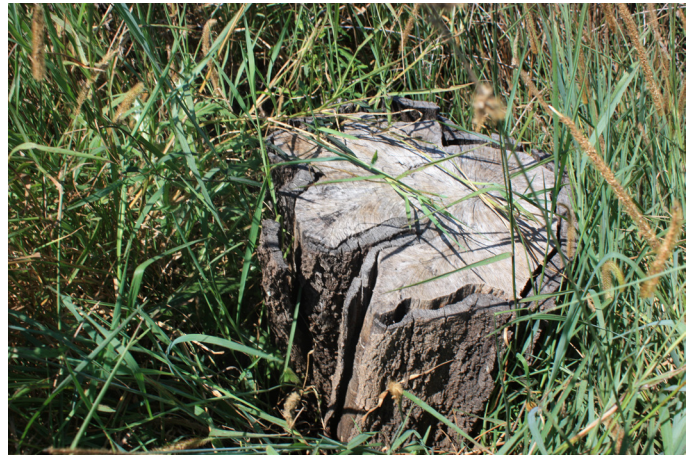
A further 3 trees were observed a few metres to the east of the Hard Quandong. They have also been lopped. The trees have died. The bark is consistent with them being Casuarina species. The condition of the stumps and deterioration of the bark is consistent with the trees having been lopped at the same time as the Hard Quandong. That is around 3 to 4 years ago.

Photo 2.
Casuarina tree that has been cut down.

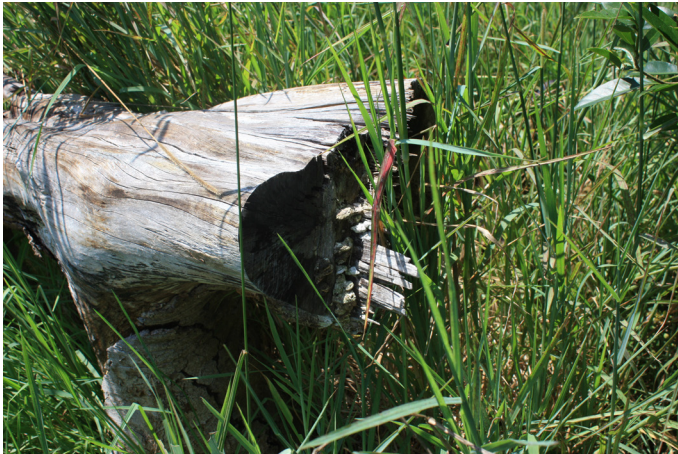
Photo 3.
Hard Quondong has clearly been cut with a saw.

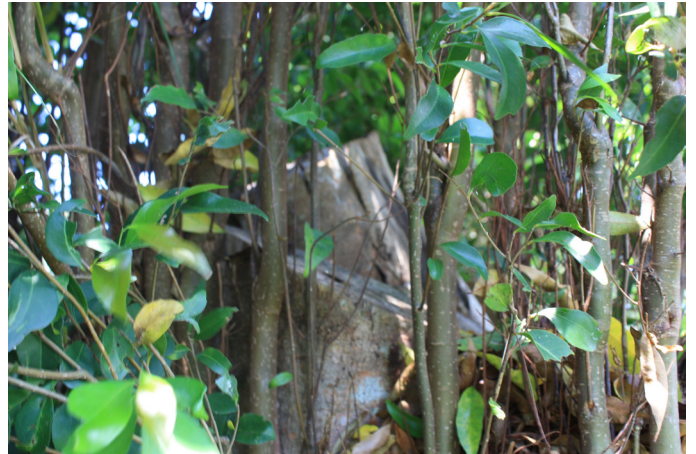
The pruning cuts were assessed to determine whether they are likely to have been carried out by professional contractors. Several of the cuts were made without a scarf and back cut as recommended by *Chainsaw Operator's Manual* (Kessel 2001);[see Photo 4]. Professional arborists employed by Council are required to be qualified to at least AQF 3 in Arboriculture and a knowledge of pruning cuts and felling procedures is a requirement of that qualification. It is considered to be very unlikely that the lopping carried out to cut down the Hard Quondong and Casuarina tree was carried out by qualified contractors.

Photo 4.
Hard Quondong. Pruning cuts not in accordance with industry best practice.

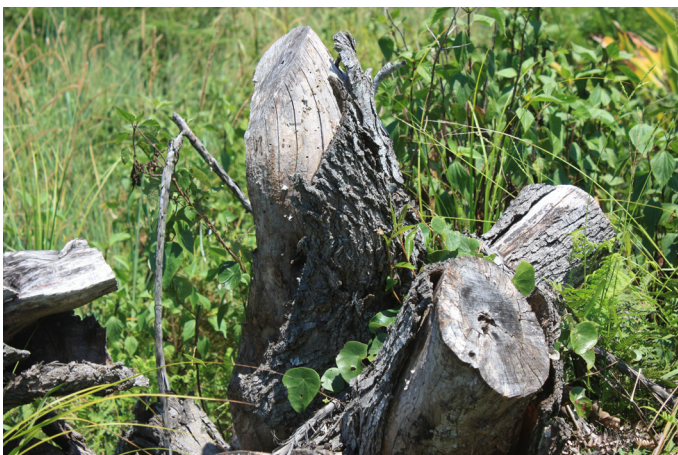
Photo 5.
Casuarina tree. Pruning cuts not in accordance with industry best practice.

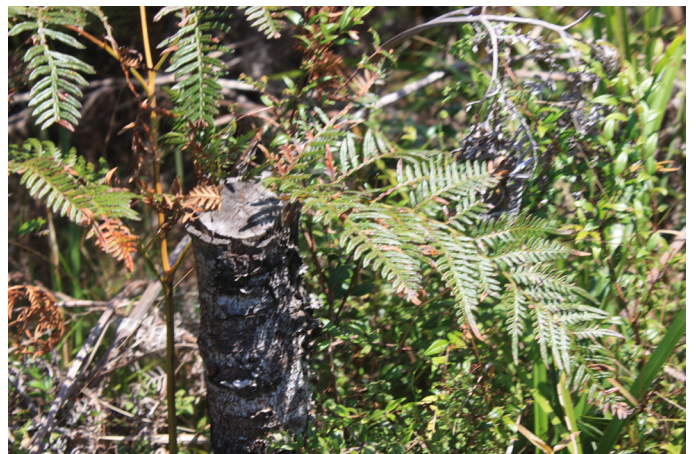
There were also a number of other trees between the Hard Quandong and the air strip that had been lopped and had died. Most of them were relatively small trees. The way in which they were lopped and the condition of the bark was consistent with them having been cut at the same time, around 3 to 4 years ago [see photo 6]. There were approximately 6 of these trees.

Photo 6.
One of the small trees that had also been lopped and died.
