REPORT TO THE GENERAL MANAGER

Subject: Monitoring Report of Access track at North Beach under Sub-licence (under RI1564194) – 13 and 23 October 2023.

File #: E2023/107313

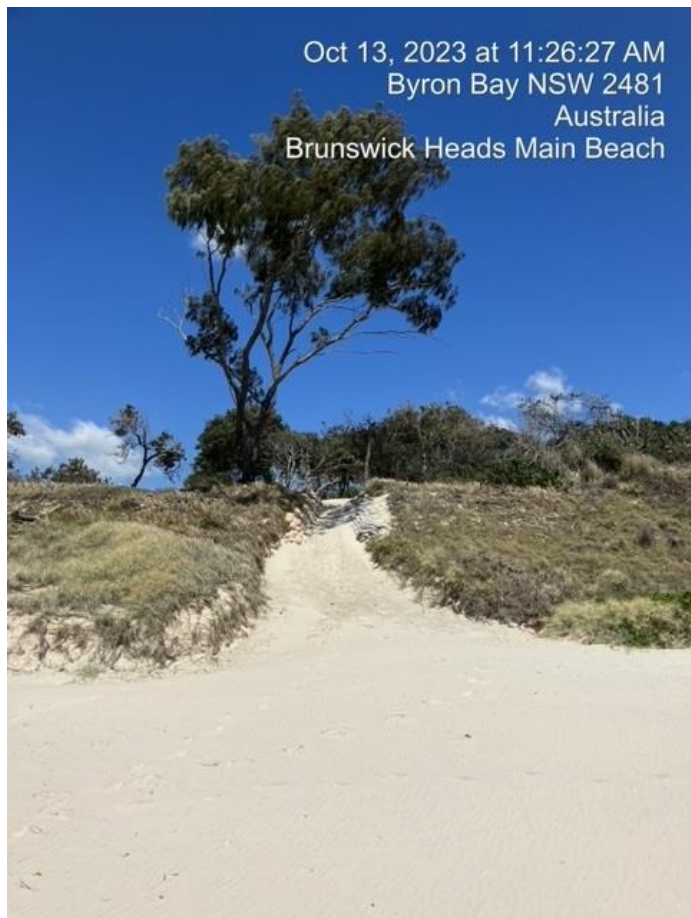
Photo 1: Seaward access track (Oct 13)

The seaward entrance to the track is very steep (photo 1) with plastic matting exposed from wind shift (photo 2). The plastic matting is assumed to have been installed to assist with stabilisation/slippage of sand on the track. It is extremely slippery (in boots) however assumably provides some traction for horses.

Of concern, is the steepness of the seaward track and lowering of sand from slippage. Some kind of stabilisation is recommended similar to the landward access track. It is recommended that pine timber logs are considered by the Licensee on the seaward track before the track becomes too steep, and cut too deep into the dune. This may include removal or lifting up the plastic matting to construct the steps.

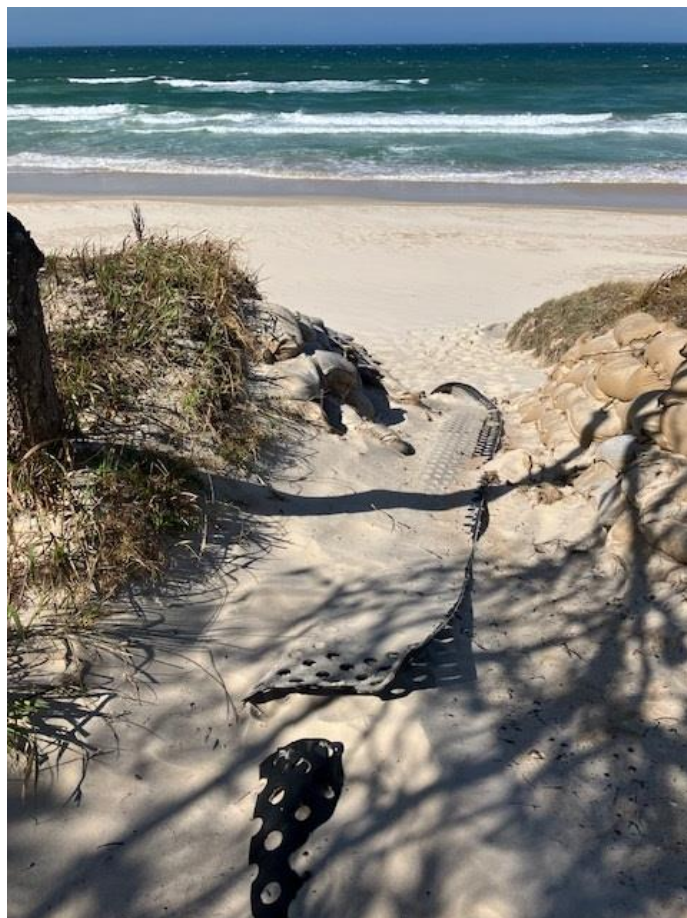
Photo 2: Seaward beach track (Oct 24)

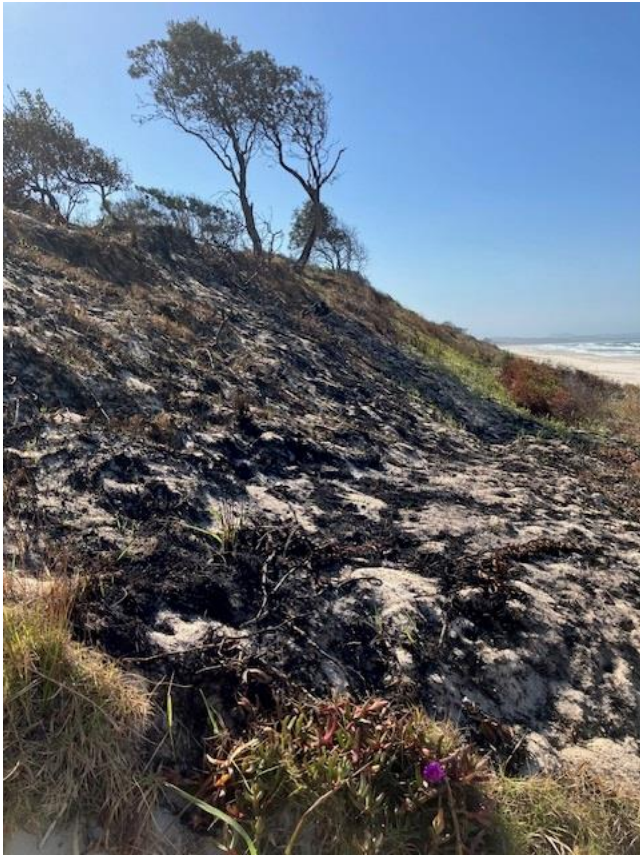
The access track appears to be more visible from above, with less vegetation foliage covering parts of the sandy track (as shown in the near maps images below). On the second day of inspection (23/10/23) areas on the western (north) side of the track had been impacted by the bushfire in the Tyagarah Nature Reserve (photos 3 & 4).

Photo 3: Dune adjacent the track on the north/western side.

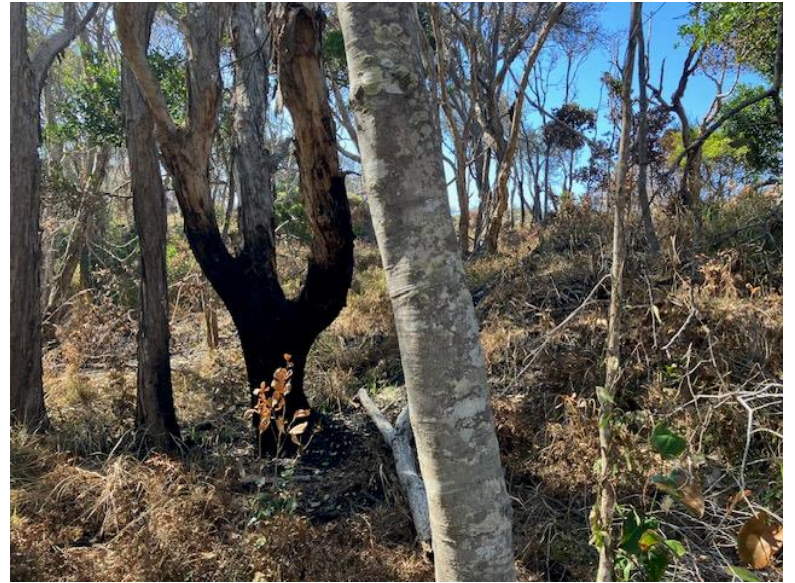
Photo 4: Coastal heath impacted by bushfire (23/10/23).

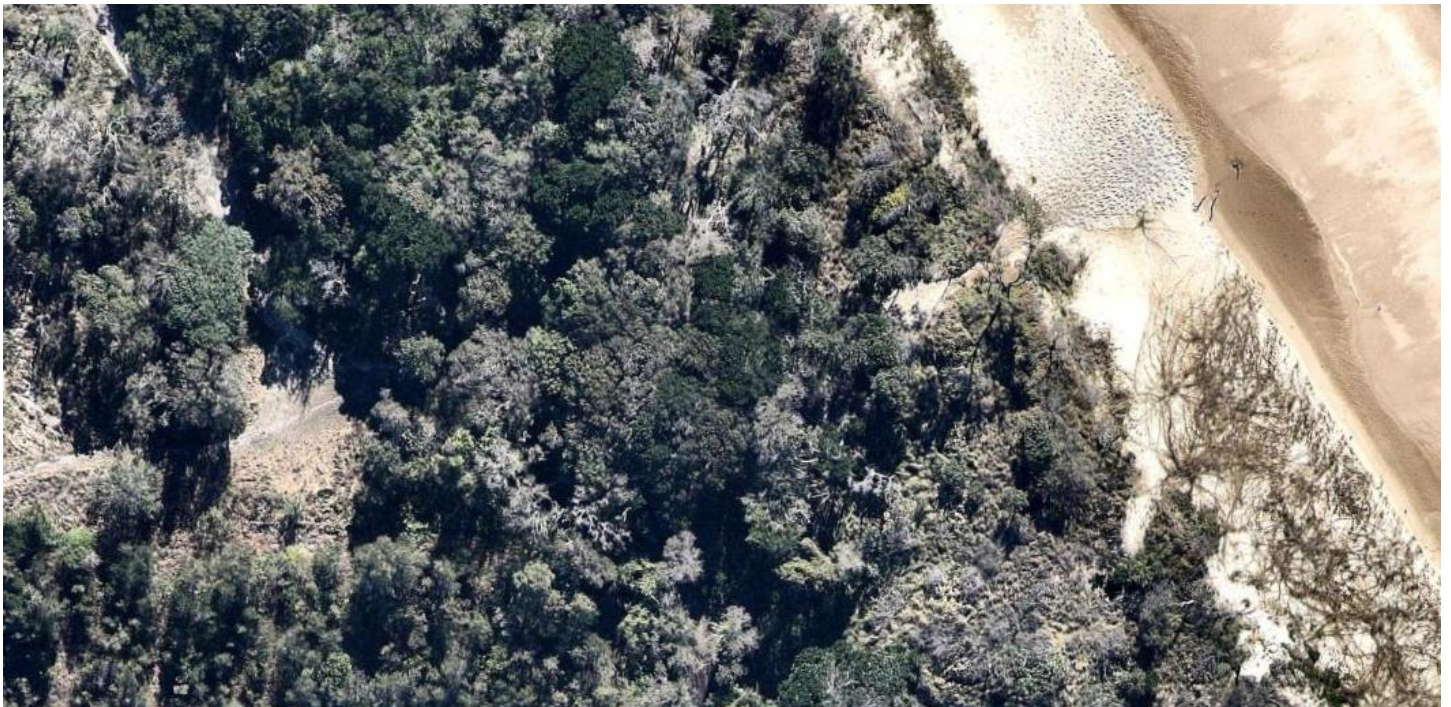
Near Maps image (14 July 2018) – central part of access track not visible and sparse vegetation on the frontal dune

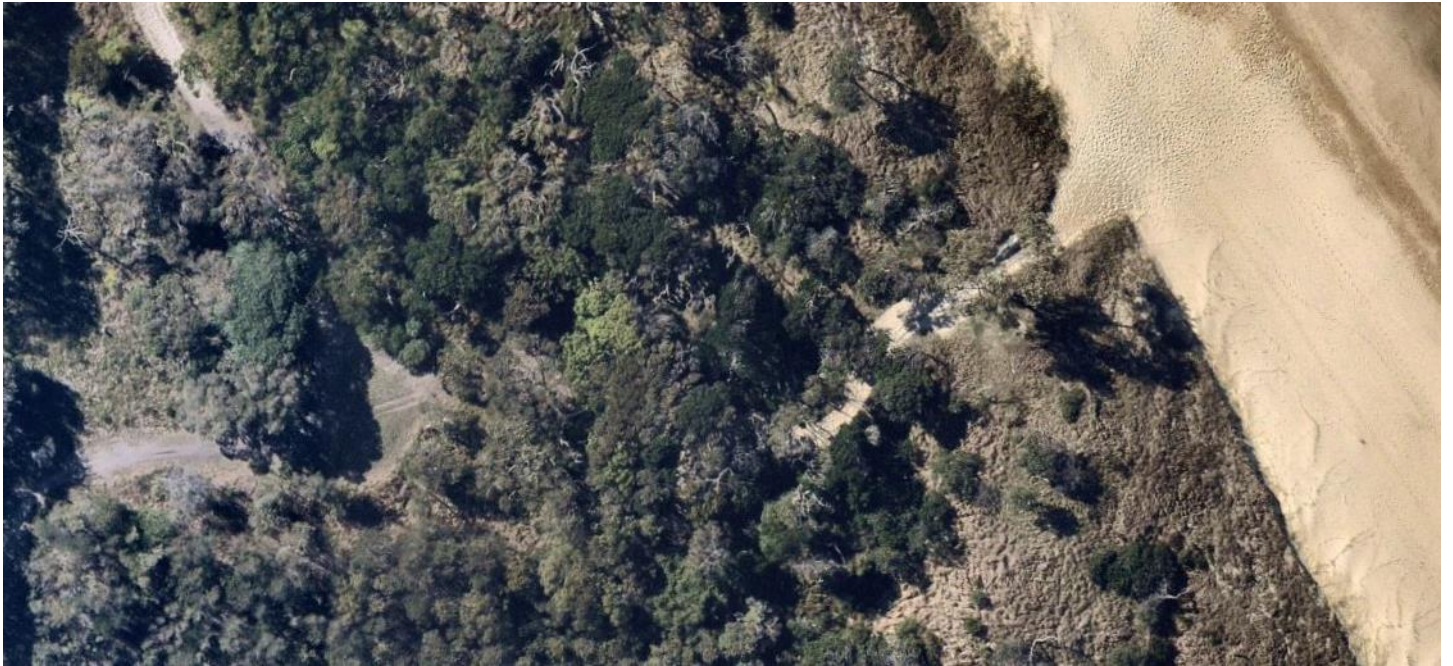
Near Maps image (16 September 2023) – access track more clear and significant vegetation growth on frontal dune

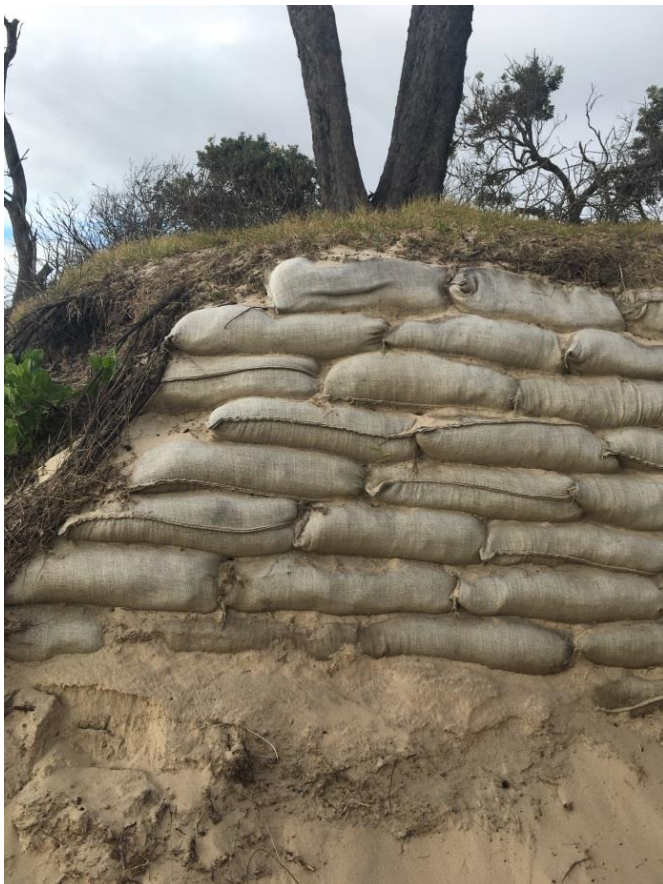
The original sandbags were installed in 2018. Over the years, due to consistent lowering of the track and exposure of the bags, they have become unstable and fallen out of place, or degraded due to exposure of the material. It is evident that replacement of the original sandbag wall on the LHS and RHS of the track (facing the ocean) has been undertaken (refer photos 5 to 8). The new sandbags are different to the original bags, have not been placed very well in an inter-locking nature and may slip and fall with time should sand levels lower. It is unknown whether any of the old sandbags were removed from the location, are still part of the structures or are buried under the sand within the dune. Discussion with the Licensee may be beneficial to understand the maintenance that has undertaken and when.

Photo 5: LHS of track – sandbags exposed (21/06/18)

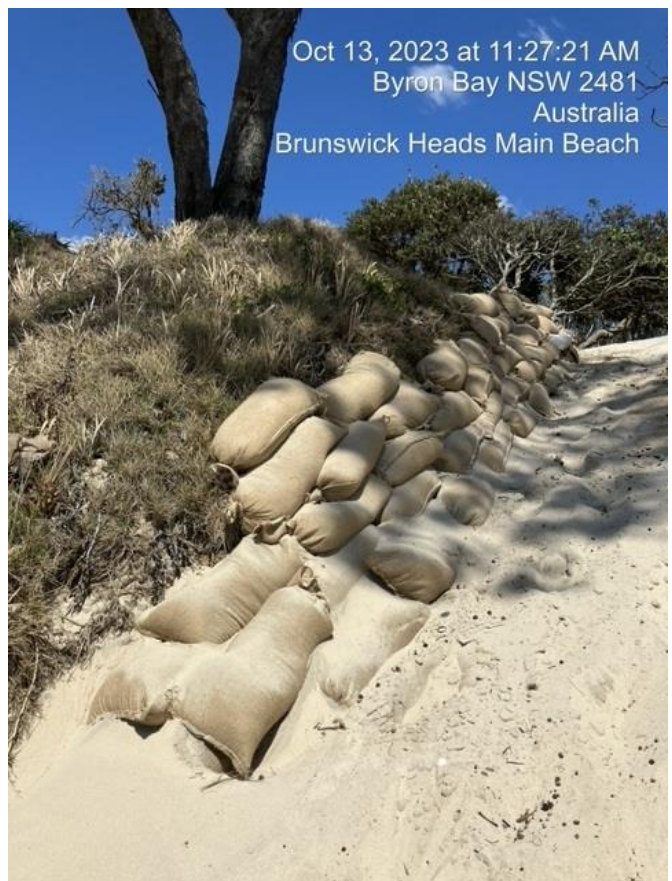
Photo 6: Replacement sand bags on LHS (date unknown)

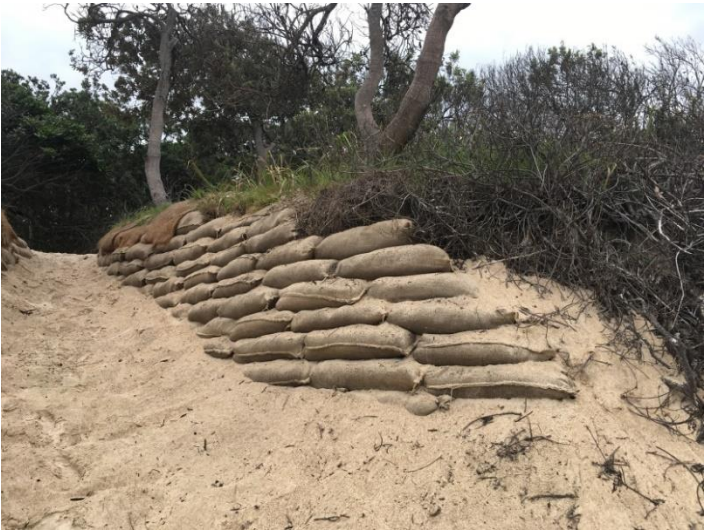
Photo 6: RHS of track – sandbags installed (13/02/18)

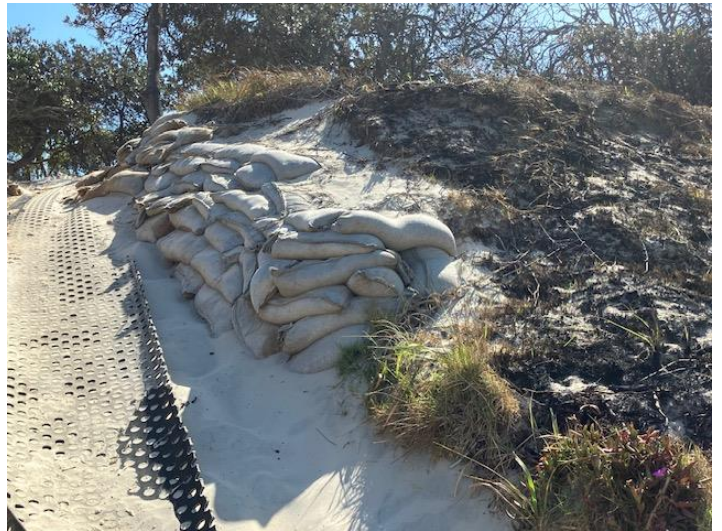
Photo 8: RHS of track – new sandbags installed (date unknown)

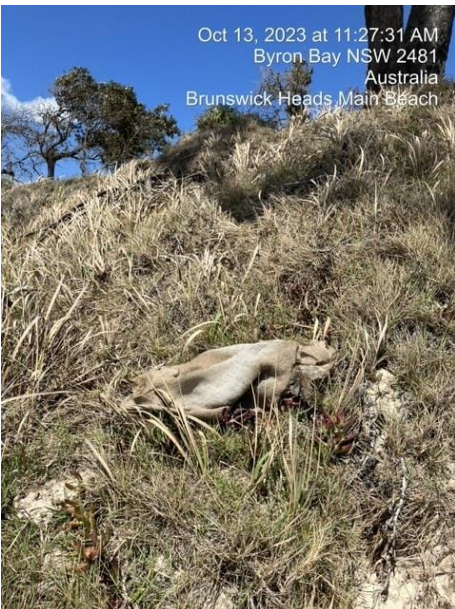
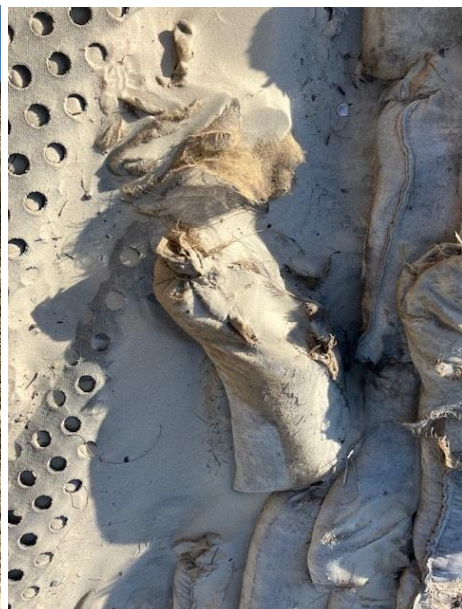
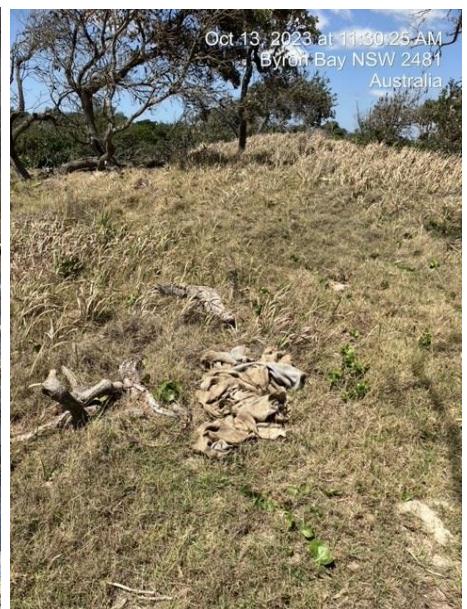
Sandbags are a temporary measure. The bags are not well interlocked, and overtime disintegrate. It is recommended that as these bags break open, they are removed from site. There has been some sand bags that have broken down and these should be removed from the location. At present they have been placed in a pile in the adjacent vegetation (photo 9, 10 & 11). If the sandbag walls unravel or need replacement/repairs - this should only be undertaken after inspection by Council and with approval.

Photos 9, 10 & 11: Degraded sandbags to be removed from site

1. That the Licensee provide information to Council regarding maintenance and replacement of sandbags undertaken on the track – works/materials and dates.
2. That the Licensee remove all failed sandbags from the site and waste.
3. That the Licensee consider construction of pine timber logs steps on the seaward track to stabilise.
4. That the Licensee notify Council for authorisation of any proposed works including replacement or addition of sandbags. Staff will subsequently advise if the works are necessary depending on conditions at the site.
5. That Council continues to monitor the condition of the track on a regular basis.
6. Should the Licensee not adhere to all conditions of the permit, then Council terminate the Licence.

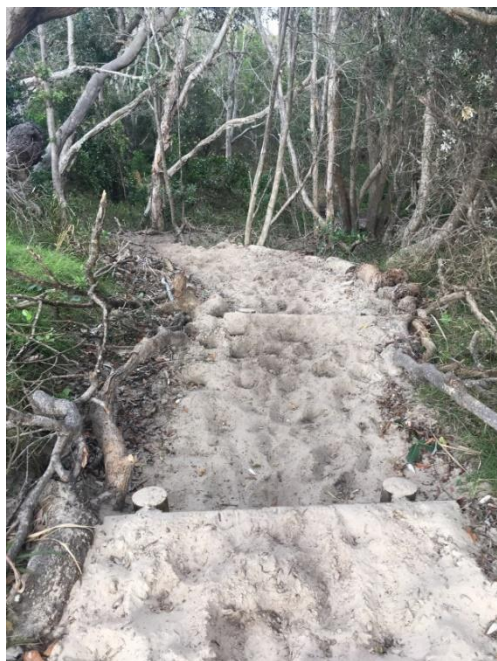
The landward access track was originally stabilised with pine timber logs to create steps along the track and regular intervals logs across in 2018 to prevent further lowering of the track and exposure of vegetation roots (photo 12). There has been an additional attempt to stabilise the track with black plastic matting (photo 13). It is unknown how much matting has been added to the track, assumed to be present at certain sections only. The matting is likely attached in place with large pegs and may be covered or uncovered by sand depending on wind conditions and traffic (horses, use of track). Some of the matting has peeled up at the edges.

Photo 12: Landward access track and steps (21/06/18) (13/10/23)

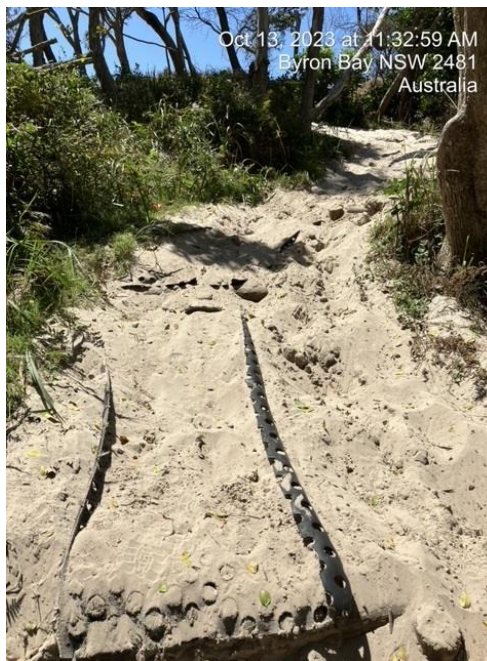
Photo 13: Landward access track plastic matting (edges peeling up)

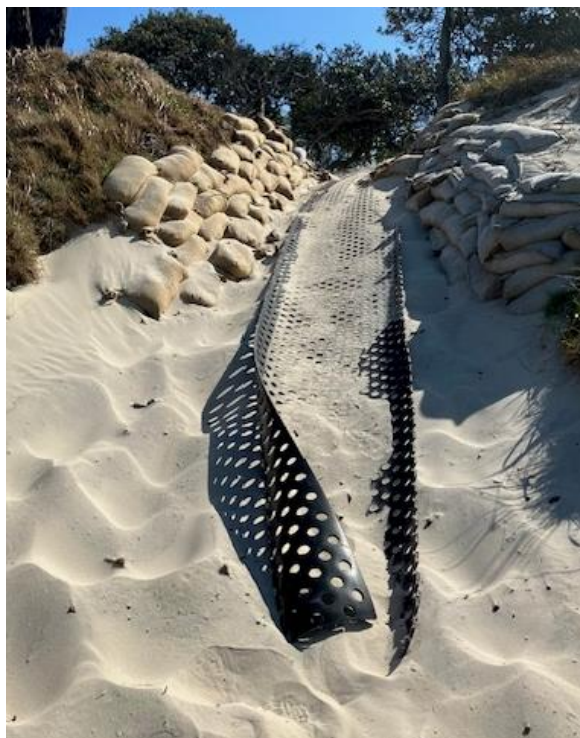
On the first day of inspection (13/10) only the matting on the landward access track was visible, with most of the matting covered by sand (only the edges visible). However, on the second day of inspection (23/10) the seaward matting was visible (photo 14).

Photo 14: Seaward track matting visible (23/10/23)

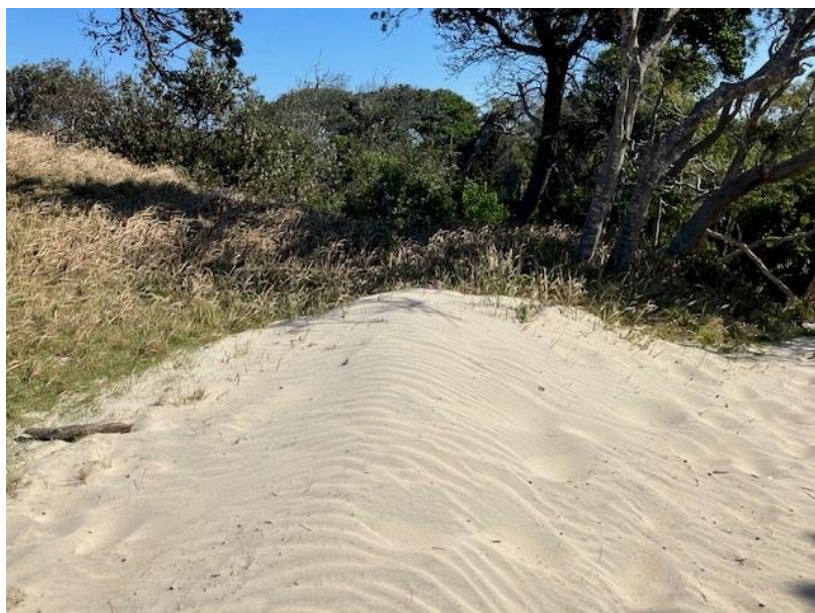
The crest of the dune has seen some growth and stabilisation of grasses on either side of the track. The area very wide with uncovered sand from sand drift (wind) mounding up at the crest (photo 15).

Photo 15: Seaward track matting visible (23/10/23)
