Terrace Holiday Park: Southern Precinct Arboricultural Impact Assessment

**Terrace Holiday Park
Brunswick Heads, NSW**

March 2018

C91119

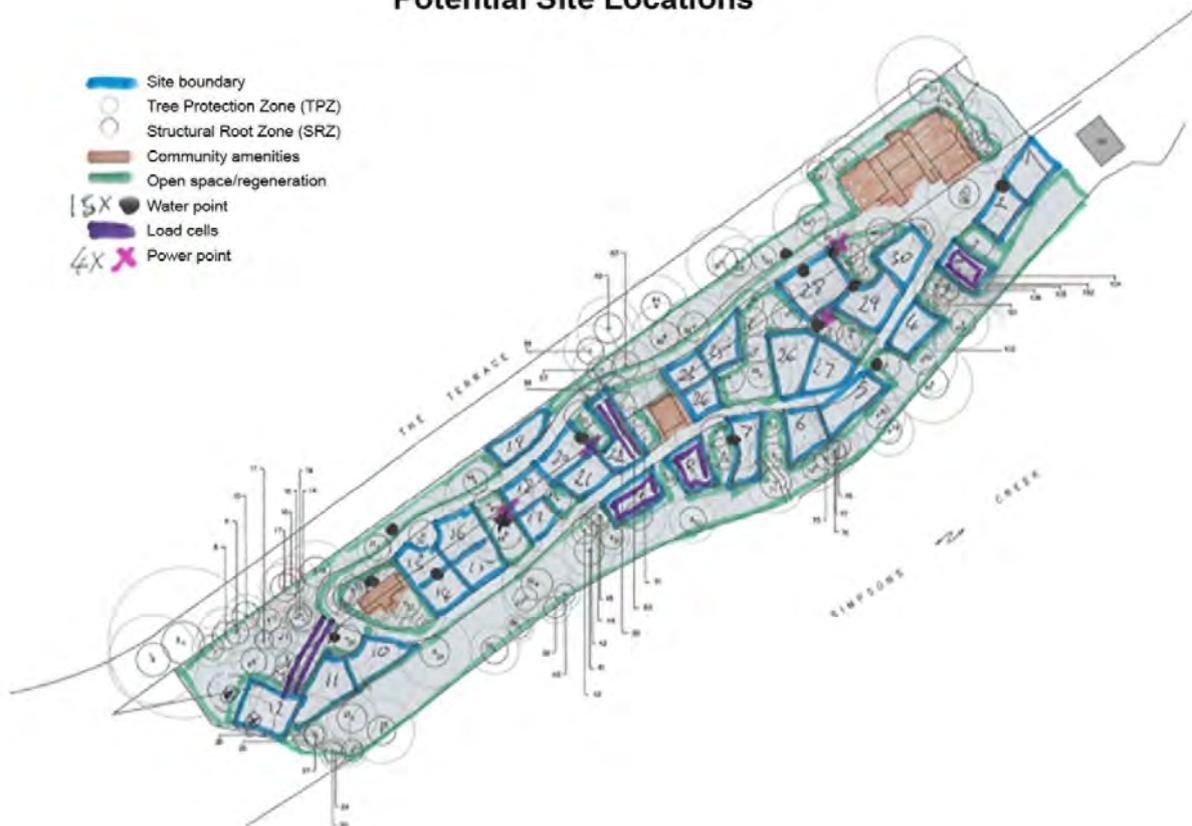
Figure 4. Site sketch showing potential site locations, regeneration/open areas, load cell installation sites, water and power points, tree positions with TPZ and SRZ. Source: ArborSafe 2018

- 9.5.2 New/additional areas for planting can be found in small pockets of land and mulched areas in and around the existing camping areas situated within the Southern Precinct along with the newly formed buffer zone (see Figure 4).

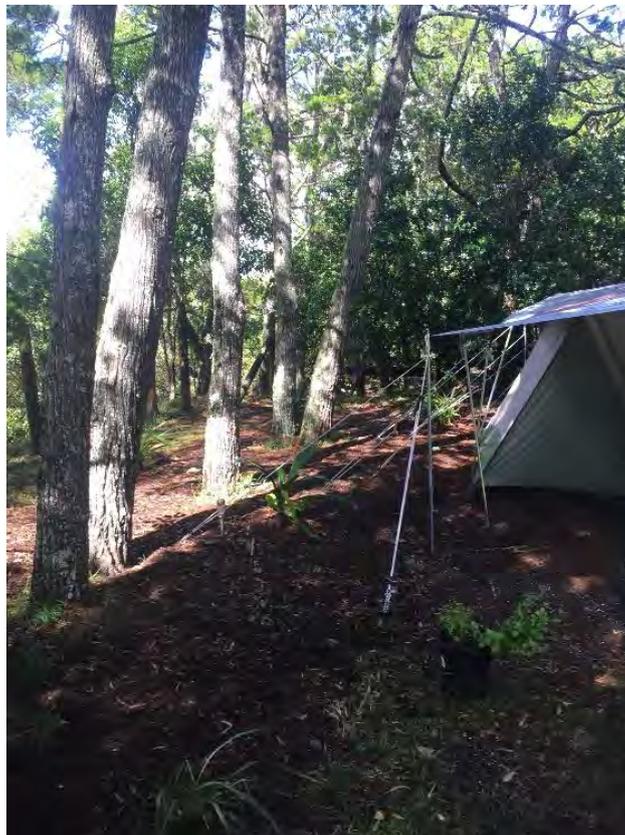
Figure 5. The photo shows encroachment from an awning into a protected regeneration area due to lack of space and inappropriate site booking. Source: Clark, March 2018

- 8.3.3 Site dimensions are to be available at the time of booking and placed on the website to allow clients to request sites based on individual camping equipment, e.g. average footprint of 4-person dome tent is 6m x 2.5m, average camper trailer is 6m x 3m plus annex of 3m x 3m, additional tarpaulins can be any size, and are frequently oversize.

- 8.3.4 The site dimensions are to be emphasized at the time of booking to stop encroachment into protected regeneration areas. If information is easily accessible, and patrons are aware prior to visiting, then encroachment issues can be resolved fairly and easily.

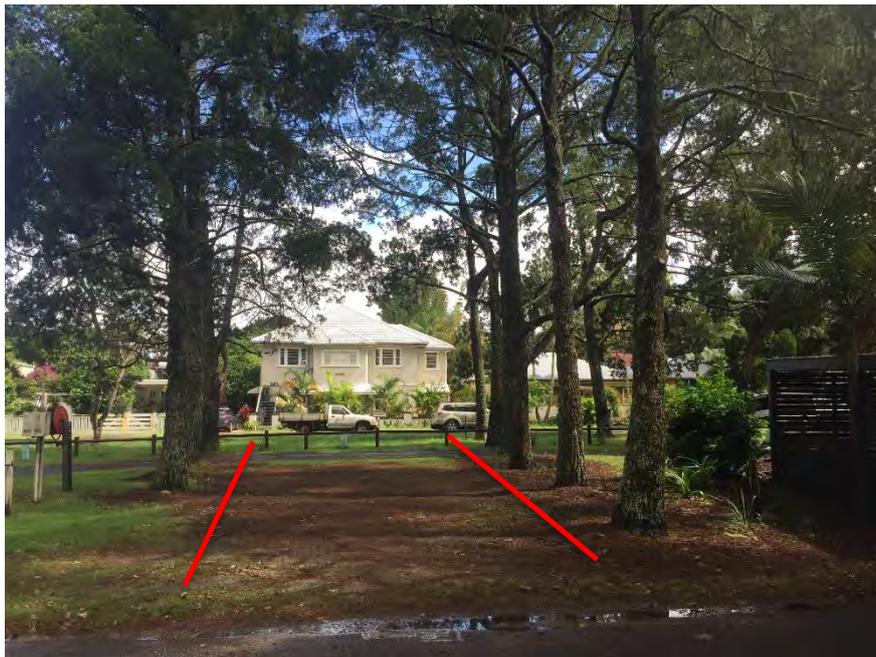
Figure 6. The photo shows site 22 (refer to Fig. 4) as an example of where load cells (between red lines) could be utilised to allow access and use of site when SRZ encroachment is unavoidable. The long narrow site could be designated for camper trailer use with awning out to the left. Source: Clark, March 2018

- 8.7.2 It is considered that installing a platform of load spreading cells (i.e. TerraCell® or TERRAM Geocell) would mitigate the negative impacts of vehicles parking within the TPZs or SRZ or of potential mechanical damage caused by camping within the SRZ.

- 8.7.5 It is anticipated that the existing trees would display a positive response following the installation of load spreading products due to the minimisation of soil disturbance within the trees TPZ and SRZ.

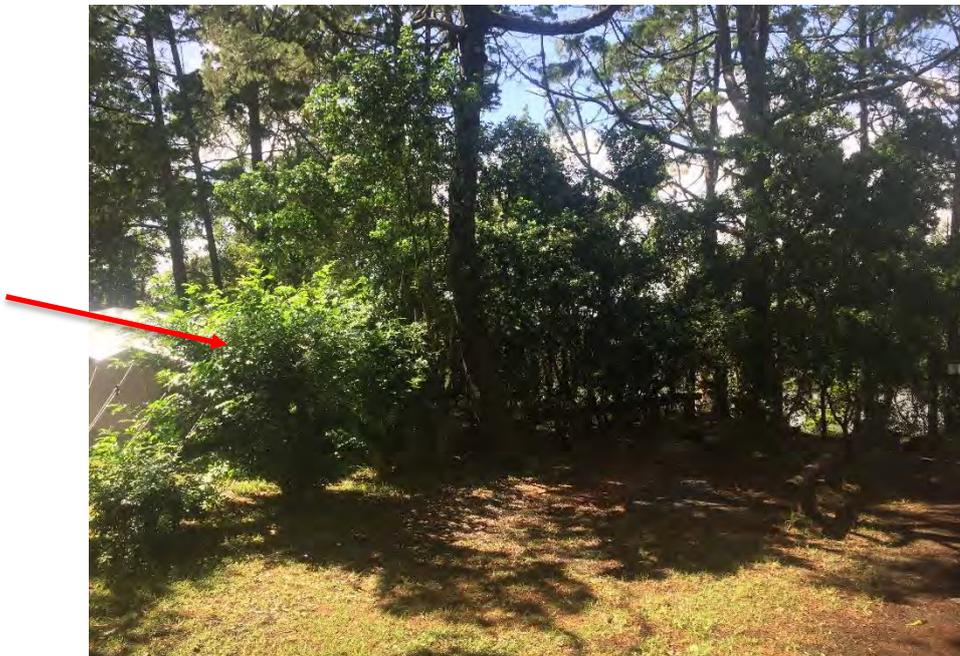
Figure 7. The red arrow indicates a planting of exotic *Murraya paniculata* not a species associated with CCPF recommended for removal. Source: Clark March 2018

- 9.1.1 All exotic trees and shrubs not aligning with the CCPF should be systematically removed from the Southern Precinct over time and replaced with CCPF associated species. This includes the removal of the *Murraya paniculate* hedges and various shrubs.
- 9.1.2 All weeding should be undertaken by hand.
- 9.1.3 Any chemical use must not impact the regeneration of CCPF.

- 11.3.1 The staggered removal of all existing trees of a species not consistent with the CCPF is recommended from within the Southern Precinct.
- 11.3.2 A local nursery is to be engaged to propagate endemic Callitris Pine seedlings for planting onsite.
- 11.3.3 Only species consistent with the CCPF are to be planted or allowed to regenerate within the Southern Precinct.

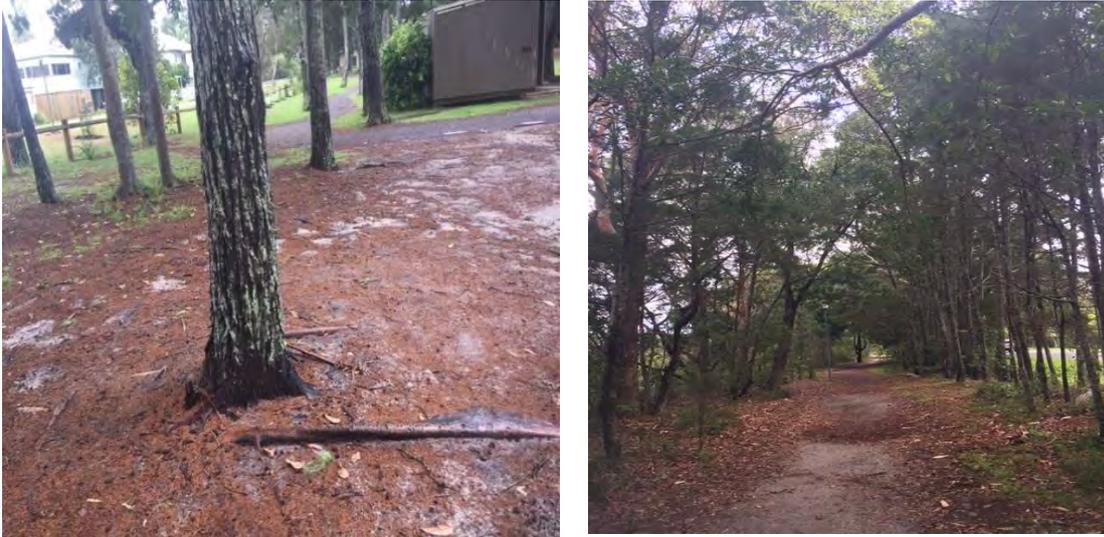
Figure 8 and Figure 92. Partial natural mulching around trees situated at the south western corner, around Trees 2–8 of Terrace Holiday Park along with an example of natural mulching around *Callitris* trees in Simpsons Reserve. Source: Clark November 2017

- 9.4.5 The pros and cons of adding mulch around the SRZ of the individual trees situated in the Southern Precinct has been reviewed. The potential increase in nutrient availability within the existing soil is likely to be beneficial to the existing CCPF trees. A review of the other benefits that mulch provides (regulating soil moisture and temperature, increased activity in the soil biosphere, weed suppression, minimising soil compaction) results in the addition of mulch being considered advantageous.

- 11.5.1 Install a native forest blend or wood chip mulch that conforms to *AS4454–2012 Composts, Soil Conditioning and Mulches* in as much of each SRZ as practicable (considering existing site constraints such as roads, paths, buildings, drainage channels).
- 11.5.2 Mulch is to be installed as per the method statement provided in Appendix D.

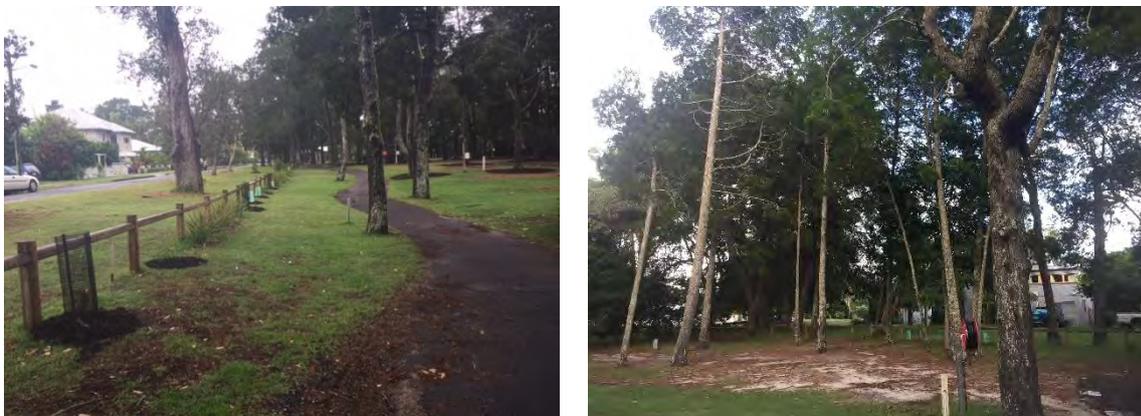
Figure 10 and Figure 11. Potential planting/regeneration areas within the southern zone. Left: The western Right: area in the south western corner around Trees 2–8. Source: Clark March 2018

- 9.5.4 Through underplanting the existing trees with species from the CCPF, the future viability of the CCPF will be enhanced. The protection of existing trees will also be improved by the indirect restriction on site use.

- 9.5.5 Care with underplanting in these areas would be required so existing tree roots are not damaged. Hand excavation and manual planting are recommended.

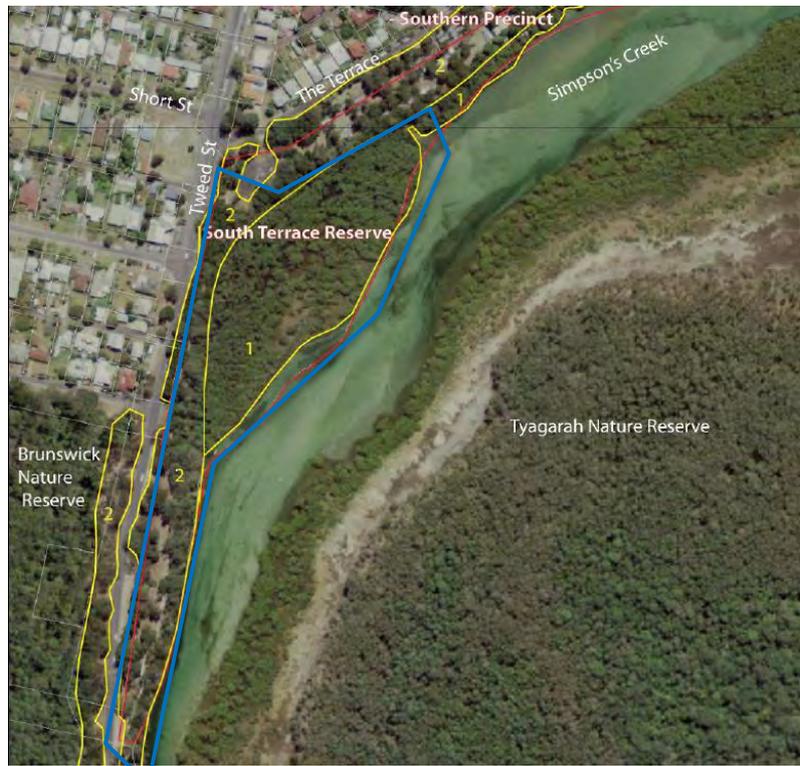
Figure 12. Depicts the location of CCPF within Simpson Reserve with a Blue line. This area appears to be suitable and appropriate for regeneration. Site use should be restricted to activities that will regenerate the EEC. Source: VPM 2011

- 9.6.1 Simpson Reserve, identified as South Terrace Reserve in the VPM, is situated immediately south of the Terrace Holiday Park Southern Precinct. The arboricultural management of the Reserve is outside the scope of this report, however it contains a significant remnant community of CCPF and has multiple areas where regeneration and assisted replanting could be undertaken to compliment the work undertaken within the Terrace Holiday Park. Simple methods such as natural regeneration, assisted regeneration and the management of weeds and regrowth would all provide for the long-term enhancement of the CCPF.

- 11.3.4 Encourage regeneration in the overlapping mulched TPZ areas and the estuary buffer zone.
- 11.3.5 Minimise weed species in the regeneration areas by hand weeding.
- 11.3.6 Simpson Reserve currently provides the best opportunity for regeneration of the CCPF ecological community on a large scale as it does not need to compete with camping/tourism. The engagement of a bush regenerator to enhance the CCPF in Simpson Reserve is recommended.
