Site Audit Statement

Site audit statement no. **0503-1904**

Title **Site Audit Report Former South Byron Sewage Treatment Plant Broken Head**

Byron Shire Council
Former South Byron STP
Long Term Environmental Management Plan
1 Broken Head Road, Byron Bay

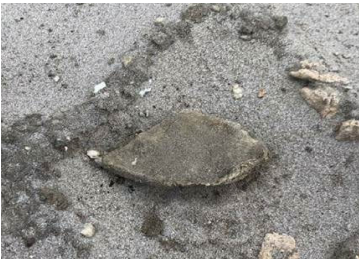
Consultant	Material description					Risk Assessment								
	Location	Material Description	Photo Reference	Reference	Laboratory results	Friability	Material condition	Likelihood of disturbance	Risk	Control method	Labelling	Estimated quantity	Units	Comments
GHD	Berm core on western and southern portion of site	Minor fragments of non-friable bonded ACM in berm core

Example photograph	South Byron Sewage Treatment Plant Remediation and Validation Report – Stage 2B. (GHD 2021a)	Chrysotile & Amosite Detected	Non-friable	Fair	Low	Low	Containment. See Long Term Environmental Management Plan (GHD 2021b)	Geofabric marker layer over berm core	2	m2	As discussed in the validation report, all ACM identified during remediation was disposed off-site or in the berm core and the site was visually validated prior to placement of topsoil. There remains a small potential for exposure to ACM fragments in fill or within the berm . Quantity estimates are very approximate.
