Roads Safety Audit

Intersection of McAuleys Lane and Mullumbimby Road, Myocum

Prepared for: Ardill Payne & Partners
© GeoLINK, 2022

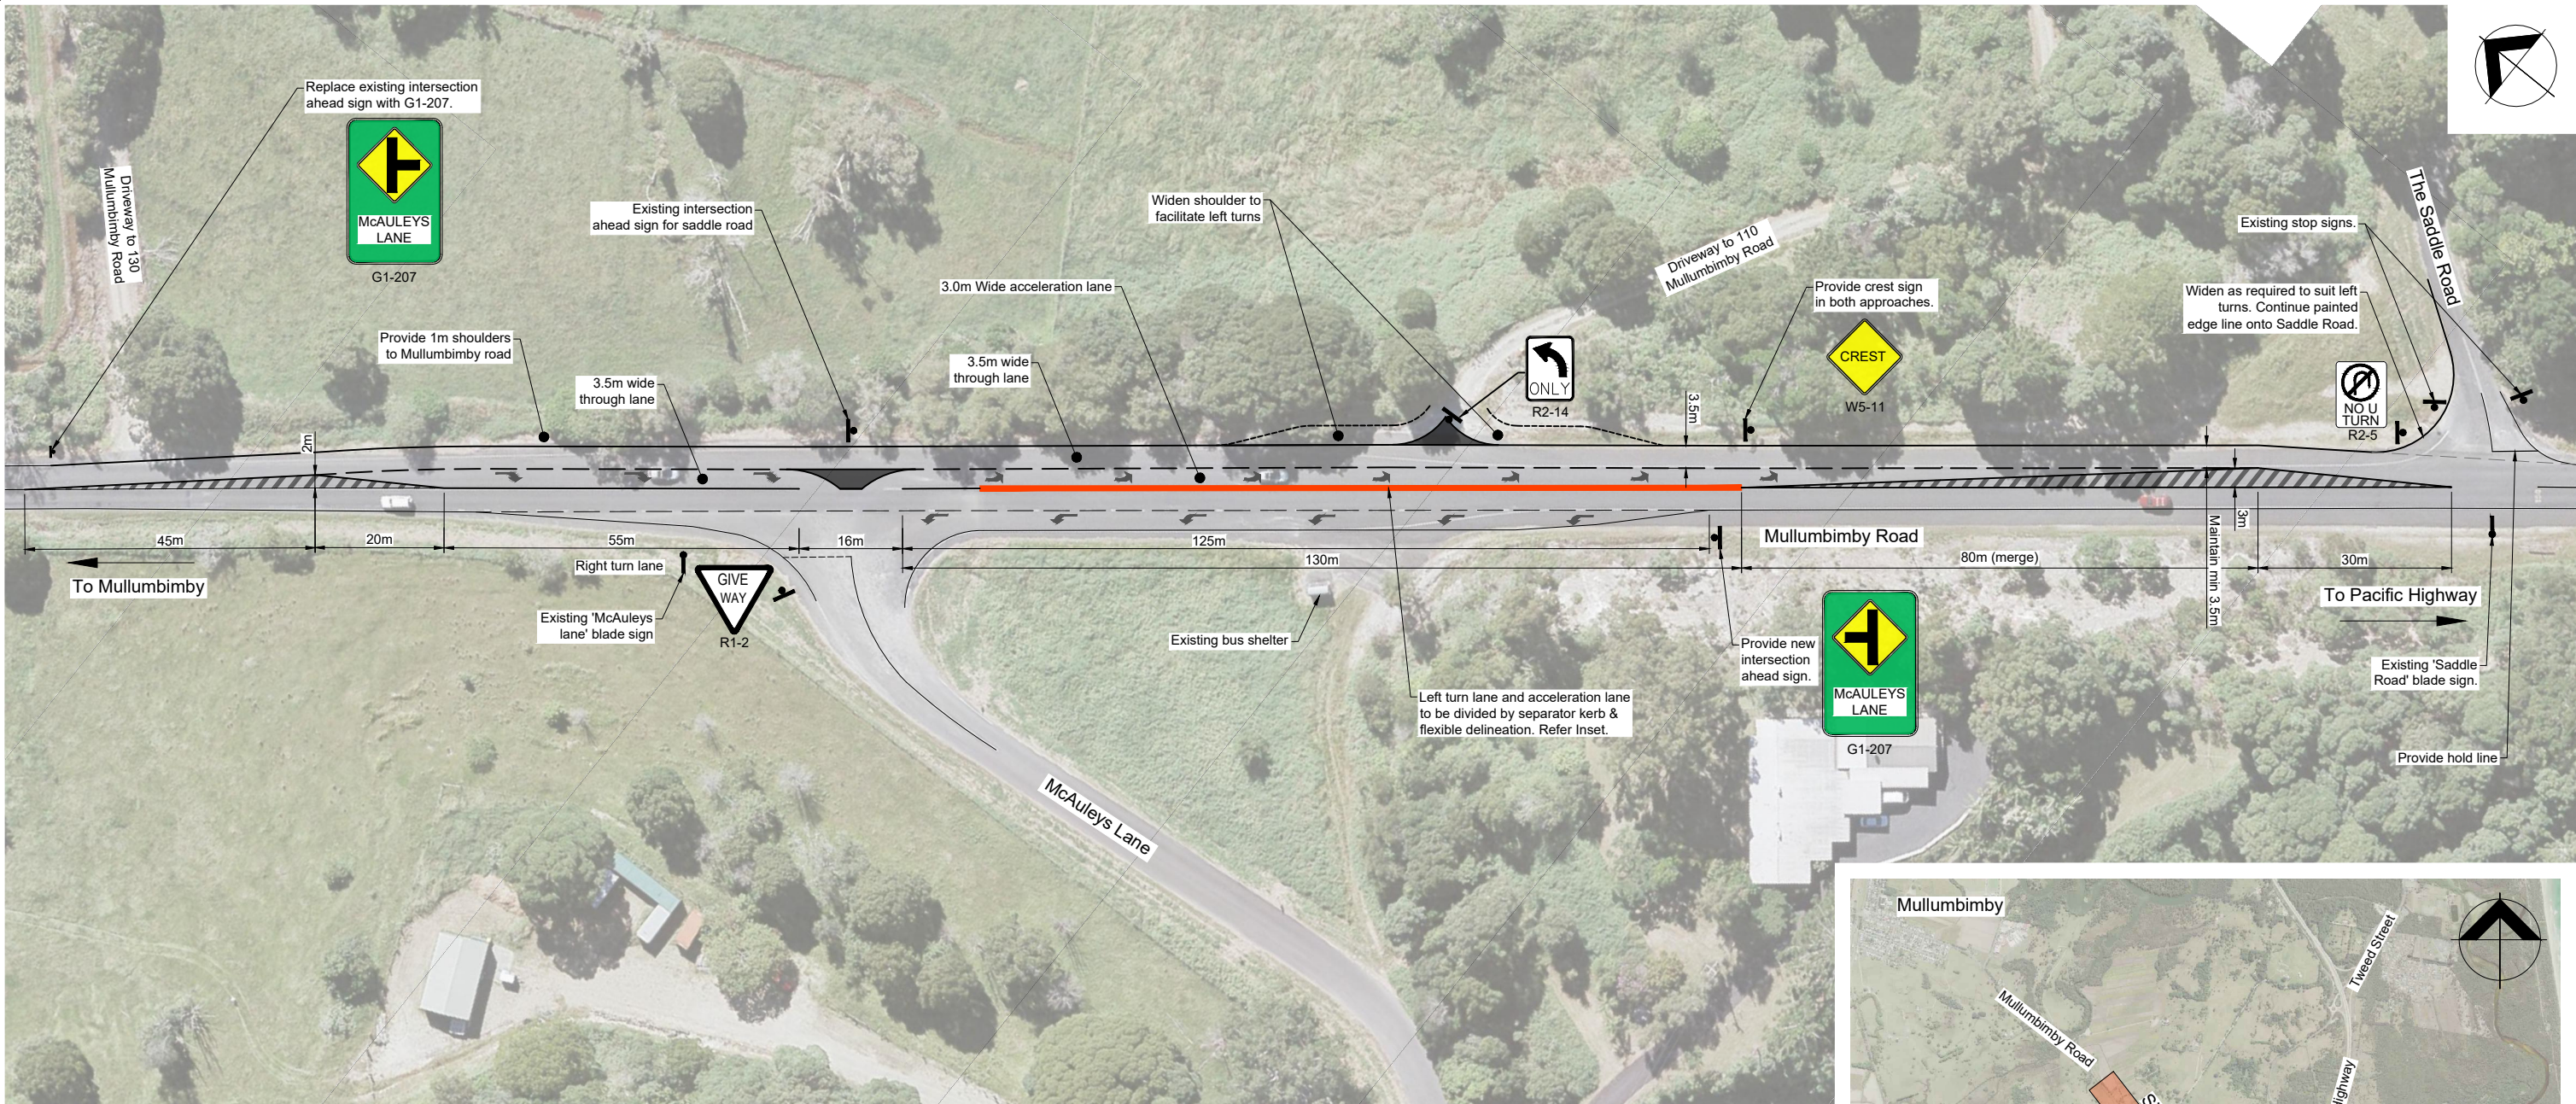
Intersection Layout
1:500 @ A1

Audit findings	Risk Ranking	Client	
		Accept	Comments
<p>1. Exiting McAuleys Lane</p> <p>Vehicles travelling in the auxiliary left turn lane may prevent motorists exiting the McAuley Lane intersection from seeing northwest bound through traffic.</p> <p>There is a risk that a motorist will proceed through the intersection unaware that there are vehicles travelling towards them in the through-lane at speed on a downhill gradient. This may result in a rear-end or left near collision (e.g. vehicles turning left out of McAuleys Lane) or a right near collision if the vehicle exiting McAuleys Lane was turning right. The latter has the potential to result in a fatal injury given the likely speed of the through traffic. However, the low volumes of traffic utilising the auxiliary left turn lane reduce the expose to this hazard.</p>	<p><i>Rare Fatal</i></p> <p>High</p>	N	There is no accident history as far as we know related to this issue. Left turn in volumes are low. Downgrade in the approach to the left turn would assist in sight distance (seeing over the approaching car). Leave turn lane as is.

<p>2. Crest on Mullumbimby Road between McAuleys Lane and The Saddle Road</p> <p>The proximity of the crest on Mullumbimby Road to the intersection of The Saddle Road and Mullumbimby Road significantly limits the sight distance available for vehicles exiting The Saddle Road. There is a risk that a motorist will proceed through the intersection unaware that there are vehicles approaching from the northwest at speed.</p> <p>This may result in a rear-end or left near collision (e.g. vehicles turning left out of The Saddle Road) or a right near collision if the vehicle exiting The Saddle Road was turning right. The latter has the potential to result in a fatal injury given the likely speed of the through traffic.</p> <p>It is noted, however, that this risk is an existing safety issue and the proposed works do not in any way exacerbate the situation.</p>	<p><i>Possible Serious</i></p> <p>High</p>	N	Noted, but issue not related to McAuleys Lane intersection design.

<p>3. Vegetation at The Saddle Road intersection</p> <p>Vegetation on the eastern side of The Saddle Road intersection limits the sight distance available for vehicles exiting The Saddle Road. There is a risk that a motorist turning right out of The Saddle Road will proceed through the intersection unaware that there are vehicles approaching from the southeast at speed. This may result in a right near collision.</p> <p>It is noted, however, that this risk is an existing safety issue and the proposed works do not in any way exacerbate the situation.</p>	<p><i>Possible Serious</i></p> <p>High</p>	N	Noted, but issue not related to McAuleys Lane intersection design.

Audit findings	Risk Ranking	Client	
		Accept	Comments
<p>4. Bus Stop on Mullumbimby Road</p> <p>The bus stop and shelter on Mullumbimby Road is located shortly after a crest vertical curve.</p> <p>Bus drivers will not be able to see if there are patrons waiting at the bus shelter until the bus is over the crest. There is a risk that a bus travelling northwest will need to break sharply to stop at the shelter. This may result in a rear-end collision involving a vehicle travelling closely the behind the bus at 80 km/h.</p>	<p><i>Rare Serious</i></p> <p>Medium</p>	Y	<p>Issue accepted. Will discuss further with Council and bus companies. May not be practical to relocate bus stop</p>
<p>5. Proposed raised island at driveway to No. 110 Mullumbimby Road</p> <p>The proposed raised concrete island appears to be located directly behind the southeast-bound travel lane on Mullumbimby Road. The loss of shoulder space creates a pinch point for cyclists travelling along Mullumbimby Road in a south-easterly direction.</p> <p>There is a risk that a cyclist will abruptly move from the shoulder into the travel lane and be struck by traffic travelling at speed in the same direction.</p>	<p><i>Unlikely Fatal</i></p> <p>Extreme</p>	Y	<p>At design stage, island will be designed to allow shoulder users to pass</p>

<p>6. Driveway to No. 110 Mullumbimby Road – Comment Only</p> <p>The site visit revealed significant safety issues associated with the proximity of the crest on Mullumbimby Road to the driveway providing access to No. 110 Mullumbimby Road. Although there is sufficient sight distance available to the right (northwest), the crest severely limits sight distance to the left (southeast).</p> <p>The measures to prevent right turns in or out of this driveway proposed in the concept design remove the exposure to this hazard.</p>	<p>Comment only</p>	-	<p>Noted</p>
<p>7. Proposed G1-207 at driveway to 130 Mullumbimby Road – Comment Only</p> <p>The proposed replacement of the 'Side Road Intersection' sign located approximately 100 m northwest of McAuleys Lane with a larger G1-207 sign may impede sight distance for drivers exiting the driveway.</p> <p>Caution should be taken to ensure this sign is located so as not to adversely impact the sight distance of motorists existing the driveway.</p>	<p>Comment only</p>	Y	<p>At design stage, sign will be located with consideration of sight distance from driveway</p>
