post-flood discussion with SGB community members west of Capricornia Canal,
on 2 May 2022 (* indicates name and contacts withheld)

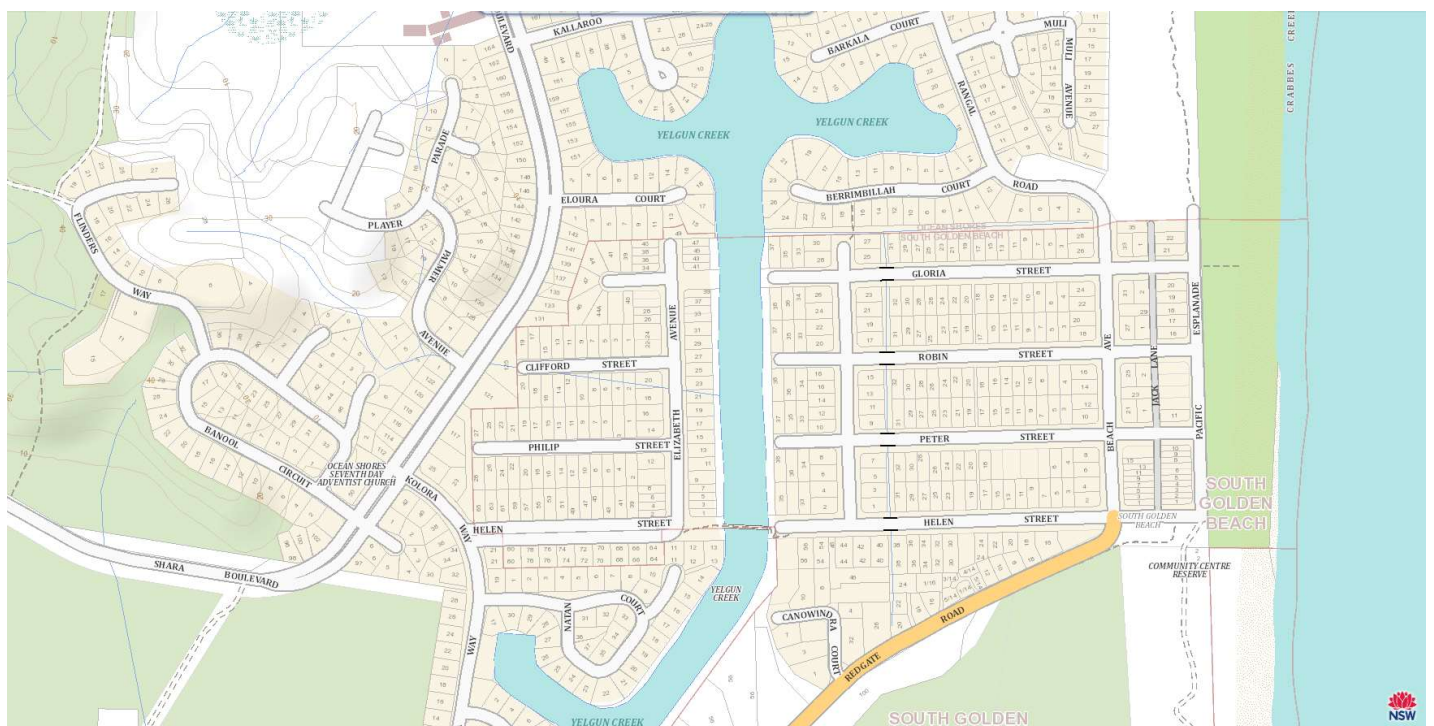
extract from SixMaps

The extract below from SixMaps still shows the blue line of the creek over which Clifford Street was placed. Development is at its worst when no arrangements are made for an overland flow path where one is clearly needed (see also my point 1 above about Phillip Street). This legacy defect now needs to be recognised and made good. Investigation is needed, and far deeper than the 2015 “Environmental Assessment”.
