Our Reference: J1074_traffic letter

Re: DA 10.2018.483.1, Montecollum Road traffic safety issues

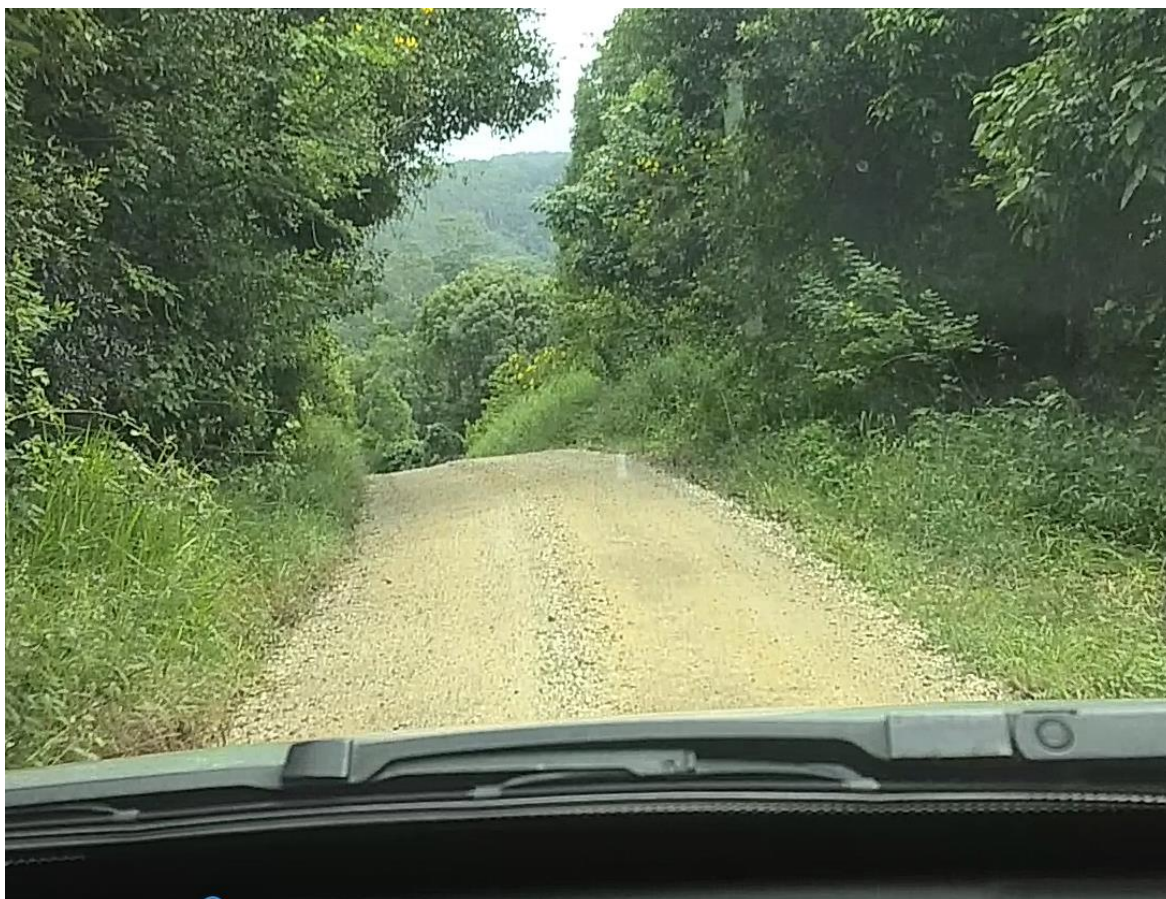
Montecollum Road is a rural no-through road in an area with steep topography and dense vegetation. The pavement width is generally narrow (around 2 to 3 metres) and limited verge width is available. An example of this is shown in Figure 1, taken using a screen shot from dashcam footage. Along this narrow and unsealed section of Montecollum Road, sight distances are limited and the pavement width is suitable only for single-lane use. The example shown is one of several sections of road where there is insufficient space to pass an opposing vehicle, and there is insufficient sight distance to achieve sufficient advance warning of a vehicle approaching from the opposite direction.

Figure 1 | Example of limited sight distance

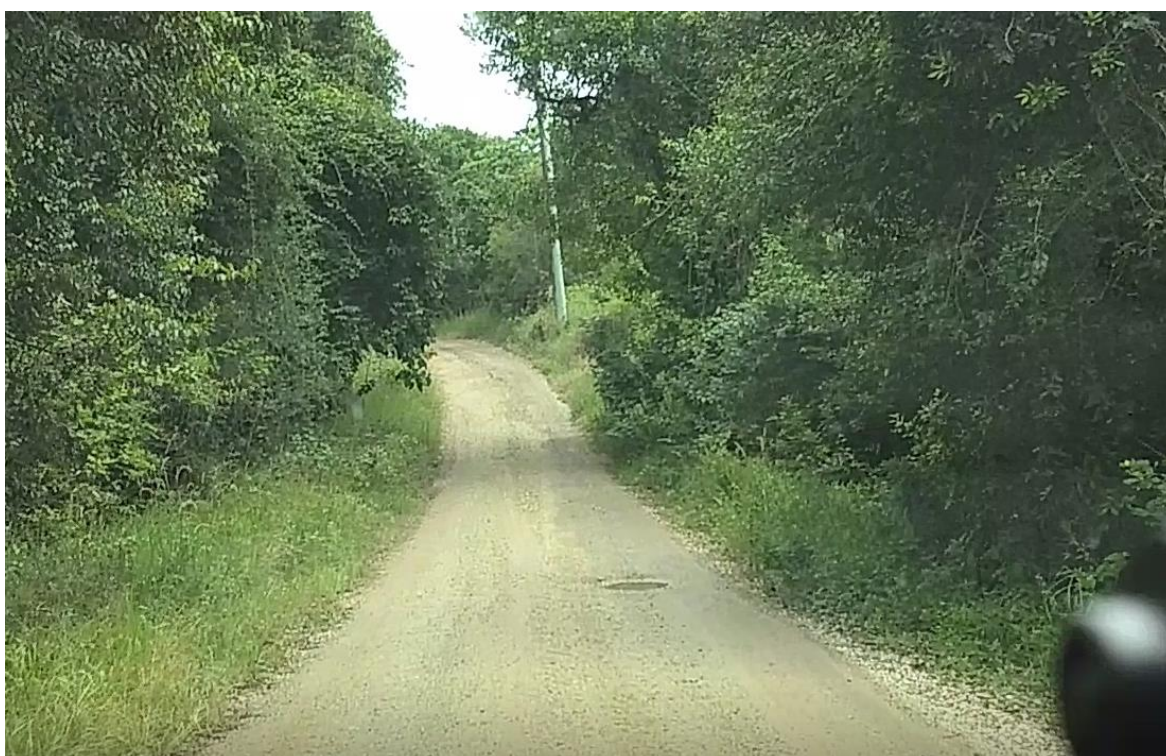
Figure 2 shows the location where in May 2018 a vehicle ran off the road and rolled down the embankment. This crash was the result of the vehicle swerving around potholes and losing control on the soft and narrow verge. Only one pothole was present during today's inspection, but I understand this is because the road was recently regraded by Council. Prior to that this section of road contained many potholes. Upon inspection of this section of road, it was apparent that there is insufficient roadside drainage available. Combined with the surface not being sealed, it is likely that potholing will re-appear after extended periods of rain.

Figure 2 | Location of recent vehicle crash

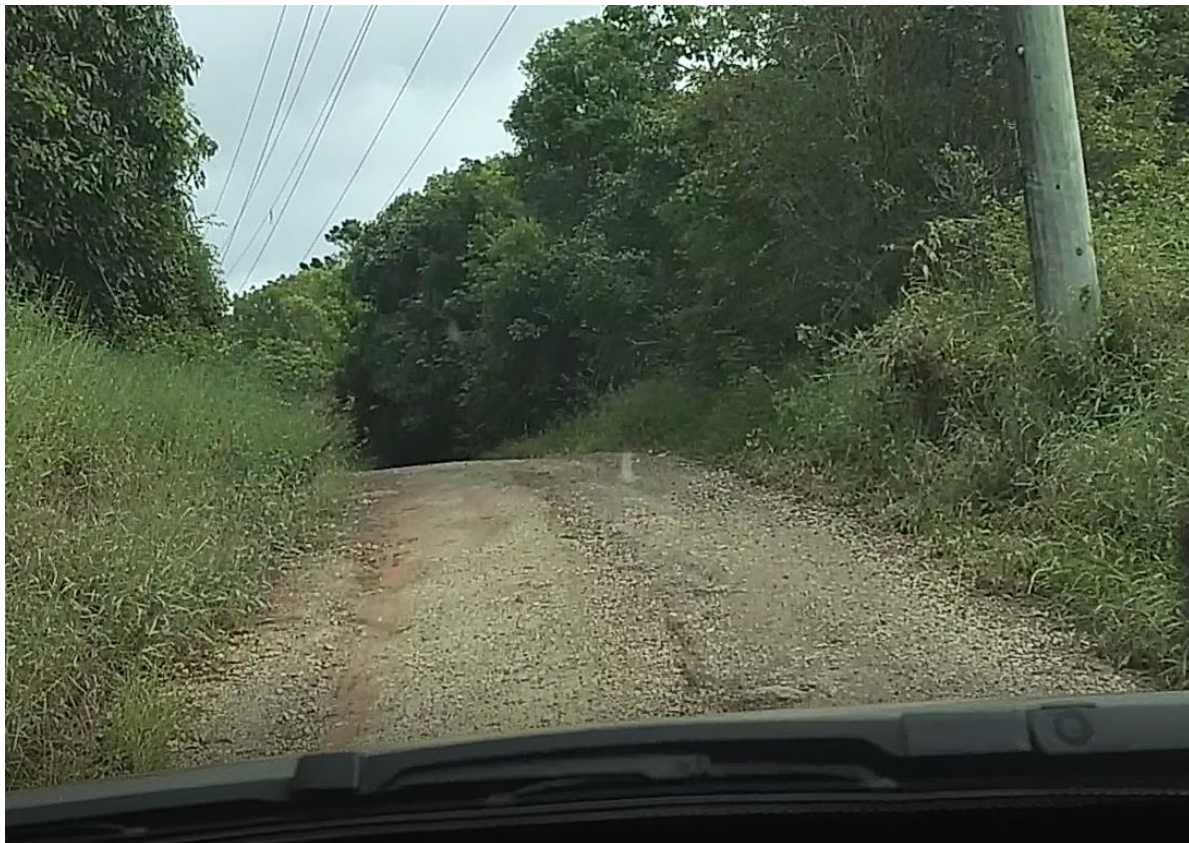
The pavement condition of Montecollum Road was generally poor. Unsealed sections of road with steep grades showed signs of scour (Figure 3) and sealed sections were patchy, in poor condition, and do not adequately seal the underlying granular pavement from rainwater ingress (Figure 4). Roadside drainage was generally inadequate or non-existent.

Figure 3 | Signs of scour on steep unsealed sections

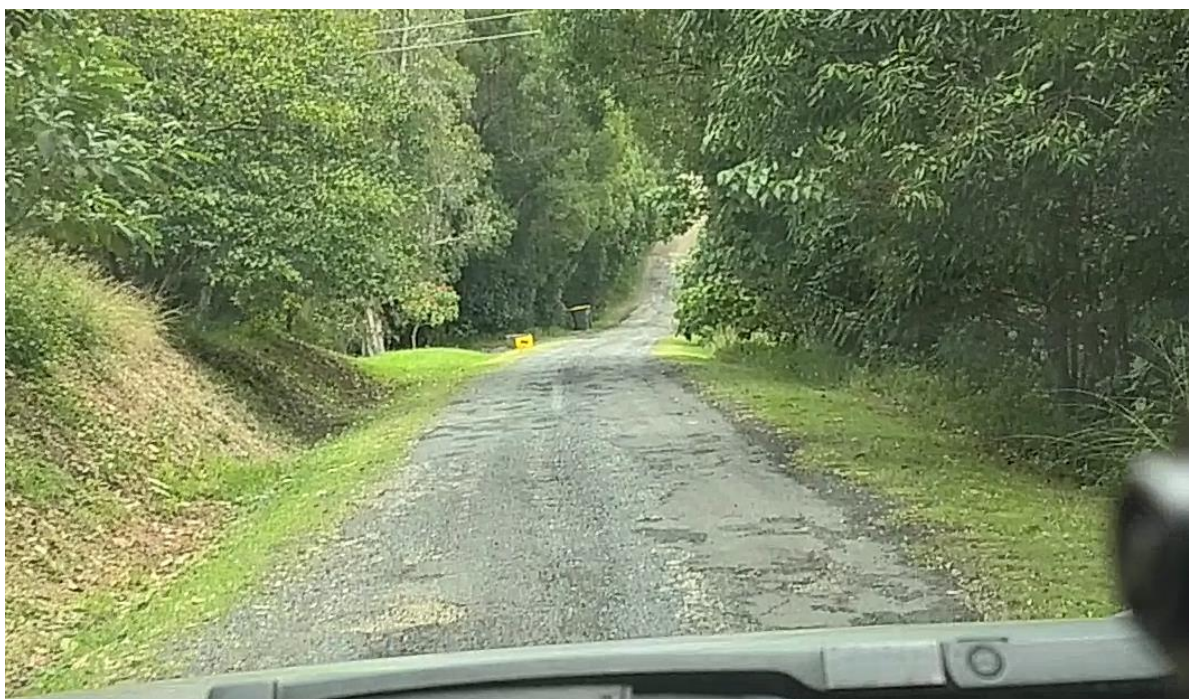
Figure 4 | Pavement seal in poor condition

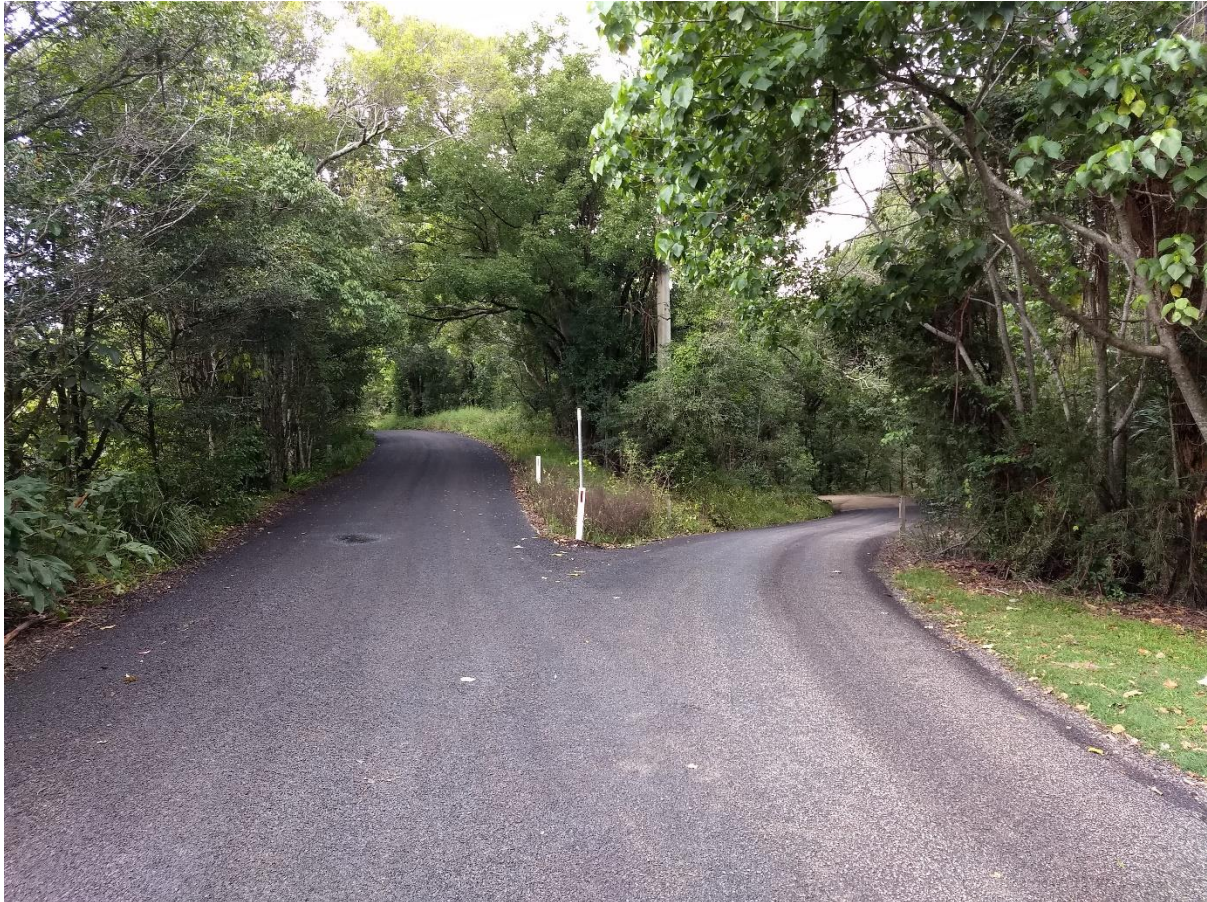
Figure 5 shows the intersection of Montecollum Road and Cedar Road. This photo was taken from the western approach to this intersection. When driving along Montecollum Road in a westbound direction towards Wilsons Creek Road, it was impossible to see oncoming traffic from Cedar Road. The priority arrangements were also unclear.

Figure 5 | Cedar Road intersection
