## Terrace Holiday Park: Southern Precinct Arboricultural Impact Assessment

**Terrace Holiday Park  
Brunswick Heads, NSW**

**March 2018**

**C91119**

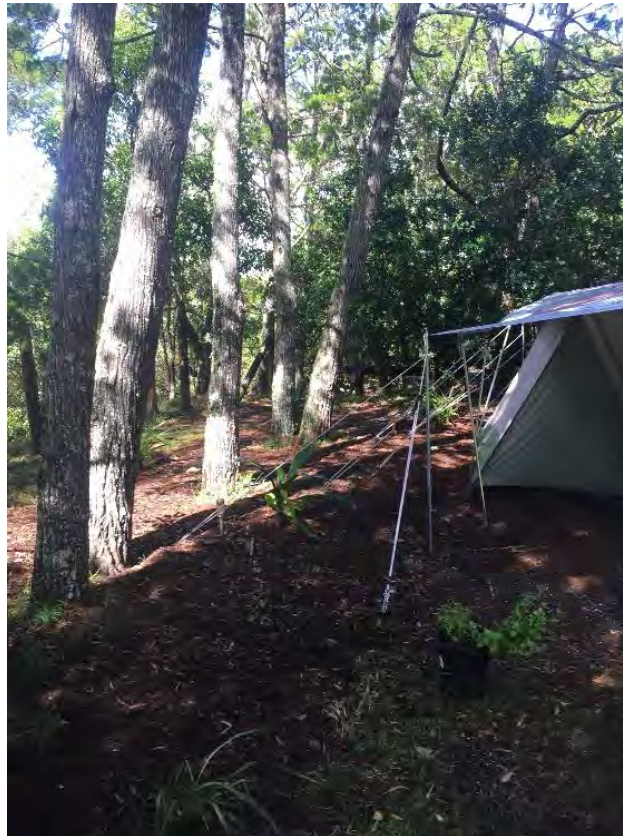
Figure 5. The photo shows encroachment from an awning into a protected regeneration area due to lack of space and inappropriate site booking. Source: Clark, March 2018

- 8.3.4 The site dimensions are to be emphasized at the time of booking to stop encroachment into protected regeneration areas. If information is easily accessible, and patrons are aware prior to visiting, then encroachment issues can be resolved fairly and easily.

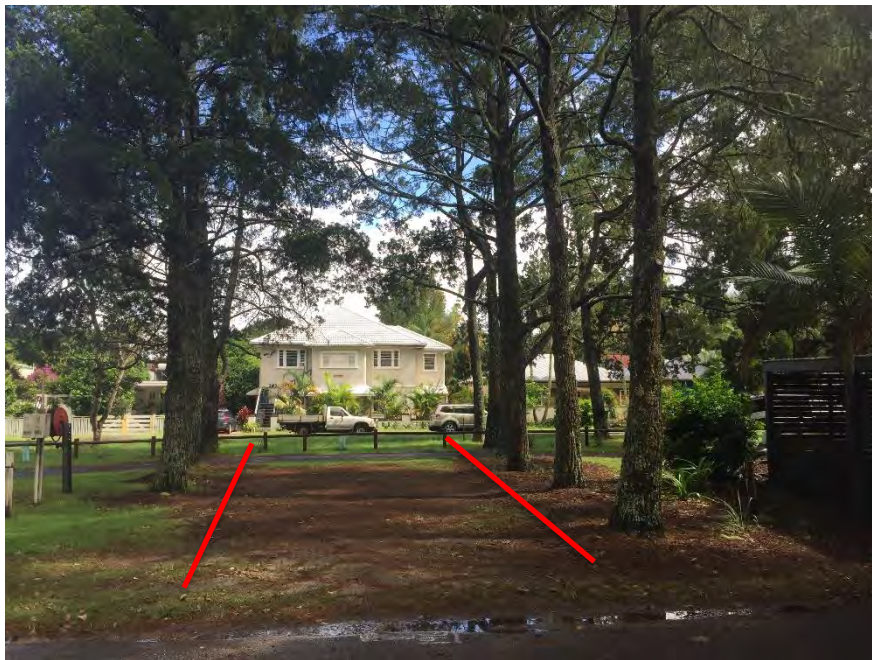
Figure 6. The photo shows site 22 (refer to Fig. 4) as an example of where load cells (between red lines) could be utilised to allow access and use of site when SRZ encroachment is unavoidable. The long narrow site could be designated for camper trailer use with awning out to the left. Source: Clark, March 2018

- 8.7.2 It is considered that installing a platform of load spreading cells (i.e. TerraCell® or TERRAM Geocell) would mitigate the negative impacts of vehicles parking within the TPZs or SRZ or of potential mechanical damage caused by camping within the SRZ.

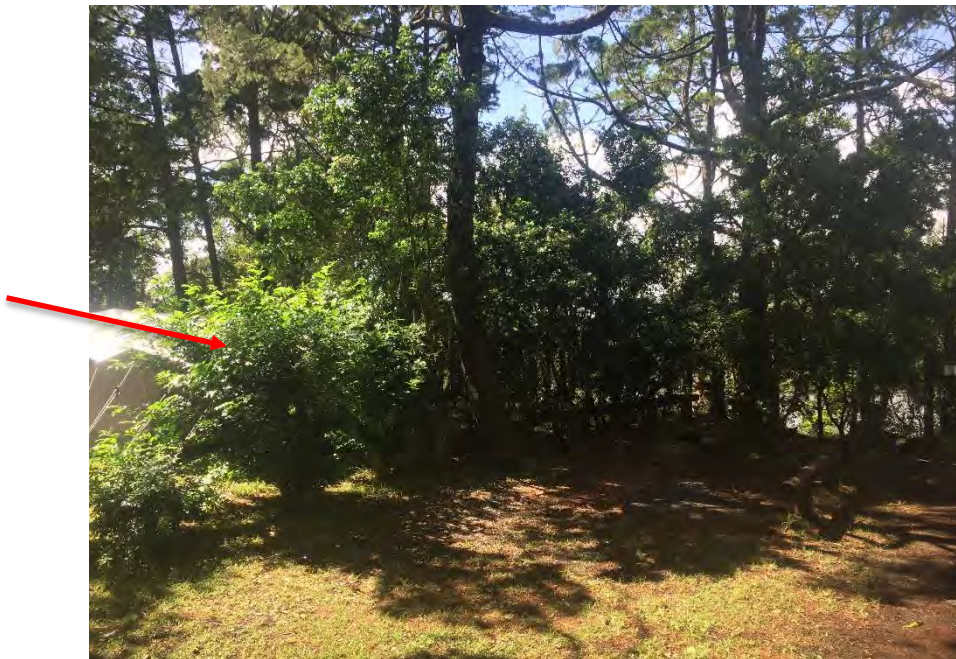
Figure 7. The red arrow indicates a planting of exotic *Murraya paniculata* not a species associated with CCPF recommended for removal. Source: Clark March 2018

- 9.1.1 All exotic trees and shrubs not aligning with the CCPF should be systematically removed from the Southern Precinct over time and replaced with CCPF associated species. This includes the removal of the *Murraya paniculate* hedges and various shrubs.
- 9.1.2 All weeding should be undertaken by hand.
- 9.1.3 Any chemical use must not impact the regeneration of CCPF.

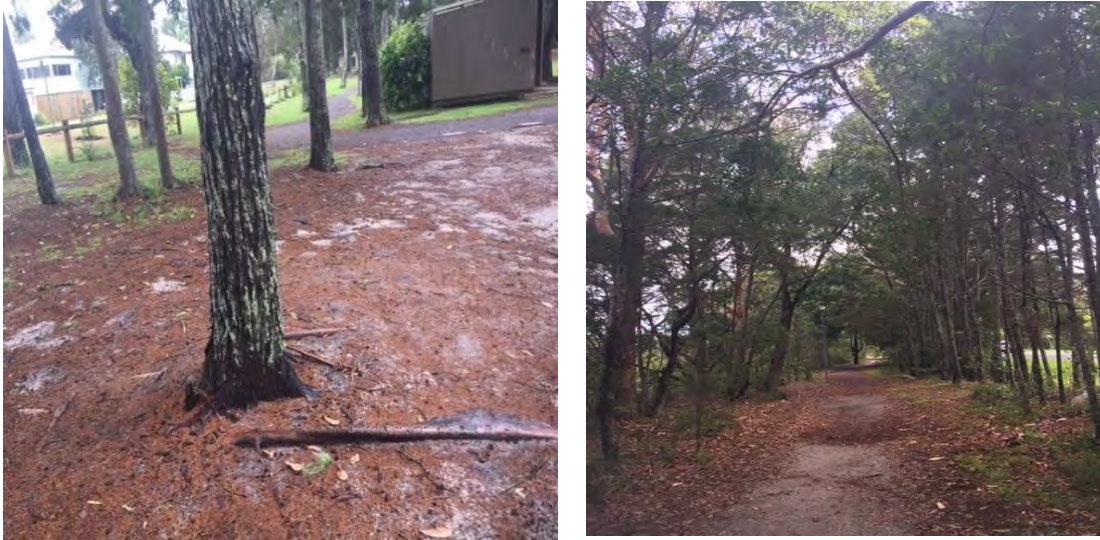
Figure 8 and Figure 92. Partial natural mulching around trees situated at the south western corner, around Trees 2–8 of Terrace Holiday Park along with an example of natural mulching around Callitris trees in Simpsons Reserve. Source: Clark November 2017

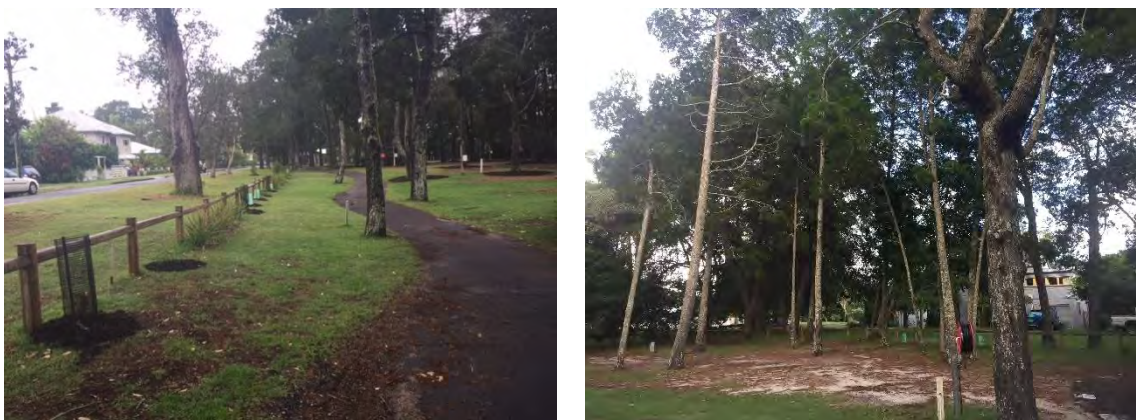
Figure 10 and Figure 11. Potential planting/regeneration areas within the southern zone. Left: The western Right: area in the south western corner around Trees 2–8. Source: Clark March 2018

- 9.5.5 Care with underplanting in these areas would be required so existing tree roots are not damaged. Hand excavation and manual planting are recommended.

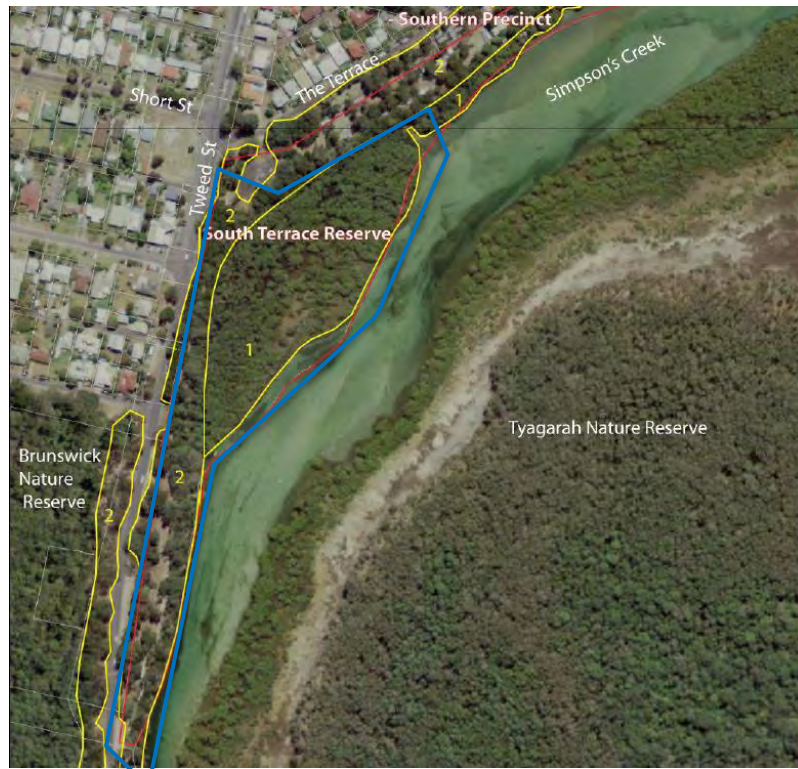
Figure 12. Depicts the location of CCPF within Simpson Reserve with a Blue line. This area appears to be suitable and appropriate for regeneration. Site use should be restricted to activities that will regenerate the EEC. Source: VPM 2011
