# Arboricultural Impact Assessment Report

STP West Byron Byron Bay.

Client: Byron Shire Council.

PO Box 81, Burringbar NSW 2483. Ph 0414186161 3rd February, 2020.

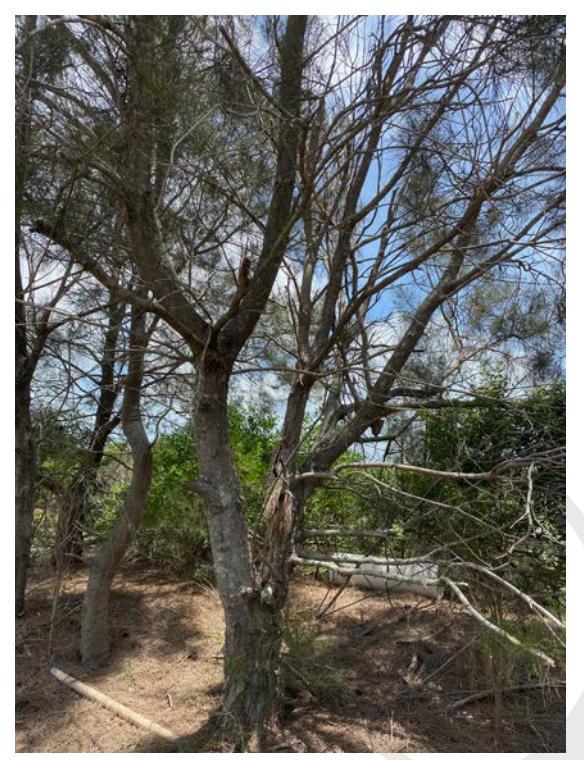
Medium sized mature aged tree. This tree has a dying central branch and is in poor condition. There is evidence of borer attack in the trunk. The branch on the northern side of the tree is likely to be in the way of trucks accessing the collection hopper. The encroachment into the TPZ by the planned construction is 18% which is a major encroachment as defined by the Australian Standard *AS 4970-2009 Protection of trees on development sites. Sect 3.3.3 Major encroachment.*

Photo 1 Tree # 1 Swamp Oak tree to be removed

It is recommended that tree # 1, 2 and 3 be removed to allow construction of the planned works. Tree # 4 should be retained. The small shrubs consisting of Banksia and Swamp Oak should be removed to allow construction of the planned works.

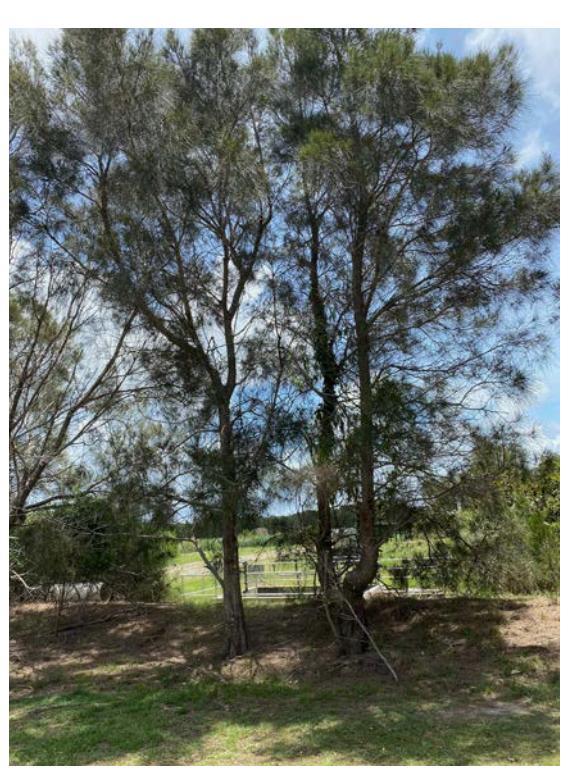
Medium sized mature aged tree in good condition. The tree is growing in the footprint of the planned loading area.

Photo 2 Tree # 2 & 3 Swamp Oaks to be removed

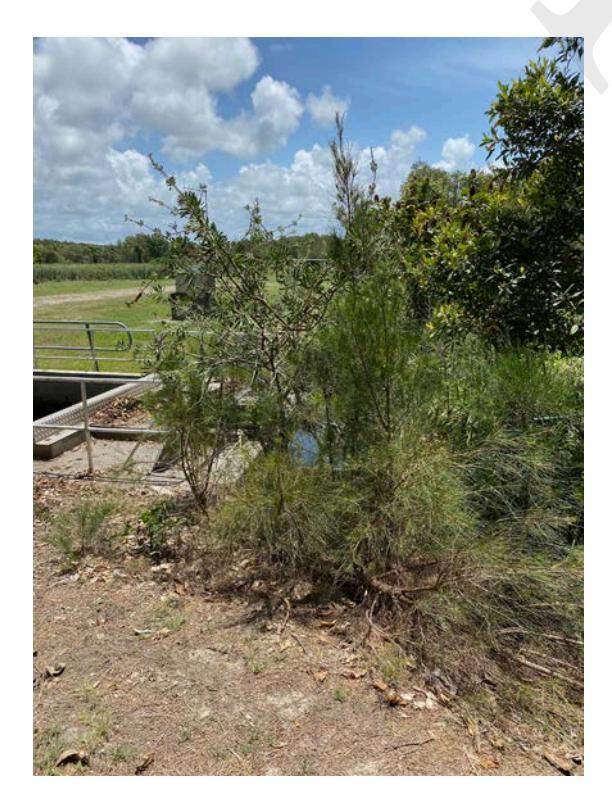
Photo 3 Banksia and Swamp Oak shrubs. Less than 3 m tall. To be removed.

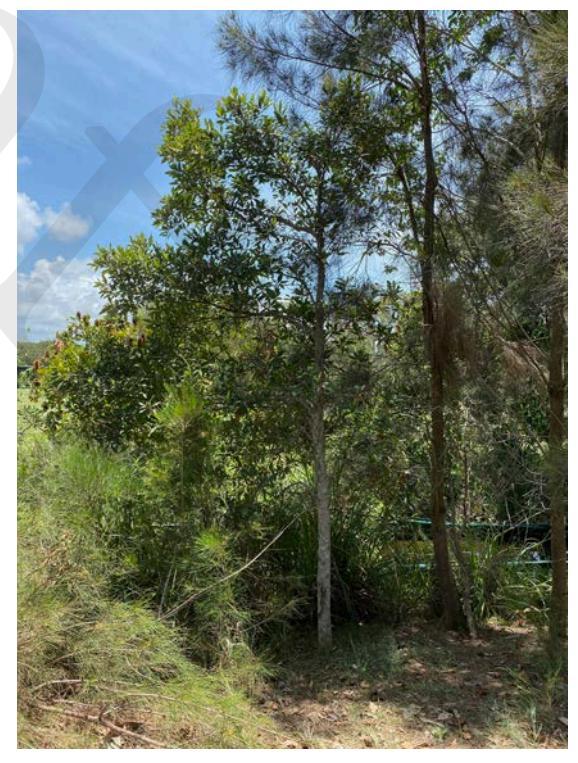
This is a small young tree in good condition. Even though it is less than 3 m tall and therefore not protected by Byron Shire Council's DCP Chapter B2 Protection of Trees and Other Vegetation it has been included in this report because it is close the the planned earthworks required to change the soil level for the truck access. The planned work is outside the TPZ of this tree.

Photo 4 Tree # 4 Blueberry Ash. Small tree to be retained.

It is not considered necessary to provide any additional protection to the trees retained on site. The trees to be retained should be identified to the works contractors and it should be explained to them that the trees must be retained in good health and condition during the works.
