Arboricultural Impact Assessment Report

**88 Station Street
Mullumbimby NSW 2482**

North Coast Community Housing

5th August 2020

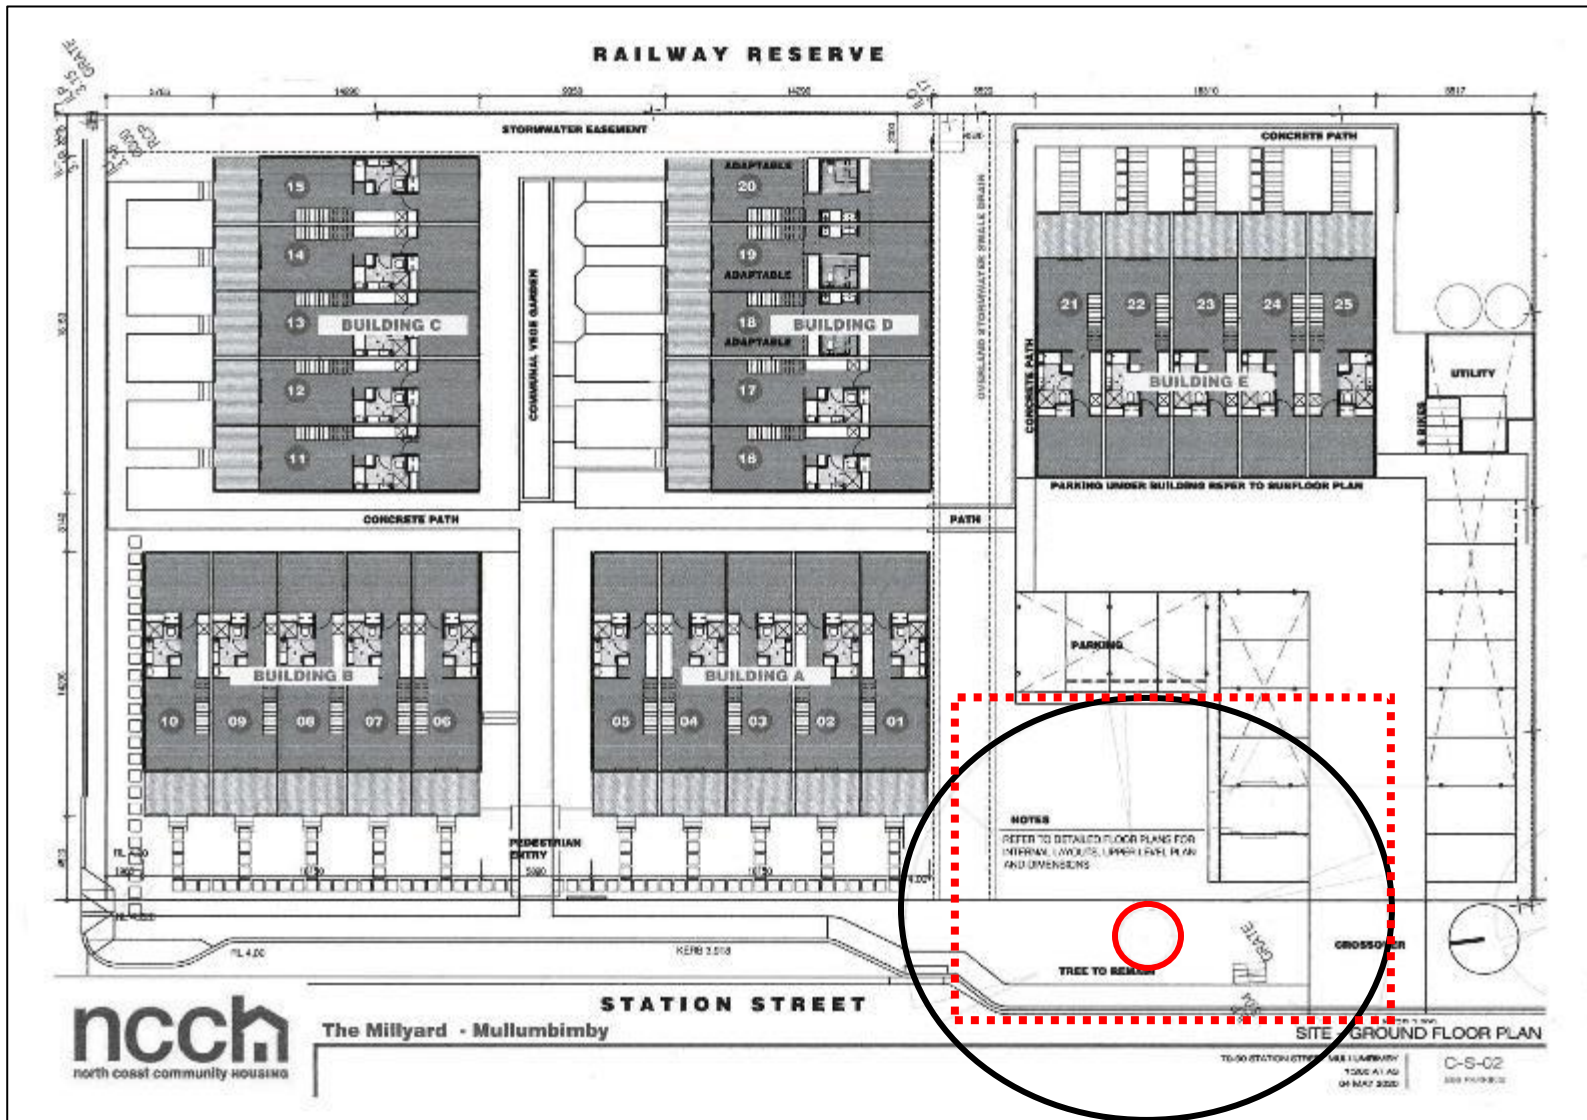
6.8 The proposed carports 09-12, crossover, a portion of the driveway, and footpath are located in the TPZ but outside the Structural Root Zone (SRZ)³ of 3.8m. At the closest point, the subject tree centre is approximate 4 m from the proposed parking space, 09. **Figure 2 and 5**

Figure 2 Overview of the proposed development with the subject tree location TPZ (black circle). Trunk location (red circle), Tree Protection Fence (red dash line). (Source: KO:HO – Site Plan - Drawing-C-S-02, dated 04.05.2020.)

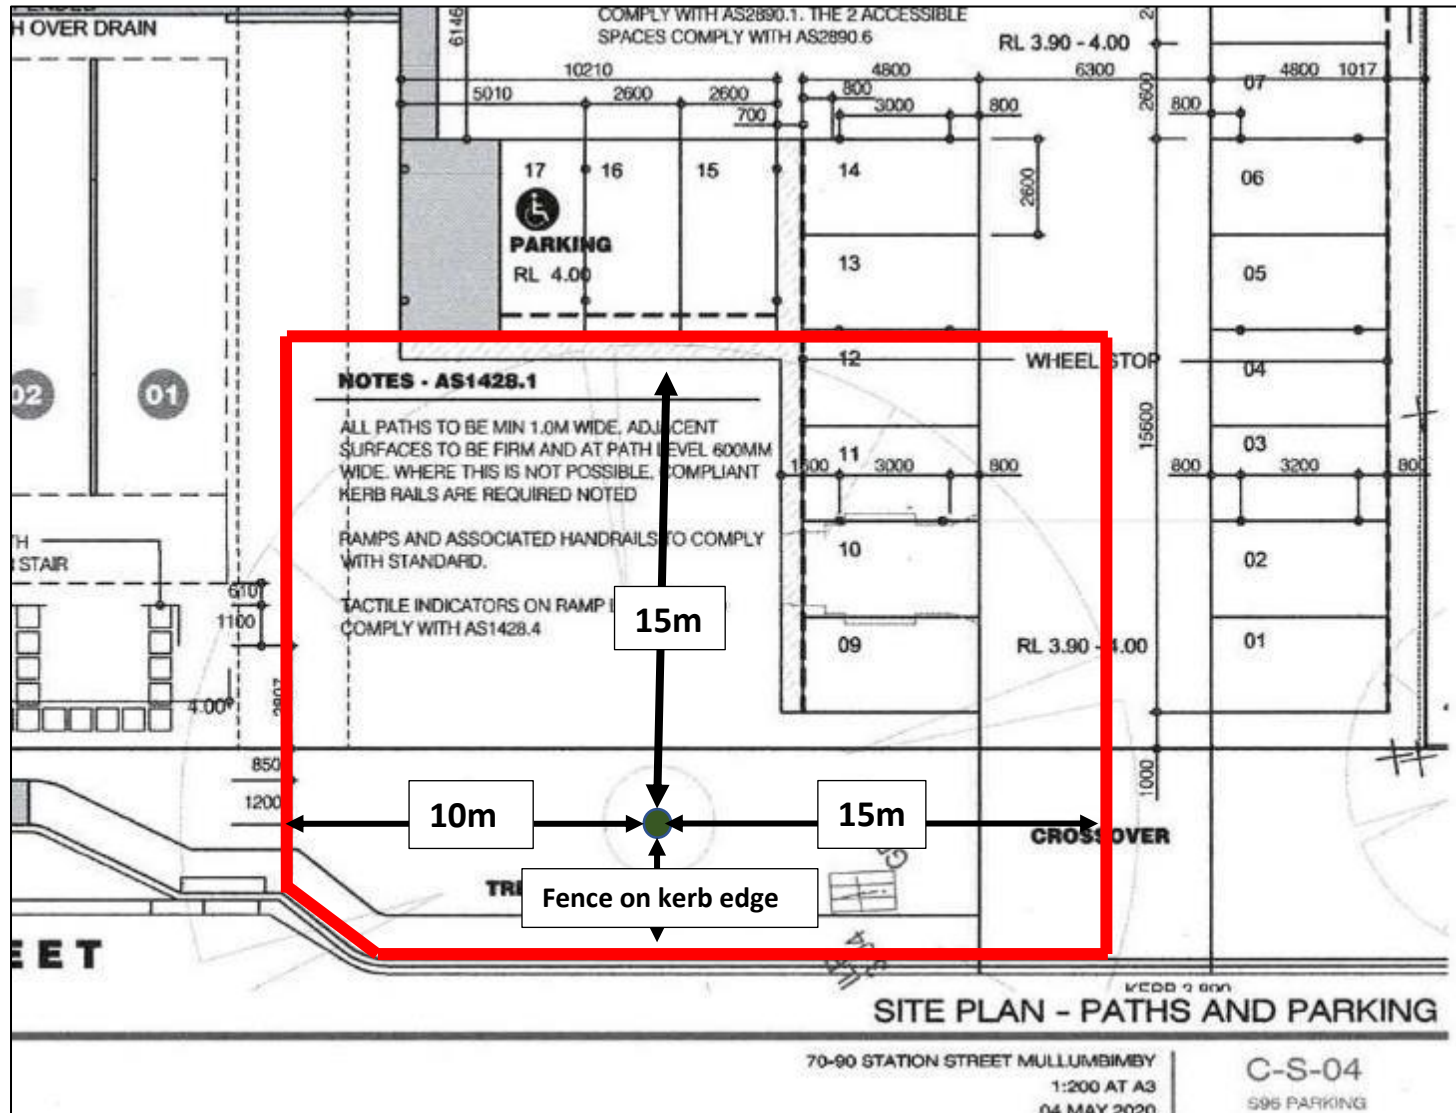
Figure 3 Tree Protection Zone where fencing must be located (red line).

8.6 The TPZ must be isolated a 1.8m high rigid temporary fence or an appropriate classed structure, with suitable signage of restricted activities, in accordance with AS 4970-2009 Cause 4.2, 4.3 and 4.4. The fence will prevent entry or placement of machinery and materials into the TPZ. The fence will stay in situ until works are complete. TPZ fencing will be placed as per **Appendix 4**. The Project Arborist is required on-site for the fence installation.

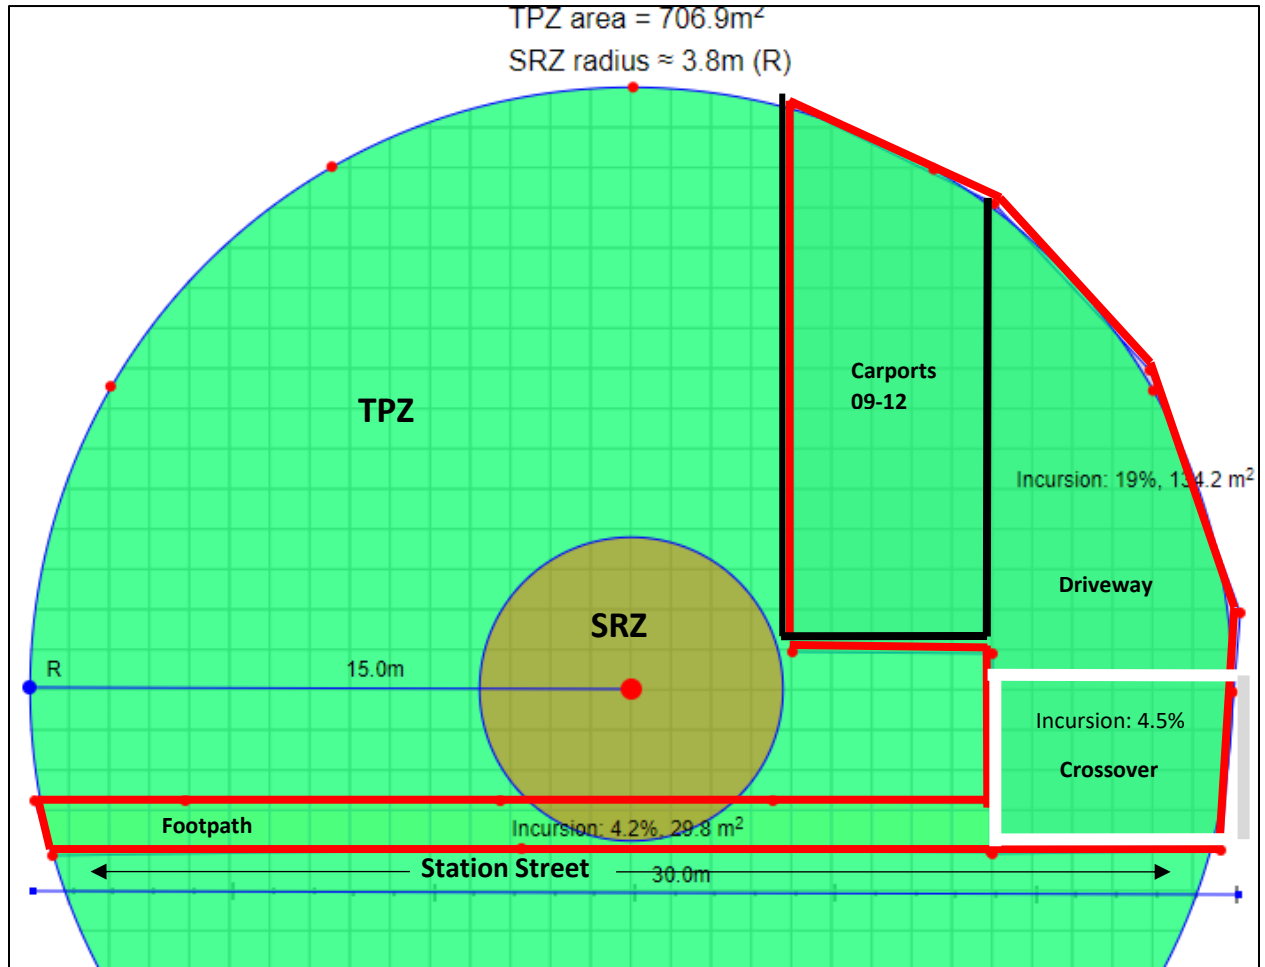
7.4 Estimations show a major encroachment into the TPZ: greater than 10% of the TPZ, due to the proposed revised plans. **Appendix 5**. AS4970 guidelines state, if the 'encroachment is greater than 10% of the TPZ', the Project Arborist must consider the trees health, age, environmental conditions, and proposed development, then demonstrate that the tree/s will remain viable during the proposed development and associated disturbance

Figure 4: Encroachment calculator showing the major encroachment into the subject tree's TPZ. Red outlined indicates total encroachment. White outlined square is crossover encroachment where excavation required.
 (Source: ProofDocs 2019)

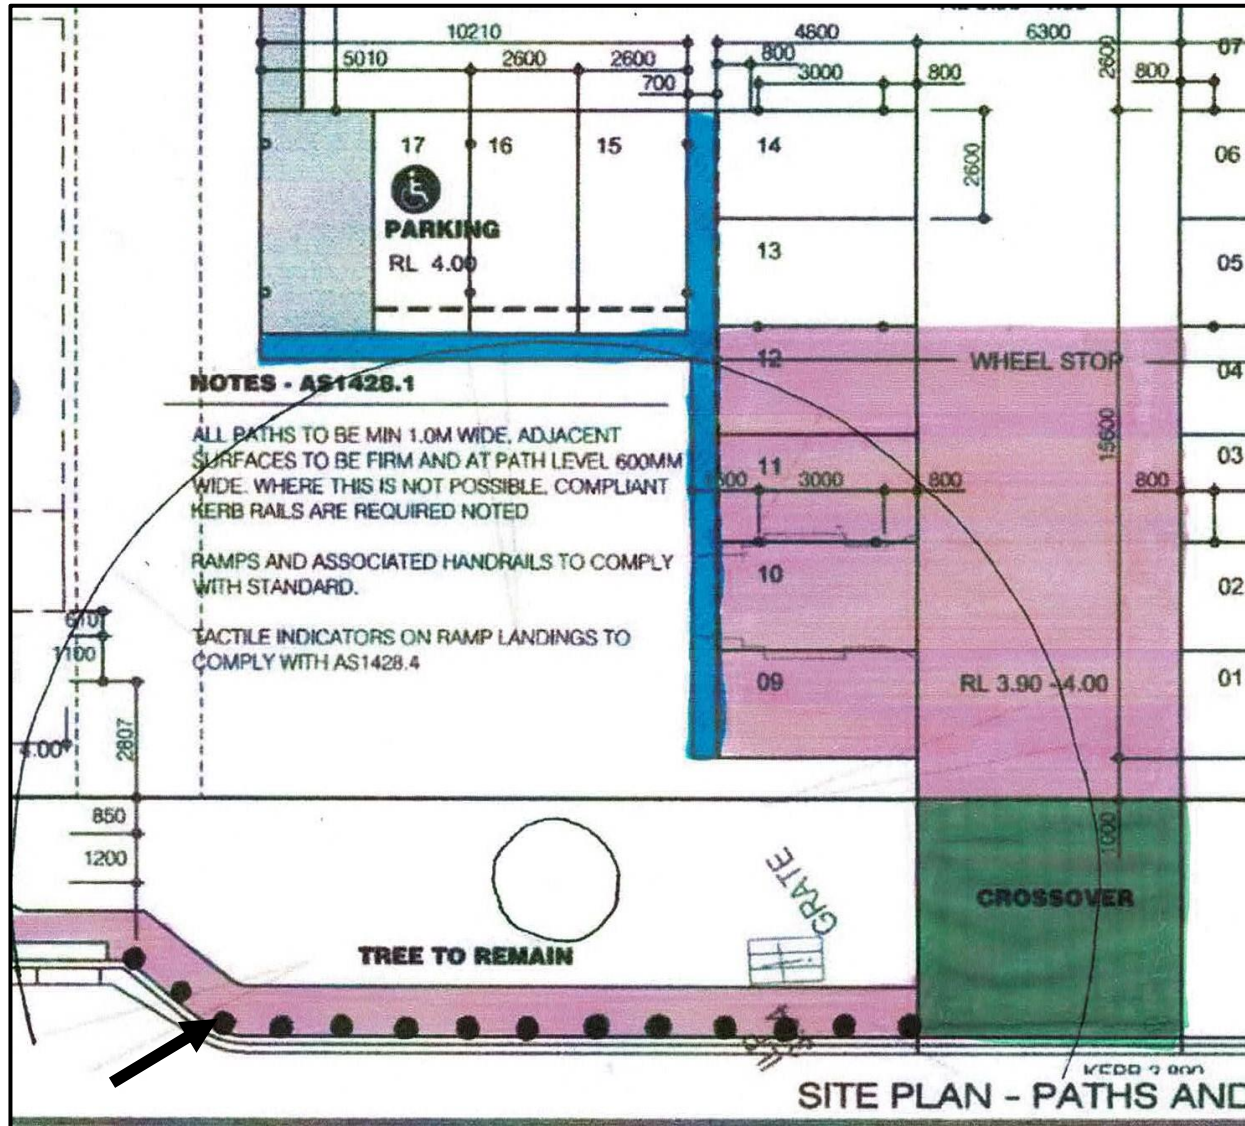
Figure 5: Specified turf or gravel cell (purple area), proposed bollard location (arrow pointing to black dots), proposed rock drain (blue) and proposed concrete crossover (green)

7.11 Turf or gravel cells are an available footing option, i.e. low impact building method, where judicious care of tree roots is required. Turf or gravel celled areas must be, carports 09-12, the driveway from site boundary level with the west extremity of carport 12, and the footpath from north of the stormwater drain to the northern edge of the cross over **Appendix 6**. Turf or gravel cells must be installed at or near ground level. Soil level adjustments must be added fill rather than removal. Removal of any soil in the TPZ, if required, must be by manual means only.

7.12 To minimise root damage support posts for carports 09-12 must be anchored by metal stirrups or something similar.

8.11 Installation of bollards along the kerb: footpath interface from south of stormwater drain to the north side of the crossover is highly recommended.

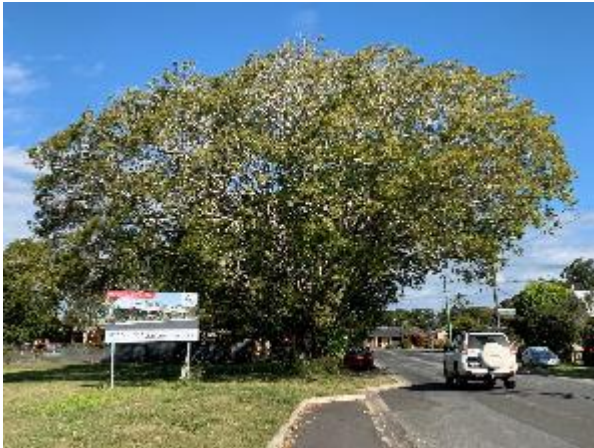
6.1 The subject tree is an established, single-stemmed specimen for the species, located in the south-west sector of the site. It shares a common boundary with Station Street Mullumbimby. **Figure 6**

Figure 6: Image looking south showing the subject tree in relation to Station Street

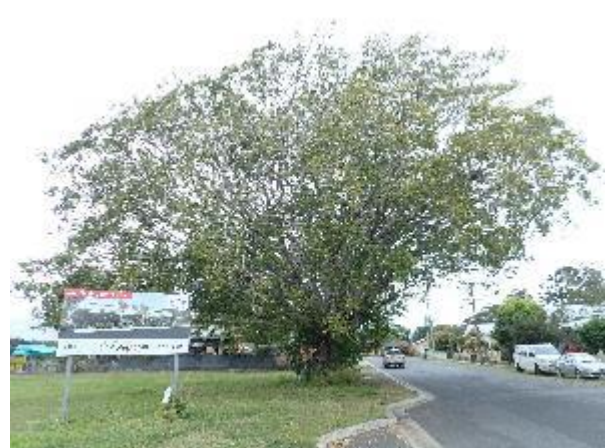
6.2 The subject tree appears in fair health for the species and location. Visual indicators show the crown density is slightly sparse and leaf colour mildly chlorotic. **Figure 7**

7.1 The subject tree is considered in fair health due to the slightly sparse condition of the crown, the mild chlorotic (yellowing) appearance of the leaves and the dead apical growth (ends) over the crown. A contributing factor for the overall condition and appearance of the crown may be the extended dry and hot periods of the past two summers. Given time, improved soil moisture and condition, subject tree health and appearance should improve.

Figure 7: A slightly sparse crown and mildly chlorotic leaves

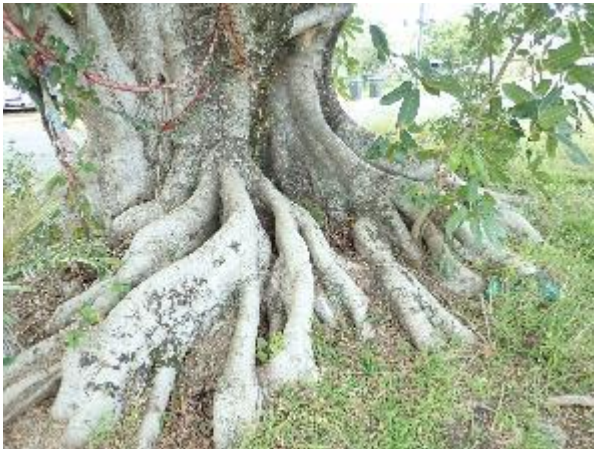
6.3 Leaf size, branch extension, branch structure, trunk, root crown and buttress of the subject tree appear in good condition and form. The subject tree appears structurally sound with no indication of internal weakness. **Figure 8 and 9**

Figure 8: Trunk, root flare and buttress in good condition

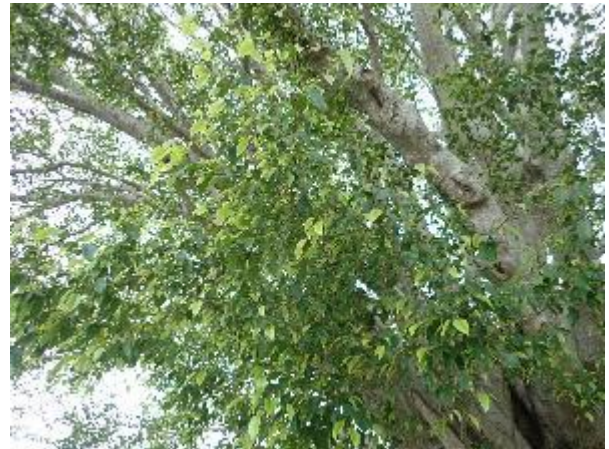
7.2 The overall condition of the trunk, root flare, buttress and structural and secondary branches appear in good health and condition. New leaf growth and branch extension over the majority of the crown, indicates good vigour, important features for a tree on a development site.

Figure 9: New foliage and branch extension

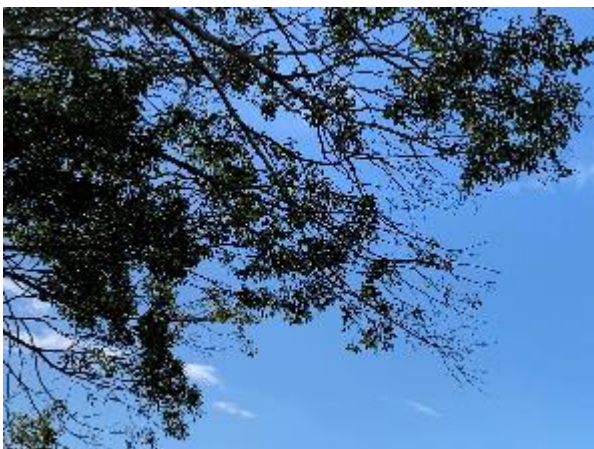
6.4 There is evidence of apical branch death over the crown. **Figure 10**

Figure 10: Apical branch death

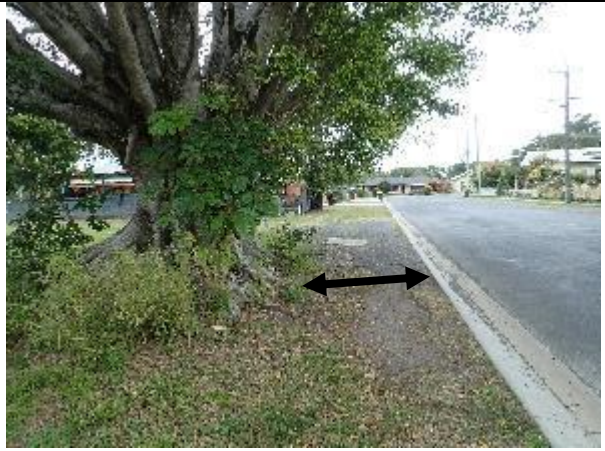
6.10 The distance between the kerb and the western side of the root buttress is approximately two (2) metres. The ground between the subject tree's buttress and the kerb is heavily compacted. **Figure 11.** Cars park under the crown (Author's observation).

7.18 The proposed footpath on the west side of the subject tree (TPZ between the subject tree and kerb edge) is a known parking space for nearby residents and visitors causing compaction to the root zone in that area. To prevent compaction and assist tree health, installing bollards from south of stormwater drain to the north side of the crossover at the kerb: footpath interface is recommended. **Appendix 6**

Figure 11: Approximately 2m from edge of buttress to kerb. Highly compacted area

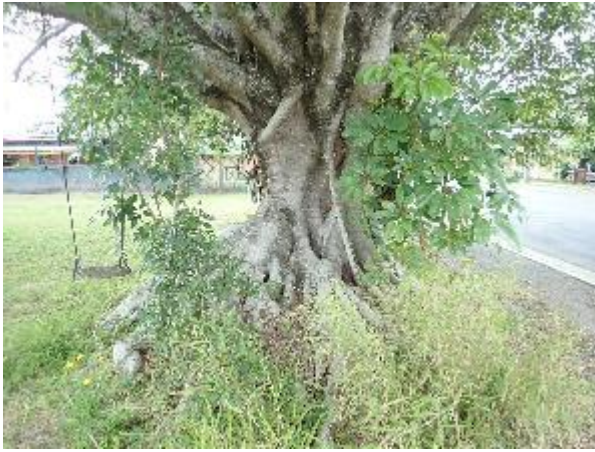
6.12 There are a number of self-germinated tree species growing at the base of the tree. **Figure 12**

Figure 12: Self germinated trees in buttress area

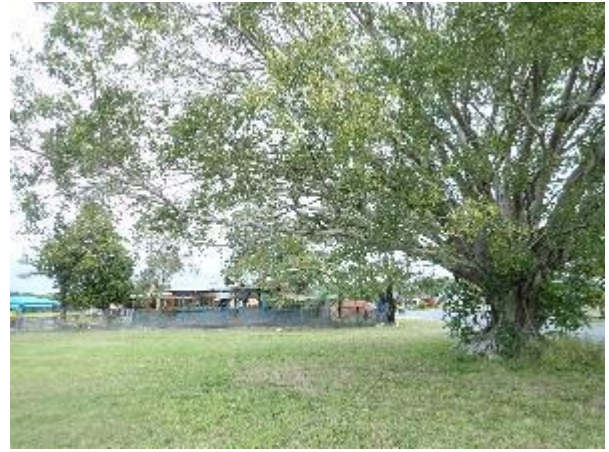
6.11 The subject tree has a low branching habit, mostly initiate between 2-2.5 metres high. **Figure 13**

Figure 13: Low branching habit
