WATER, WASTE AND SEWER ADVISORY COMMITTEE MEETING

Byron Shire Effluent Management Strategy 2017—2027

VALLANCES ROAD, MULLUMBIMBY

Capacity assessment of the Belongil Creek Drainage System

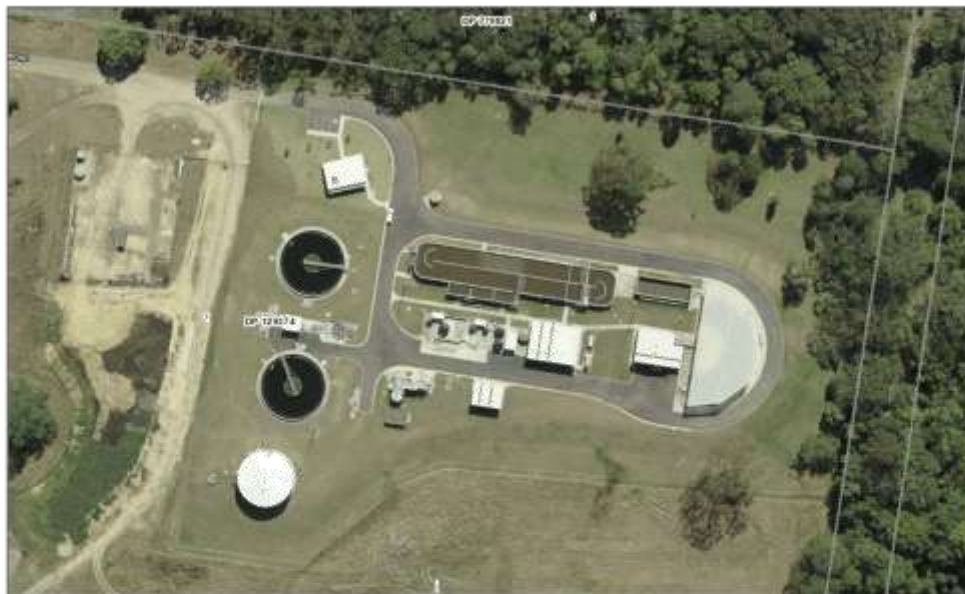
Figure 6 – Existing Sewage Treatment Plant

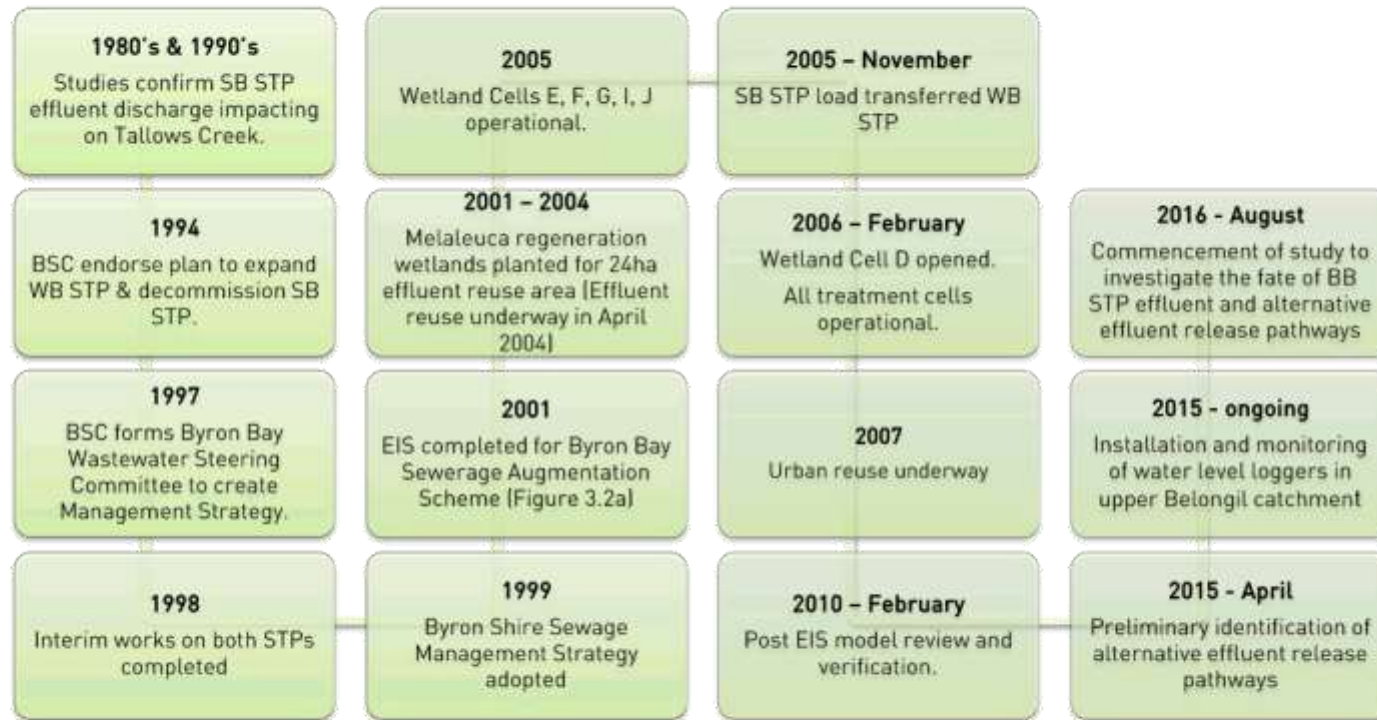
Figure 1-2: Flow diagram of major activities undertaken by the Byron Shire Council on the township sewage systems since 1980's

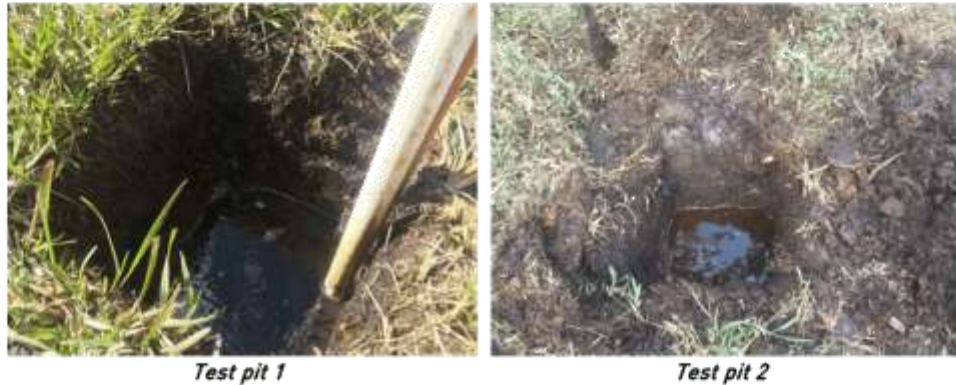
Plate 3-1: Photograph of test pits located in land west of the BBIWMR (refer to Figure 3-1).

At each of the sites shown in Figure 3-1, two 50cm x 50cm x 60cm (L x W x D) test pits were dug (Plate 3-1) and a 80cm Odyssey water level logger positioned to record changes in the level of water within the pit. Using a 10L bucket, water within the pit was rapidly bailed out and the logger set to record the level of water within the pit every 5secs. Each pit was assessed three times.

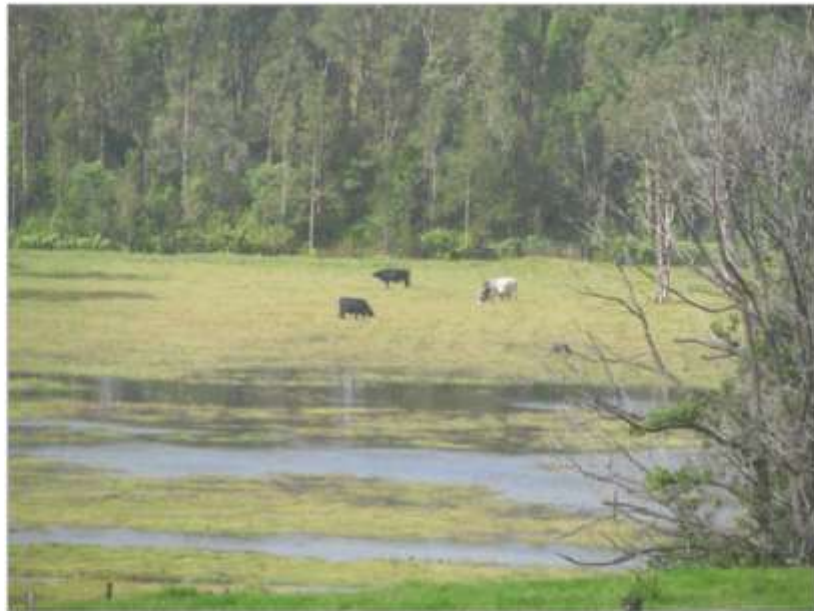
Figure 17-6: Photo Inundation: April 2009 [Source, Tidswell]

- April 2009 - Approximate rainfall totals - 2 April 10mm, 3 April 67mm, 4 April 58 mm and 5 April 12 mm. Refer Figure 17-6; and
- May 2009 - Approximate rainfall totals - 42 mm 19th May, 8 mm 20th May, 136mm 21st May, 132 22nd May and 32 mm 23rd May. Refer Figure 17-7; and
- June 2016 - Approximate rainfall totals - 3 June 9 mm, 4 June 45 mm and 5 June 166 mm. Refer Figure 17-8.

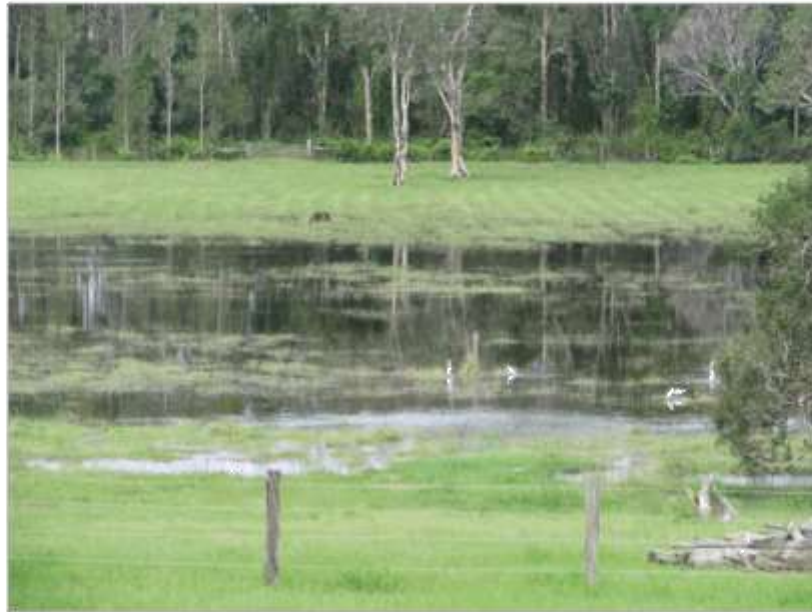
Figure 17-7: Photo Inundation: May 2009 [Source, Tidswell]

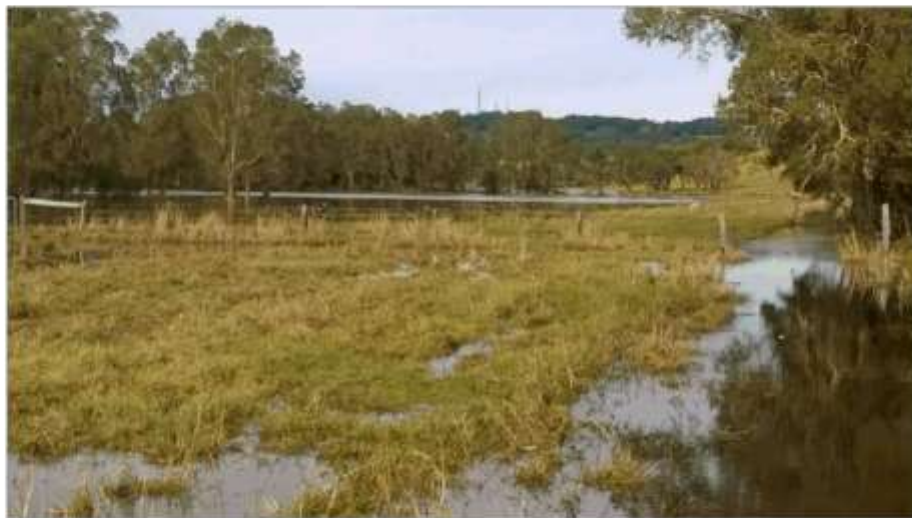
Figure 17-8: Photo Inundation: June 2016 [Source AWC]
