# Technical Memorandum

## Sandmining drain/track status and impact on Belongil catchment

To: Bryan Green (Byron Shire Council)  
From: Damian McCann, Jesse Munro (AWC)  
Date: 13 November 2018  
Pg/Attach.: 5  
Job ref: 1-181009\_03\_A\_sandminetrack

## Sandmining track/drain

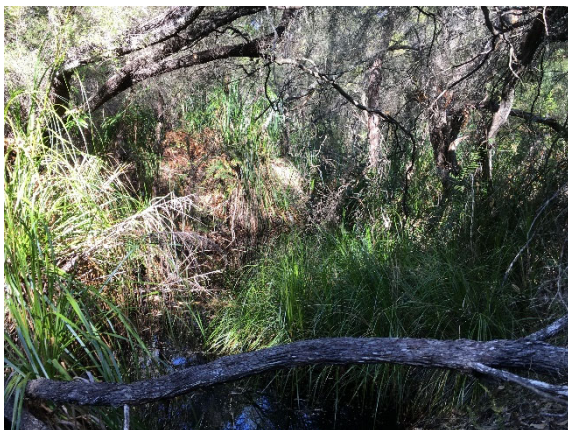
Photo 1 - Example drain in the north

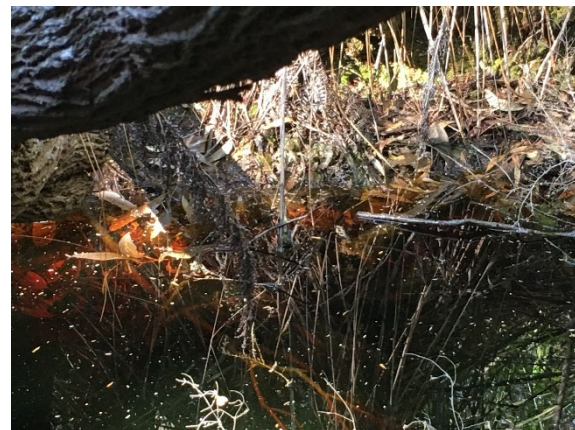
Photo 2 - Tannin coloured drain water in the north

A water sample was analysed for pH and conductivity; it showed pH of 4.24 and conductivity of 282 $\mu$ S/cm. The relatively low pH value is consistent with the wallum heath type of vegetation evident in the vicinity. The water shows a tannin stained colour, as seen in Photo 2 (above), a result of peat and tea tree pigments from the surrounding areas.

The conductivity shows the area is freshwater and is not tidally influenced. This is also reflected in the vegetation.

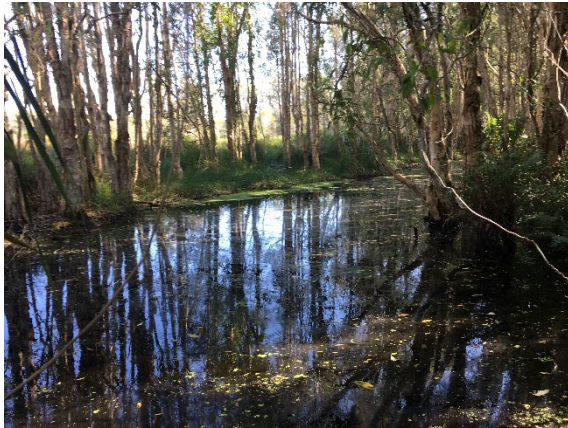
Photo 4

Paperbark and macrophytes. The drain is approximately five metres wide and had standing water during the inspection (refer photo below). A track or remnants was not visible through this area due to the dense vegetation.

Although there was no flow on the inspection day, it is assumed the flow is in a southerly direction. The drain stops at the boundary of the WBSTP with water dissipating through the site with no formalised channel. (Example images four and five).
