PRELIMINARY CONTAMINATION ASSESSMENT

Bangalow Public School Redevelopment

Byron Street, Bangalow NSW

Date:
May 2021

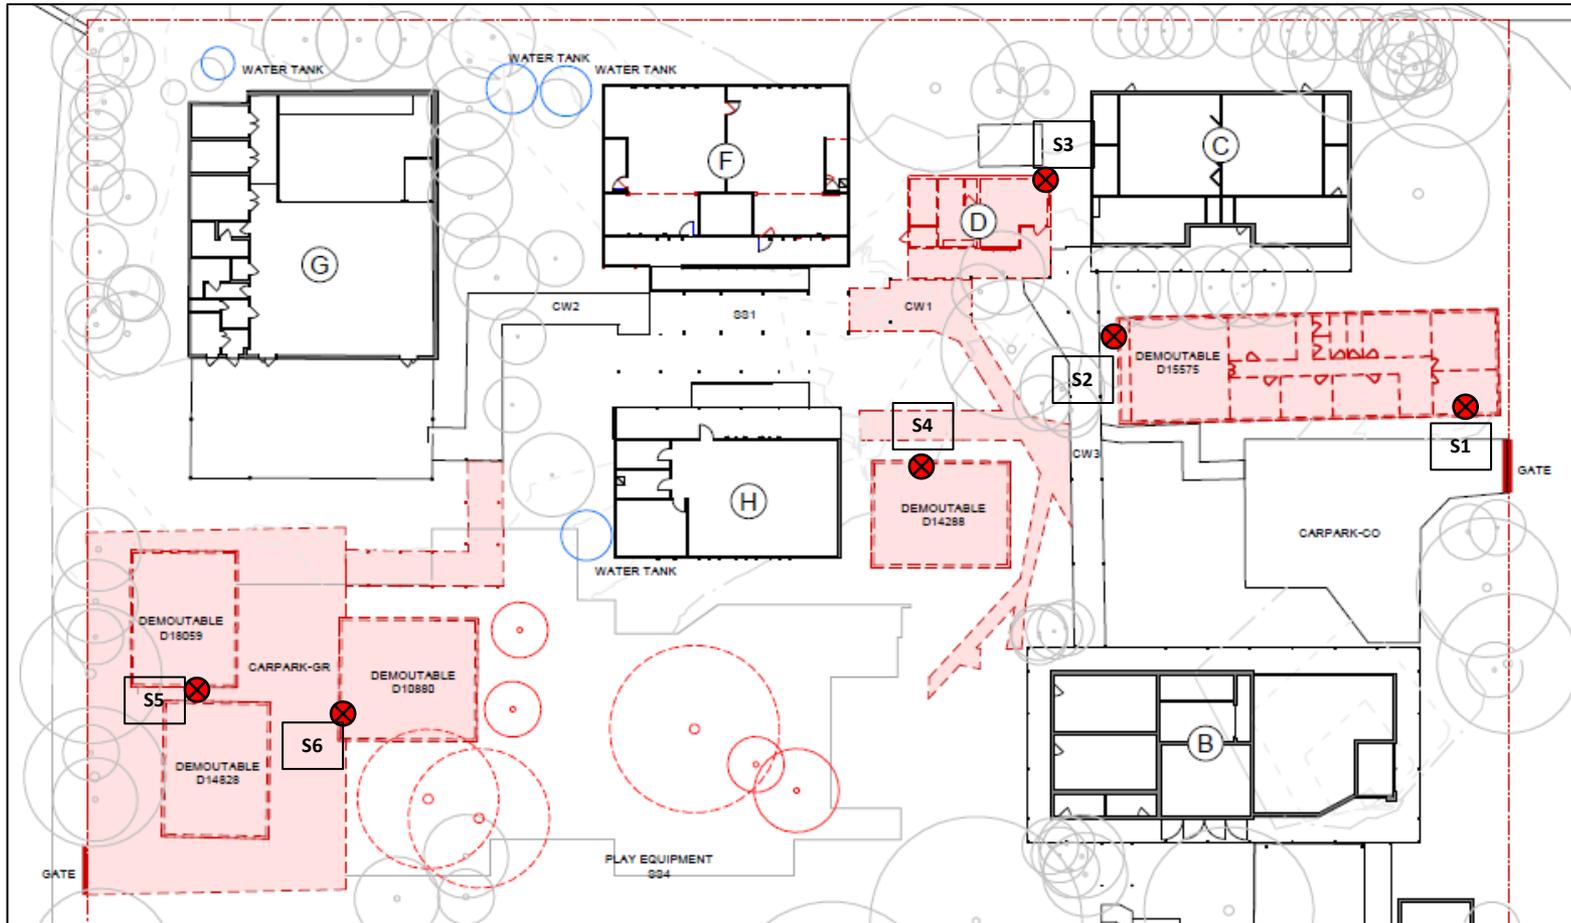
Figure 3 - Sample Locations (Demolition)
Bangalow Public School: Byron Road, Bangalow, NSW

Building to be Demolished

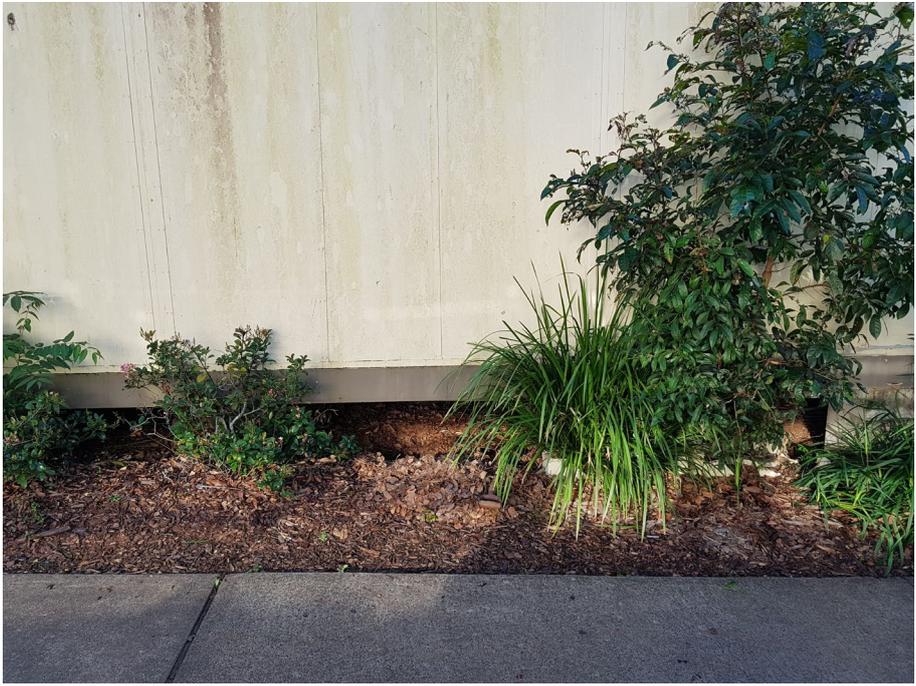
Photo No. 1	Date 13/05/2021

Description Looking north at the base of the existing administration building (to be demolished). This was the location of sample S1.

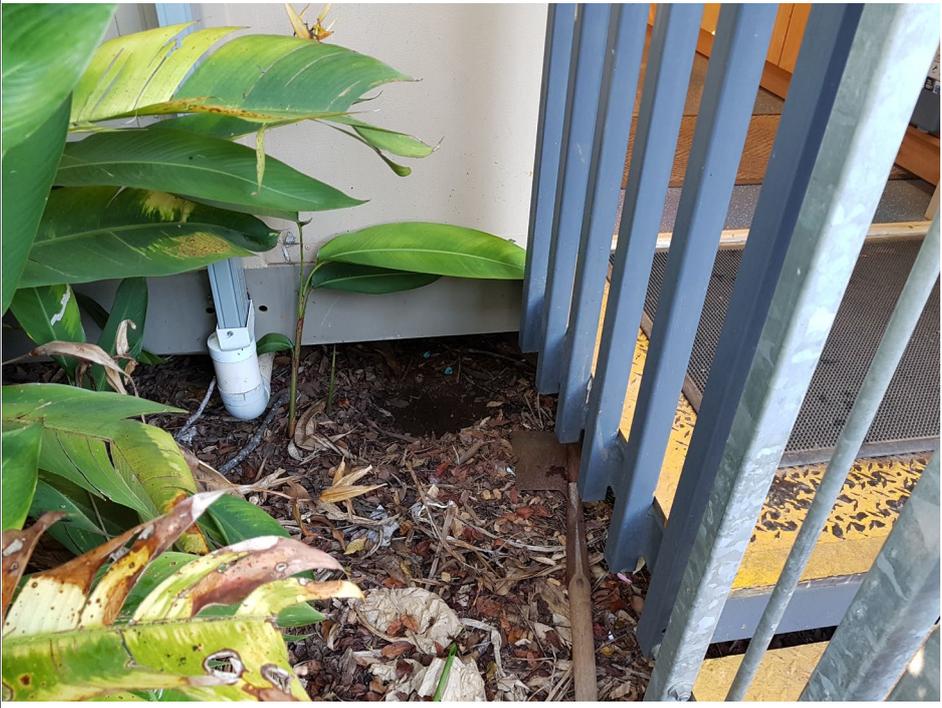
Photo No. 2	Date 13/05/2021

Description Looking south beneath one of the demountable buildings to be demolished. This was the location of sample S4.

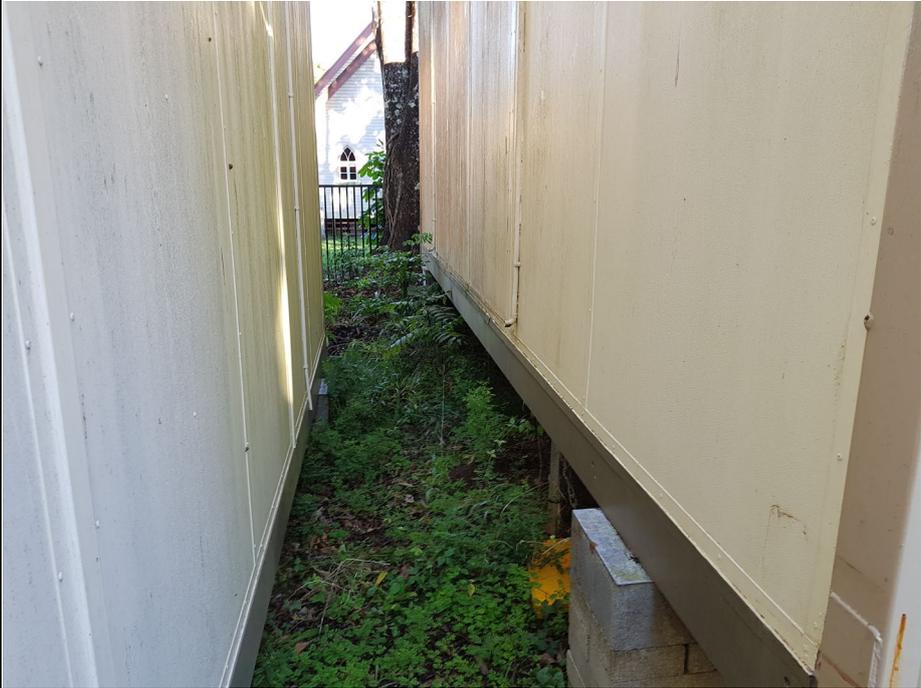
Photo No. 3	Date 13/05/2021

Description Looking west between two of three demountable buildings to be demolished in the site's central west portion. Sample S5 was collected from beneath the edge of the building on the right.

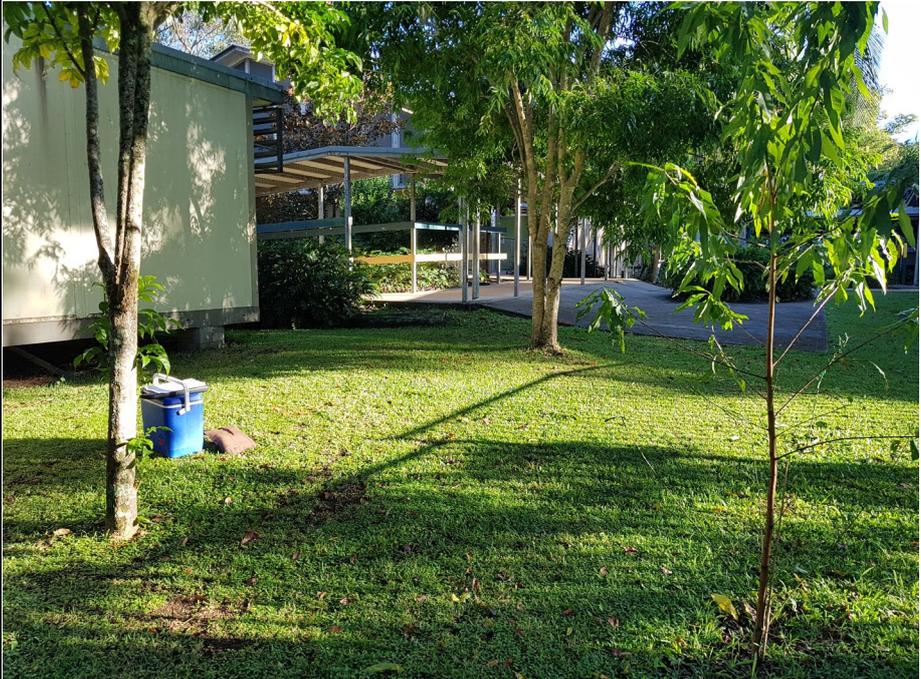
Photo No. 4	Date 13/05/2021

Description Looking north-west across the area where a new building will be constructed in the site's central portion. Sample S7 was collected from this area.
