Notice of Meeting Local Traffic Committee Meeting

LOCAL TRAFFIC COMMITTEE MEETING

Report No. 6.1 New Road Barriers for Riverside Crescent, Brunswick Heads

Report No. 6.3 Bayshore Dr / Ewingsdale Rd Roundabout Linemarking Improvements

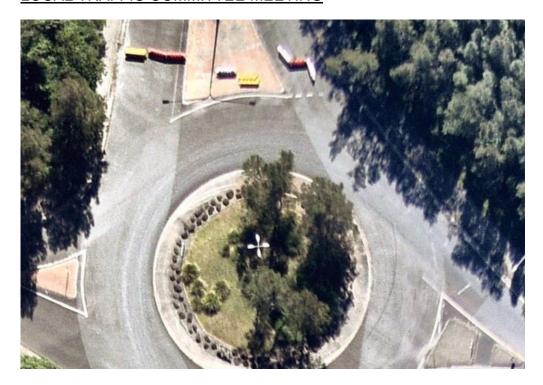
Figure 2: Aerial image showing barriers on Riverside Crescent roundabout

In late 2020, Byron Shire Council installed water filled barriers on the Riverside Crescent roundabout at Brunswick Heads to prevent vehicles entering Reflections Caravan Park (see Figures 1 & 2 below).

Since that time, they have been continuously vandalised and moved by drivers trying to access the Caravan Park. We also receive a number of community complaints in relation to their appearance.

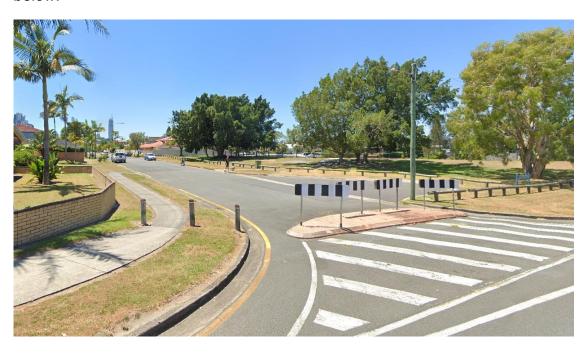
Figure 3: Example of proposed signage to replace water barriers

As there is no intention of re-opening this access road, we would like to replace these water barriers with new fixed concrete blisters and black and white chevron signage across the two lanes and island. This would look similar to the image shown in Figure 3 below.

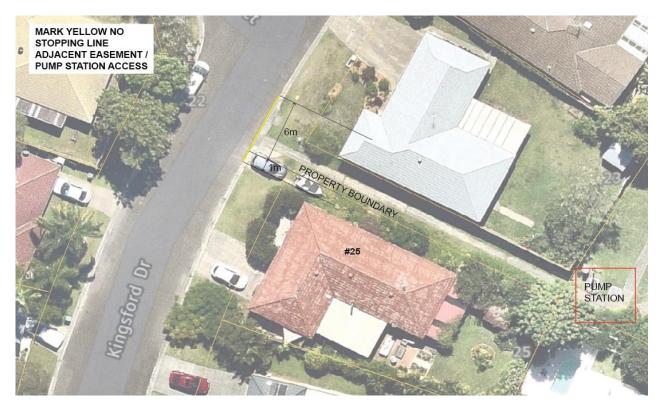
Figure 1: Stopping restrictions adjacent pump station access.

The purpose of this report is to allow staff to provide a section of restricted kerb-space adjacent two sewage pump stations to ensure access is available for maintenance purposes (examples of locations below).

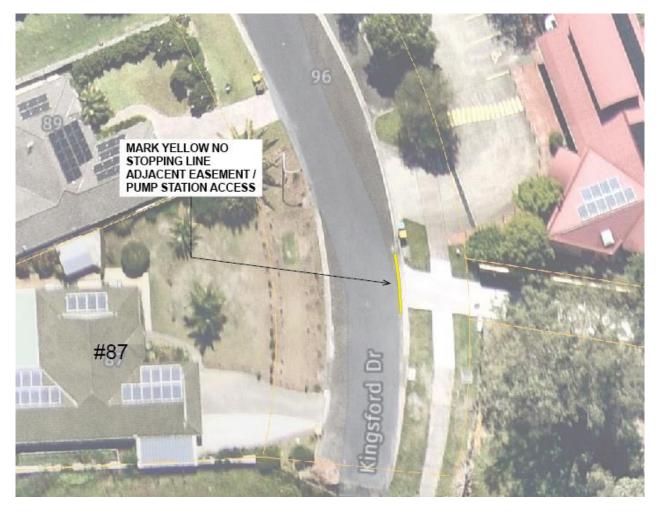
Figure 2: Kingford Dr, Brunswick Heads sewage station access

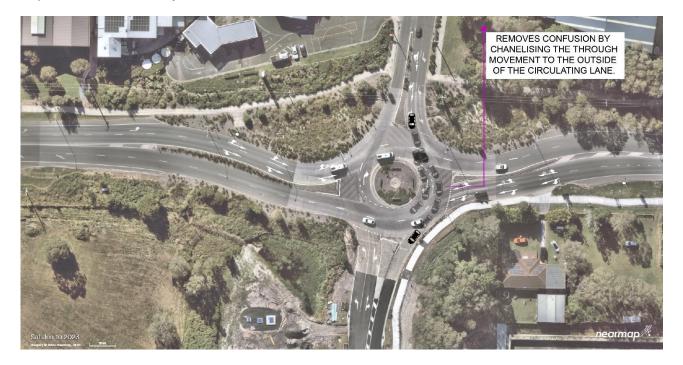
Figure 3: Traffic flow spiral lane markings

This treatment (spiral lane) will push the through movement (north and southbound) to the outside of the circulating lane, reinforcing the driver's intent to exit the roundabout. This will also improve sight distance for the opposing east and westbound through traffic. It is considered that this treatment while not being currently used within the Shire can be implemented with very little risk even if drivers are unfamiliar.

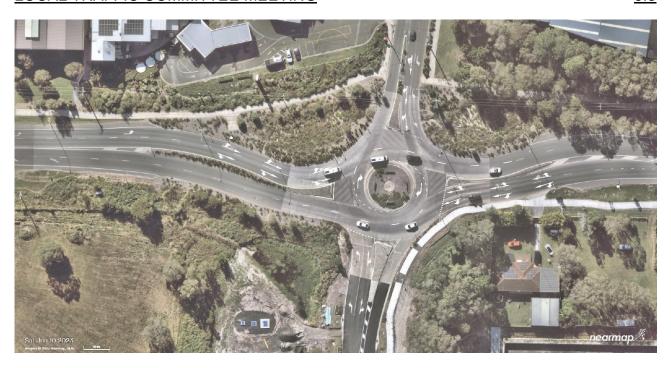
Figure 4: Spiral Lane treatment concept

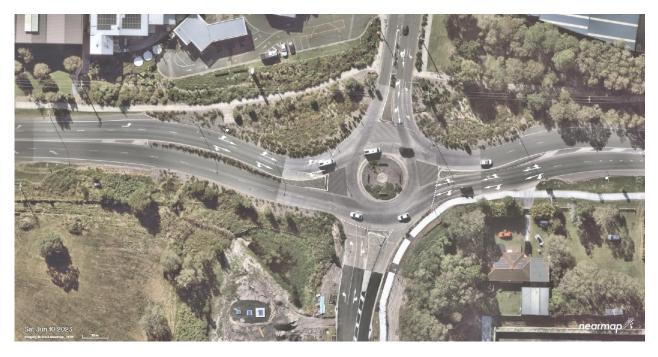
Figure 5: No circulating delineation within the east and west sections of the circulating lane

Removal of all chevron line-marking from within the circulating lane of the roundabout,
without any form of delineation (below). This option is not recommended due to the current sight distance issues; drivers may still stick close to the central roundabout island when exiting southbound.

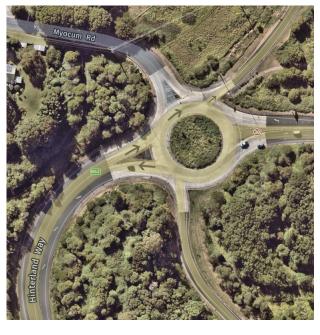
Figure 7: Myocum Rd/Hinterland Way western M1 interchange

This works at the Myocum Rd/Hinterland Way western M1 interchange, however it has been observed that the eastbound approach (kerbside lane) still seems to have the same
