Coast and ICOLL Advisory Committee Meeting

Byron Shire ICOLL Water Pollution Source Tracking Program

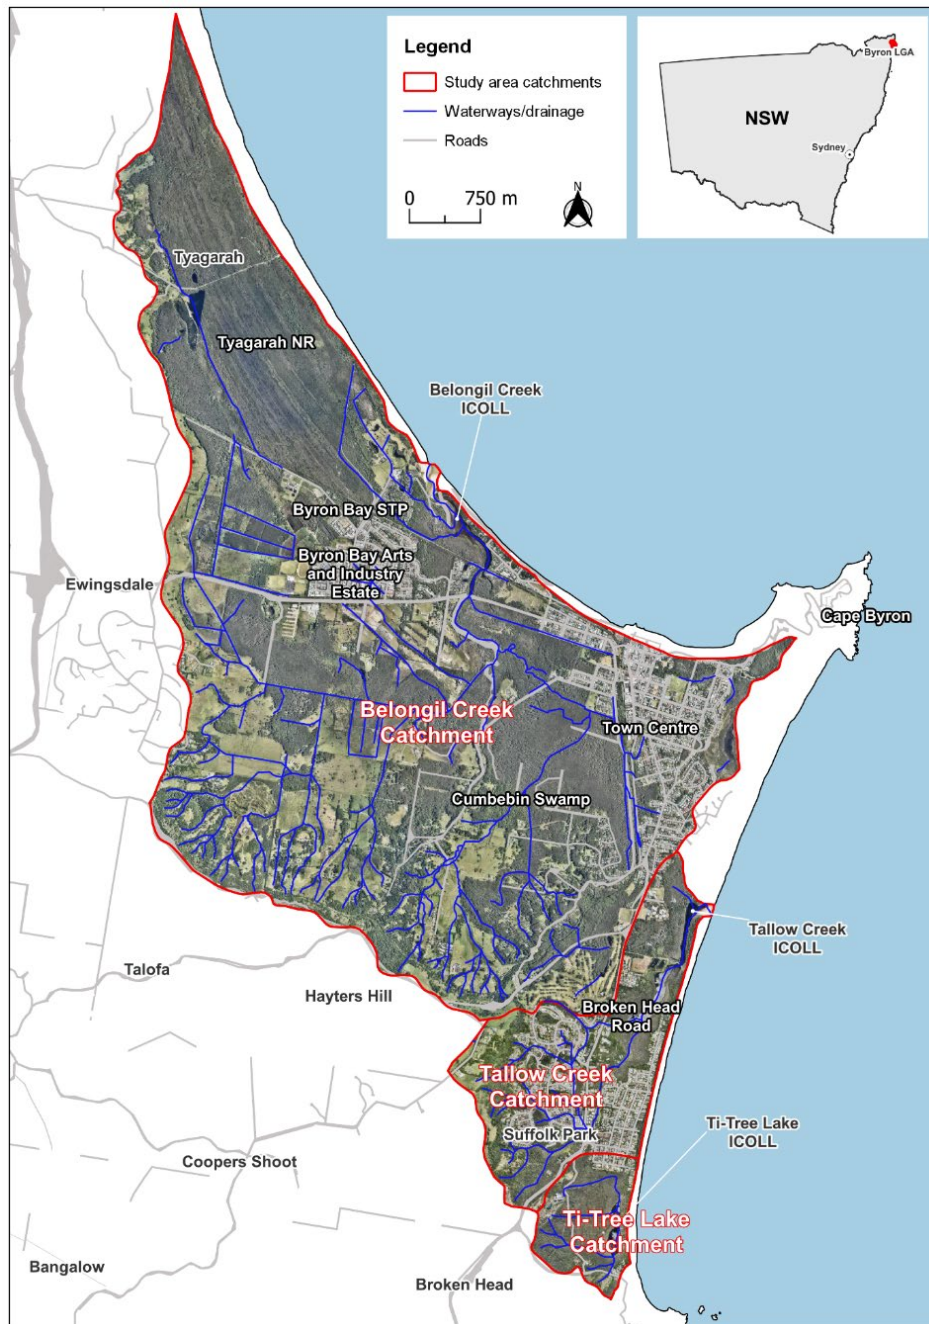
Figure 1: Study area map

The study area is defined by the hydrological catchment boundaries of Belongil Creek, Tallow Creek and Ti-Tree Lake ICOLLs. The spatial extent of the study area is illustrated on Figure 1.

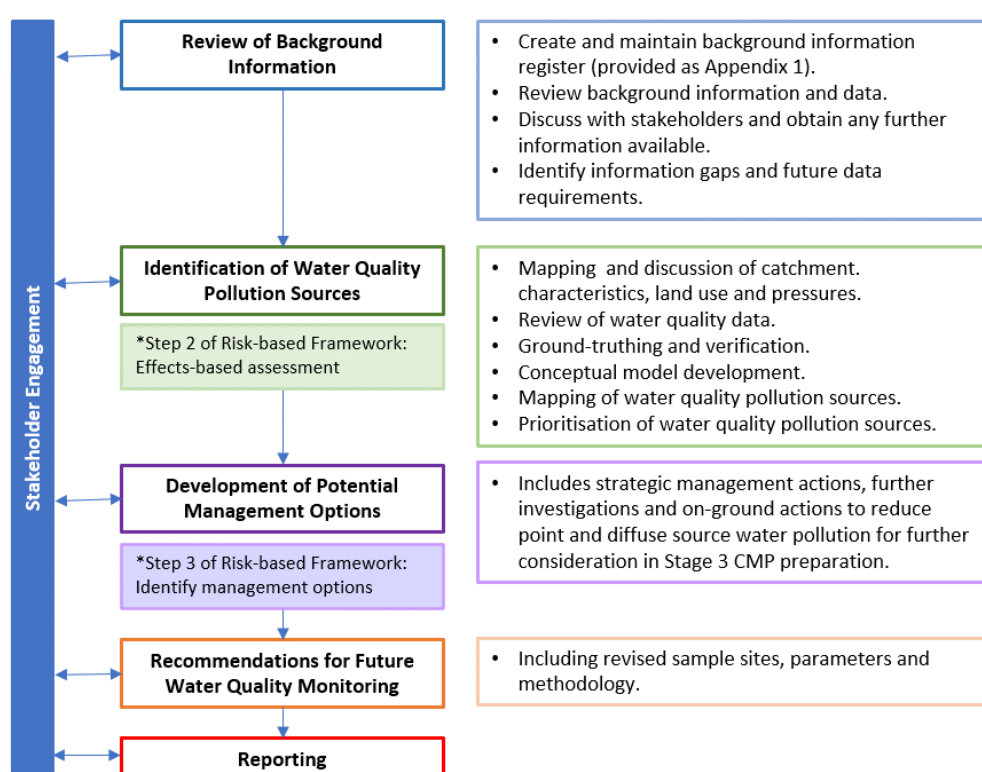
Figure 2: Project methodology key tasks

The Byron Shire ICOLL Water Pollution Source Tracking and Pollution Control Programs were developed through desktop study, stakeholder consultation and inspection of key sites in the catchments. Review and integration of existing information, and datasets was a critical component in the identification of water quality pollution sources. Data sources included background reports and studies, mapping data (e.g. catchment characteristics, land use and infrastructure), and water quality data provided by BSC for catchment monitoring and ICOLL entrance management (refer Appendix 1 for a full list of data sources used). Stakeholder engagement was also vital in confirming the understanding of key issues and in verifying information as observed and experienced by those that live and work in close proximity to the ICOLLs. Key tasks and project stages are shown below in Figure 2.

The current Stage 2 study aligns with Steps 2 and 3 of the Risk-based Framework (noted in Figure 2 above). While the scope of the current study did not include implementation of the Risk-based Framework, there are many elements that are similar between the two approaches including:

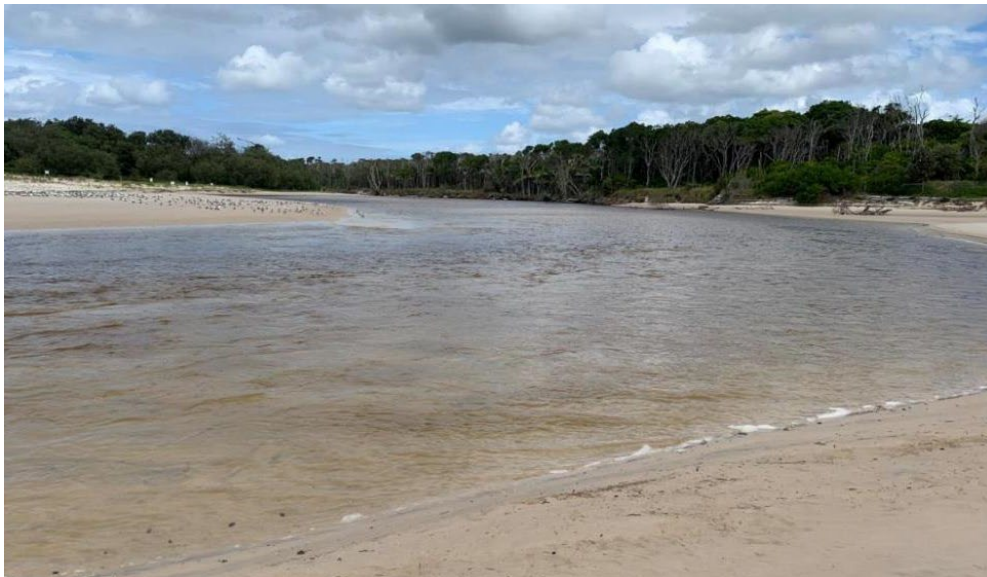
Plate 2: Belongil Creek Entrance, April 2023

- Extensive vegetation clearing.
- Floodplain drainage works undertaken to drain floodplain wetlands and enable the expansion of agricultural, urban and light industrial development across low-lying areas.
- The entrance of Belongil Creek has been artificially managed for over 100 years to manage flood risk and water quality issues.

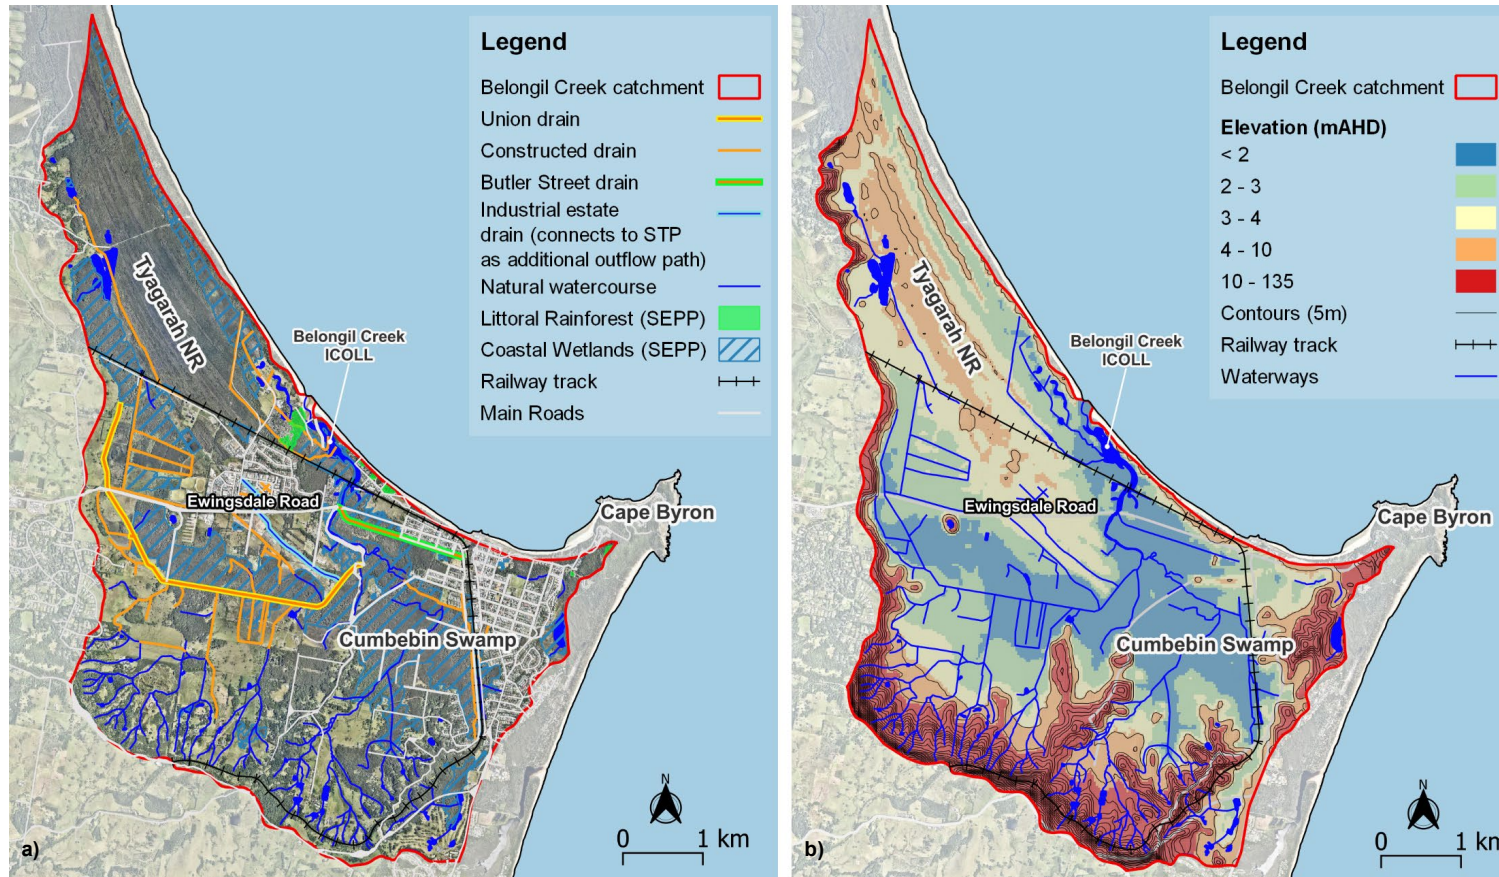
Figure 3: a) Belongil Creek natural waterways, wetlands and artificial drainage b) Belongil Creek elevation and waterways (natural and constructed)

Catchment characteristics for Belongil Creek are mapped in Figure 3. Catchment elevation ranges from approximately 135 mAHD in the upper catchment to 1 mAHD on the floodplain. Both natural and artificial drainage is shown including major drainage systems connecting catchment areas to Belongil Creek:

- The Union Drain is the major drain on the western side of the catchment connecting floodplain areas to Belongil Creek. It was constructed in 1913 by the Belongil Creek Drainage Union (Alluvium, 2019). It is estimated that there could be up to 40 km of secondary drains constructed within the catchment including Council and private works (WetlandCare Australia, 2005).
- Butler Street Drain is the major surface water drain on the eastern side of the catchment connecting the Byron Bay town centre stormwater network to Belongil Creek near Ewingsdale Bridge in the mid-estuary. This drain runs through Cumbebin Swamp Nature Reserve.
- The Industrial Estate Drain is the major surface water drain through the Byron Bay Arts and Industry Estate connecting into the Union Drain and upper Belongil Creek.

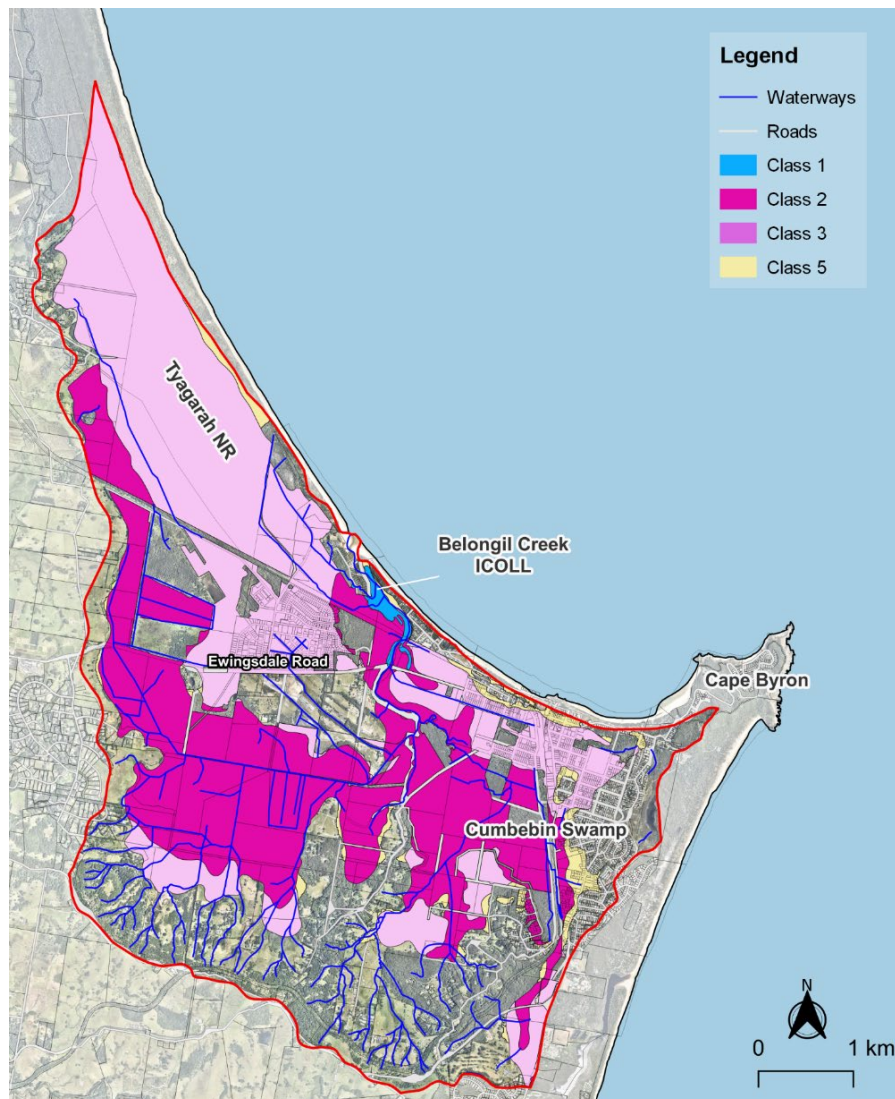
Figure 4: Belongil Creek Catchment acid sulfate soil risk

- Dry times when the water table is low enough to expose PASS to air and cause oxidation of previously waterlogged ASS. Artificial drains exacerbate the issue by exposing PASS layers beneath the ground surface, by facilitating the lowering of the water table and acting as a conduit for rapid transportation of acid runoff and pollutants to Belongil Creek during subsequent rainfall events.
- During excavation and/or disturbance of soil (e.g. during earthworks, drain maintenance etc.). Effective management involving testing and treatment of ASS is necessary to manage risk and prevent adverse water quality impacts.

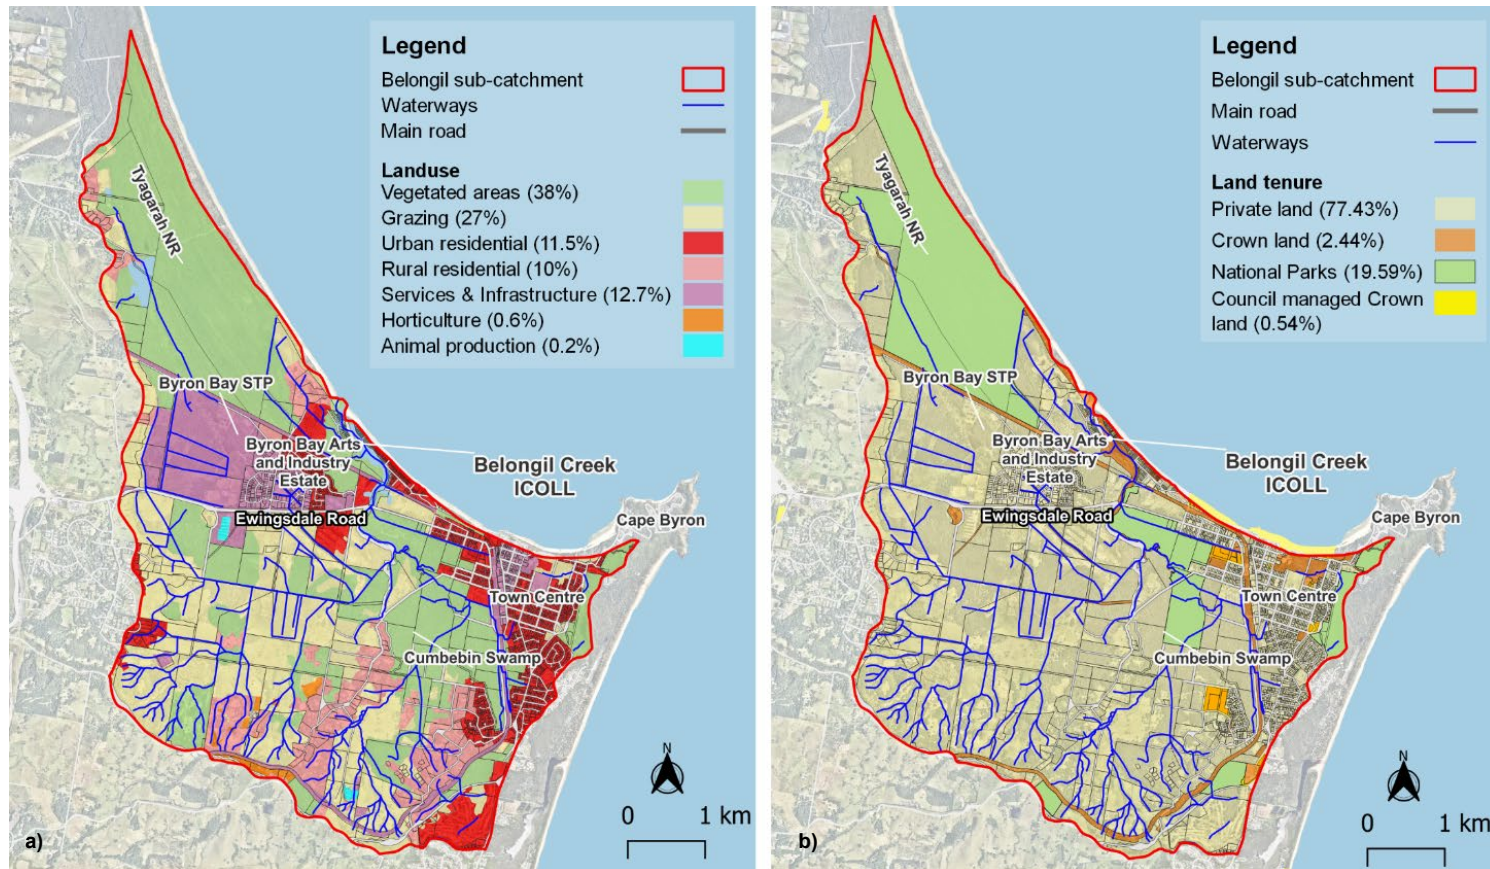
Figure 5: a) Belongil Creek catchment landuse b) Belongil Creek catchment land tenure

Land tenure within the study area is illustrated on Figure 5. Most of the study area is freehold land under private ownership (77.43%). Approximately 20% of land is managed as National Park/Reserve. Crown land is divided into Council - managed (0.54%) and Crown land not managed by Council (2.44%). Native Title (non-exclusive) exists across parts of the Belongil catchment including much of Tyagarah Nature Reserve, parts of the lower Union Drain and the lower section of Belongil Creek.

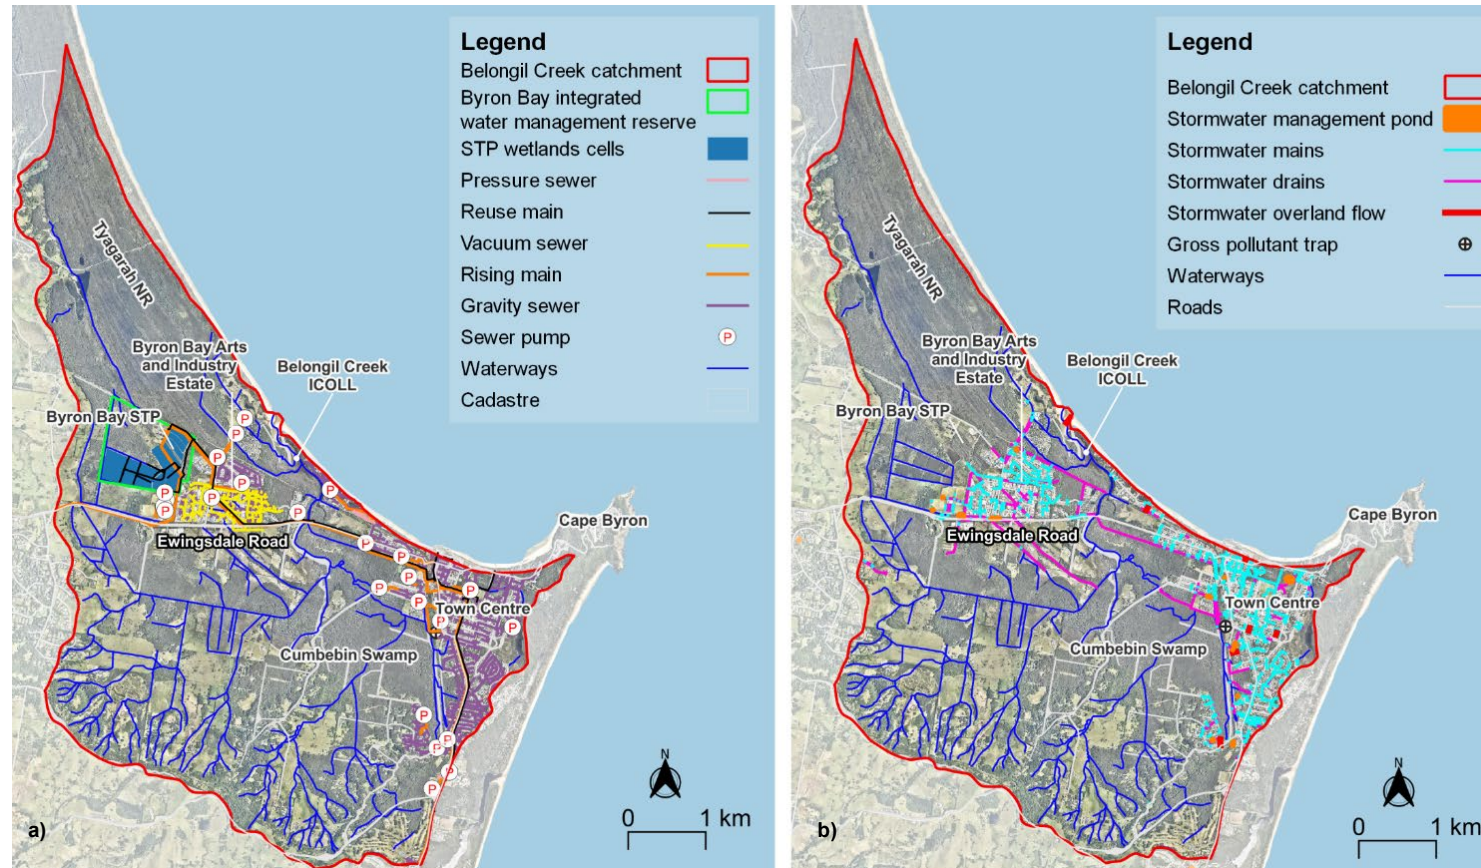
Figure 6: a) Belongil Creek catchment sewer infrastructure b) Belongil Creek catchment stormwater infrastructure

All urban and industrial areas of Byron Bay are serviced by a reticulated sewerage system, a series of pipelines and pumps that convey wastewater from households and businesses to the BBSTP for treatment. In 2006 the South Byron STP in the Tallow Creek catchment was decommissioned and all wastewater from the Suffolk Park and Broken Head urban areas is now transferred to the BBSTP. On average the BBSTP currently discharges approximately 3.85ML/day of tertiary treated effluent to constructed wetlands (BBIWMR) and the 24 ha Melaleuca forest (AWC and BMT, 2017). This aligns with monitoring data for the past five years (P. Orams, pers. comm., 18 July 2023). The constructed wetlands further 'polish' the treated effluent to a very high standard prior to release to the drainage network on the upper floodplain of Belongil Creek (Figure 7) at approximately 2.5 ML/day in dry weather as seen in monitoring data for station EPA4 (P. Orams, pers. comm., 18 July 2023). In addition, some treated effluent (currently approx. 0.5 ML/day) is supplied back to town as recycled water for outdoor irrigation and municipal uses (Figure 7). A reduction in the incidence and severity of ASS impacts and peat fires in the upper Belongil Creek catchment has been reported since the regeneration and irrigation of the 24 ha wetland area (Melaleuca forest) within the BBIWMR using tertiary treated effluent (AWC, 2020a), this being an explicit objective of the BBIWMR. This is a result of maintenance of higher groundwater levels that increase soil moisture and prevent exposure of ASS.

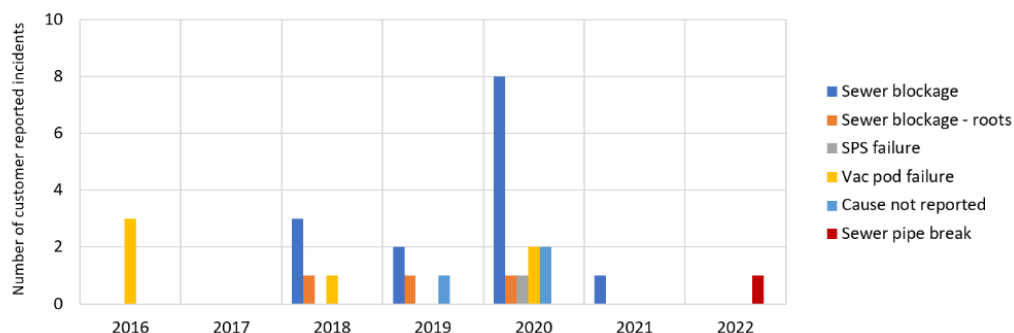
Figure 8: Number of customer-reported sewer overflow incidents in the Belongil Creek catchment April 2016 – April 2022.

Figure 8 shows the number and type of customer reported sewer overflow events from April 2016 – April 2022 in the Belongil Creek catchment. There was a total of 52 customer reported incidents over this six year period. The highest number of reported incidents by customers occurred in 2020 (total of 31) which was substantially more than in any other year and is likely due to the higher than average rainfall experienced in 2020 leading to overloading of the sewer system (Figure 8). The majority (27) were caused by sewer blockages/ chokes, six were caused by tree root blockages, eight were related to vacuum pod failures, four were related to sewer pump station failures, three were due to sewer pipe breaks and the remainder were due to other equipment failure (1) or not reported (3). Illegal development in Byron Bay (renting out illegal structures) or overloading the capacity of dwellings has been previously identified as putting strain on the sewer system, particularly in peak holiday periods (Alluvium, 2019). Council staff responded to all incidents and completed inspections, repair and clean up actions as required. Some incidents were associated with overflows from private properties and property owners were responsible for corrective actions.

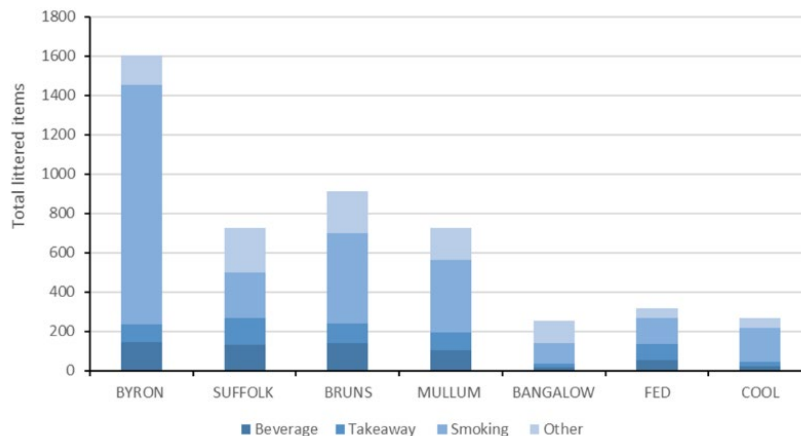
Figure 9: Total number of littered items per suburb from monthly local litter check surveys undertaken throughout the Shire in 2020/2021.

Results from local litter surveys undertaken monthly in hot spots throughout the Shire in 2020/ 2021 reveal that Byron Bay is by far the most littered suburb, followed by Brunswick Heads and Suffolk Park (Figure 9, BSC, 2023c). Cigarette butts (smoking) were the most frequently littered item in Byron Bay, followed by beverage and takeaway containers and other items. The increased litter volumes detected within Byron Bay was attributed to the significantly higher volume of visitors to Byron Bay as opposed to other parts of the Shire (BSC, 2023c).

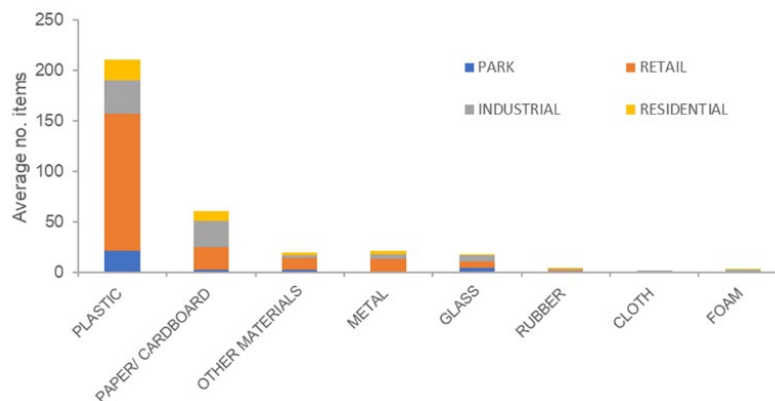
Figure 10: Average no. of littered items and material compositions identified at various land type sites during baseline AUS LM (land-based) data surveys undertaken in Byron Bay in August 2022.

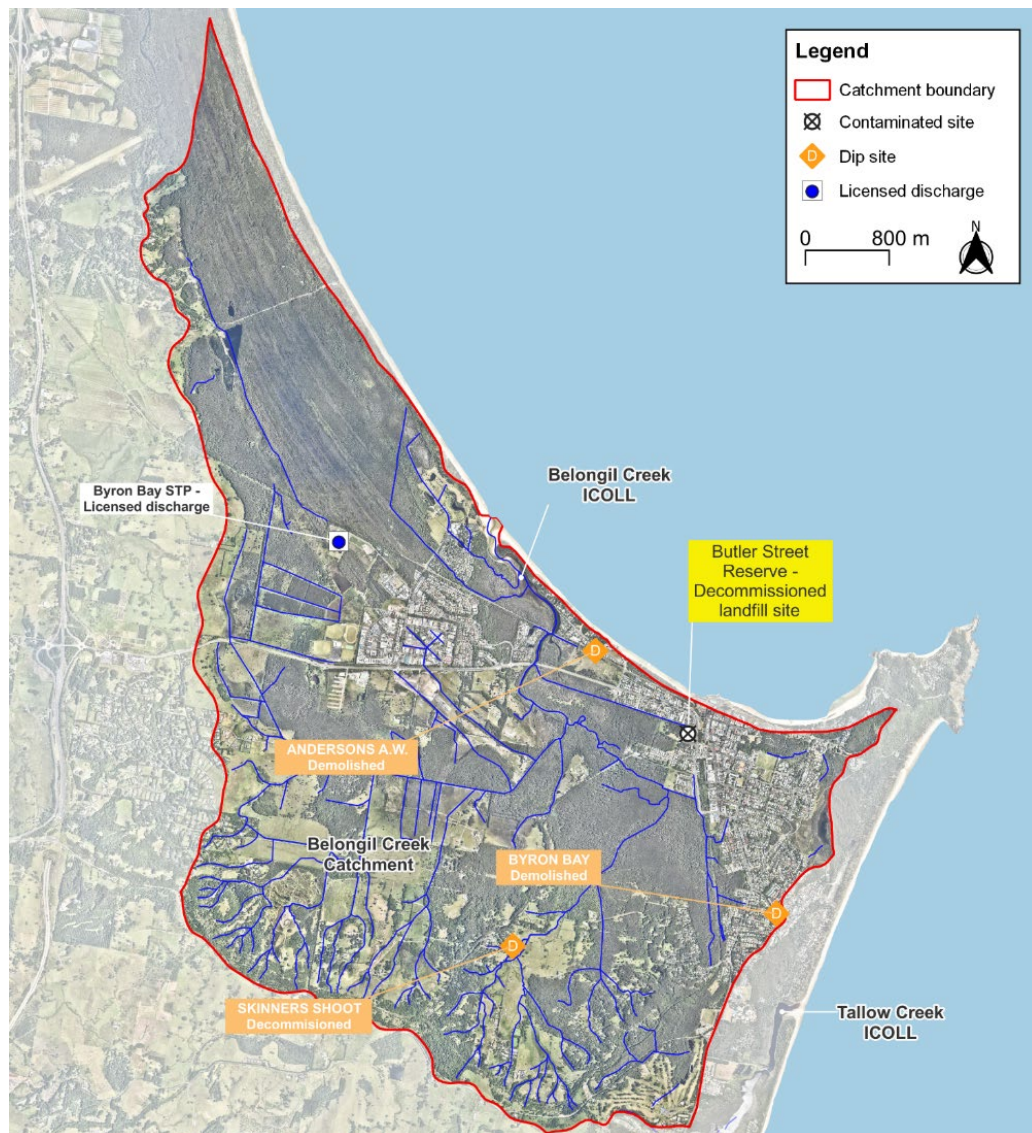
Figure 11: Search results of the POEO Act Public Register and DPI cattle dip site locator.

A search of the *Protection of the Environment Operations Act 1997* (POEO Act) Public Register (NSW EPA, 2023) and DPI cattle dip site locator (DPI, 2023) identified five sites within the catchment with potential to contaminate downstream waterways. These are shown in Figure 11.

Information is available from DPI (2023) on the status of the three recorded dip sites in the catchment including a list of chemicals used historically at the dips (Figure 11). The impact from historical dip sites on Belongil Creek is unknown. There is also the potential for further unknown contaminated land sites within the catchment associated with small private landfills, and animal industries etc. that do not appear on government registers.

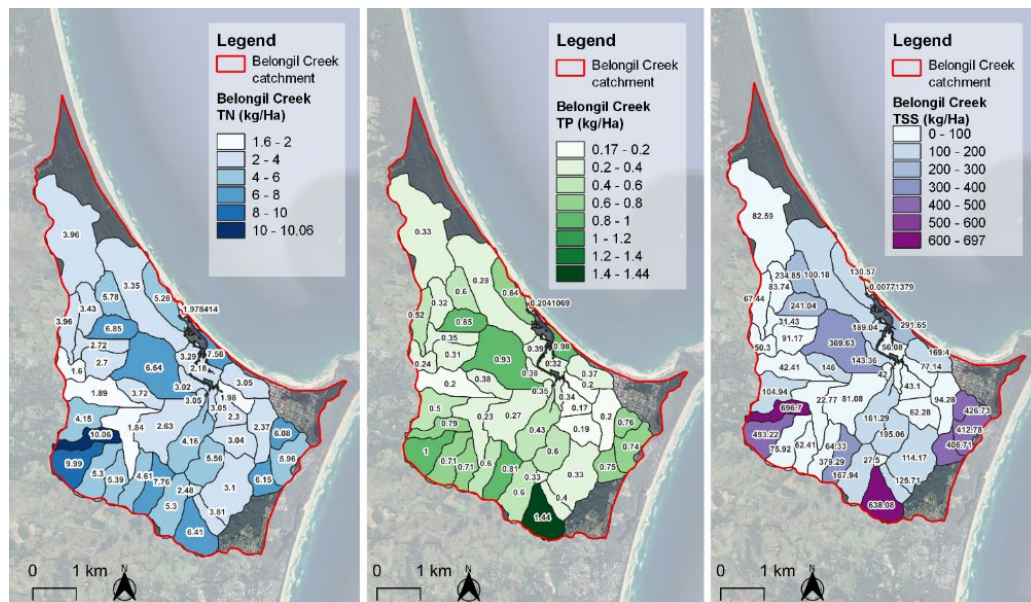
Figure 12: Belongil Creek Estuary Health Risk Dataset results for TN, TP and TSS (kg/ha/yr)

The water quality data review, ground-truthing and verification tasks completed as part of this study provides more detailed local information that is generally consistent with the overall results produced by the modelling.

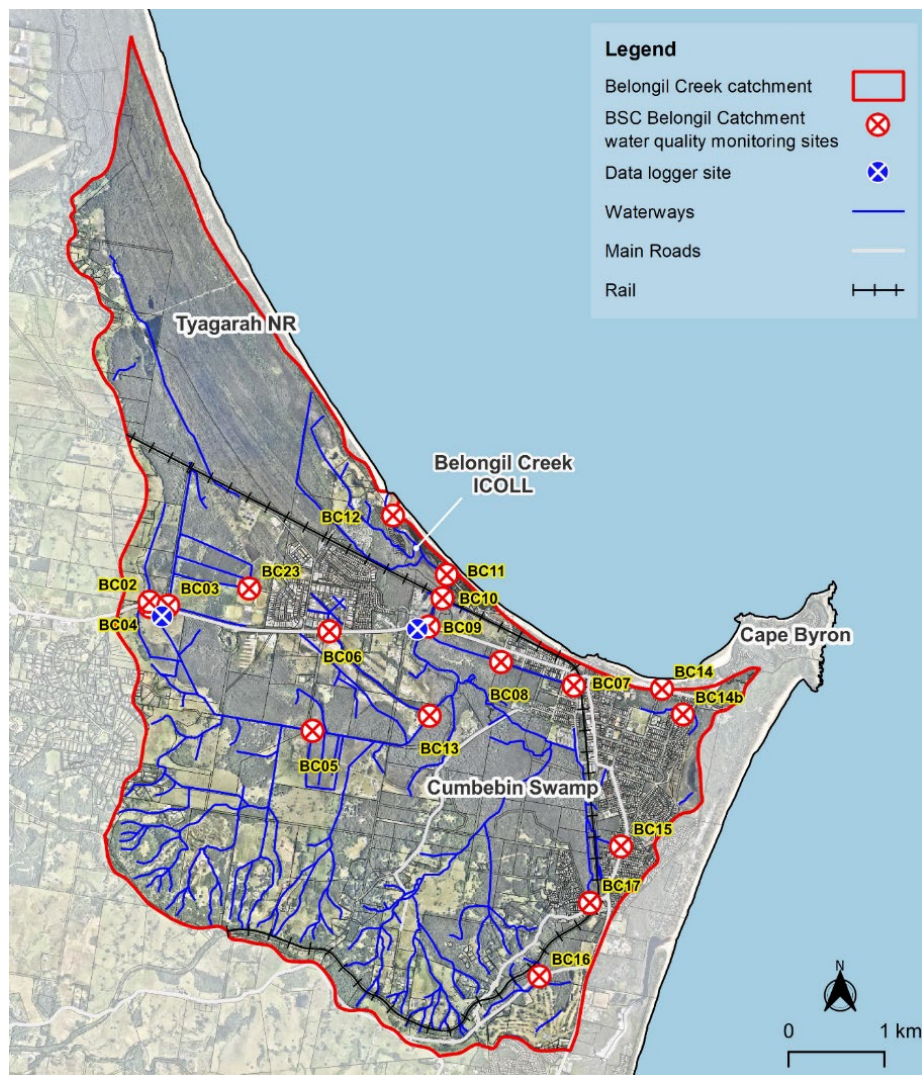
Figure 14: Belongil Catchment water quality sampling sites

Zone	Site ID	Location	Sample type	Status
Coastal draining (Urban Stormwater)	BC14b	Massinger Street – on Sunny Hills side – opposite Kipling Street	Monthly and event	Discontinued December 2022
Monitoring Parameters assessed:	Salinity, pH, turbidity, total suspended solids (TSS), total nitrogen (TN), oxidised nitrogen (NO _x), ammonia (NH ₃), total phosphorus (TP), ortho-phosphate (Ortho-P/PO ₄), chlorophyll a, <i>E. coli</i> , enterococci, dissolved oxygen (DO, loggers only). Refer to Glossary and Abbreviations at the end of this report for further descriptions of parameters.

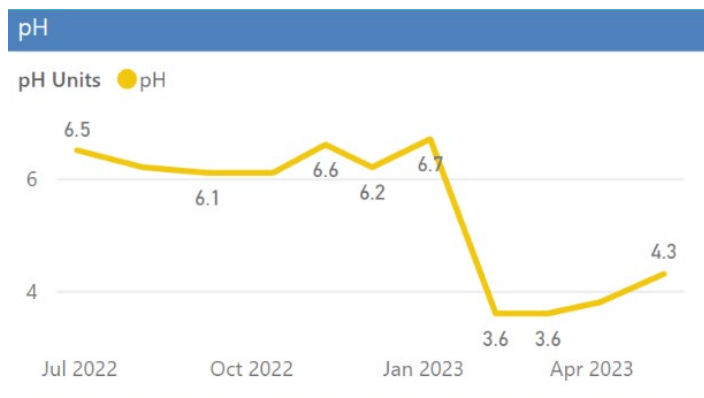
Figure 15: Site BC13 pH results for July 2022- May 2023

- While not included in the 2016-2022 dataset, of note are recent results published on the BSC Water Quality Public Data Portal (BSC, 2023e), showing a decrease in pH at site BC13 from near neutral pH levels (pH 6.1 – 6.5) to acidic conditions (pH 3.6 – 4.3) from February 2023 – May 2023 (Figure 15). These results were significantly more acidic than all previous values recorded at this site from 2016-2022 (range of pH 5.6 – 7). BSC's Environmental Health Officer investigated the Harvest construction site (West Byron Subdivision) which is located immediately upstream of BC13 in May 2023 and identified site pH values of pH 3.1 (newly constructed swale), and pH 4.1 within an existing swale on site (pers. comm M. Bingham, 2023). These results highlight the impact of soil excavation activities within ASS areas on downstream water quality. ASS mitigation measures were undertaken at the site following BSC discussions with construction site managers. BSC will continue to monitor the site throughout the construction phase.

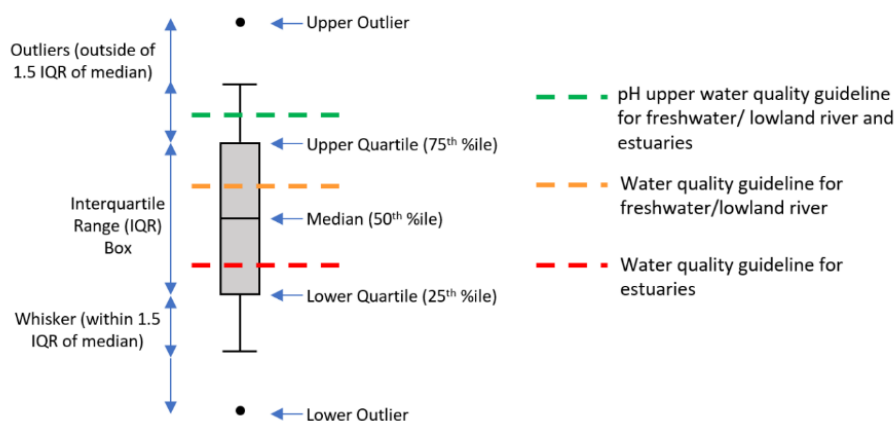
Figure 17: Explanation of box plots and water quality guidelines

A review of water quality data collected over the last six years of BSC's Byron Bay Surface Water Quality Monitoring Program was undertaken (monthly monitoring from 2016-2022). Box and whisker plots for all data available for this period are shown in Figure 18, Figure 20 and Figure 19. Sampling sites have been grouped by geographical location and pollutant source category. See Figure 17 for an explanation of box plots.

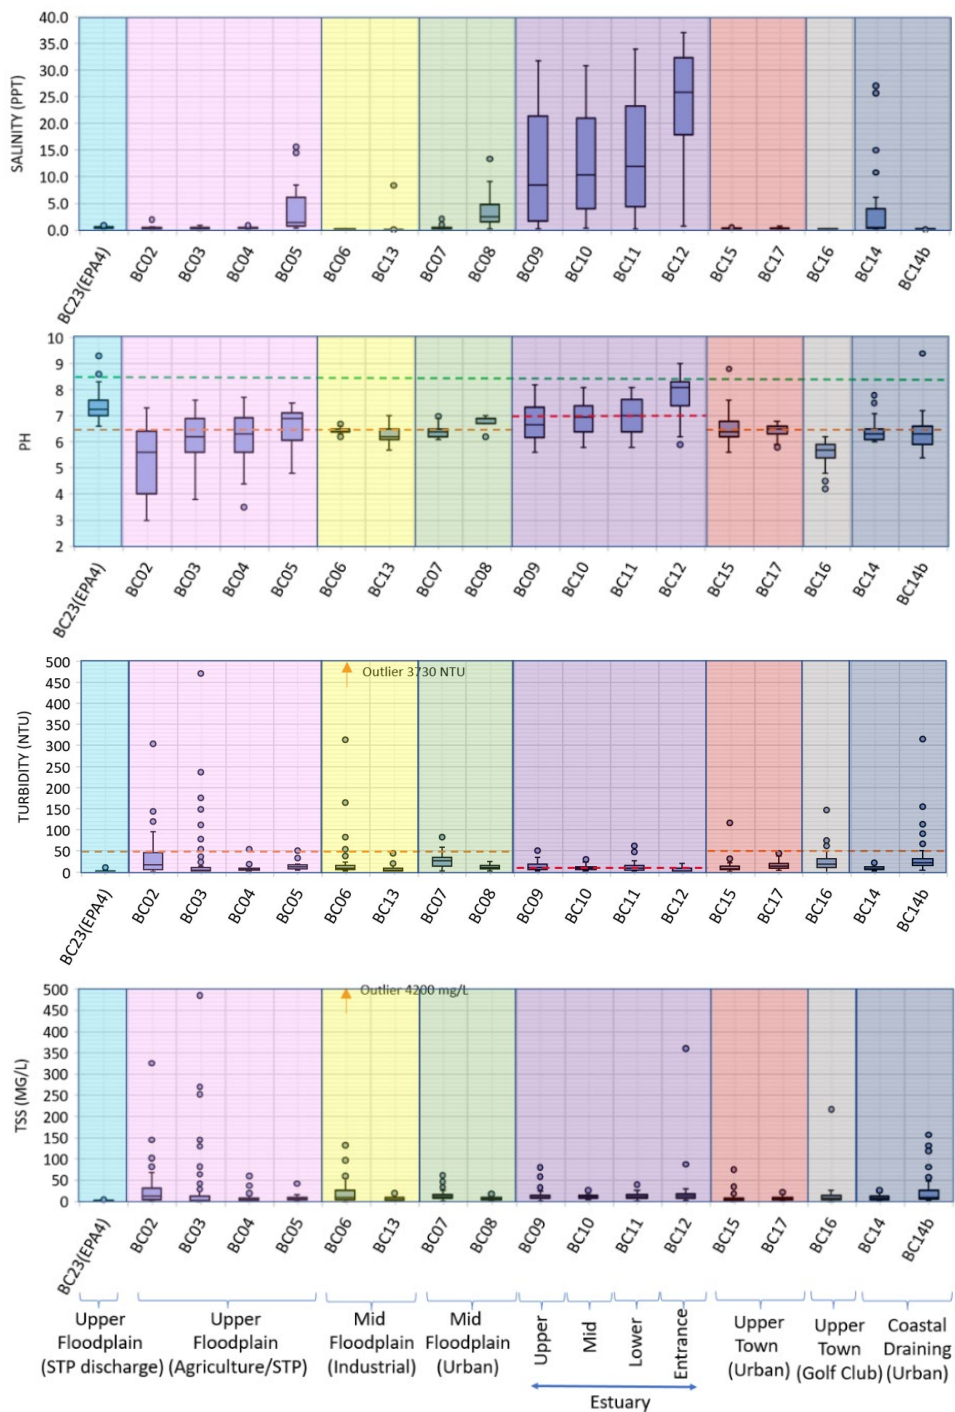
Figure 18: Belongil Creek water quality data 2016-2022 (salinity, pH, turbidity and TSS).

- Belongil Creek estuary sites recorded salinity ranges from freshwater through to marine water indicative of an ICOLL with variable entrance opening regime. As expected, the typical salinity levels were highest at the entrance and decreased with distance upstream. A freshwater to saline salinity range (0-30 ppt) was observed at BC08 (mid Butler St. Drain) indicating periodic tidal ingress at this site. This tidal influence was not observed at BC07 in the upper Butler St. Drain over this time period. Site BC05 (Melaleuca Drive) in the mid-floodplain also showed elevated salinity range (0-30 ppt)

- The majority (67%) of sites recorded low pH (i.e. acidic water) with median values during 2016-2022 being outside of the guideline ranges recommended for aquatic ecosystem health. The lowest pH values were recorded at sites in the upper floodplain, dominated by agricultural landuse and modified by artificial drainage works. Site BC02 (Moran's Hill Drain) upstream of the BBSTP discharge confluence recorded the lowest pH (with a median value of pH 5.6 and a range of pH 3 – 7.3). pH gradually increased with distance downstream to the estuary. Several of the sites in the mid floodplain influenced by urban and industrial drainage and landuse also recorded median values below the recommended guidelines, with the exception of BC05 (Melaleuca Drive), which may have been buffered with higher pH tidal influence. The mid, lower and entrance estuary sites were within guideline values, likely as a result of the increased buffering capacity of marine water, which is able to neutralise acidic catchment inputs to the estuary. Site BC23 (STP discharge) also consistently recorded values within the guideline range of pH 6.5 – 8.5, which is in line with the STP licence conditions for wastewater discharge.

- Median turbidity values at all sites assessed over the time period were within the ranges recommended for aquatic ecosystem health (<50 NTU freshwater and <10 NTU estuarine water). Maximum values and outliers identify sites that are susceptible to periodic elevations in both turbidity and TSS indicating poor water clarity at times, likely due to sediment runoff during rainfall events or potentially algal bloom conditions. The highest median turbidity levels occurred within Butler Street Drain (BC07, 26 NTU), followed by the Byron Bay Golf Course outlet (BC16, 18 NTU) and Moran's Hill site in the upper Union Drain, upstream of the confluence with the STP treated effluent outflow (BC02, 16 NTU). A maximum turbidity value of 3,730 NTU was recorded at site BC06 (Industrial Estate Drain) which coincided with a maximum TSS value of 4,200mg/L. Of note is the effect of tannin-stained waters such as occur in Belongil estuary that contain colour and can absorb more light causing turbidity to appear higher than it is. Tannin-staining / colour does not affect TSS values.

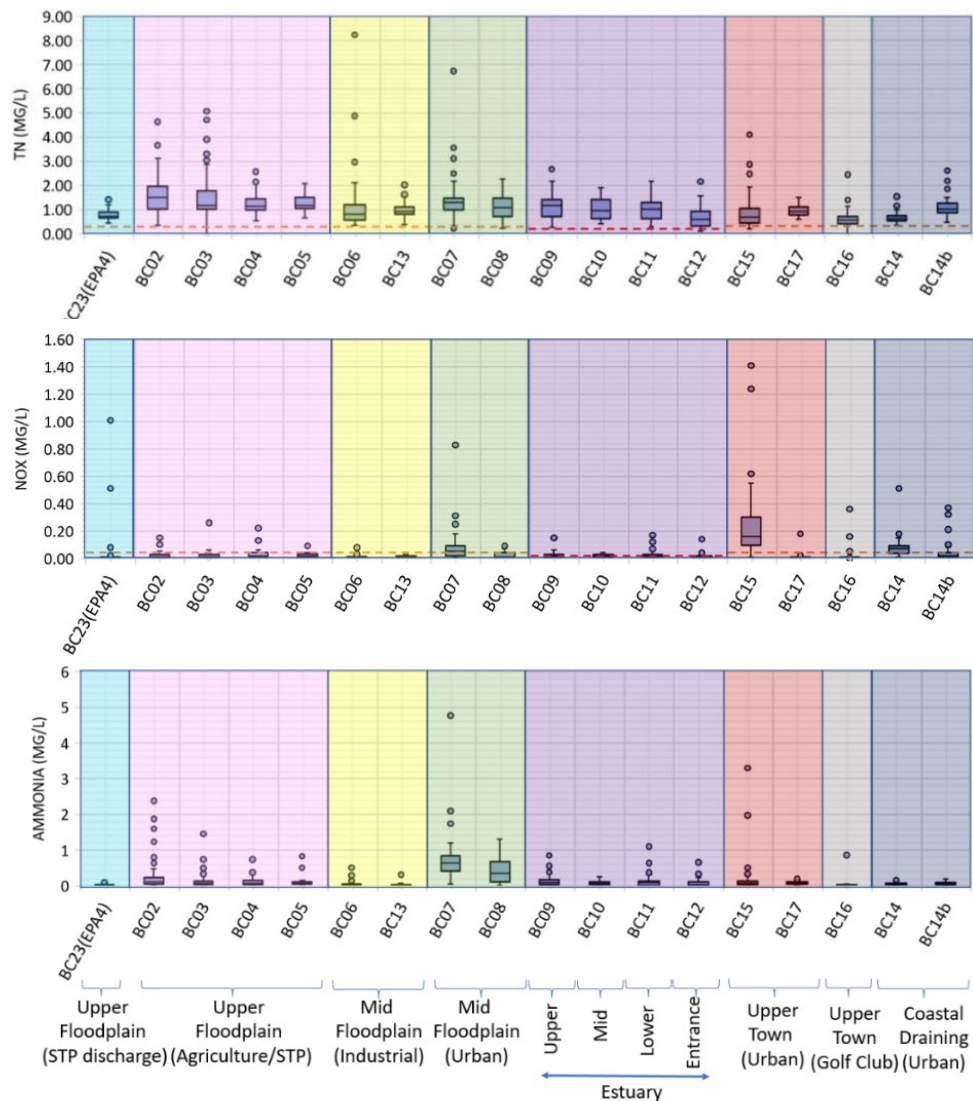
Figure 19: Belongil Creek water quality data 2016-2022 (TN, NO_x and NH₃). Water quality guideline values shown as dashed lines.

- Ammonia (NH_3 another bioavailable form of N typically dominant in low dissolved oxygen conditions) was noticeably higher at sites BC07 and BC08 (Butler Street Drain, urban area) and is likely to indicate a pollutant source from urban areas and/or the Butler Street historical landfill site.

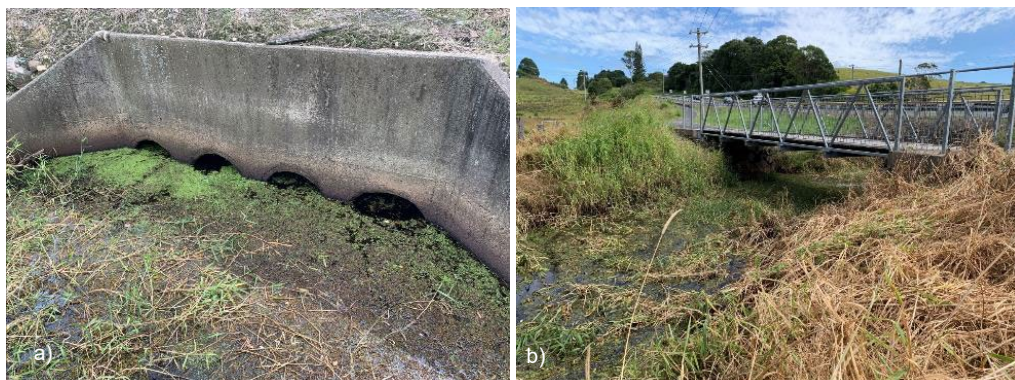
Plate 3: a) Culvert south of Ewingsdale Road within the Upper Union Drain (Moran's Hill) b) Footbridge over Union Drain downstream/ south of culvert.

The majority of constructed surface water drains visited in April 2023 were in poor condition. Poor water quality was recorded at many sites including low dissolved oxygen values and high turbidity. Many drains including the Upper Union Drain, Industrial Estate drains and Butler Street Drain were observed to be showing signs of nutrient enrichment (e.g. excess algae and aquatic plant growth, Plate 3, Plate 4, Plate 5, Plate 6). The aquatic weed *Salvinia molesta*, was also observed at several sites within the Upper Union Drain (Plate 3), within BBSTP wetlands and some urban stormwater drains. *Salvinia* is a fast growing and highly adaptable weed that can spread rapidly when conditions are favourable. Still or slow moving, warm fresh water with high nutrient concentrations are ideal conditions for growth. *Salvinia* can form thick mats which prevent light and oxygen from entering a waterway/ waterbody and can shade out other aquatic plants and degrade habitat for aquatic organisms. Decomposing *Salvinia* can reduce water quality by consuming large amounts of dissolved oxygen. Council's preferred management strategy to control *Salvinia* is biological control using the *Salvinia* weevil (*Cyrtobagous salviniae*).

Pont and Parker (2001) discussed the two major issues associated with deep, steep-sided, square or rectangular drains which are common on the Belongil floodplain such as the upper Union Drain and drains within the Byron Arts and Industry Estate:

1. Deep drains carry more water at a higher velocity which can result in increased flooding at catchment outlets and increased bank erosion.
2. Deep drains may cause a draw-down effect on groundwater resulting in greater exposure of ASS.

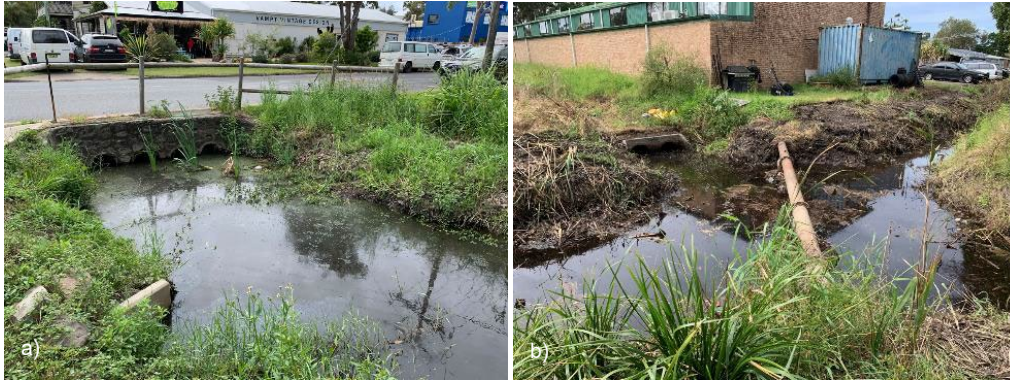
Plate 4: a) Industrial Estate Drain at Banksia Drive b) Confluence along Industrial Estate Drain.

Oil-like sheens were observed on water in the Industrial Estate Drain at Banksia Drive (Plate 4 a) though it was not identified whether these were algal-based or from hydrocarbons. Build-up of litter (mostly plastics) was observed in the upper Butler Street Drain upstream of the bypass culvert Plate 5 b).

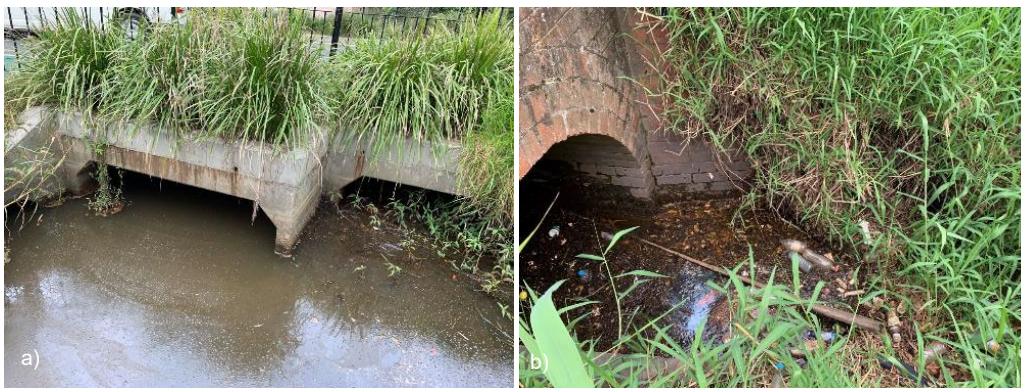
Plate 5: a) Butler Street Drain downstream of bypass culvert b) Butler Street Drain upstream of bypass.

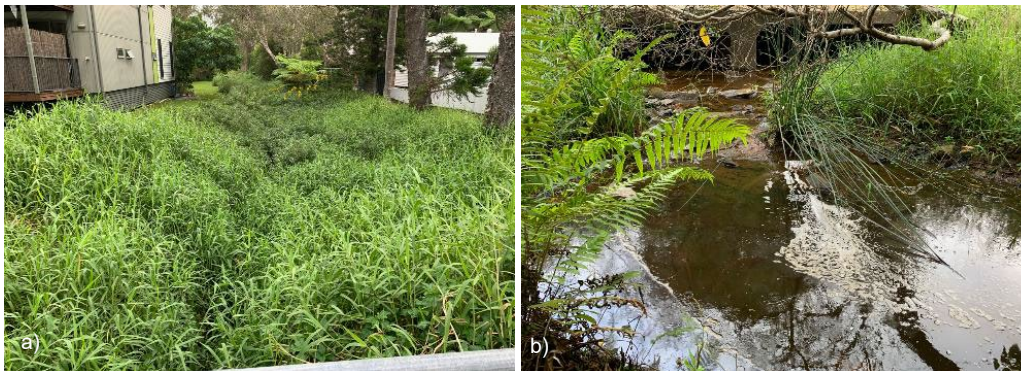
Plate 6: a) Water quality sample site BC15 downstream of Bangalow Road b) Water quality sample site BC17 downstream of Old Bangalow Road.

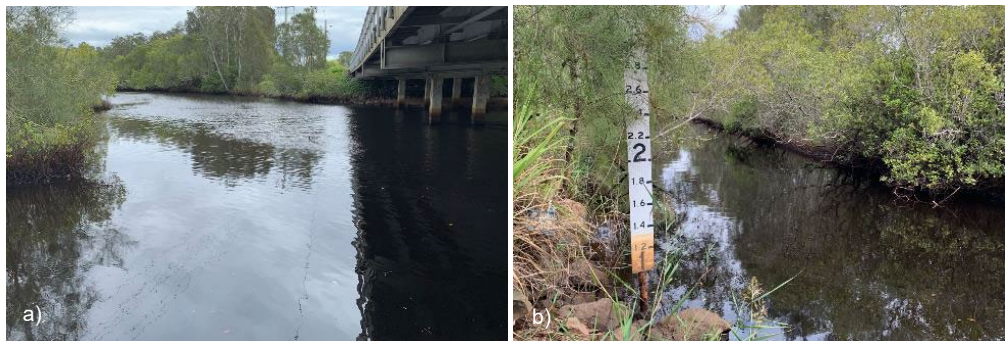
Plate 8: a) Belongil Creek at Ewingsdale Bridge b) Confluence of Butler Street Drain with Belongil Creek at Ewingsdale Bridge, note orange iron-staining at base of flood level marker.

The Belongil Creek estuary sites inspected all showed improved water quality conditions with higher dissolved oxygen levels and lower turbidity compared to the sites further upstream. The creek entrance was open to ocean at the time of the site inspection and the creek was flowing strongly downstream.

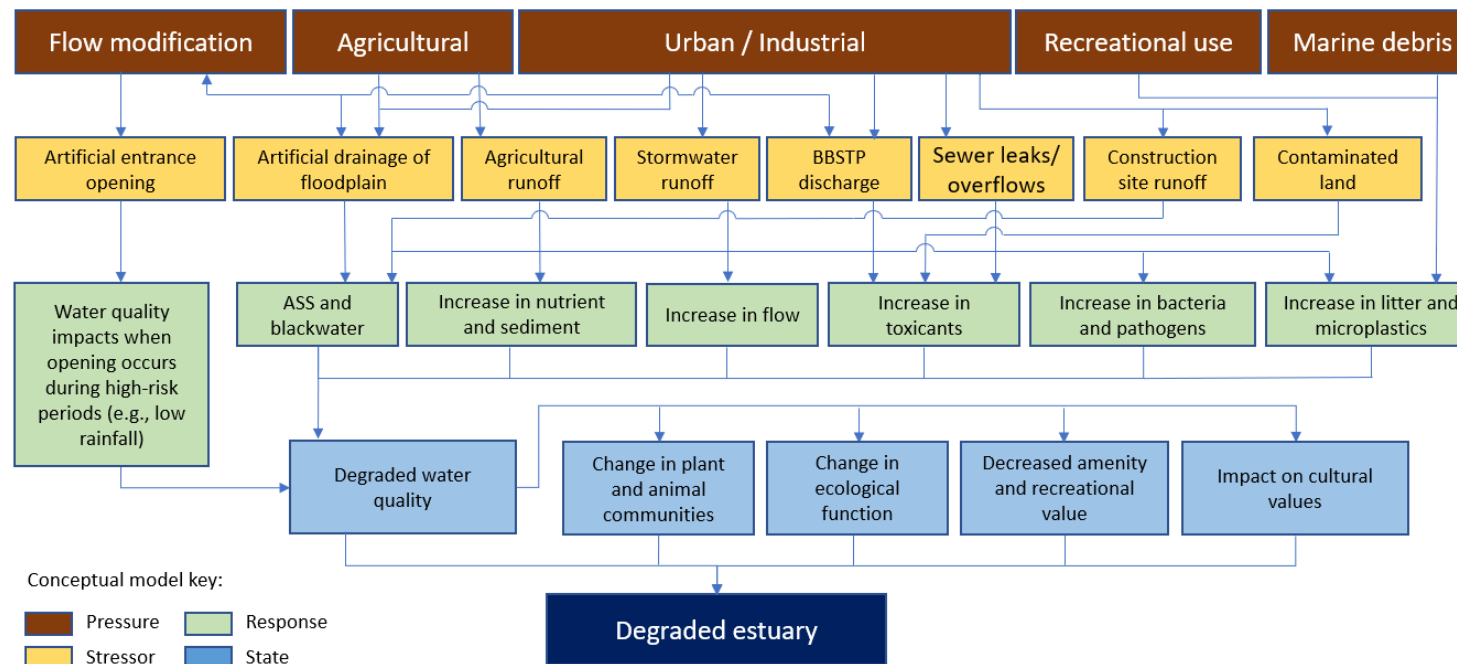
Figure 21: Belongil Creek pollutant sources conceptual model

Based on the information gathered during this study a conceptual model has been developed for Belongil Creek ICOLL to provide a broad overview of pressures, stressors and state of waterways (Figure 21).
