Coast and ICOLL Advisory Committee Meeting

Byron Shire ICOLL Water Pollution Source Tracking Program

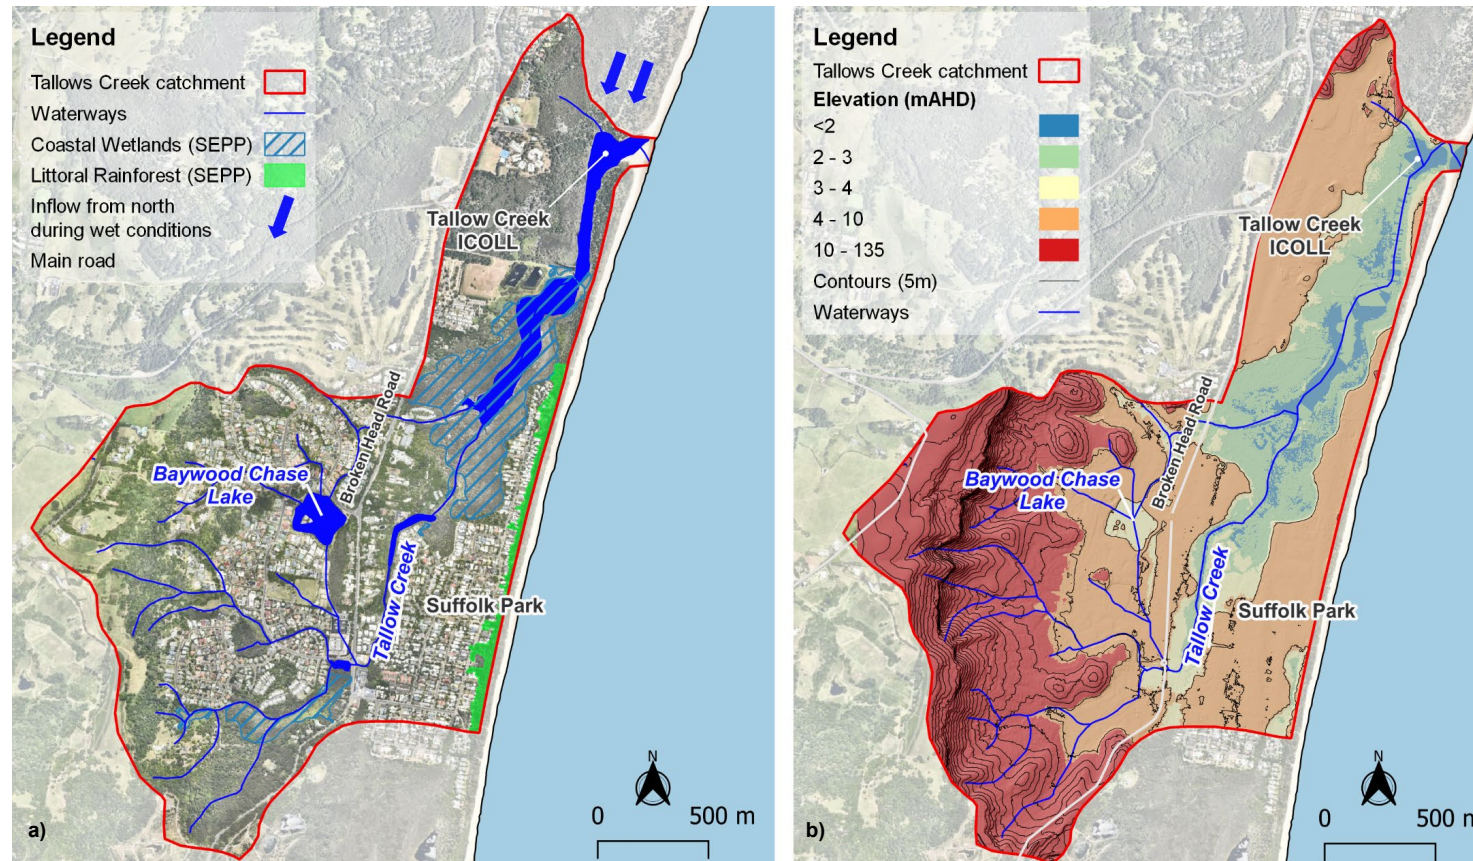
Figure 23: a) Tallow Creek drainage, b) Elevation and natural waterways

Catchment characteristics for Tallow Creek are mapped in Figure 23. Catchment elevation ranges from approximately 135 mAHN in the upper catchment to 1 mAHN on the floodplain. Natural waterways and floodplain areas of the Tallow Creek system have been modified through development and other human activities including:

- Stormwater drains, swales, pipes and culverts to convey stormwater away from roads and dwellings / businesses to downstream waterways.
- Morphologic changes to the Tallow Creek waterway, including:
 - a straightened and widened section of the previously narrow sinuous creek (as seen on 1958 air photo) to the north of the current Tallow Creek footbridge as a result of sand mining.
 - a realigned and filled section of the upper estuary running parallel to Broken Head Road constructed as part of the Suffolk Park estate subdivision.
- Baywood Chase Lake, a large artificial lake constructed for stormwater detention as part of the Baywood Chase subdivision (refer to stormwater infrastructure section below for more details).

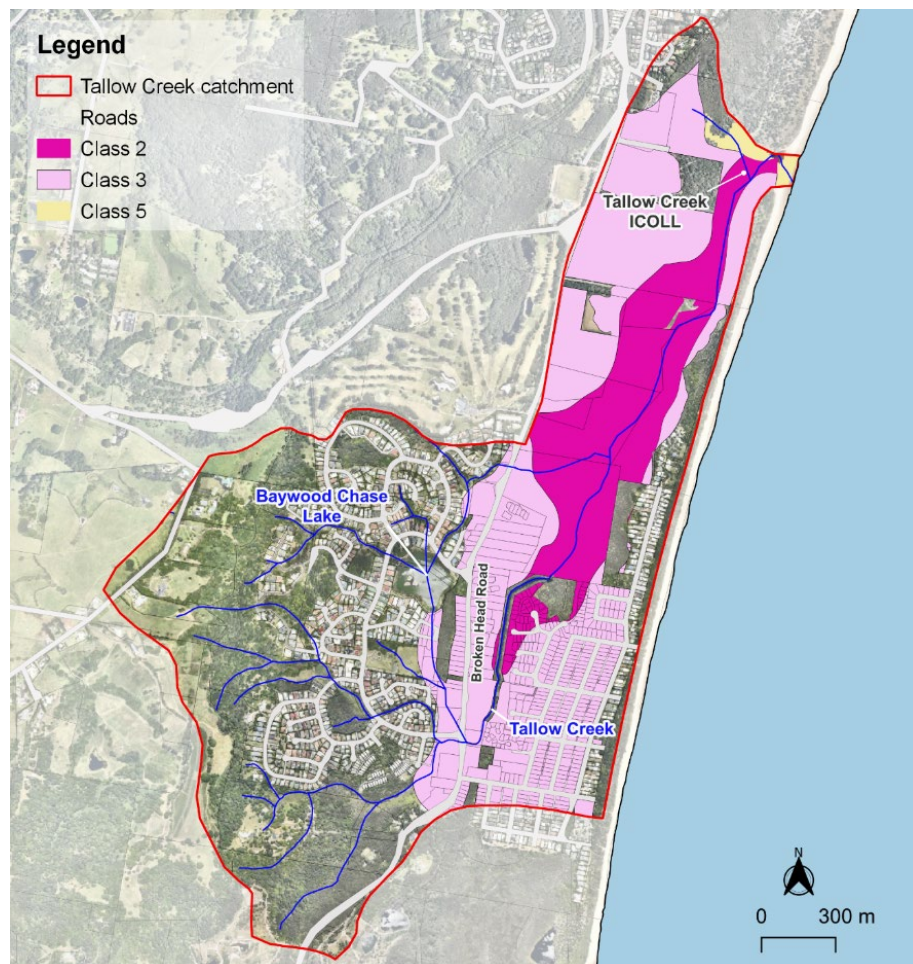
Figure 24: Tallow Creek acid sulphate soil risk.

The *Byron Local Environmental Plan 2014* ASS risk maps show that the majority of the eastern side of the Tallow Creek Catchment is either Class 2 or Class 3 ASS (Figure 24). This indicates the likely presence of potential ASS occurring just below the natural land surface (Class 2) and >1m below the natural land surface (Class 3). Exposure of these soils to air through excavation or lowering of the water table can produce sulfuric acid which may impact nearby waterways including Tallow Creek. Generally, pH values have been reported within guidelines for healthy aquatic ecosystem function in Tallow Creek (AWC, 2020; WBM, 2015), however low pH values (below guidelines) have been detected periodically at water quality sampling sites in the upper estuary and this has been associated with estuary opening events. This could indicate increased drainage of ASS during lower water levels when the entrance is open. It has also been suggested that lower pH could be due to mobilisation of Monosulfidic Black Ooze (MBO) from bottom sediments during opening events (Waddy, 2019).

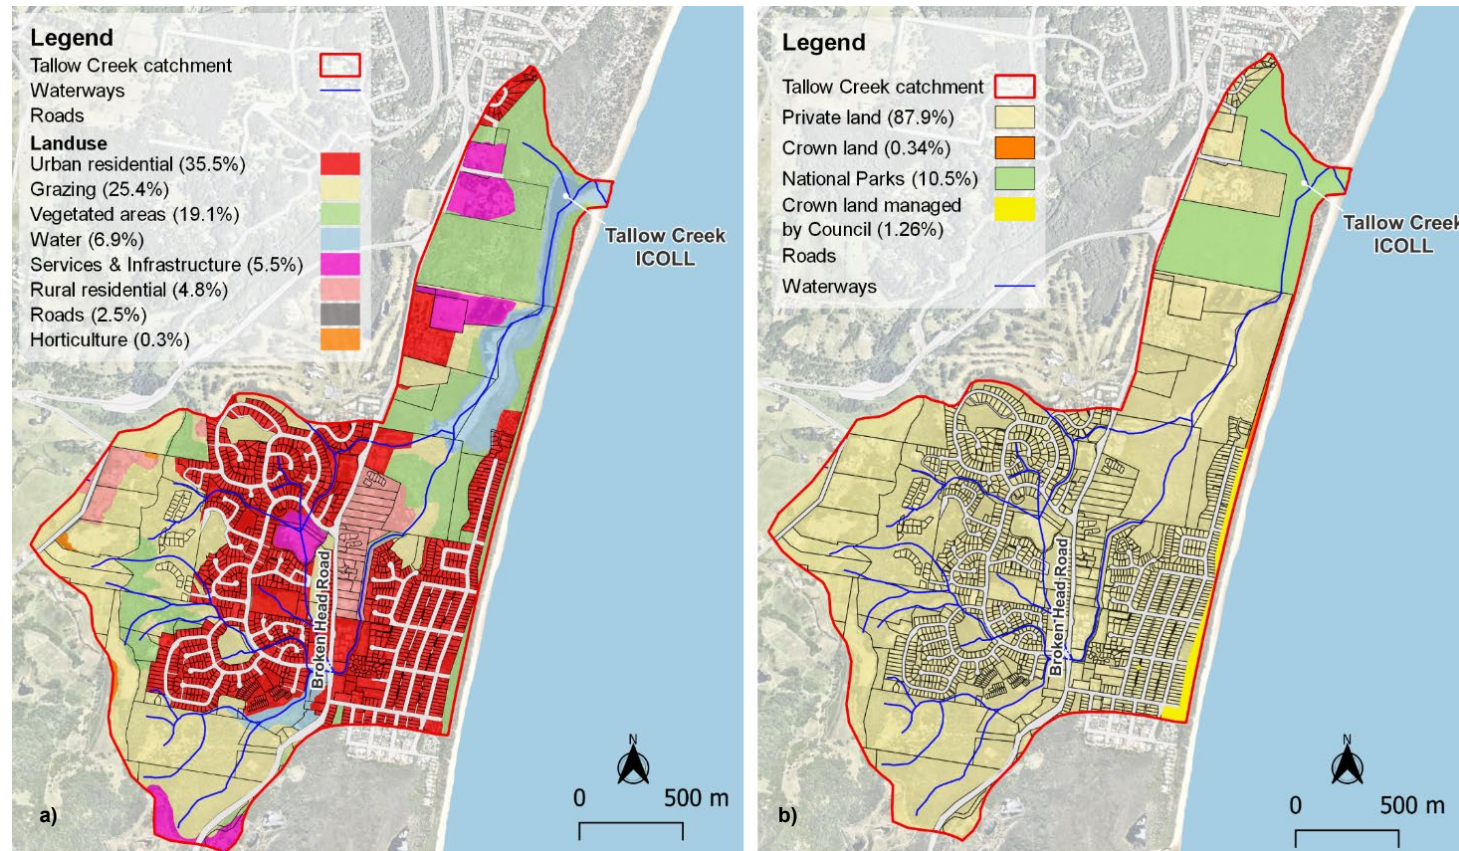
Figure 25: a) Tallow Creek catchment landuse and b) Tallow Creek land tenure

The Tallow Creek catchment has a mix of land uses as shown on Figure 25, the dominant land use classification within the study area is urban residential, comprising approximately 35.5% of the catchment which includes much of the localities of Baywood Chase, Byron Hills and Suffolk Park. Construction of 17-lot community title subdivision is currently underway on Bottlebrush Crescent, Suffolk Park. The next most dominant land use as indicated by the land use mapping data (DPE, 2020) is grazing land and accounts for 25.4% of the catchment, occurring mostly around the fringe areas of the Baywood Chase subdivision. This area is previously cleared farm land, although regrowth of vegetation is now evident for much of this area and active grazing likely to only occur on part of this area on the western slope of the catchment. Vegetated areas comprise 19.1% including lower catchment areas within Arakwal National Park in addition to vegetated areas on private and Council and Crown land. 6.9% of the catchment is covered by water whilst Services and infrastructure comprise 5.5% of the catchment including the decommissioned South Byron STP site and Byron Bay High School. Rural residential land use makes up 4.8% of the catchment area in close proximity to Baywood Chase and Suffolk Park urban areas. Roads account for 2.5% whilst Horticulture accounts for 0.2% of the catchment area.

Land tenure within the study area is illustrated on Figure 25. Most of the study area is freehold land under private ownership (87.9%). Approximately 10.5% of land is managed as National Park/Reserve. Crown land is divided into Council - managed (1.26%) and Crown land not managed by Council (0.34%).

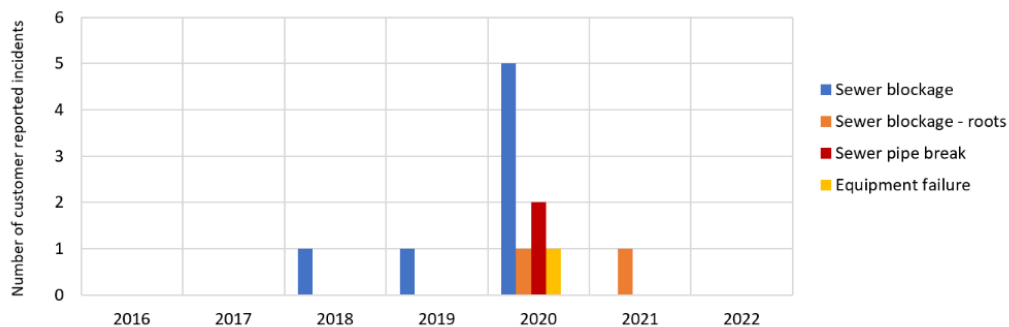
Figure 27: Number of customer-reported sewer overflow incidents in the Tallow Creek catchment April 2016 – April 2022

Figure 27 shows the number and type of customer reported sewer overflow events from April 2016 – April 2022 in the Tallow Creek catchment. There was a total of 12 customer reported incidents over this six-year period. The majority (7) were caused by sewer blockages/ chokes, two were caused by tree root blockages, two were due to sewer pipe breaks and the remainder were due to other equipment failure (1). The highest number of reported incidents by customers occurred in 2020 (total of 9) which was substantially more than in any other year and is likely due to the higher than average rainfall experienced in 2020 leading to overloading of the sewer system. Council staff responded to all incidents and completed inspections, repair and clean up actions as required. Some incidents occurred within private properties and property owners were responsible for corrective actions. There were no incidents during 2016-2022 in the Tallow Creek catchment that met the criteria requiring Council to report the incident to the NSW EPA (i.e. no environmental damage occurred as a result of discharge to the environment).

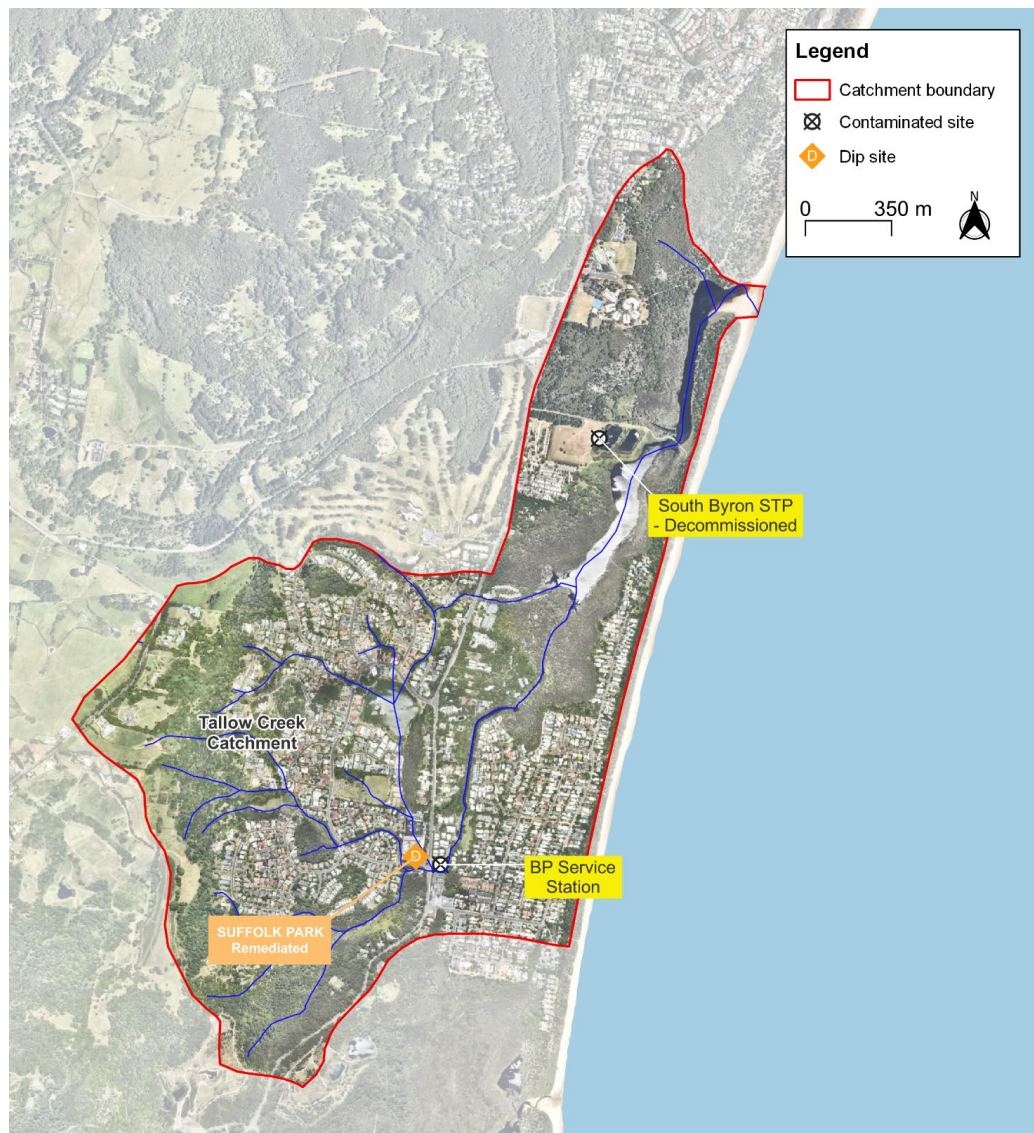
Figure 29: Search results of the POEO Act Public Register and DPI cattle dip site locator.

A search of the POEO Act Public Register (NSW EPA, 2023a), DPI cattle dip site locator (DPI, 2023) and the NSW EPA List of Notified Contaminated Land Sites (NSW EPA, 2023b) identified three sites within the catchment (Figure 29). The EPL for the decommissioned South Byron STP site is no longer active (surrendered) but the site is currently subject to investigations to determine the risk of decommissioned STP ponds to water quality in Tallow Creek (refer Sewer infrastructure discussion above for details). The Suffolk Park Service Station appears on the NSW EPA list of notified contaminated land sites, but the NSW EPA has investigated contamination at the site and decided that regulation under the *Contaminated Land Management Act 1997* is not required (NSW EPA, 2023b). The Suffolk Park dip site has been remediated and does not pose an ongoing risk to Tallow Creek (DPI, 2023). Further information on contaminated land and historical dip sites including a list of chemicals used historically at the dips is provided in Figure 29 and in Appendix 4.

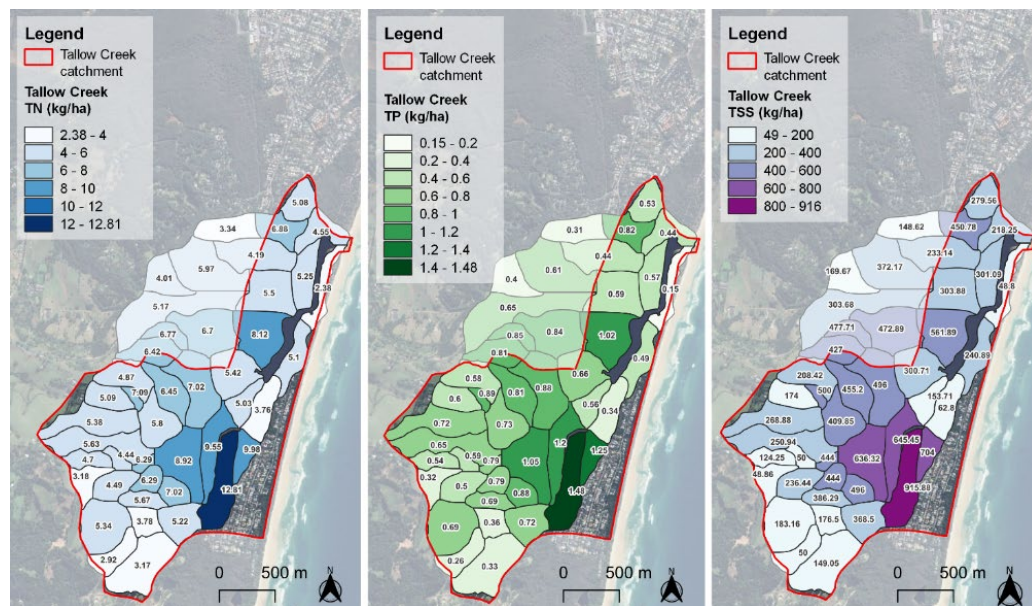
Figure 30: Tallow Creek Estuary Health Risk Dataset results for TN, TP and TSS (kg/ha/yr)

further studies and/or management actions in a catchment would contribute to achieving some of the management objectives relating to nutrient and sediment load reduction. Risks from other pressures such as ASS, blackwater events, bank erosion, pesticides, point source pollution and other catchment contaminants are not considered in the risk assessment. The current estuary health risk results are mapped in Figure 30, noting that the DPE catchment for Tallow Creek differs to the catchment defined for this study.

- Urban development in the mid catchment, particularly in the vicinity of the Suffolk Park Shopping Centre, Suffolk Park Petrol Station and surrounding urban residential/tourist accommodation areas (high export of TN, TP and TSS relative to other areas of the catchment).
- Tourist accommodation, decommissioned South Byron STP site and vegetated areas adjacent to Tallow Creek ICOLL mid-estuary reaches including the Ingenia Holiday Park (moderate export of TN, TP and TSS relative to other areas of the catchment).
- Urban residential areas in the Baywood Chase estate, particularly to the north of Baywood Chase Lake (moderate export of TP and TSS and low to moderate export of TN relative to other areas of the catchment).
- Byron Bay High School and surrounding land in the north of the catchment, close to the entrance.

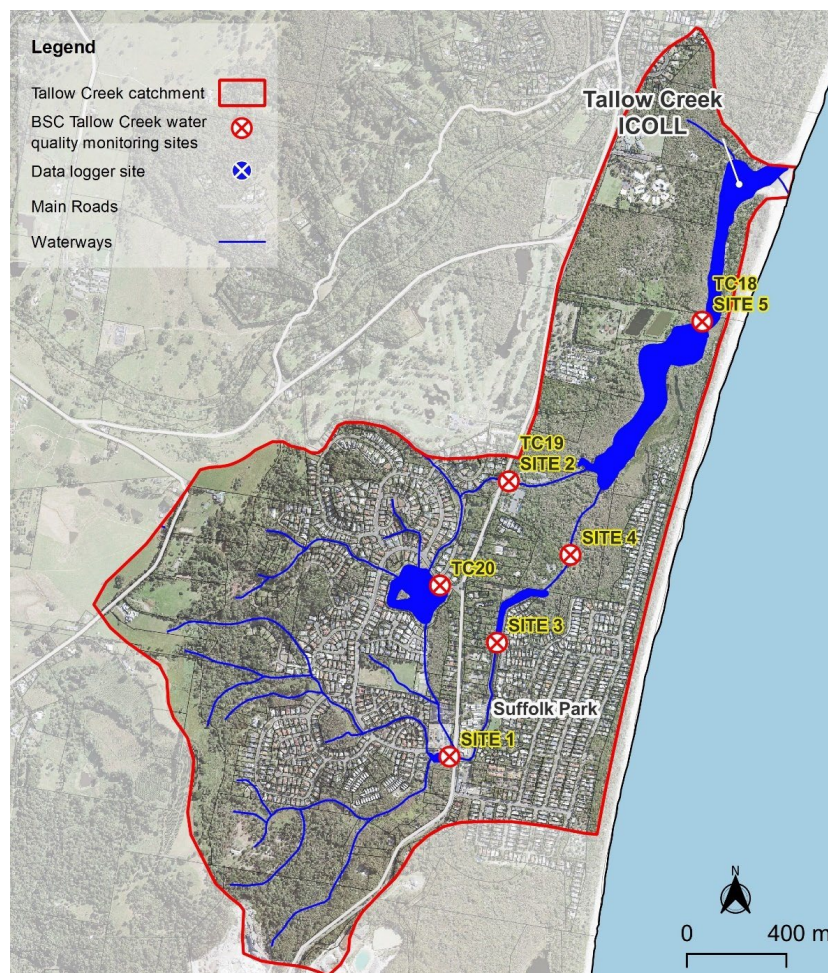
Figure 31: Tallow Creek catchment water quality monitoring sites

1. Byron Bay Surface Water Quality Monitoring Program – between 2016 and 2022 the program included surface water sampling at 3 sites on a monthly basis and in response to rainfall events.
2. Entrance Opening Strategy (EOS) monitoring - water quality and level loggers and event based sampling in accordance with the Environmental Management Plan and Opening Strategy for Tallow Creek (BMT WBM, 2015) and requirements of licences and permits in currency (a NPWS licence and a Marine Parks permit is required for entrance management works in accordance with the EOS).

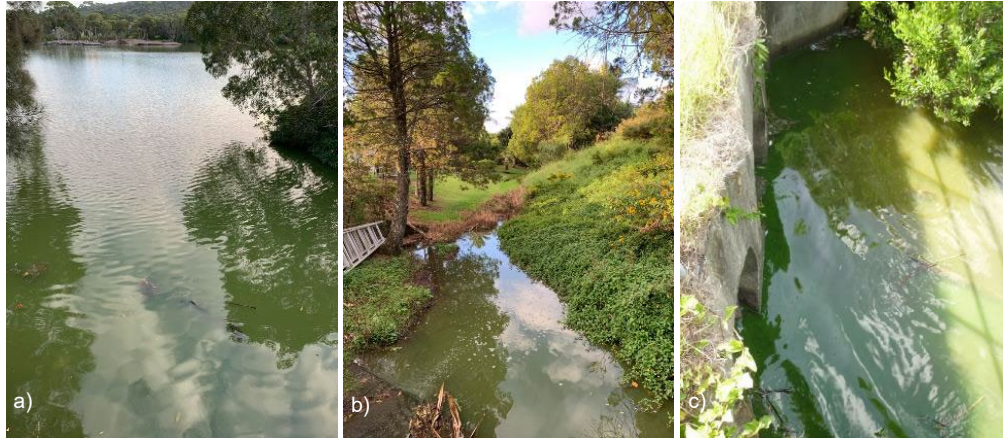
Plate 11: a) Baywood Chase Lake looking south to islands b) Immediately downstream of lake outlet c) Lake outlet in 2018 during previous study (AWC, 2018)

nutrient enrichment (e.g. excess algae and aquatic plant growth). Baywood Chase Lake, in particular was showing signs of eutrophication including very high dissolved oxygen conditions (106.5 % saturation), high pH (9.85), high turbidity (76.6 NTU), and a green tinge to the water (Figure 12) indicating an algal bloom. A foul odour was also noted around the lake and while no testing for algal species was undertaken, it is possible the bloom was cyanobacteria as has been identified previously on several occasions.

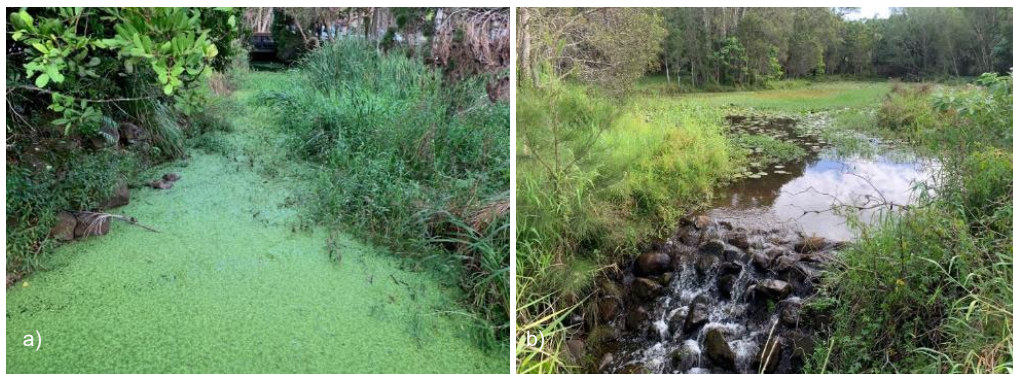
Plate 12: a) Water quality sampling site TC19 at Crystalbrook Resort downstream of Broken Head Rd. culvert, choked with *Salvinia* b) Shallow pond opposite Suffolk Park Service Station upstream of Broken Head Rd. culvert.

Salvinia molesta an aquatic weed was also observed at several sites within urban stormwater drains and, in some cases, covered the entire water surface (Plate 12a). The stormwater pond opposite the Suffolk Park Service Station also contained *Salvinia*, but to a lesser extent, and was dispersed between water lilies and other aquatic macrophytes (Plate 12b). Council manages *Salvinia* in this stormwater pond as an upper catchment source to the catchment and estuary using *Salvinia* weevil (*Cyrtobagous salviniae*) which has kept growth under control in recent months. It is understood that resort management also manages an ongoing *Salvinia* infestation in the channel and within the wetlands at the Crystalbrook Resort. In 2021, during a long dry period and a long period of creek entrance closure with elevated water levels, the *Salvinia* infestation became rampant across Tallow Creek estuary as well as several other locations within the Shire. Management at that time was hampered by a lack of weevil availability which is the recommended management method for Council-managed sections of the Tallow Creek catchment.

- Oxidised nitrogen (NO_x - bioavailable forms of N) were noticeably higher at site TC19 than at the other sites (including T20 Baywood Chase Lake outlet) and warrants further investigation of potential pollution sources at this location (e.g. potential sewer leaks/overflows, excess fertiliser use etc.). Figure 32 shows all NO_x results at TC19 from September 2017 to November 2022 showing consistently elevated levels and occasional spikes of NO_x occurring in November 2019 and again in February 2022. The consistently high NO_x results indicate an ongoing issue at this site. This is consistent with field observations in April 2023, when this location was choked with *Salvinia* covering the entire water surface indicating nutrient enrichment /eutrophication (Plate 12).

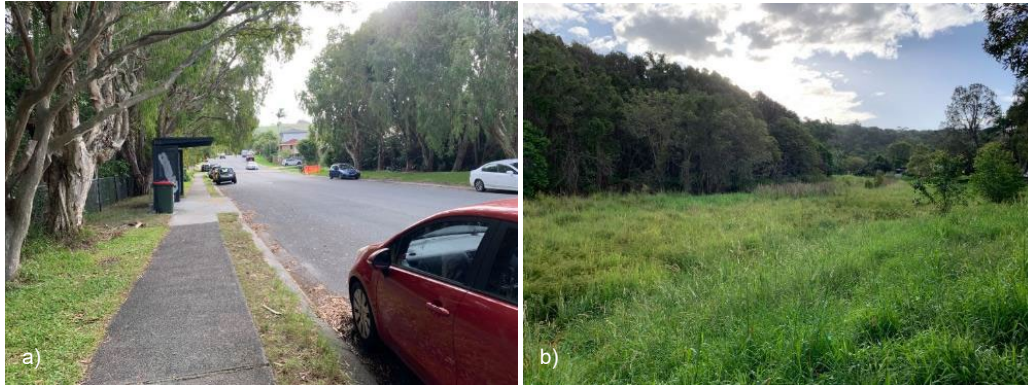
Plate 13: a) Typical curb and gutter roadside Beech Drive, Suffolk Park b) Stormwater swale bordering a parcel of urban bushland, Beech Drive.

The majority of urban areas observed during site inspection in Suffolk Park were characterised by curb and gutter stormwater infrastructure (Plate 13a) draining to open stormwater drains and/or vegetated swales and drainage basins. A large, vegetated swale was inspected along Beech Drive which was in generally good condition (Plate 13b).

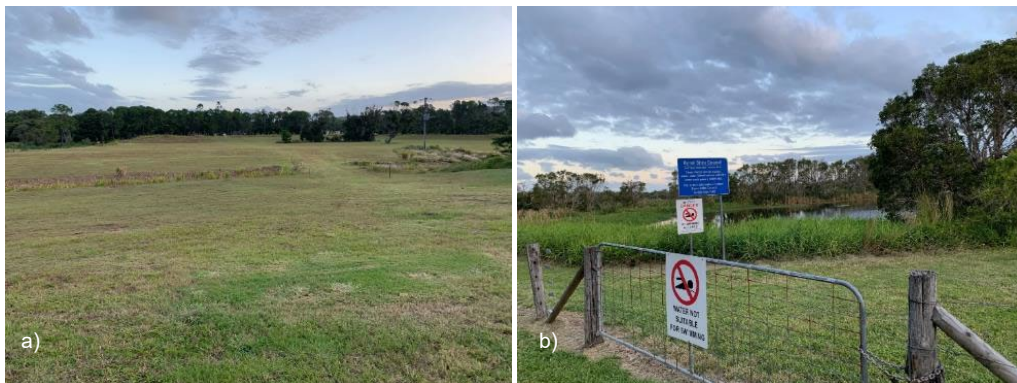
Plate 14: a) Remediated land at site of former STP / landfill site b) Decommissioned South Byron STP sewage ponds adjacent to mid estuary reaches of Tallow Creek.

The site of the former South Byron Bay STP was visited (Plate 14). The former STP has been remediated and there are plans to remediate the ponds (though bank reprofiling, revegetation and fencing) in the future. No water quality sampling was undertaken at the ponds due to restricted access to the waterbody. The ponds appeared to be in good condition with well vegetated riparian zones, clear open water and emergent macrophytes along the edges. There were no signs of algal bloom conditions or *Salvinia* infestations observed during site inspection. Abundant wildlife was noted in and around the ponds.

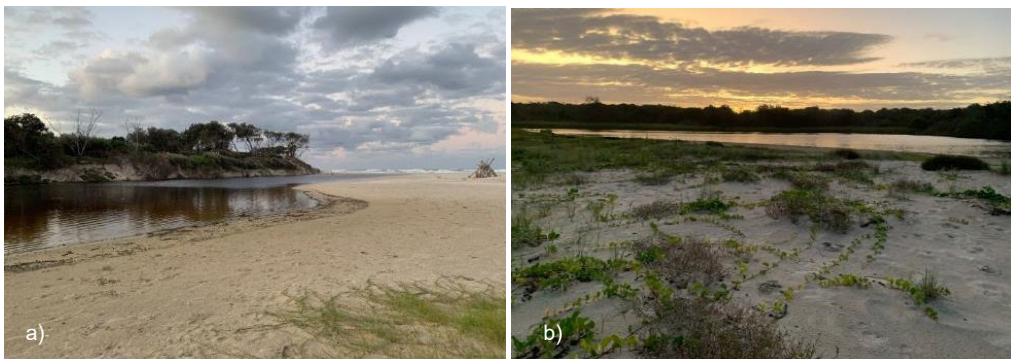
Plate 17: a) Tallow Creek mouth on Tallow Beach b) Lower Tallow Creek near entrance

The lower catchment area bordering Tallow Creek estuary was dominated by natural vegetation. Water quality conditions observed in these reaches were vastly improved compared to the upstream areas. Water was typically tannin-stained, clear (low turbidity and improved dissolved oxygen levels at 60-90% saturation). There was little evidence of litter or *Salvinia* / algal blooms within the estuarine sites at the time of the site visit (Plate 15, Plate 16). The creek entrance was closed at the time of the site inspection with very little downstream flow evident (Plate 17).

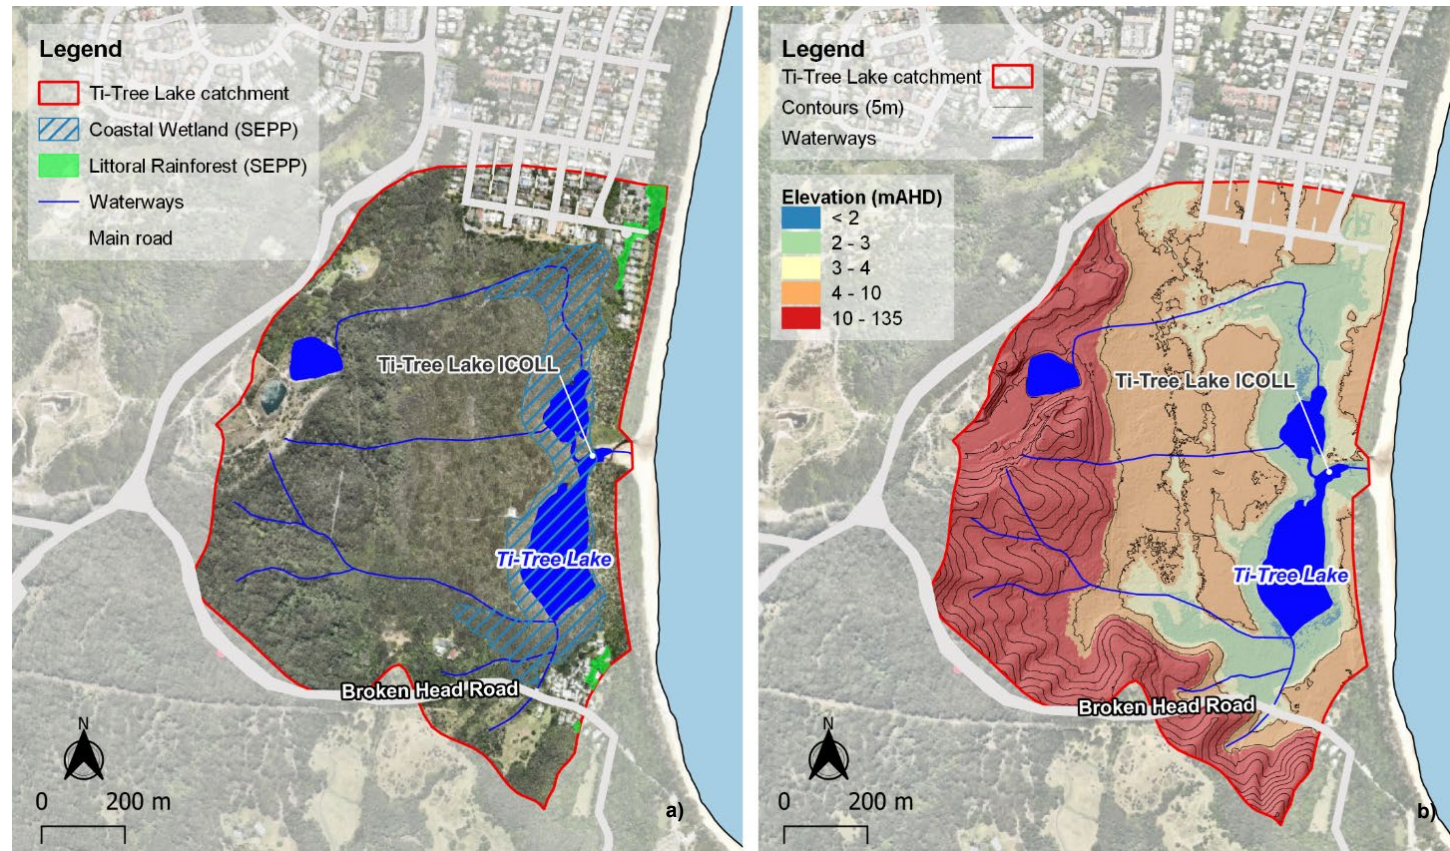
Figure 37: a) Ti-Tree Lake drainage b) Ti-Tree Lake elevation and natural waterways

Catchment characteristics for Ti-Tree Lake are mapped in Figure 37. Catchment elevation ranges from approximately 60 mAHD in the upper catchment to 1 mAHD on the floodplain. Waterways are shown including major drainage systems connecting catchment areas to Ti-Tree Lake.

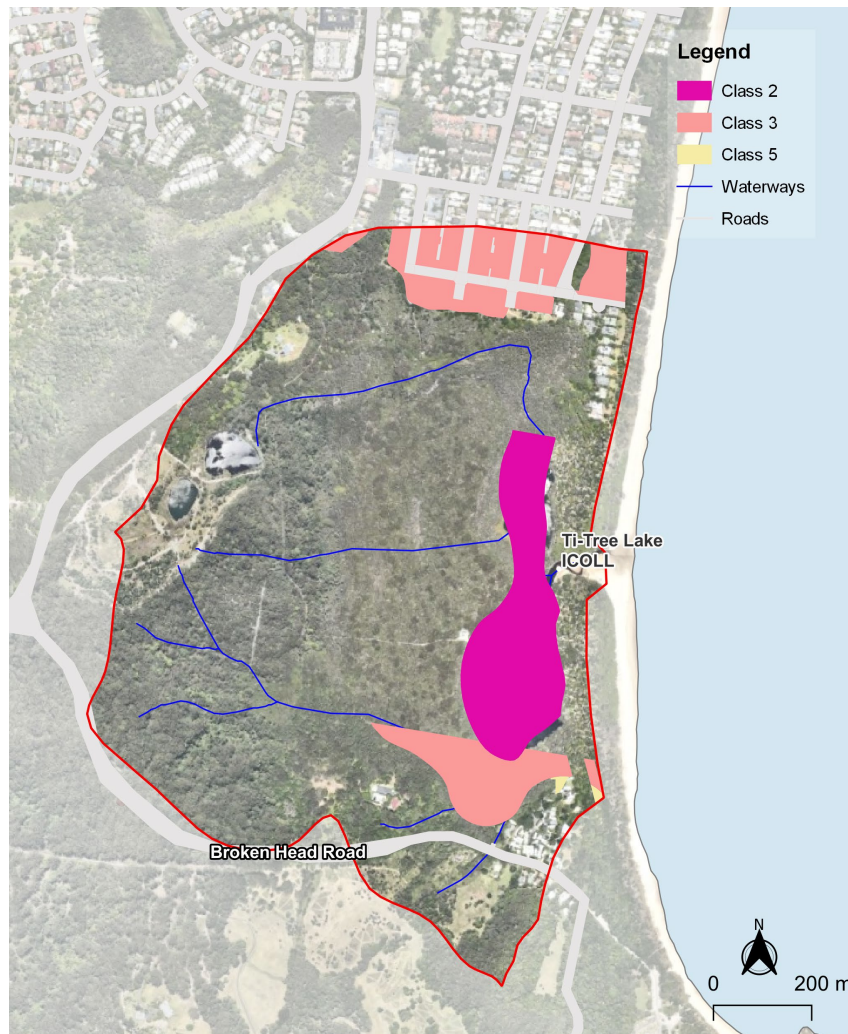
Figure 38: Acid sulfate soil risk map

The Byron Local Environmental Plan 2014 ASS risk map show small areas of the Ti-Tree Lake Catchment is either Class 2 or Class 3 ASS. This indicates the likely presence of potential ASS occurring within 0-1m below the land surface over a relatively small area of the catchment to the south and north of the lake and including the lake bed itself. Exposure of these soils to air through excavation or lowering of the water table can produce sulfuric acid which may impact nearby waterways.

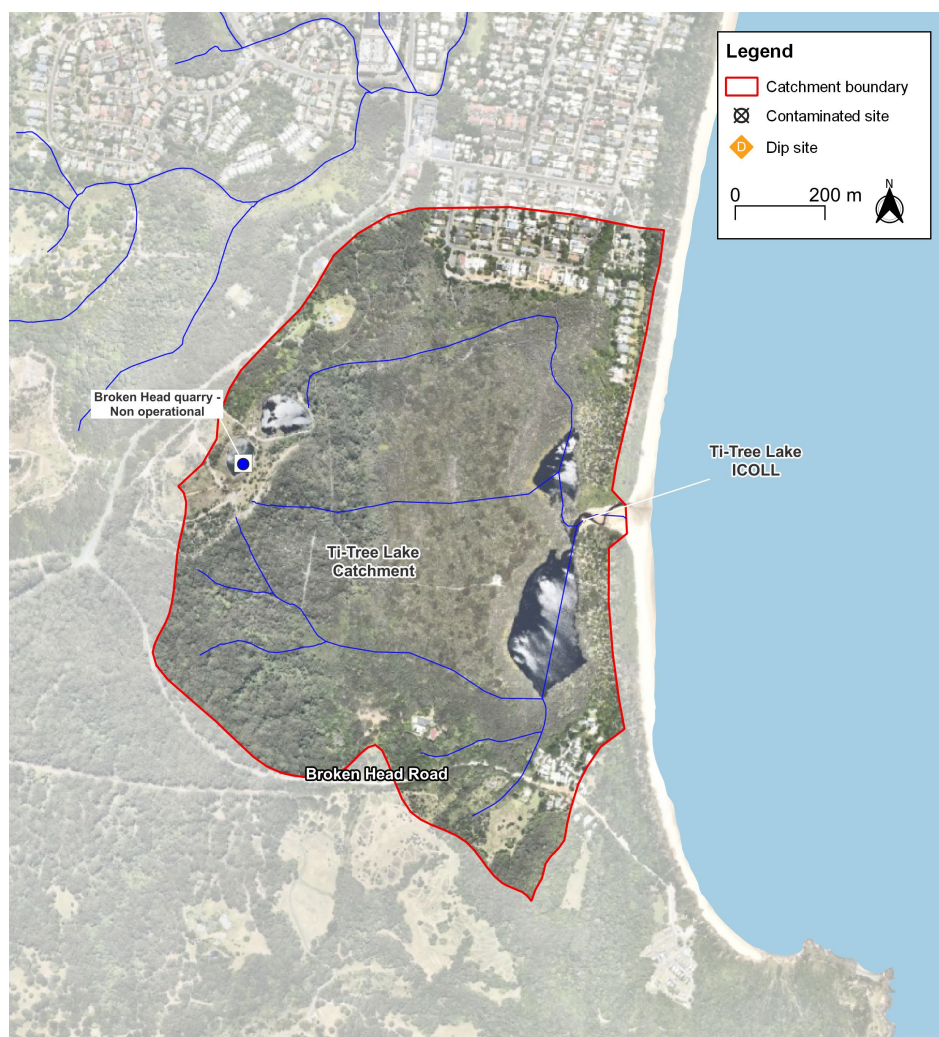
Figure 41: Search results of the POEO Act Public Register and DPI cattle dip site locator.

A search of the POEO Act Public Register (NSW EPA, 2023) and DPI cattle dip site locator (DPI, 2023) identified one site within the catchment – the Broken Head Quarry site (Figure 41). The Broken Head Quarry is a land-based extractive activity licenced under the POEO Act (EPL 4860). The quarry has now ceased operations within the Ti-Tree Lake catchment on the eastern side of Broken Head Road and this area is being rehabilitated and revegetated. Two sediment basins remain within the quarry site as shown in Figure 41 which drain eastward to Ti-Tree Lake. The site's EPL requires rainfall events up to 82.5 mm (up to five-day event duration) to be held on site. If discharge occurs it must achieve water quality requirements of <50mg/L TSS and pH of 6.5-8.5 (Morris, 2019). Some non-compliances with water quality limits were recorded for the site in recent years (ENV Solutions, 2020).

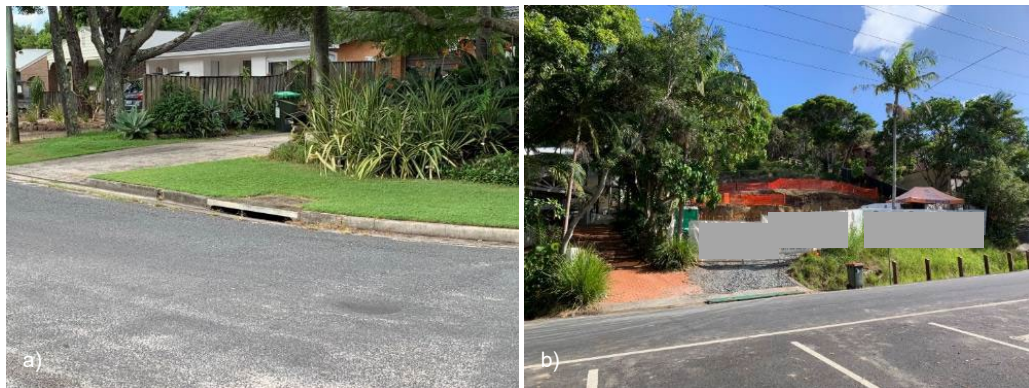
Plate 19: a) Typical curb and gutter roadside MacGregor Street, Suffolk Park b) Building construction along Broken Head Road (business signage has been obscured).

The small area of urban residential development at Suffolk Park bordering the northern upper catchment boundary for Ti-Tree Lake were characterised by curb and gutter stormwater infrastructure (Plate 19a). Sheet metal, wood and other building waste was observed dumped along the track within the Ti-Tree Lake Aboriginal Area. Other waste including chairs, mattress, bottles and plastic was also observed along the track.

Urban areas of Broken Head in the south, did not have formalised stormwater infrastructure with roadside swales conveying stormwater to nearby bushland (Plate 19a). A building construction site was observed along Broken Head Road with recent soil excavation of the hillside evident (Plate 19b).

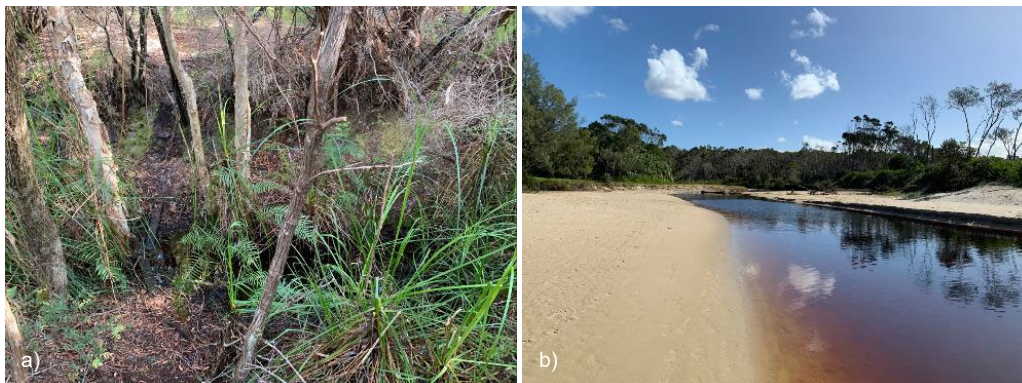
Plate 21: a) Small tannin-stained waterway draining to Ti-Tree Lake b) Ti-Tree lake entrance on Broken Head Beach

Water quality was assessed in-situ within a small tannin-stained waterway draining from Suffolk Park to Ti-Tree Lake (Plate 21a). The water was clear (turbidity 2.4 NTU), acidic (pH 4.07), with low dissolved oxygen (7.4 % saturation) likely to reflect the high level of organic matter present and lack of flow. Water at the ICOLL entrance on Broken Head Beach was also tannin-stained and clear (Plate 21b).

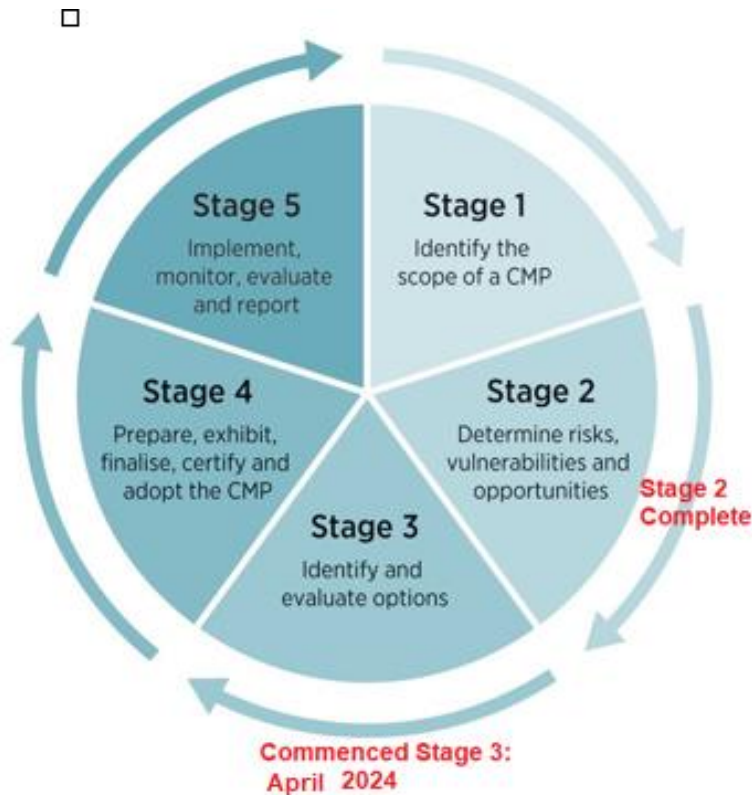
Figure 1 - CMP Stages

Council is finalising Stage 2 of preparation of Coastal Management Programs (CMPs) for the Shire's coastline to fill key information gaps on threats, issues and opportunities in the coastal zone (refer Figure 1). Simultaneously, Council is commencing Stage 3 in which management options for key threats to the coastal zone are identified and evaluated in collaboration with key stakeholders and the community.

Stage 2 studies confirm current knowledge on key issues and concerns and to fill information gaps that are critical to the development of management strategies and actions that will occur in the next stage (Stage 3). Scoping of Stage 3 & 4 CMP development is currently underway.
