Lilli Pilli Photo Monitoring

11 Tristran Parade, Mullumbimby Creek NSW 2482

Baseline monitoring

26-09-2019

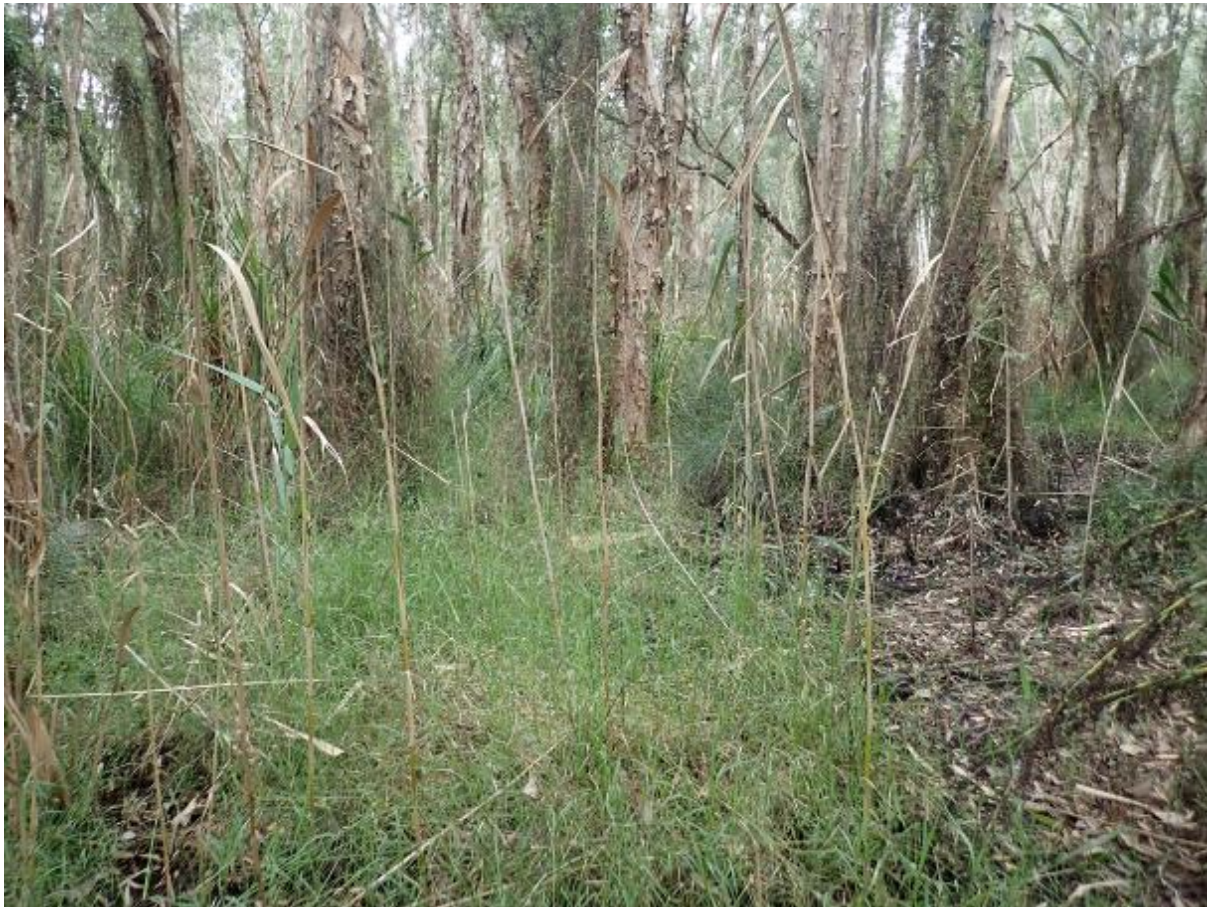
Figure 2: Point A 260919

Time	Conditions	Ground cover (%)	Notes
1.38pm	Light cloud	60 – 80%	<i>Melaleuca quinquenervia</i> dominant canopy, minimal weed infestations, sodden ground, even after prolonged dry period.

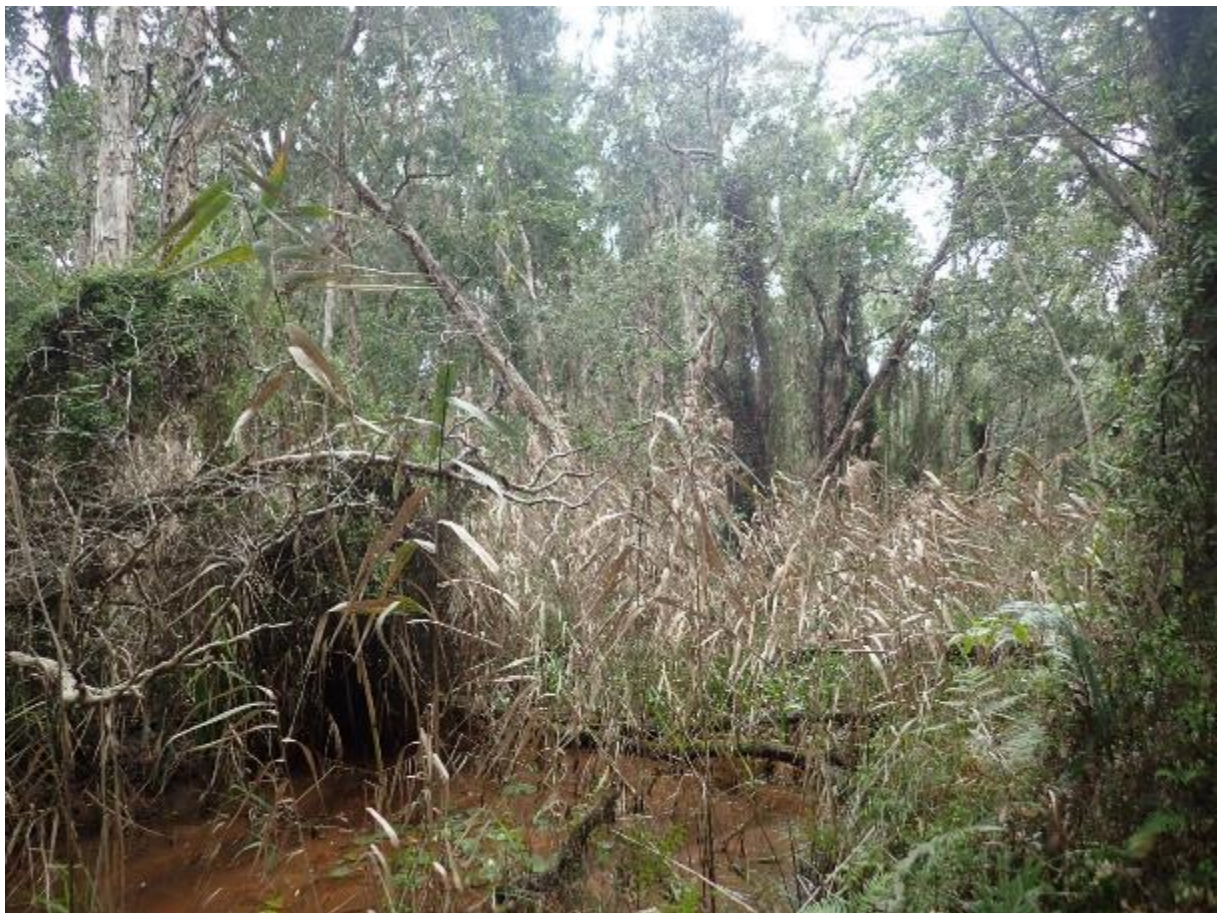
Figure 3: Point B 260919

Time	Conditions	Ground cover (%)	Notes
1.01pm	Light cloud	80%	Adjacent a watercourse, with vine growth and sunlight penetration. Water colour is very opaque orange, possibly due to acid sulphate. Recommend water testing. Two scats near point B, most likely from a cat. Additional photos can be provided.

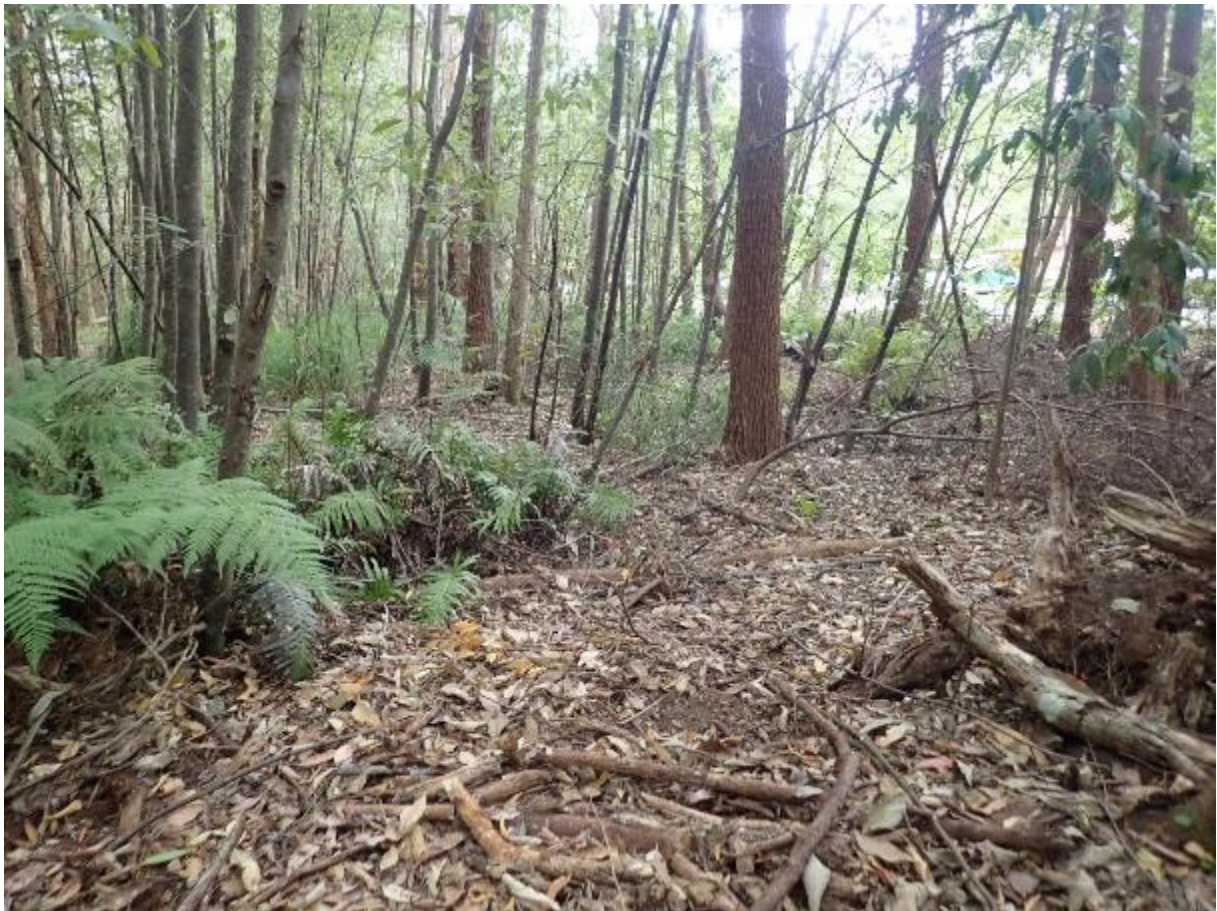
Figure 4: Point C 260919

Time	Conditions	Ground cover (%)	Notes
1.17pm	Light cloud	20%	This monitoring point is nearest road verge. There was rubbish present, with some weed infestations. Both rubbish and weeds should will be able to be removed by hand.

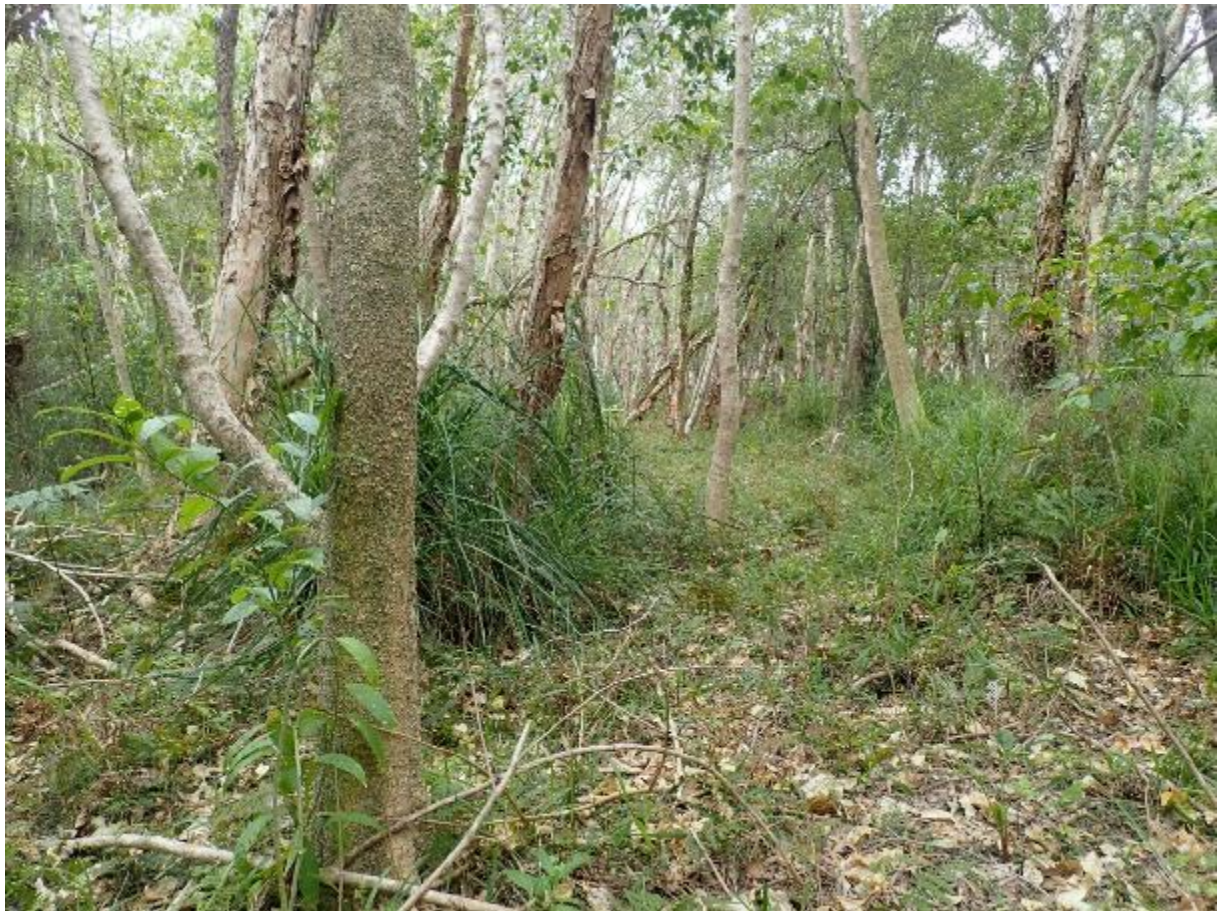
Figure 5: Point D 260919

Time	Conditions	Ground cover (%)	Notes
1.54pm	Light cloud	60 - 70%	Many weed species present, including Cassia (<i>Senna pendula</i> var. <i>glabrata</i>) and night scented jasmine (<i>Cestrum nocturnum</i>), with a more open canopy than the other monitoring points. Large amounts of litter present.

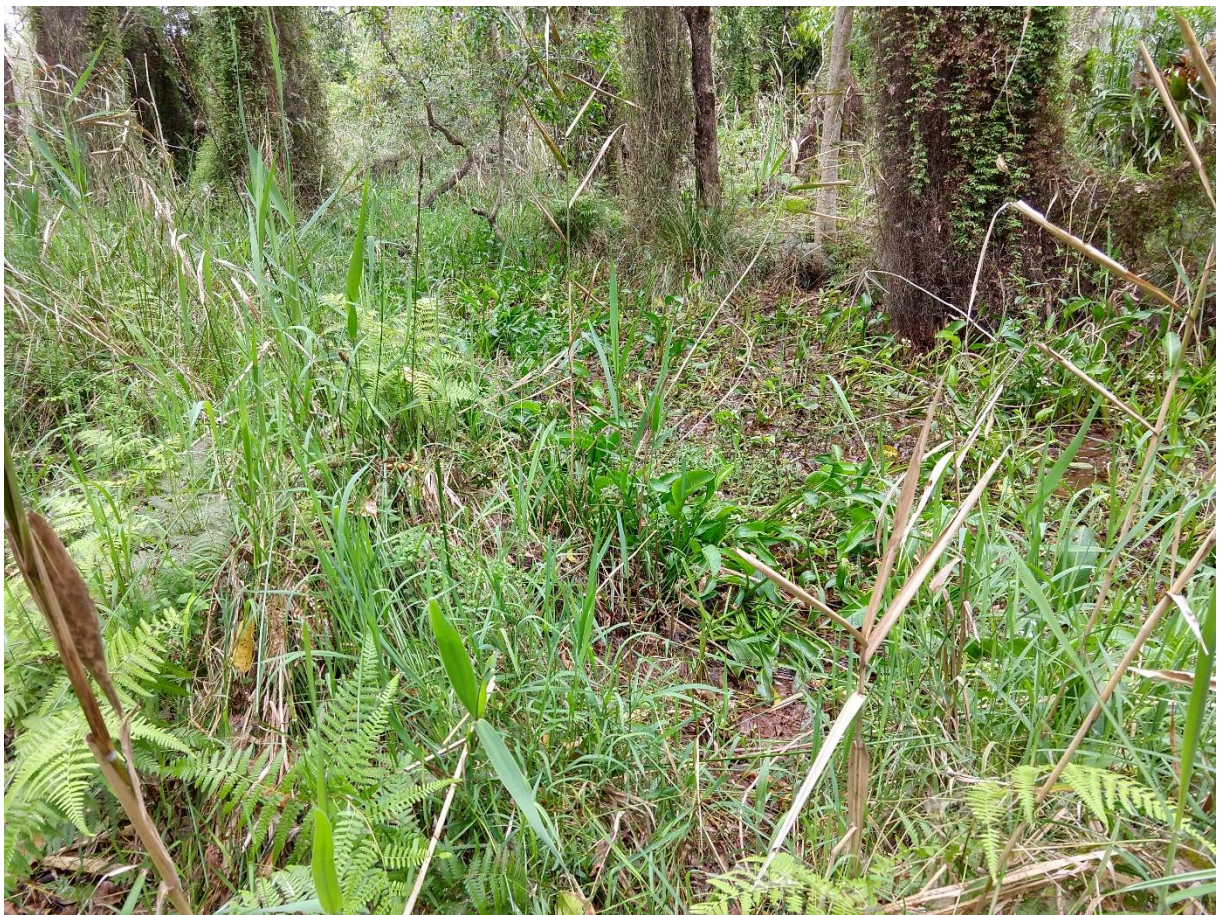
Figure 6: Point E 221019

Time	Conditions	Ground cover (%)	Notes
9.41am	Light cloud	70 - 80%	The photo point E captures one of a number of open water sections toward the southern end of the site dominated by <i>Sagittaria</i> (<i>Sagittaria platyphylla</i>), an aquatic weed in NSW with aggressive growth and rapid spread - https://weeds.dpi.nsw.gov.au/Weeds/Sagittaria .

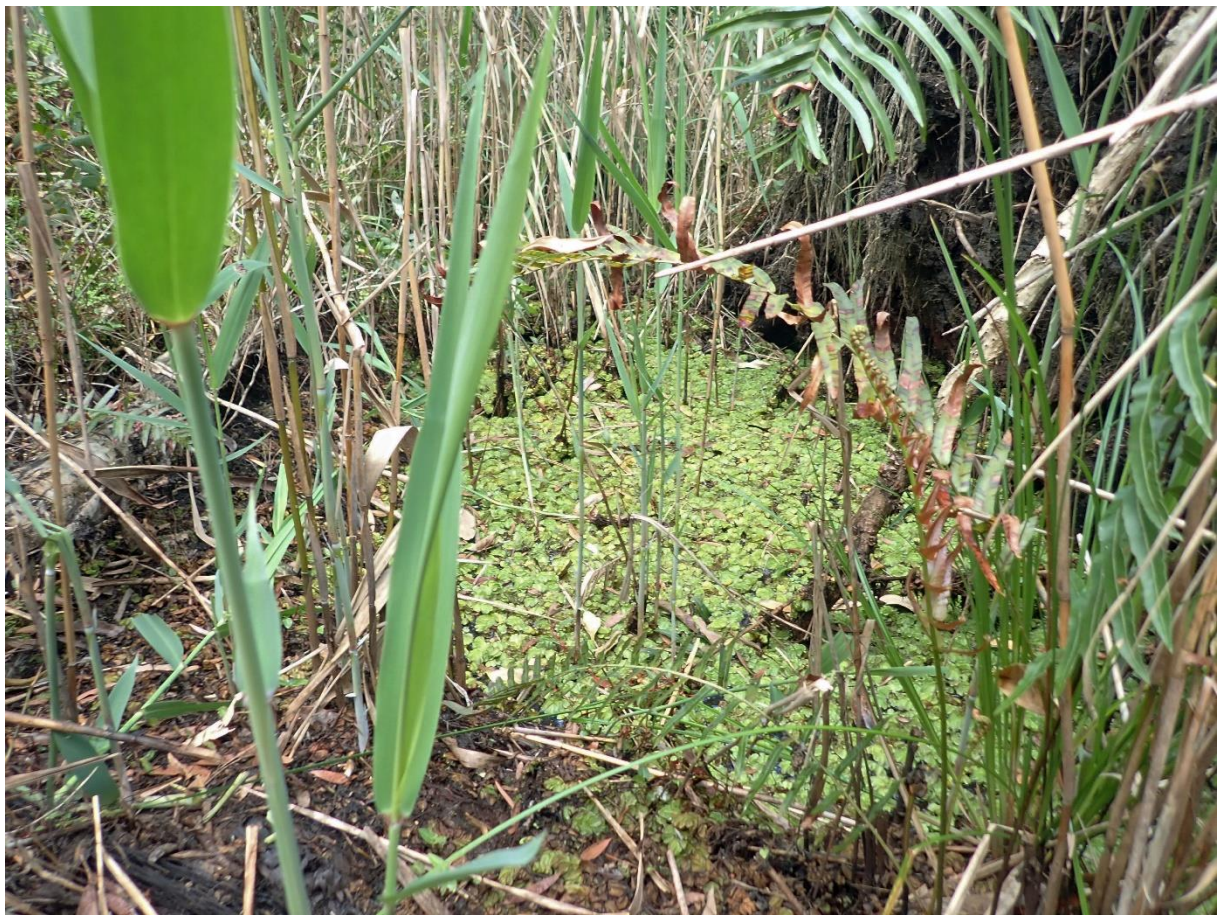
Figure 7: Point F 221019

Time	Conditions	Ground cover (%)	Notes
9.12am	Light cloud	60 -70%	The photo point F represents many of the permanent water sections through the middle of the site, with Salvinia (<i>Salvinia molesta</i>) becoming established. Salvinia is classed as a weed of National Significance in Australia, and is regarded as a “serious threat to waterways...” https://weeds.dpi.nsw.gov.au/Weeds/Details/118 .
