Federation Bridge Debris Control - Draft

Stage 1 – Options Assessment

27th APRIL 2023

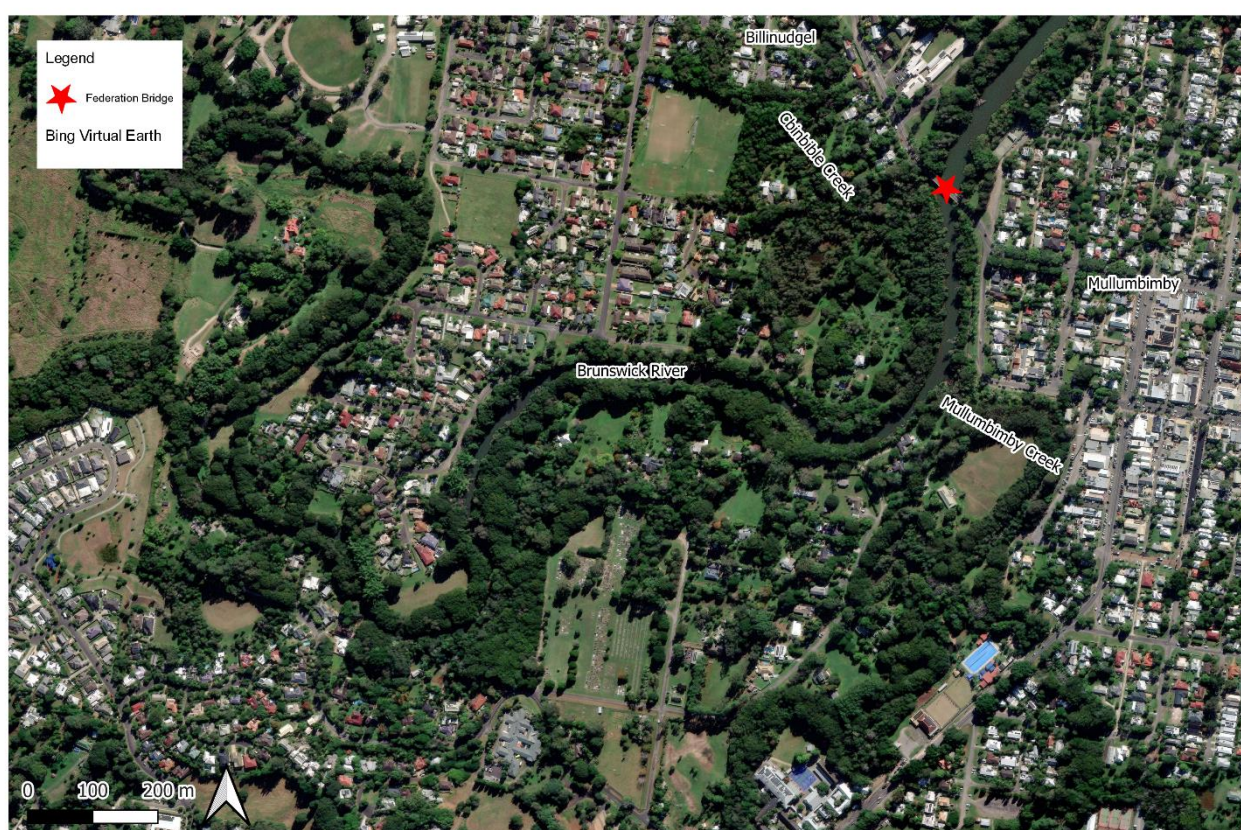
Figure 2.1 Study Area Federation Bridge and Brunswick River

Federation Bridge is a multi-span bridge on Murwillumbah Road that crosses Brunswick River in Mullumbimby, NSW. It connects the eastern and western sides of Mullumbimby township and Billinudgel township to the north. The Study Area also includes Brunswick River and the foreshores upstream Federation Bridge, given in the below figure.

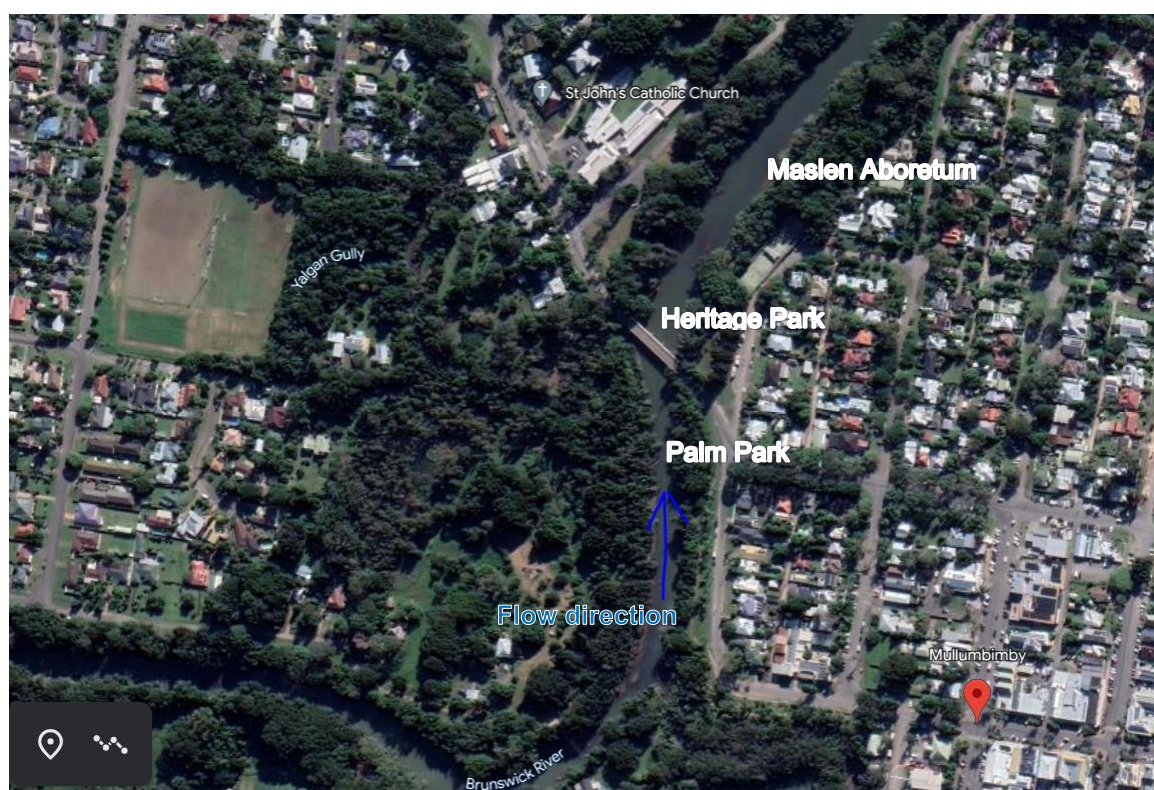
Figure 2.4.1 Site Visit – Observed Locations

A site visit was conducted on the Brunswick River within the estuarine section, around Mullumbimby approximately 400m upstream and downstream of the Federation Bridge. The purpose of this visit was to inspect the foreshores in the study area, to ascertain source and type of the debris load. The Figure below provides a locality of the site visit.

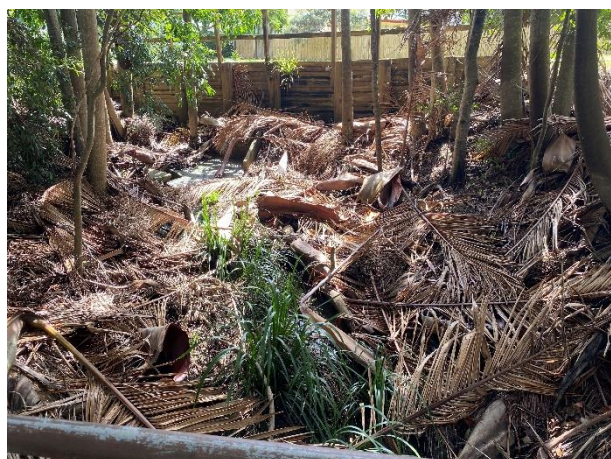
Figure 2.2.1 Palm Fronds at Palm Park

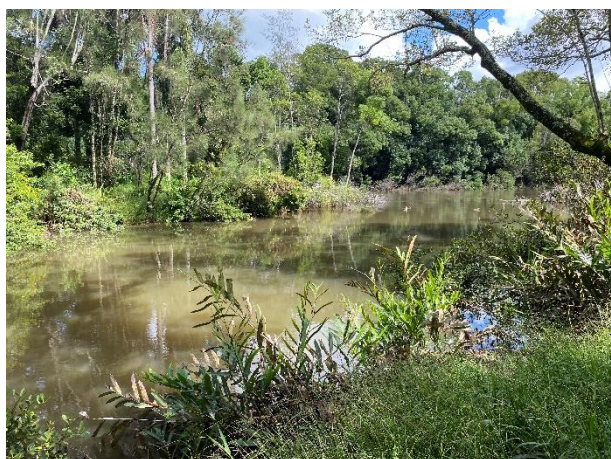
Figure 2.2.3 Palm Park looking across Brunswick River at west banks

The western side of the river holds significant flood storage with several layers or “steps” leading to the river bank, allowing for significant forest growth below the bridge level but above the Highest Astronomical Tide (HAT). This would allow for significant debris accumulation during dry times, then release during high water levels of the river. Large woody debris, mainly trees, were sighted falling into the river on this side.

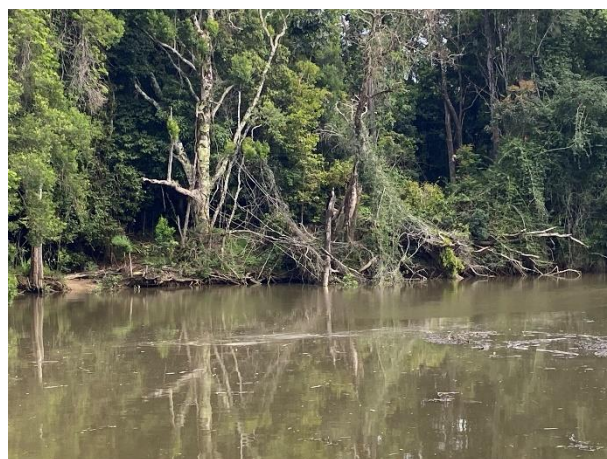
Figure 2.2.4 Downstream of Federation Bridge on the eastern side of Brunswick River looking at the western bank

As Federation Bridge is situated on a bend in the river, these gullies tend to accumulate debris which then drifts in and around the bridge with the changing tides. Some areas of the bank look to be subject to scour, which also increases the chance of becoming a collection point for debris. It was also noted that the Camphor Laurels along the river bank have shallow roots and are not effectively holding the bank together.

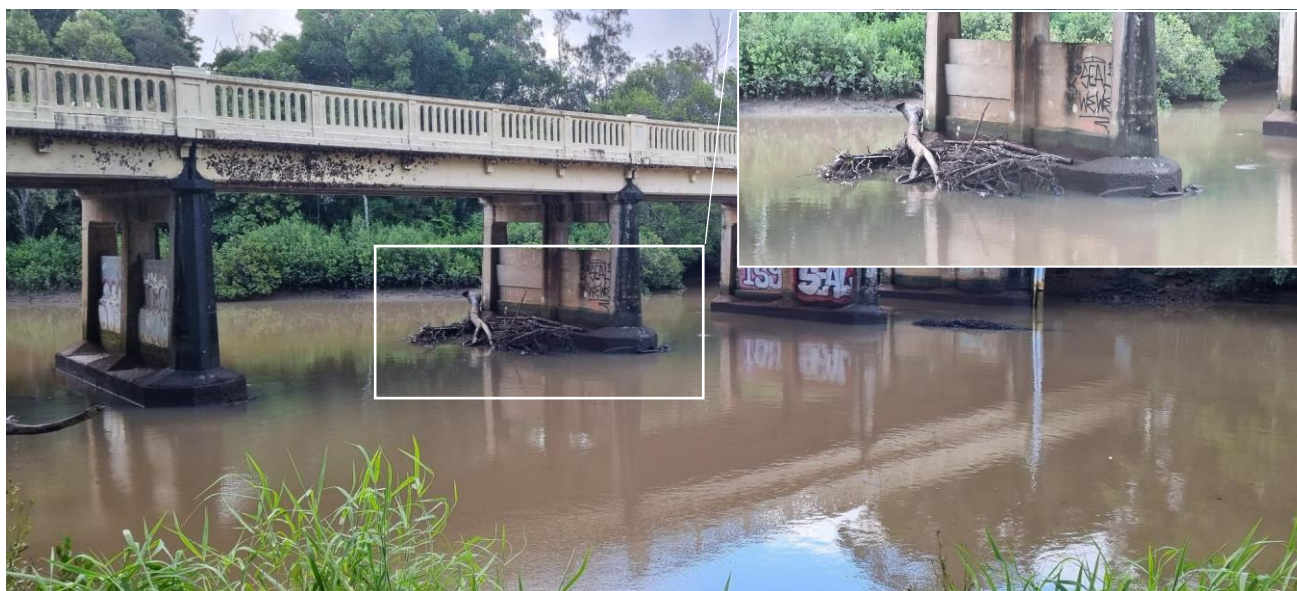
The observed debris accumulating under Federation Bridge is predominantly woody debris reported by the local community. **Figure 2.5.1** shows picture supplied by local community member which is typical of what is observed.

Figure 2.5.1 Debris Accumulation under Federation Bridge (Local Community Member, 2022)

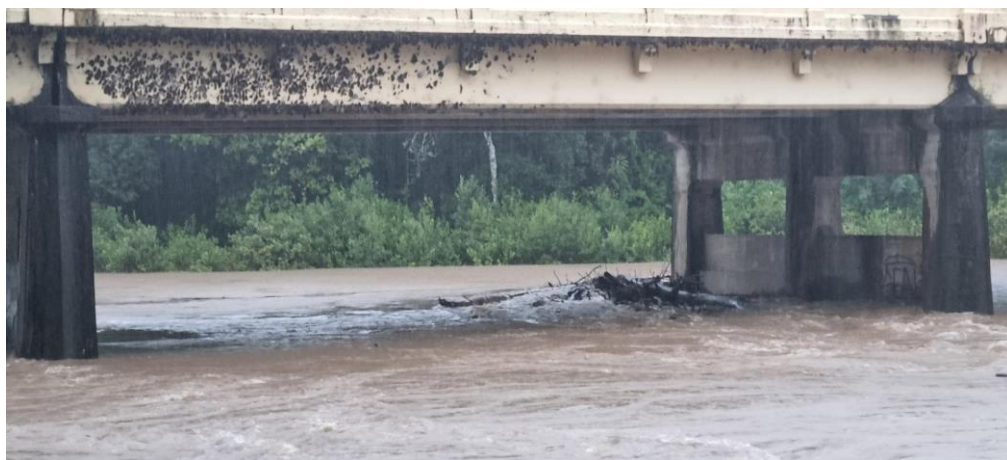
Figure 2.5.2 Debris Accumulation under Federation Bridge during 2022 Flood Event (Local Community Member, 2022)

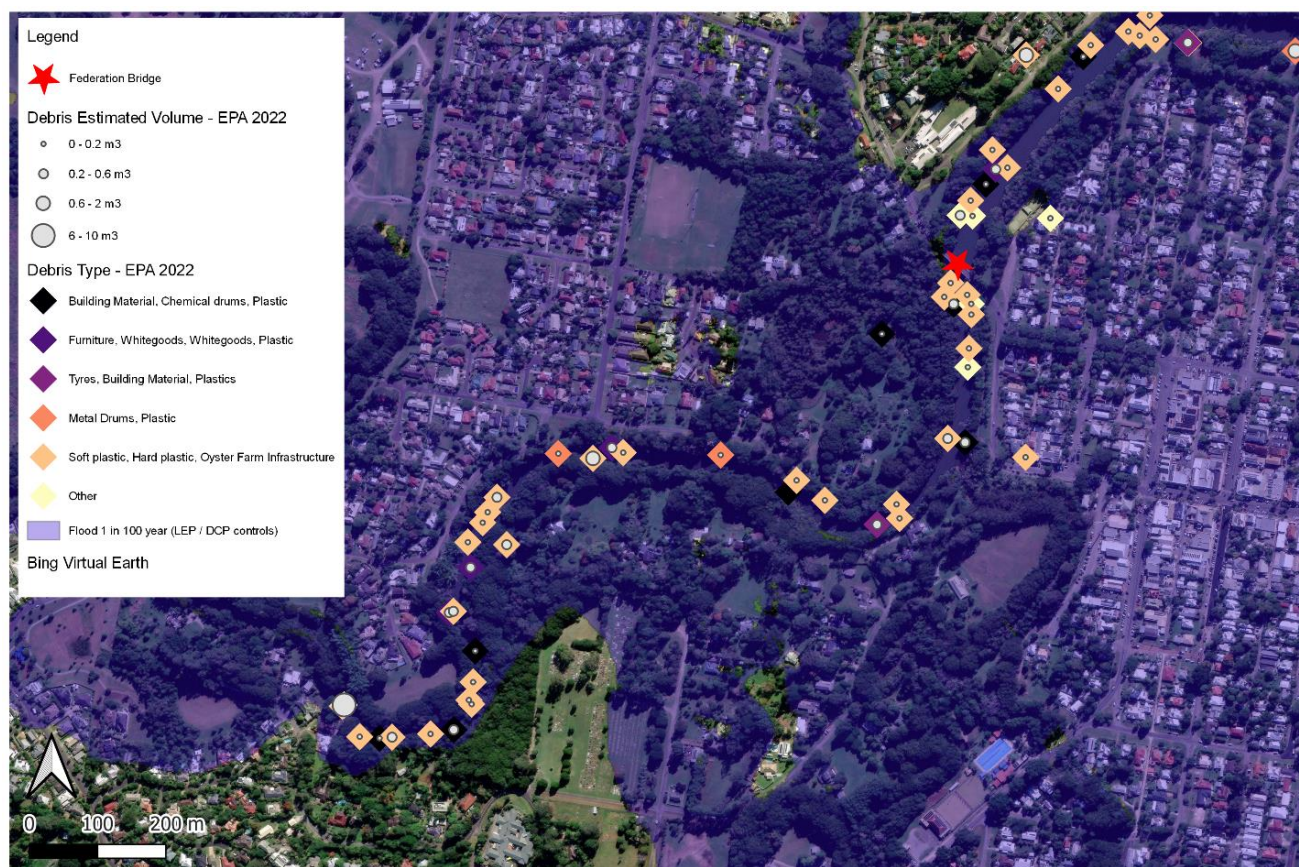
Figure 2.5.3 2022 debris collection data (EPA, 2022) (Debris type categorisations include overlaps in types; the largest items have been listed first in the description)

Figure 2.5.3 shows approximate locations of debris collected and cleared from the Study Area, also showing type and volume of the debris collected. As expected, larger debris items have been predominately on the outer bends of Brunswick River. Larger items were predominately building material and chemical drums. Smaller items were mainly small and hard plastic.

After the 2022 east coast flood, in particular the Northern Rivers the region of NSW, the EPA conducted a debris removal operation on 22nd – 26th August 2022. Only large anthropogenic debris was targeted.

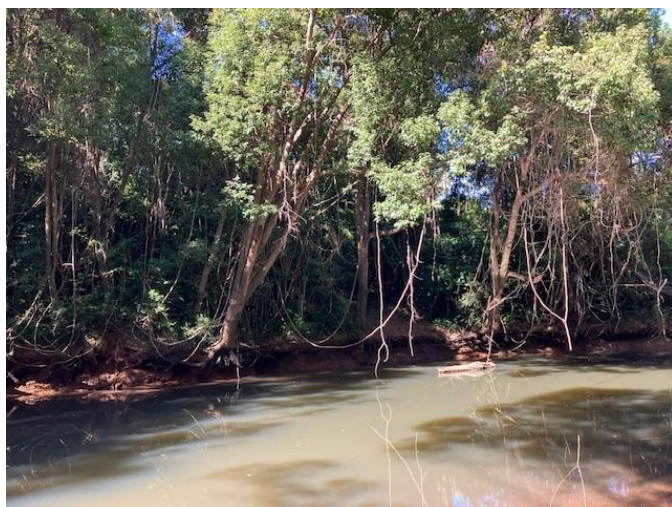
Extensive invasive flora species have been identified with Camphor Laurel dominating much of the foreshore as seen in **Figure 2.6.1**. There is also significant erosion along the banks Brunswick River and Mullumbimby Creek (BSC, 2018), where Camphor Laurel is causing undercutting due to their shallow root system (DPI, 2023), seen in **Figure 2.6.2**.

Figure 2.6.2 Camphor Laurel undercutting banks on Brunswick River in the Study Area

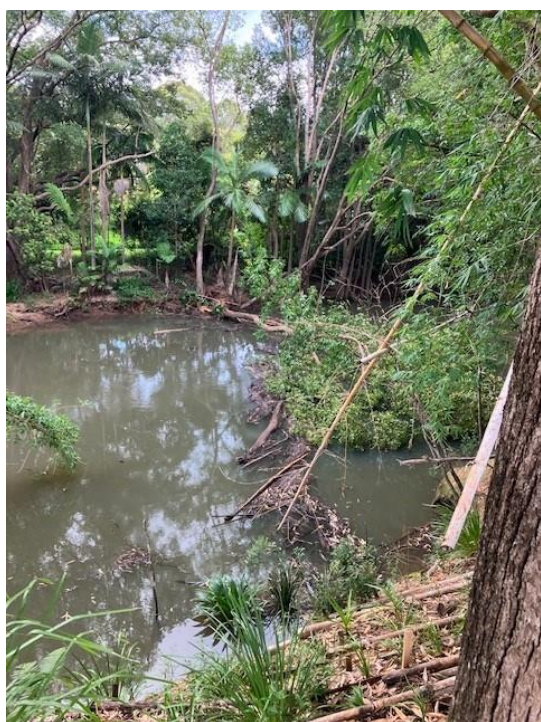
Recent ground truthing (work undertaken separate to this study) show a number of dead Camphor Laurel adult trees on the foreshore of Brunswick River, either already entering or on the verge of entering Brunswick River, contributing to the debris loads (**Figure 2.6.3**, approximately 2.5km upstream of Federation Bridge). It is suspected that poisoning Camphor Laurel has been undertaken as an effort to remove Camphor Laurel. Additionally, the Figure also demonstrates other invasive species such as bamboo entering Brunswick River.

Figure 2.6.3 Dead Camphor Laurel and bamboo logs in Brunswick River (ground truthed by BSC 2023)

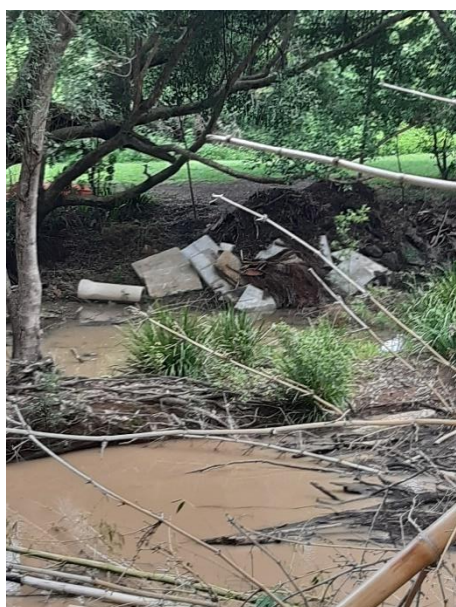
Illegal dumping regularly occurs upstream of Federation Bridge, contributing to anthropogenic debris loads. Two problem areas have been identified as Riverside Drive and Azalea Street. An example of accumulated debris, which has the potential to reach Federation Bridge can be seen in **Figure 2.6.4**. This is currently being managed by BSC through signage and fine enforcement.

Figure 2.6.4 Illegal Dumping on Azalea Street (BSC, January 2023)

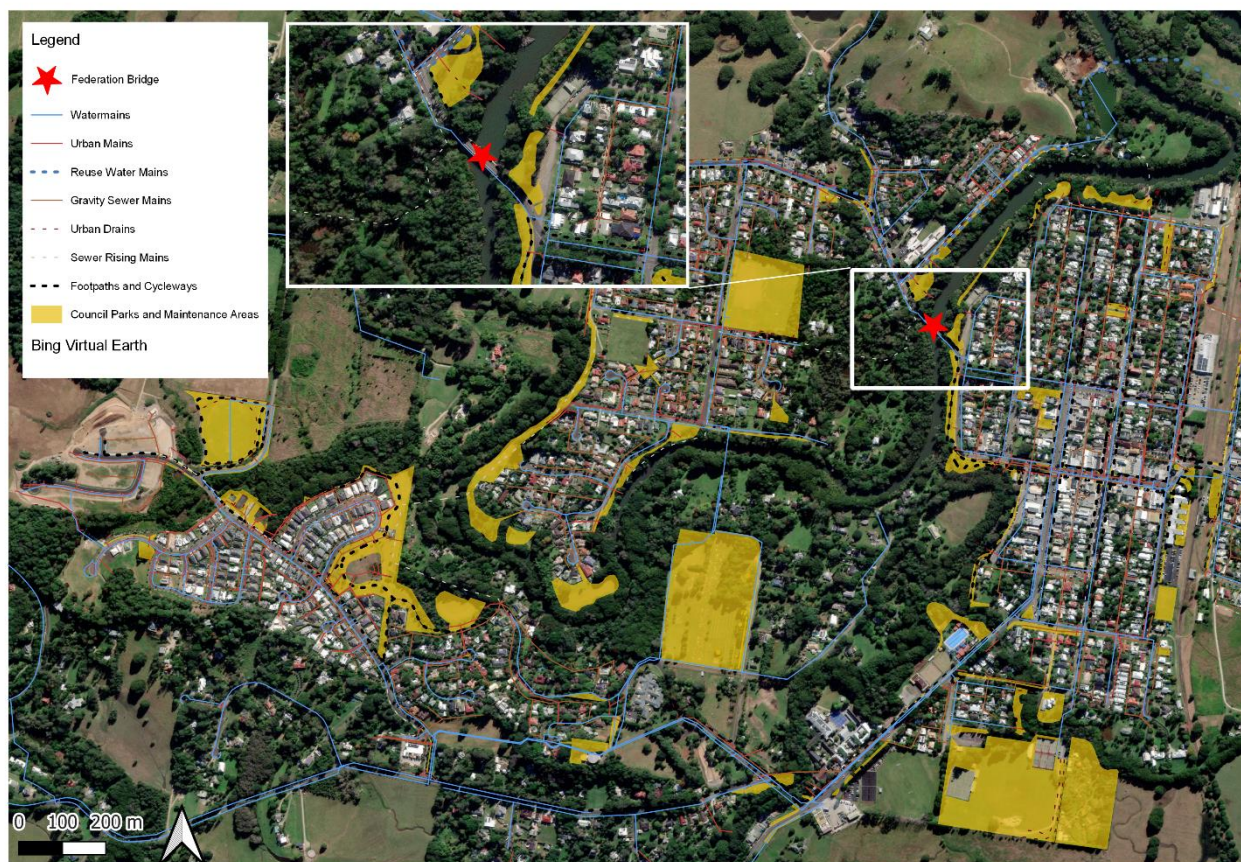
- Critical council services (water main) are located on the upstream side of Federation Bridge, extending along the span of the Bridge.
- Footpaths and cycleways are also located on the eastern foreshore of Brunswick River in Palm Park.
- Palm Park is Council managed open space.
- Although not Council's operational responsibly, Federation Bridge also includes a footpath and cycleway.

Figure 2.6.5 shows Council managed utilities and areas

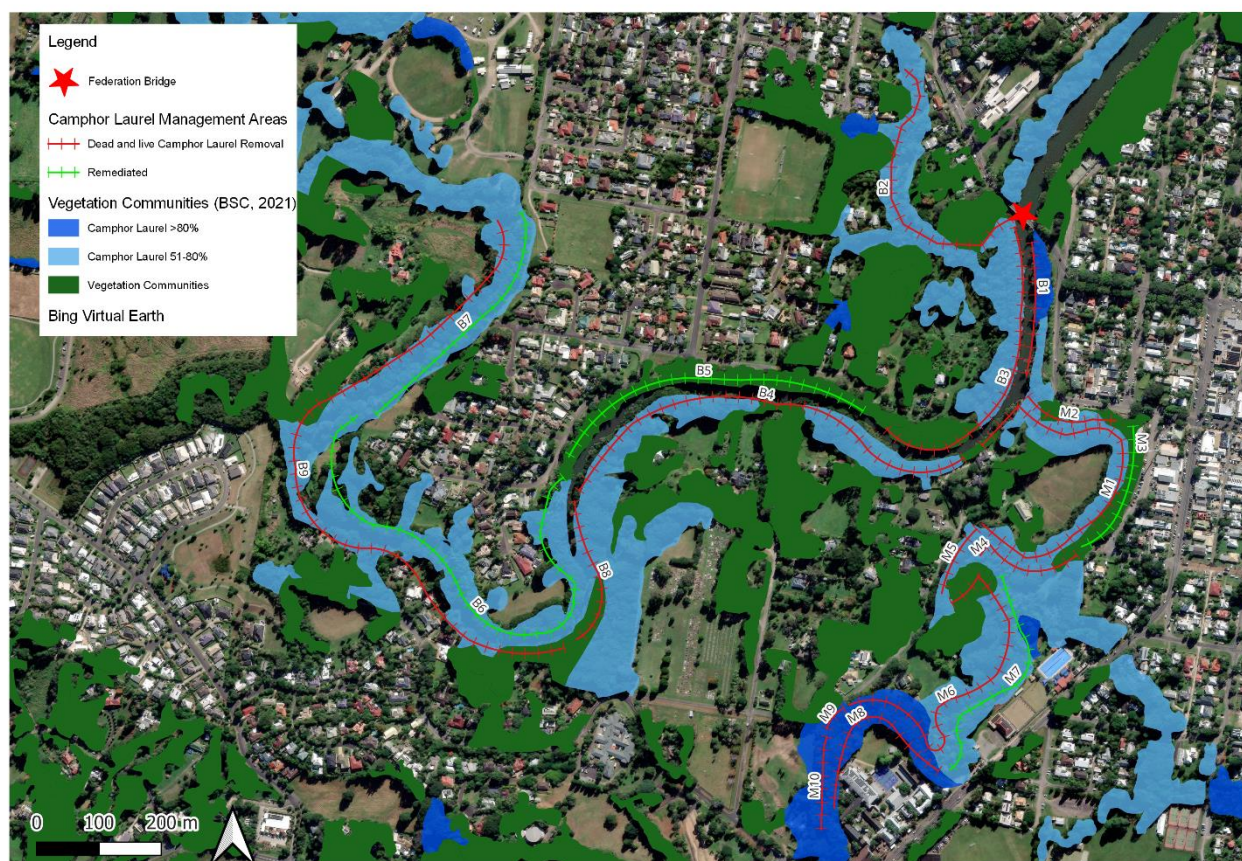
The following figure shows areas upstream of Federation Bridge of the proposed bush management areas that are likely to contribute to woody debris loads entering Brunswick River. Approximately 3.2km of the foreshore have been recently cleared of dead and selected live Camphor Laurel species (vegetation community layer is of 2021) by BSC Bush Regeneration Team. This option estimates a further 2.57km of remediation is required.

Figure 4.2 Option 3 Camphor Laurel Management Areas

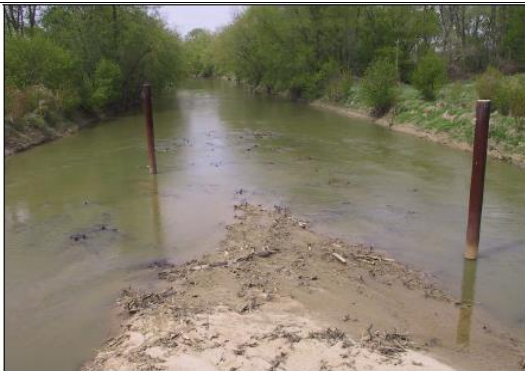
S.1	The Treibholzfange debris-detention device

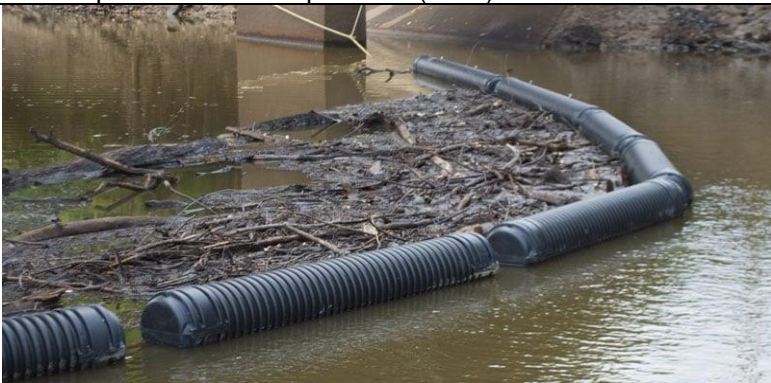
<p>U.S. Department of Transportation (2005)</p>
S.2	Debris booms

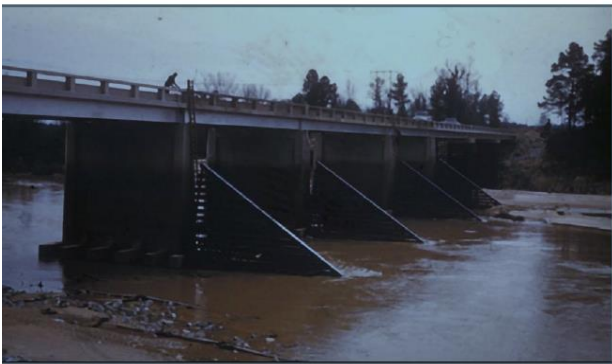
<p>https://www.elastec.com/products/floating-boom-barriers/trash-debris-boom/</p>
S.3	Debris fins

Option 1 Structural: Debris Fins	Score	Assessment
Financially Responsible		
Opinion of Initial outlay / Capital costs	1	Circa \$1,000,000 Assumes structural works are required to reinforce the Bridge due to the age and condition. Assumes 2 concrete fins on middle piers (where debris tends to accumulate) are constructed. Environmental impact assessment, heritage assessment and bridge condition assessments, river flow assessments will be required prior to any design works and construction.
Opinion of operational costing (30 year scenario)	3	Circa \$900,000 Due to the skew of the bridge and reports from existing debris fins, clearing and maintenance will likely be required. (Sheeder and Johnson, 2008 cited by Bridge Engineering Center, 2012).
Funding Potential	1	TfNSW is the asset owner of Federation Bridge and is responsible for the operational maintenance. Additional structural elements which increase maintenance cost will likely not be funded by TfNSW, due to their asset maintenance programme and the priority given to Federation Bridge in the region.

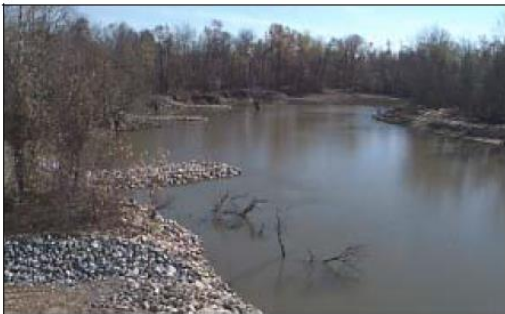
<p>U.S. Department of Transportation (2005)</p>
S.4	River training structures

<p>Figure 5.41. Bendway weirs on outer bank of Hatchie River looking upstream (TDOT).</p> <p>U.S. Department of Transportation (2005),</p>
S.5	Debris sweeper

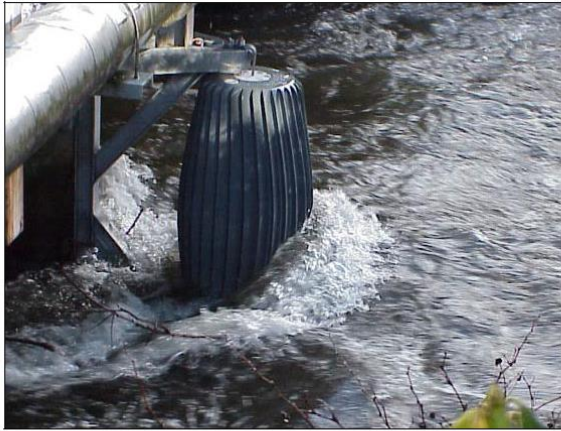
<p>Figure 5.45. Close up of a debris sweeper installed on the Cedar Creek in Washington.</p>

Option 1 Structural: Debris Sweeper	Score	Assessment
Financially Responsible		
Opinion of Initial outlay / Capital costs	2	Circa \$500,000 Assumes minimal structural works are required to reinforce the bridge. Assumes 2 sweepers middle piers (where debris tends to accumulate) are constructed. Environmental impact assessment, heritage assessment and bridge condition assessments, river flow assessments will be required prior to any design works and construction.
Opinion of operational costing (30 year scenario)	2	Circa \$1,500,000 Ongoing maintenance is required to ensure sweepers continue to rotate freely; any debris interfering with debris sweepers may worsen debris build up. (Bridge Engineering Center, 2012).
Funding Potential	1	TfNSW is the asset owner of Federation Bridge and is responsible for the operational maintenance. Additional structural elements which increase maintenance cost will likely not be funded by TfNSW, due to their asset maintenance programme and the priority given to Federation Bridge in the region

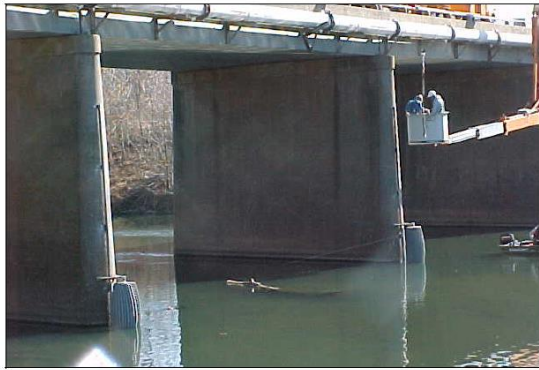
<p>Figure 5.44. Debris sweeper being installed on a bridge over Staunton River in Altavista, Virginia.</p> <p>U.S. Department of Transportation (2005)</p>
S.6	Debris deflectors

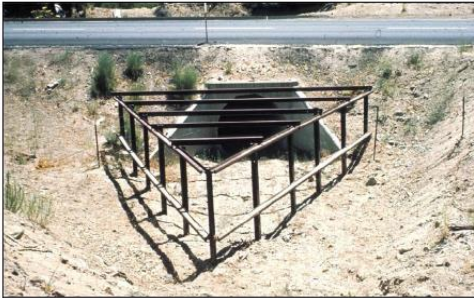
<p>Figure 5.2. Steel rail debris deflector (looking downstream).</p> <p>U.S. Department of Transportation (2005)</p>

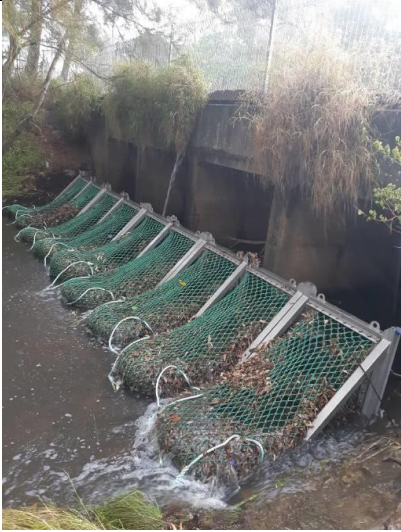
S.7	Trash racks

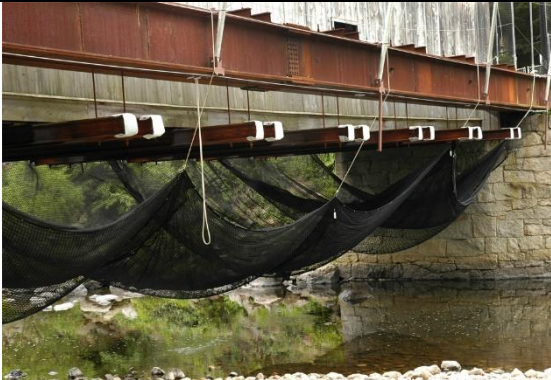
<p>(Red City Bulletin, 2020)</p>
S.8	Furling / Net

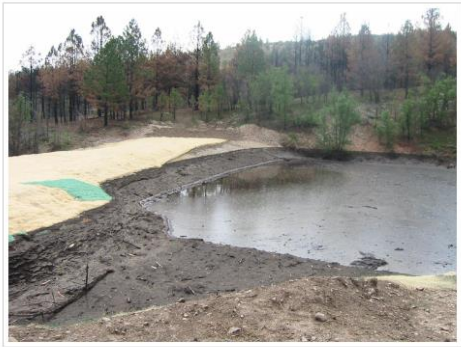
<p>(Protect Construction, 2022)</p>
S.9	Debris retaining basin

S.9	Debris retaining basin		<p>X</p> <p>Not widely applied and usually used as an option of last resort for large volumes of debris in larger rivers. Due to the volume of the debris observed under Federation Bridge and the relatively small width of Brunswick River at Federation bridge, this option is not technically suitable.</p>		<p>No</p> <p>Not effective due to the volume of debris and width of Brunswick River</p>
S.10	Bridge pier adjustment	<p>X</p> <p>Bridge pier adjustment will require costly major structural works.</p>		<p>X</p> <p>Works will require lengthy bridge closures causing</p>	<p>No</p> <p>Impacts on local residents due to bridge closures</p>
