# Planting

## Small Steps to Healthier Roadsides

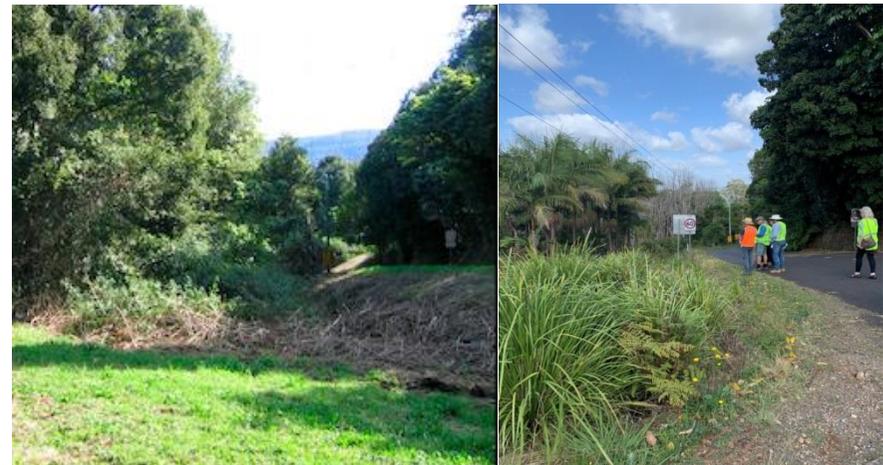
1. Modification of the headwater of Byrangerry creek (Figure)

**Figure .** Byrangerry creek headwater before (left) and after (right) planting. (Source: B. Cameron, 2017 and K. Love, 2019)

Working in conjunction with Council, Essential Energy and the Environmental Trust, Goonengerry Landcare initiated and completed a planting in 2017 along the roadside and at the headwater of Byrangerry Creek (Figure..). Utilising restoration techniques, they have maintained the roadside planting, successfully reducing maintenance and the use of herbicide over time.

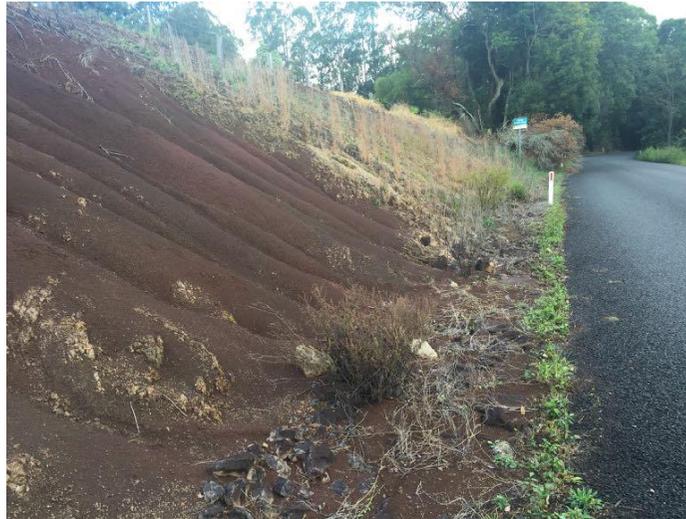
2. A steep bank cutting to enable the road up-grade and associated drainage (Figure ).

**Figure ..** Road cutting on roadside (Source: B. Cameron, 2017)

However, germination of the grass seed failed, leading to soil erosion, weed infestation and clogging of the table drain. This resulted in an increase in exotic species, siltation across the road and slip and subsidence on adjacent properties and road pavements.

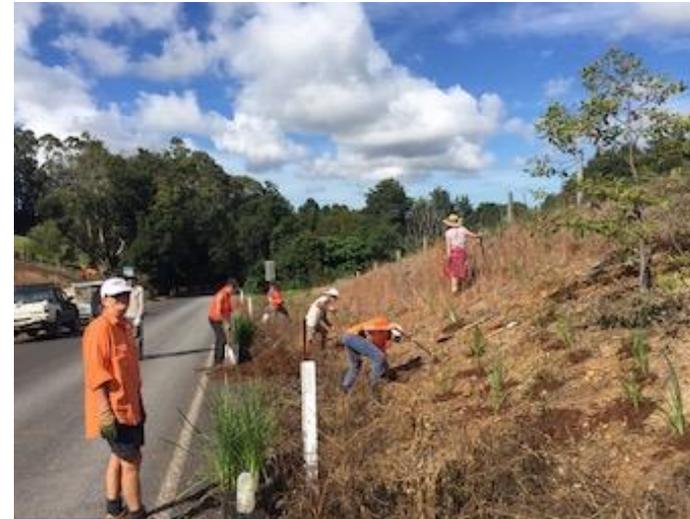
**Figure ..** Roadside planting on cutting by Goonengerry Landcare (Source: B. Cameron, 2017)

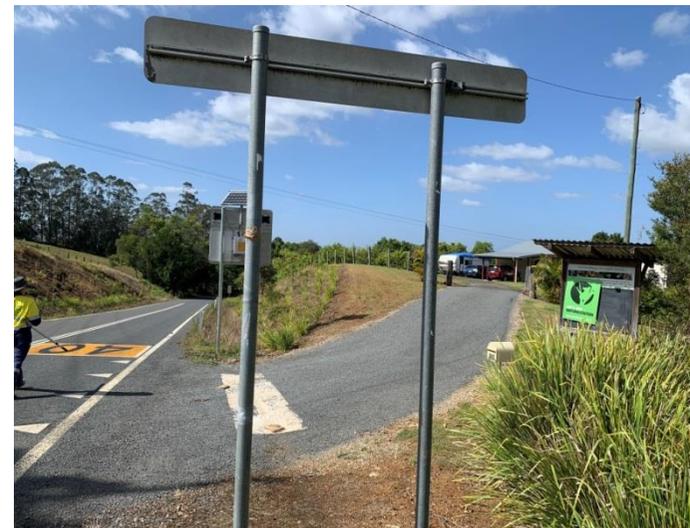
**Figure..** Successful planting on road cutting (Source: K.Love, 2019)
