# Byron Shire Council

## Buildings Asset Management Plan

DRAFT

October 2019

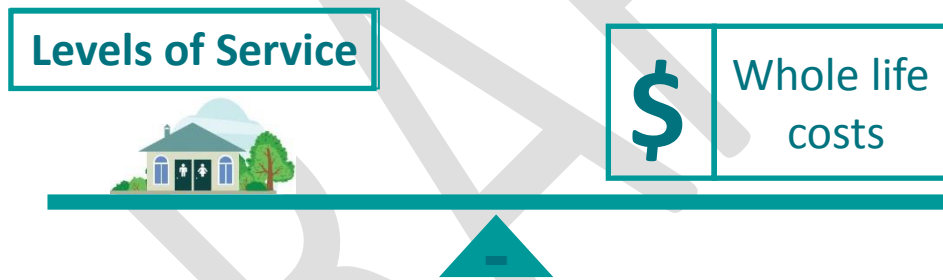
Figure 1 Asset Management simplified

*Asset Management needs to balance Levels of Service  
and  
whole of life cycle costs.*

This asset management plan aims to meet the required levels of service in the most cost-effective way for present and future communities (Figure 1).

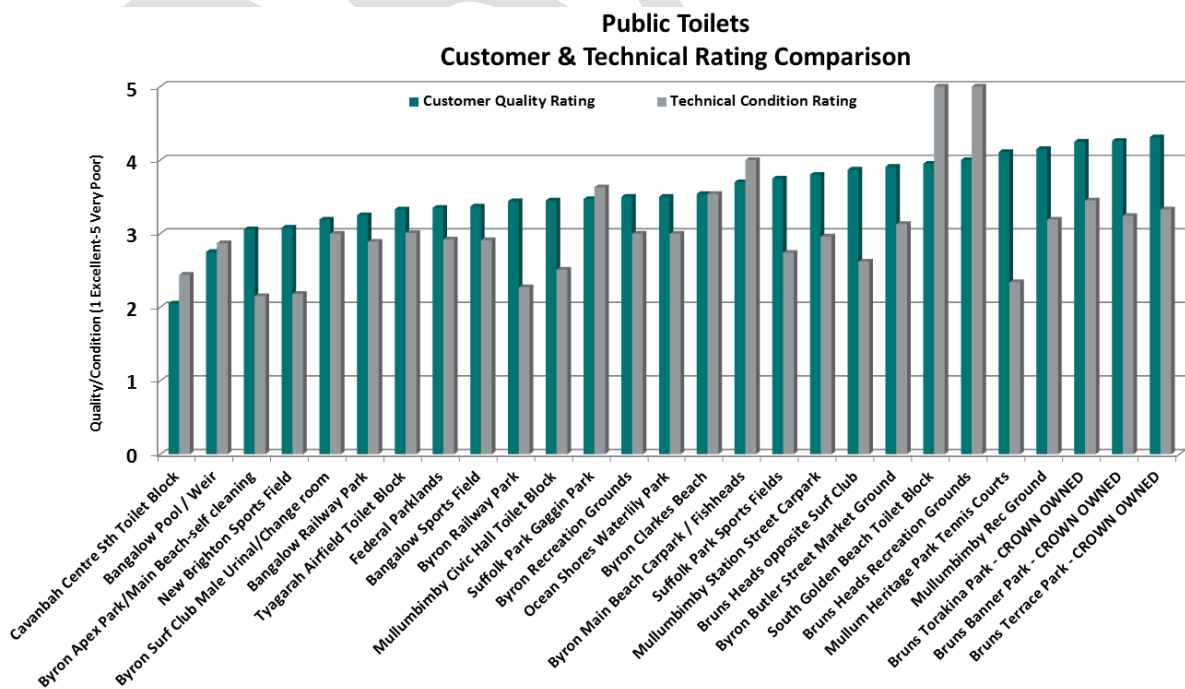
Figure 6 Customer & Technical Rating Comparison

The public toilet average ratings were compared. The average customer quality was rated at **3.6** and technical condition at **3.0**, refer to Figure 6. This indicates that the community expects a higher level of service than Council provides. This is also relevant in terms of the survey feedback in which respondents listed many requirements including: no graffiti, baby change tables, paper towels, hand dryers, soap, single sex toilets as opposed to multi-use cubicles, and no stainless steel toilets without seats that are unpleasant in winter. The responses indicate the community prioritises renewed modern and clean toilets above more toilets.

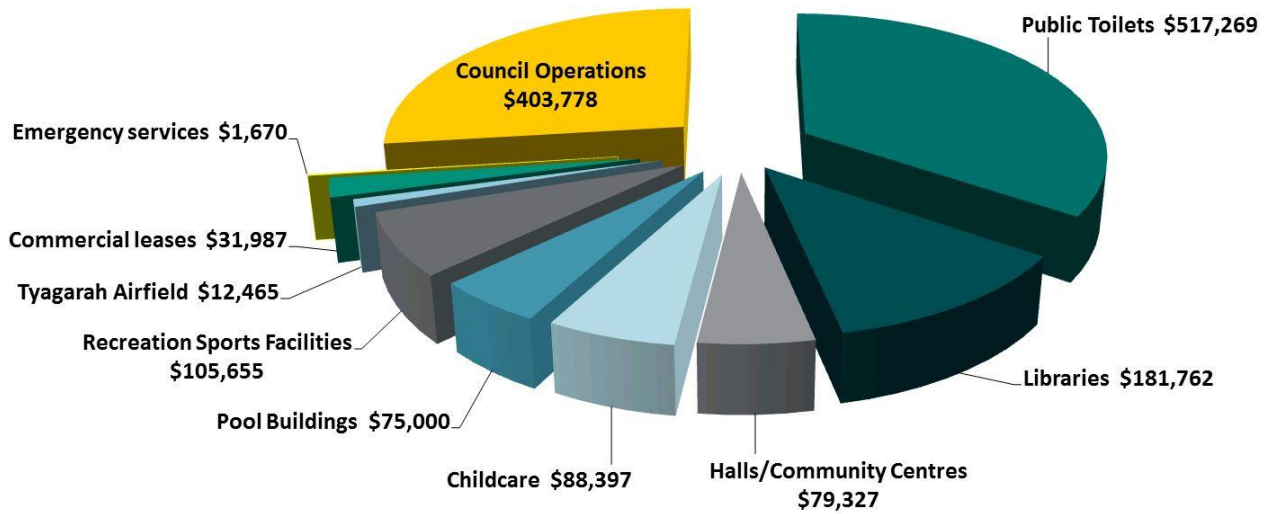
Figure 15 Buildings Operations & Maintenance Actuals 2017/18

Figure 15 details the actual expenditures of building operations and maintenance. Notably public toilets account for nearly half the expenditure due to the high operational cleaning costs as perviously detailed in Table 11.

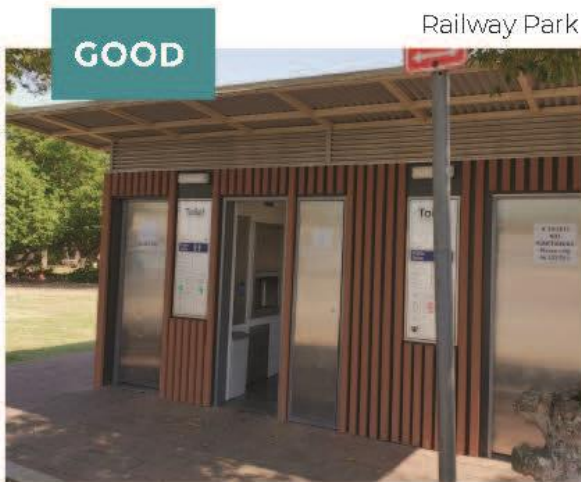
- ➔ **GOOD** (e.g. Railway Park Byron Bay) - 19%
- ➔ **FAIR** (e.g. Mullumbimby Civic Hall Park & Brunswick Heads The Terrace.) - 63%
- ➔ **POOR** (e.g. Clarkes Beach Byron Bay) - 19%
