28 July 2023  
Ref No: 13/2023

**Contamination Summary Planning proposal over the former District War Memorial Hospital Site, Azalea Street, Mullumbimby**

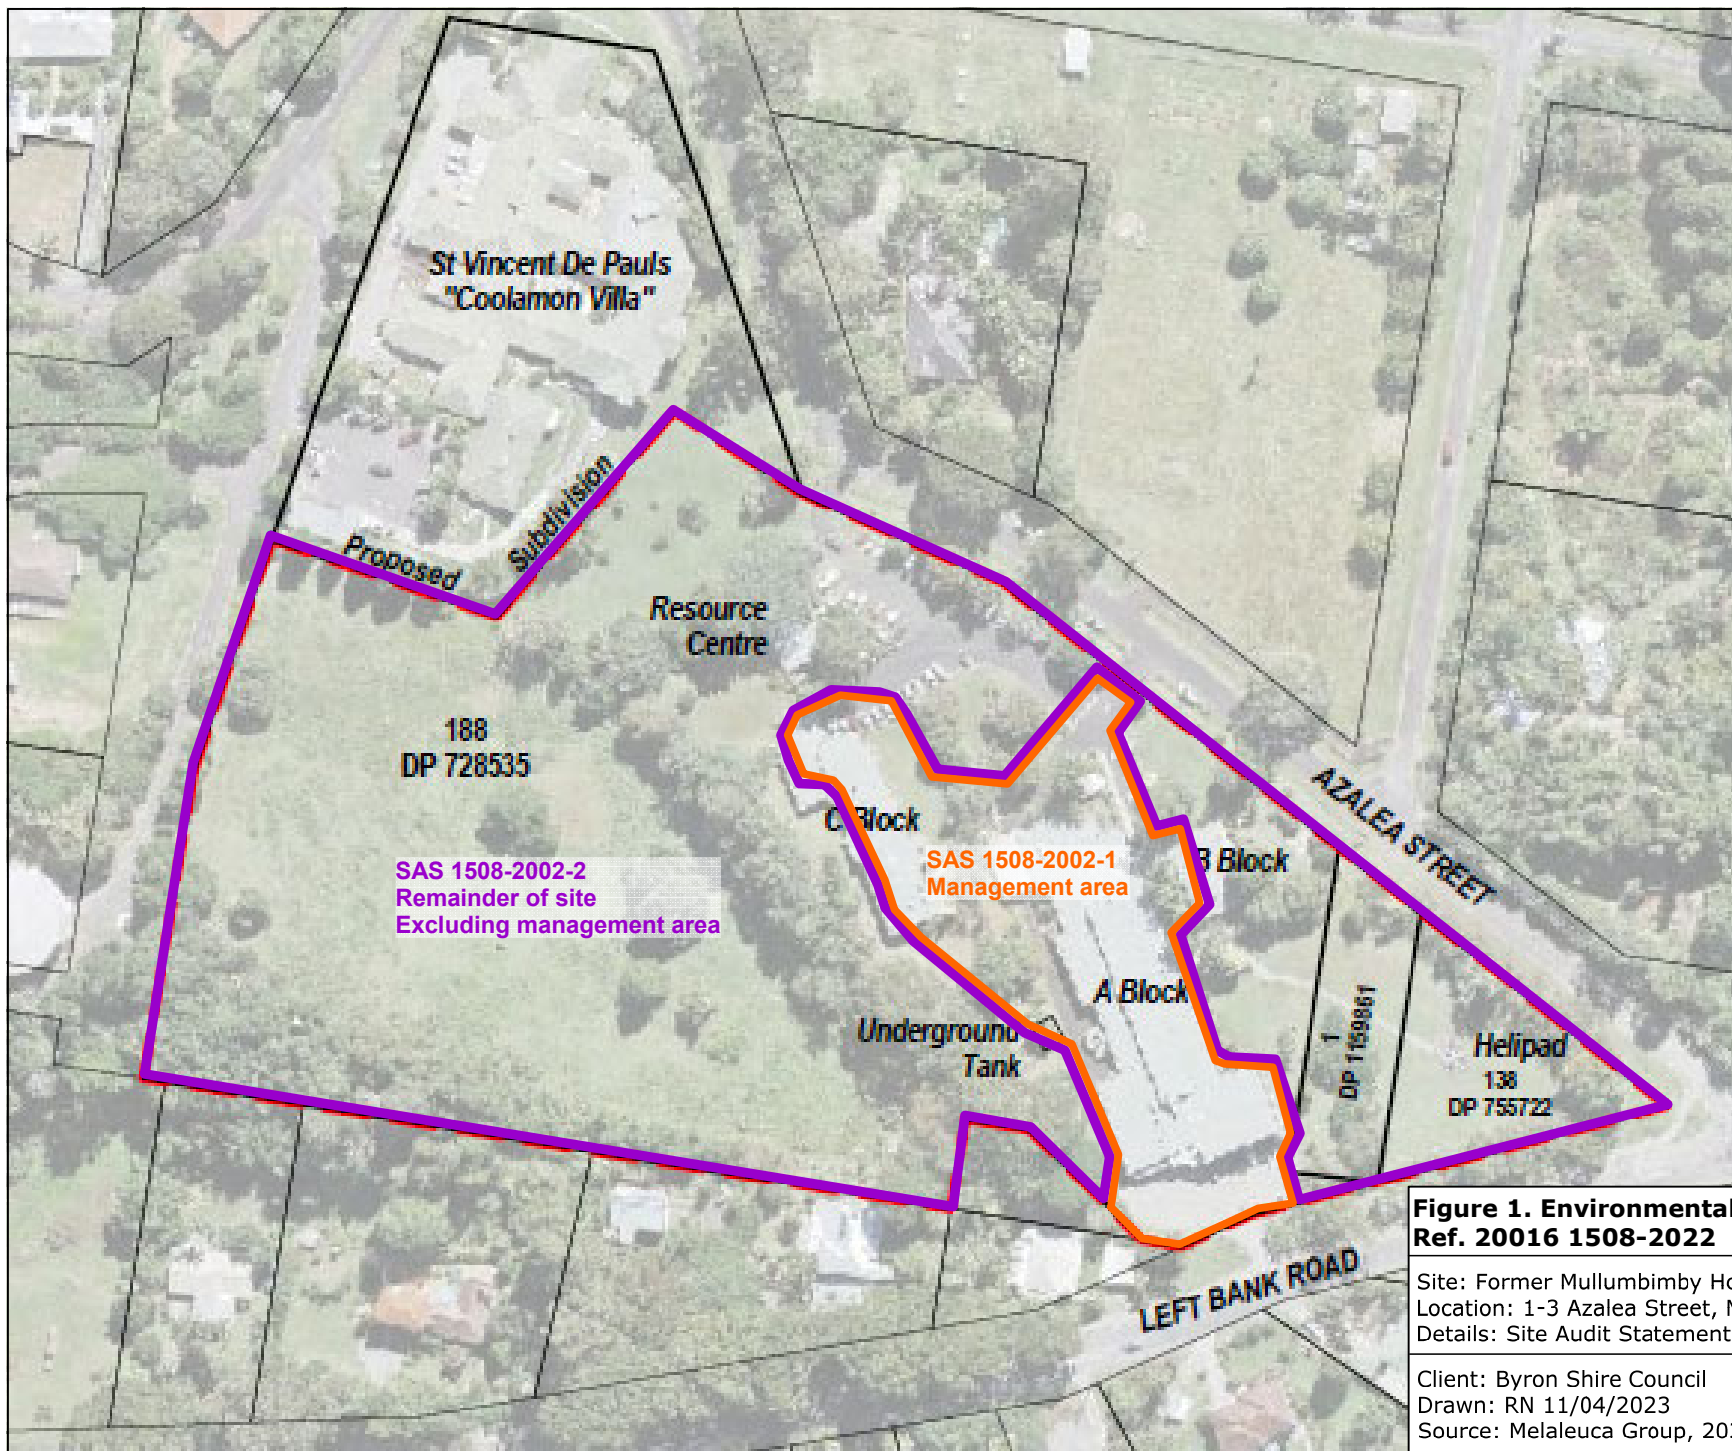
**Figure 1      Environmental Management Area**

- Management area boundary
- Remainder of site boundary

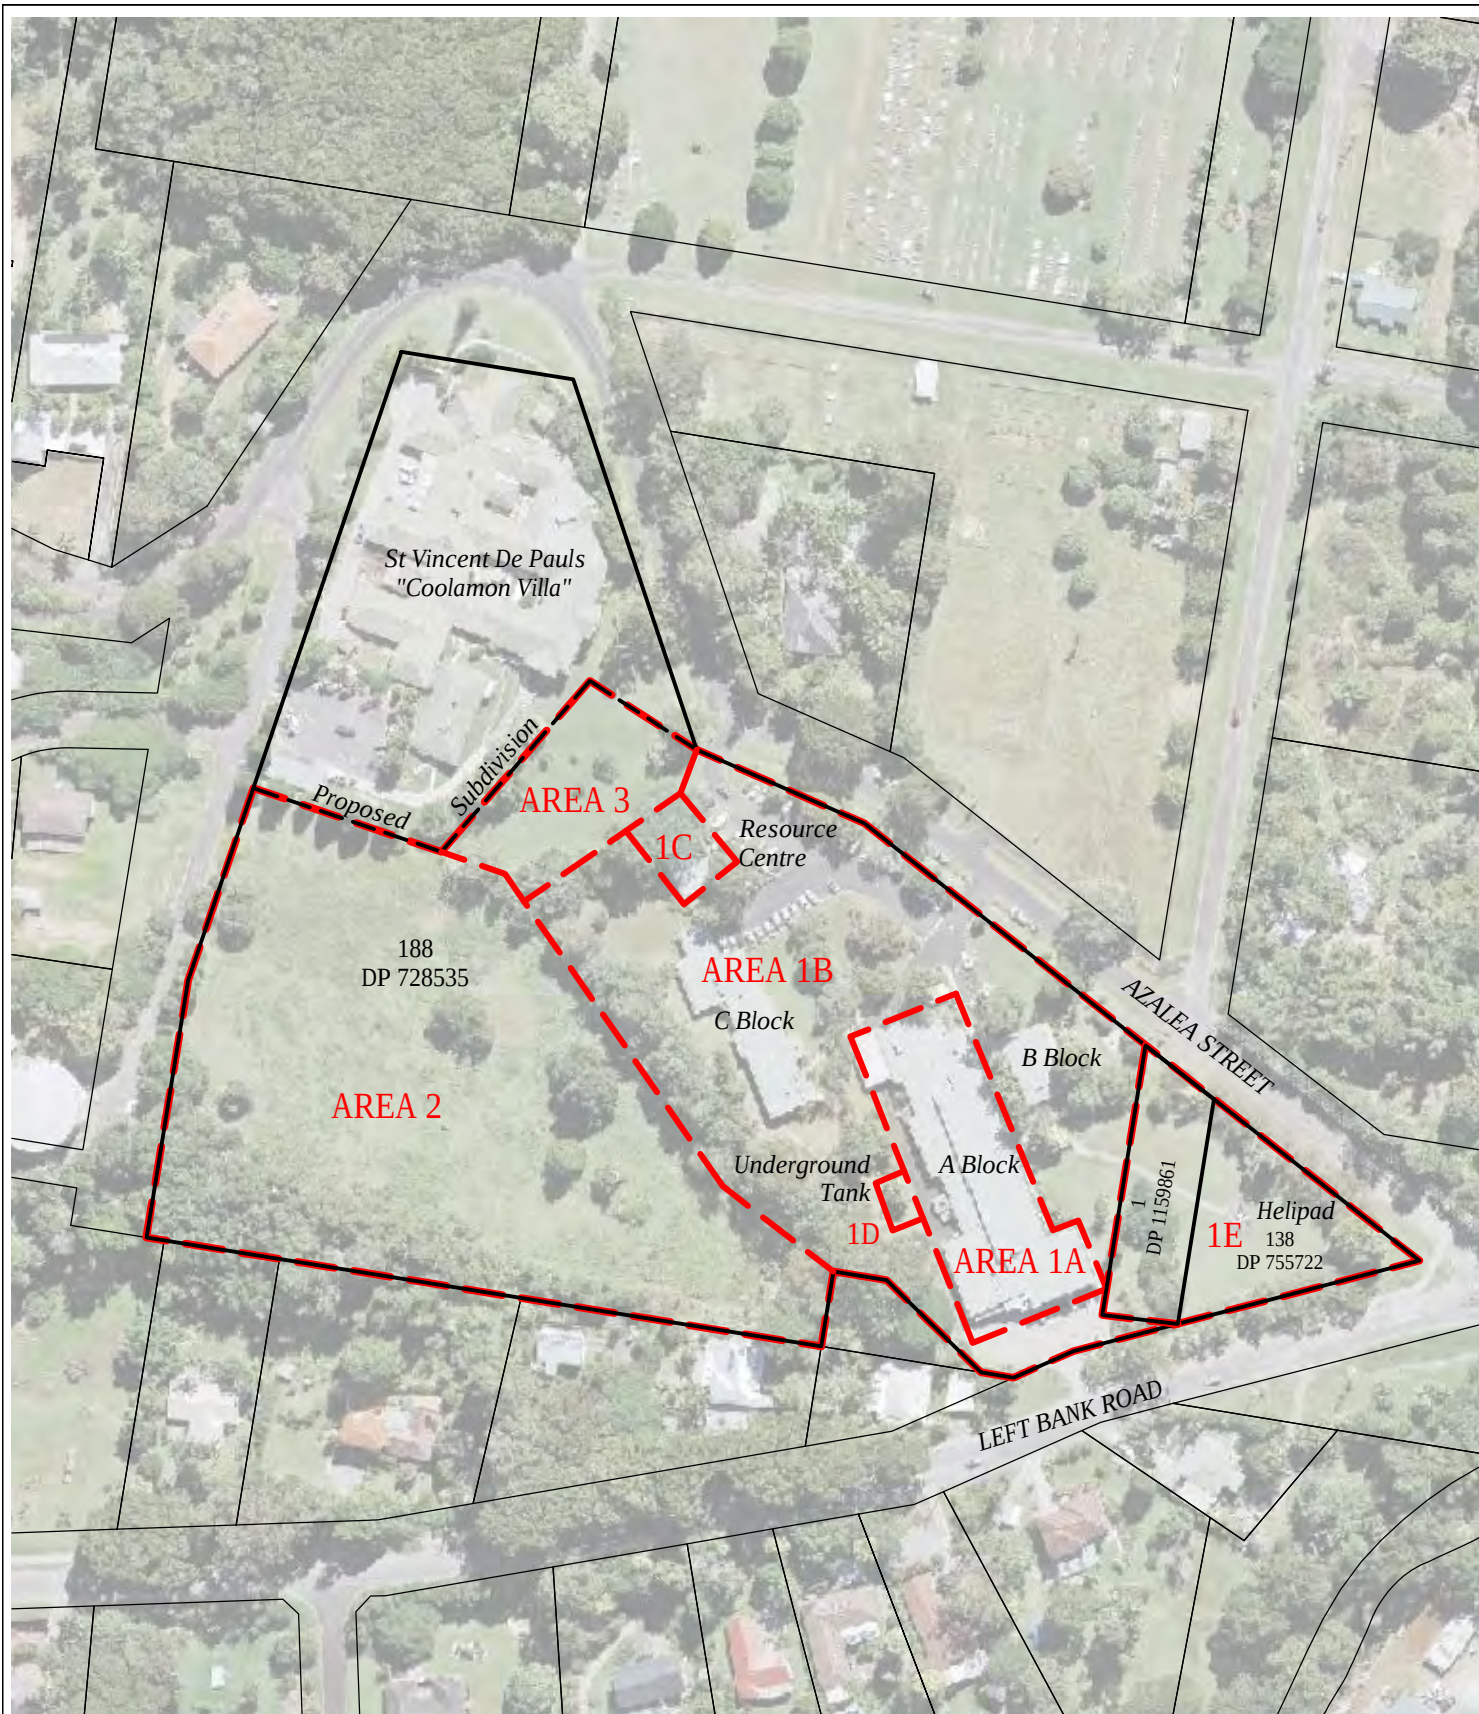
**Figure 2      Investigation Areas (Melaleuca 2020)**

----- INVESTIGATION AREAS

To assist the reader with interpretation of the site, the Consultant divided the site into the following areas:

- Area 1A: A Block building footprint;
- Area 1B: B Block;
- Area 1B: C Block;
- Area 1B: Remaining area surrounding Hospital buildings;
- Area 1C: Resource Centre Area;

- Area 1D: Former underground storage tank area (adjacent to A Block footprint);
- Area 1E: South-eastern portion of site including former Helipad
- Area 2: Western section of Lot 188 DP 728535, former vacant land;
- Area 3: Coolamon Villa Orchard area.

The areas of the site are shown on Melaleuca Group 2020 (see **Figure 2**).
