Natural burial ground site suitability

A brief investigation of the suitability of two sites, Vallances Rd Mullumbimby and Clunes cemetery, for use as natural burial sites based on their soil characteristics.

Prepared by Stephanie Alt, Give Soil a Chance, Principal consultant.

6 August 2022

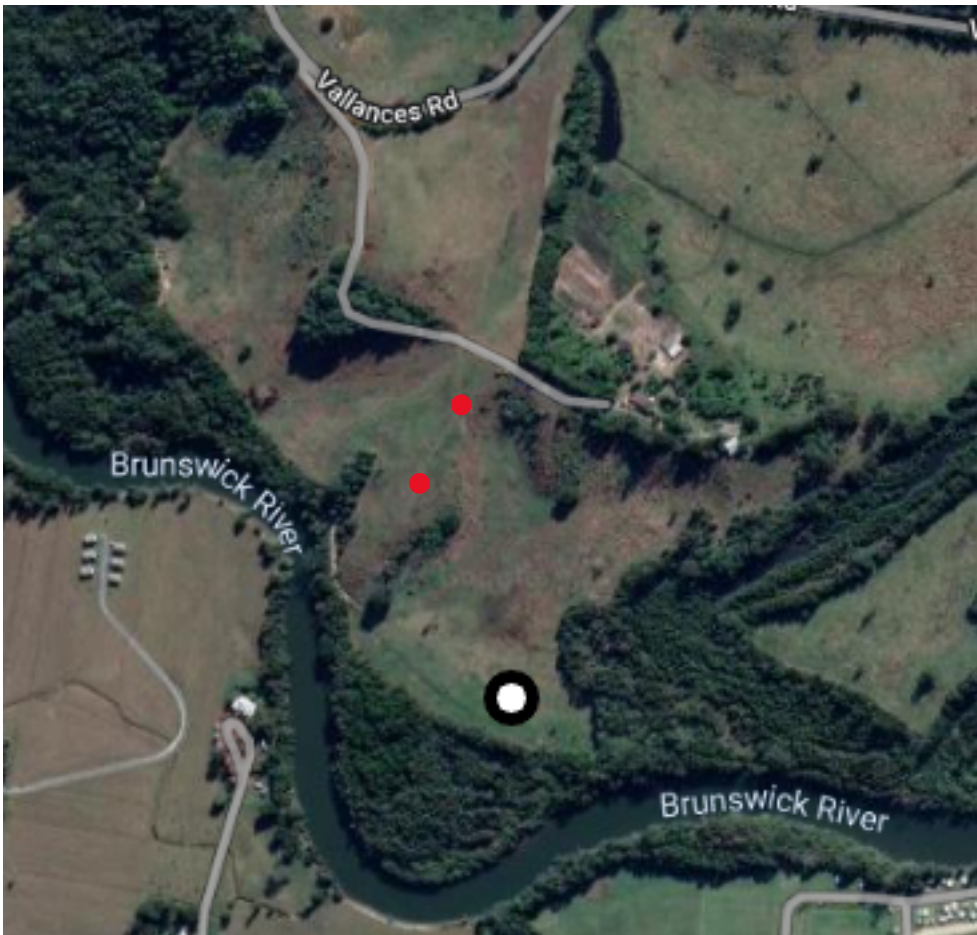
The Vallances Rd site proposed for a natural burial ground is a ridgetop north of Mullumbimby, with an outlook over the town. The property slopes steeply from the ridge down to a floodplain of the Brunswick River. Only a small proportion of the site is elevated with low slope. Two soil pits were investigated on the ridgetop, shown in figure 1. Soil pit 2 was at an elevation approximately 1 m below soil pit 1.

Figure 1. The Vallances Rd site is adjacent to the Brunswick River. The location of soil pits are marked with red spots. The white spot indicates the location of a previous soil investigation obtained from the NSW Land and Soil Information System (1004002).

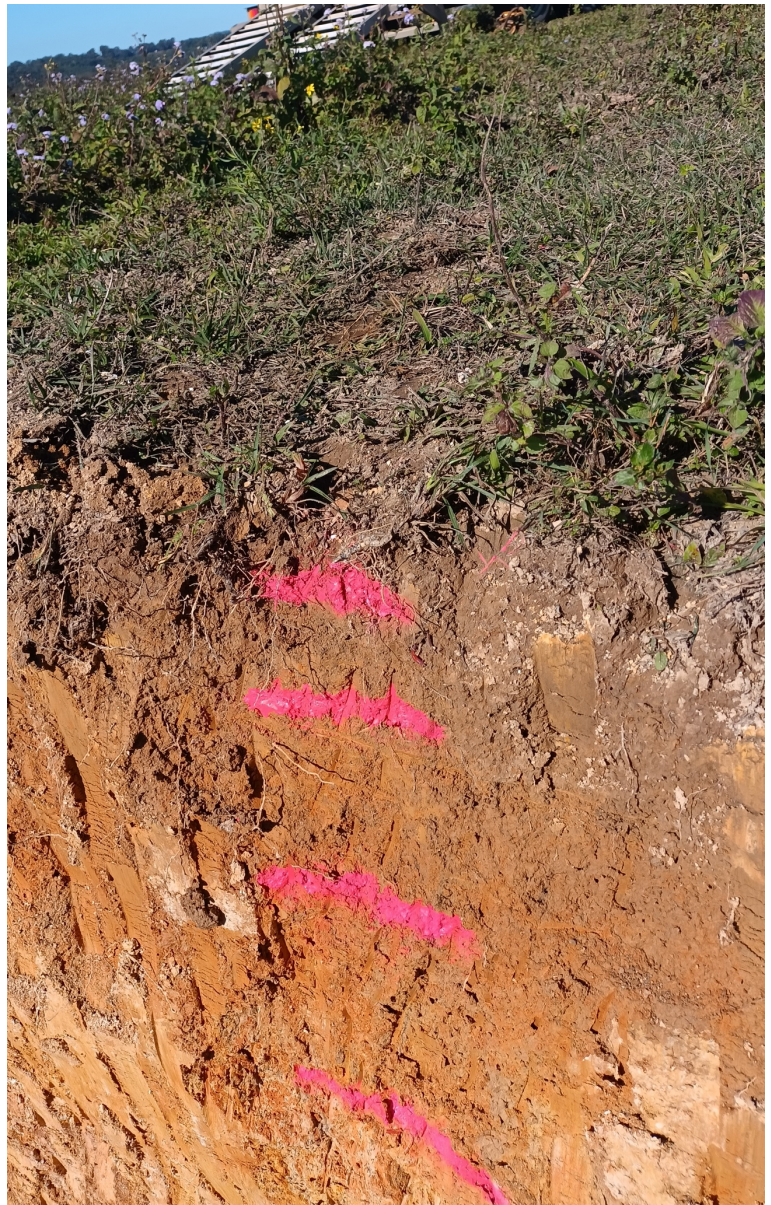
SOIL PIT 1

The soil pits were 2.2 m deep. The soil material below 0.8 m was hard, proving difficult for the 5t excavator to dig. The sides of the pits were smooth clay with no visible pores. Plant roots were confined mainly to the upper 10 cm, with very few roots to 70 cm. No permanent water table was observed within the pit depth. Soils were in moist condition at the inspection with approx. 1 week since last rainfall. Water infiltration into the soil was extremely limited. Coloured mottles in the clay from 8 cm indicate anerobic conditions prevail within the soil.

Horizon A1

Structure: Weak pedality, peds 2–5 mm, sub-angular blocky, earthy.

Infiltration: not tested, no visible porosity, more constrained than A1, likely to be very poor.

Upper bound: 65 cm Lower bound: Possible boundary to C2 at 120 cm or could be continuous C1 to base of soil pit at 2.2m

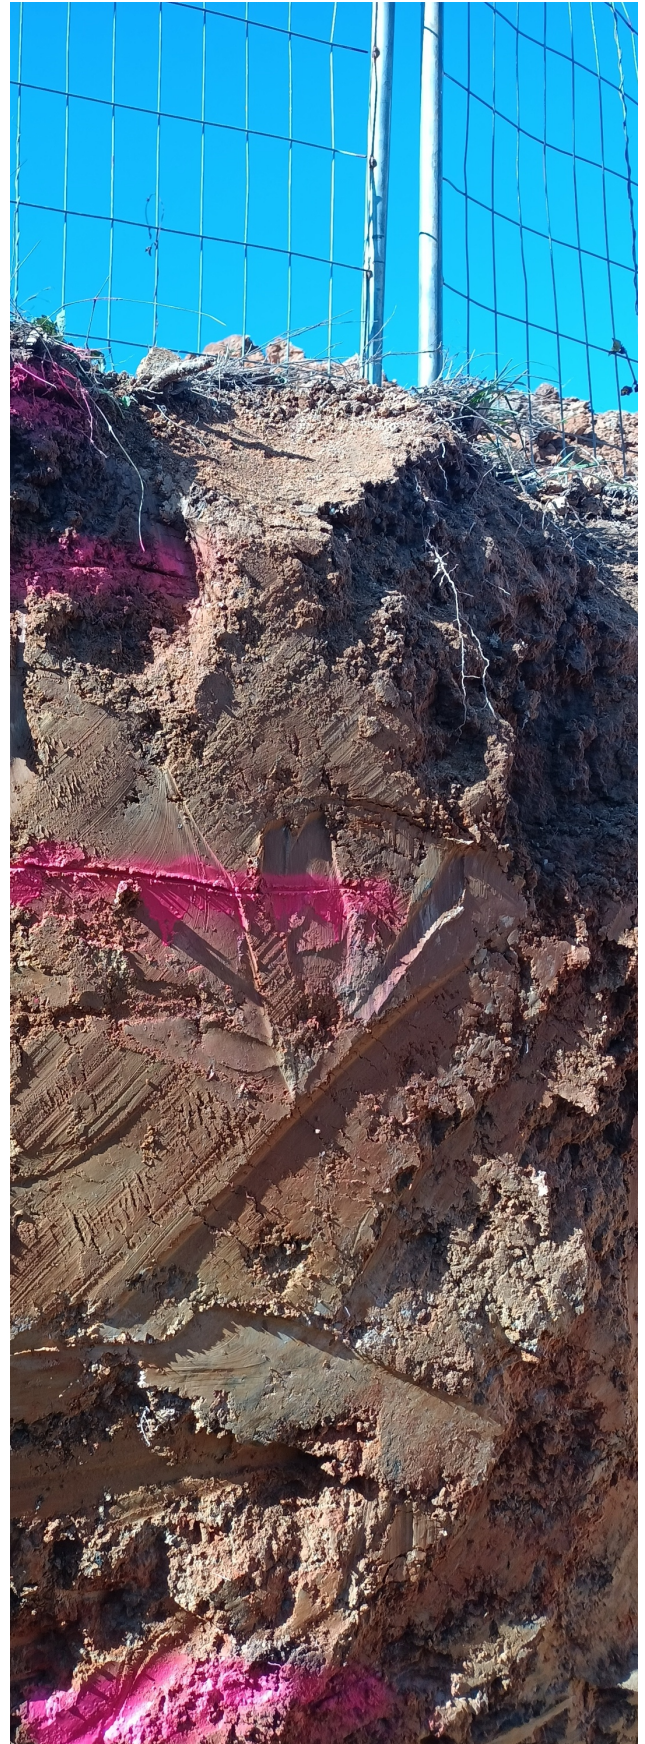
SOIL PIT 2

Horizon A1

Structure: moderate pedality, peds 5–10 mm, granular, earthy.

Colour: red-brown in moist condition, with mottles

Upper bound: 45 cm Lower bound: continues to base of pit at 2.2m

Colour: orange-grey in moist condition with mottles

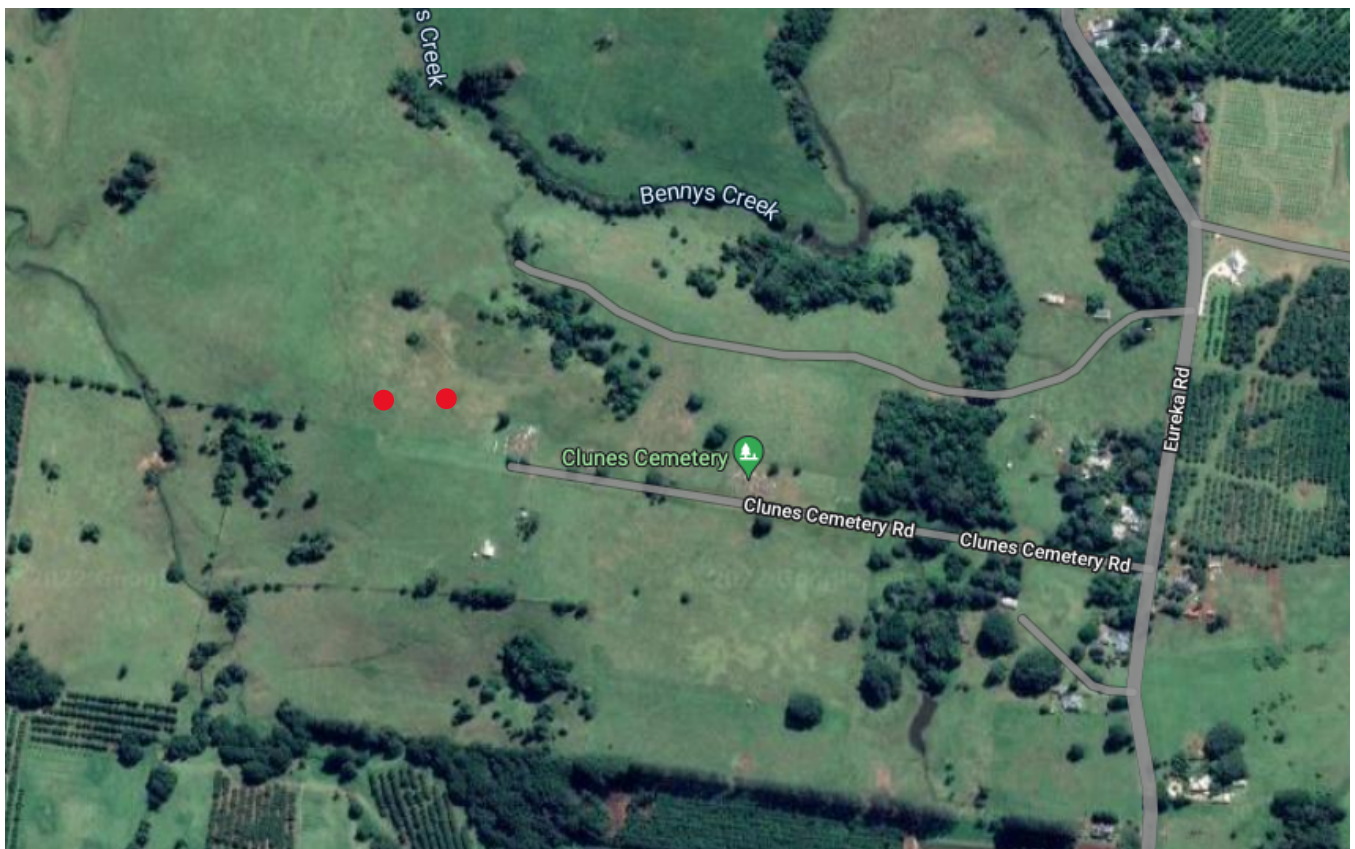
The site at Clunes is a ridgetop sloping gently to the north, adjacent to an existing traditional cemetery. Soil pit 2 was at an elevation approximately 2 m below soil pit 1.

Figure 2. Location and surrounds of Clunes cemetery site. Soil pits are indicated with red dots.

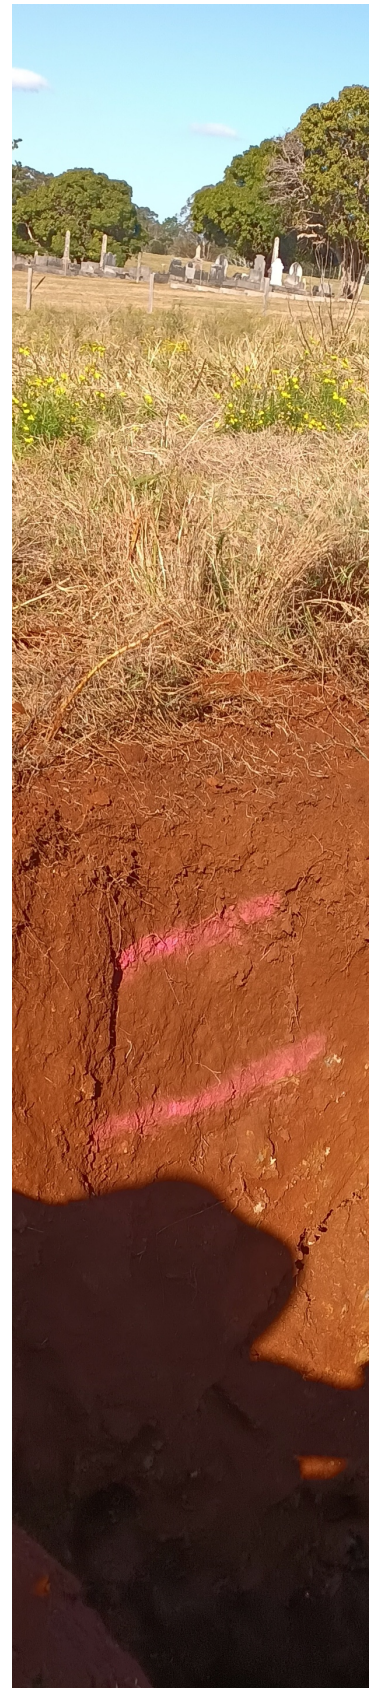
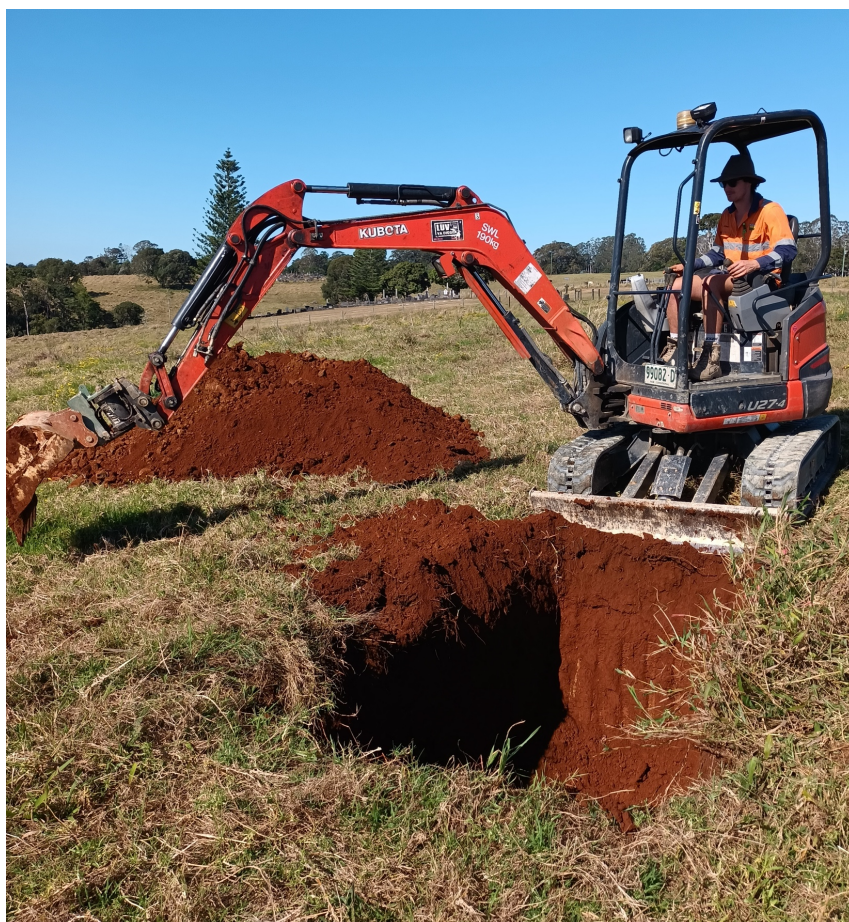
SOIL PIT 1

The soil pits were 1.8 m deep. The soil material was easy for the 5t excavator to dig. The sides of the pits were coherent with earthy fabric and visible pores. There were dense plant roots throughout the upper 15 cm, with some roots to the base of the pits.

Soils were in moist condition at the inspection with approx. 1 week since last rainfall. Topsoil appeared high in organic matter. Water infiltration into the topsoil was limited but at depth was good. The presence of weathered basaltic core stones below 40 cm and the absence of mottles indicates aerobic conditions prevail in the subsoil. No permanent water table was observed within the pit depth.

Structure: Strong pedality, crumbly, peds 2–5 mm crumbs, earthy, self-mulching at the surface

Infiltration: Poor, 15 minutes to infiltrate 150 mL water via the infiltrometer. Note that soil structure indicates the potential for good infiltration, the current high level of soil moisture is likely to be impairing further infiltration at the time of testing.

Structure: moderate pedality, peds <2 mm, basaltic corestones present.

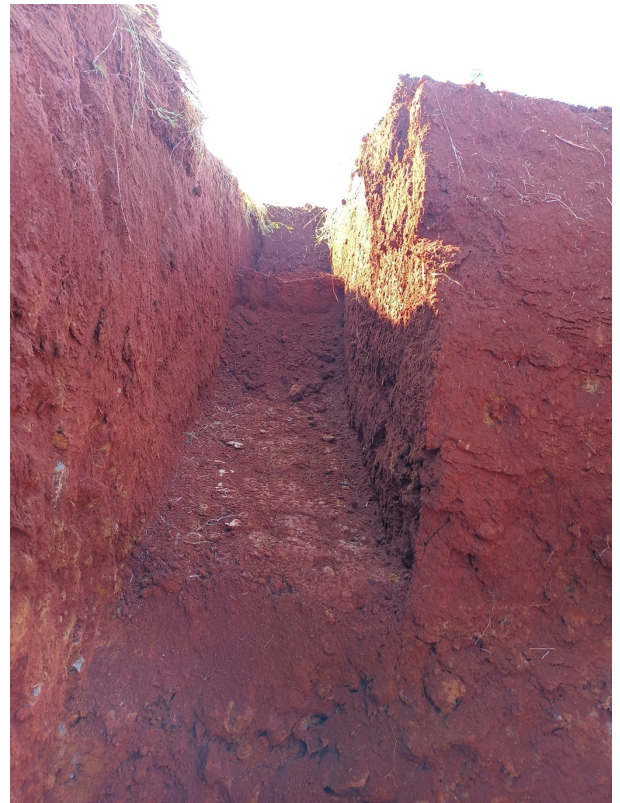
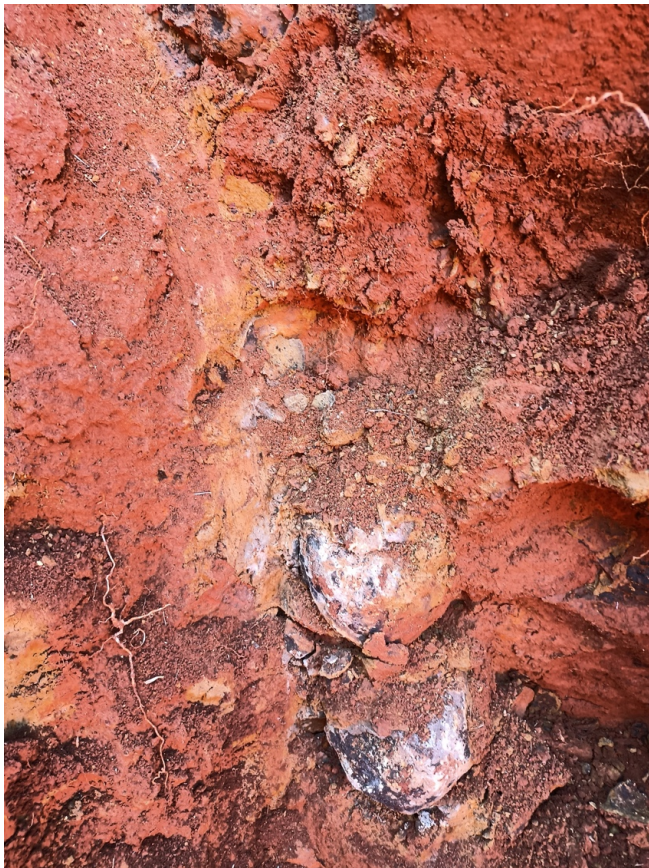
SOIL PIT 2

Structure: Moderate pedality, peds 5–10 mm crumbs, self-mulching at the surface.

Structure: strong pedality, peds 2–5 mm crumbs, rough-faced.

Structure: moderate pedality, peds 2–5 mm crumbs, rough-faced. Basaltic corestones present.

Infiltration: Good. At 45 cm and 120 cm depth, 7.5 minutes to infiltrate 500 mL of water via the infiltrometer. Radial saturation pattern to 10 cm around the infiltrometer tube perimeter.
