FORMER SOUTH BYRON  
STP TREATMENT PONDS  
**OPTIONS ASSESSMENT - DESIGN REPORT**

03 MAR 23

221573

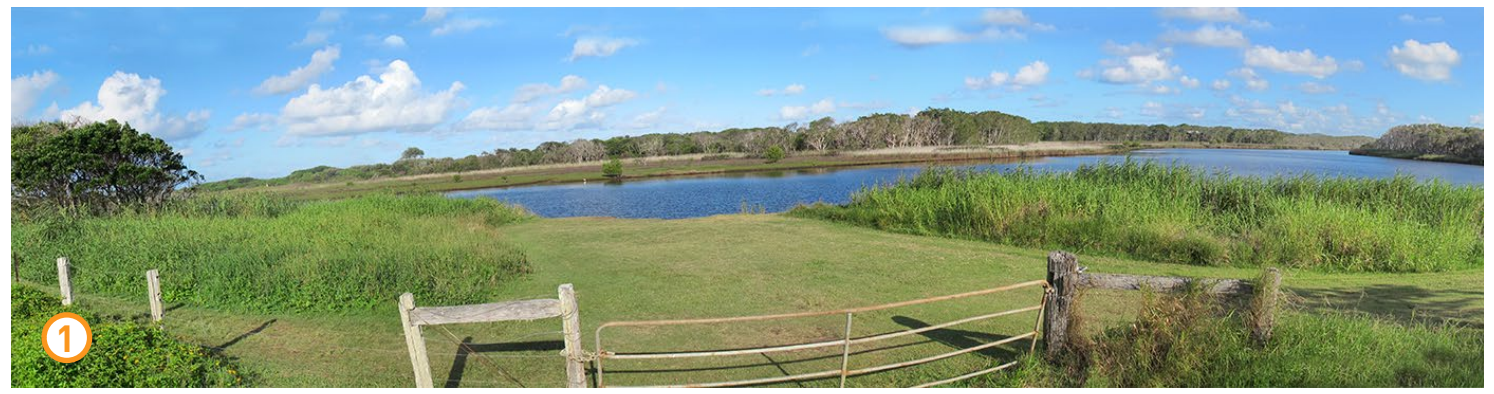
INTERFACE WITH TALLOWES CREEK

Areas between Tallows Creek and ponds are currently mown. This mowing regime should be reviewed along with defining revegetation areas and dog exclusion zones.

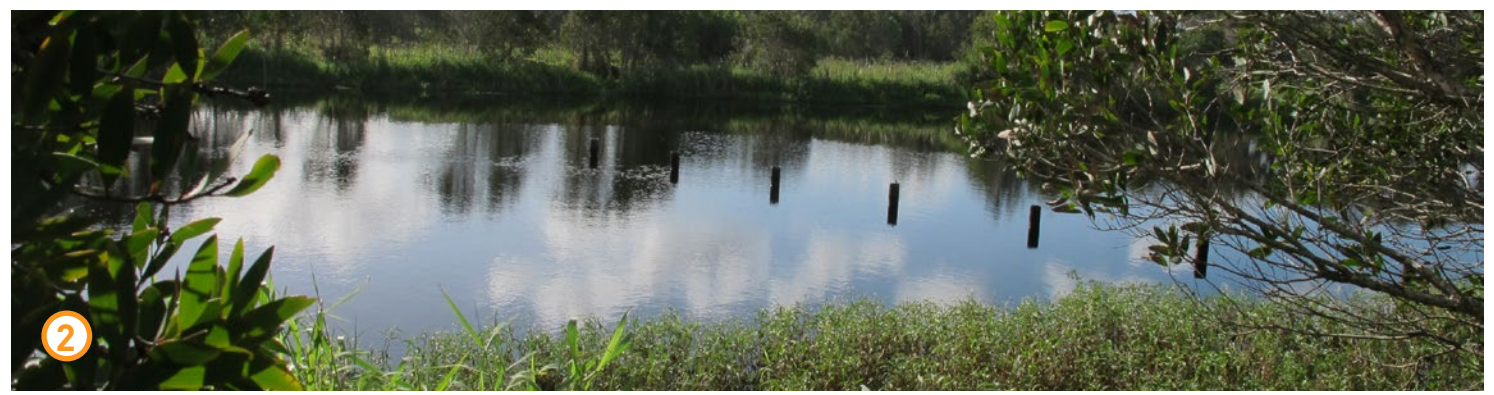
REMNANT INDUSTRIAL FEATURES

Upright pipes within the eastern cell could be retained as a reminder of the sites industrial past, Birds also frequent these pipes as perches, inclusion of more perches should be considered as a means of increasing habitat features.

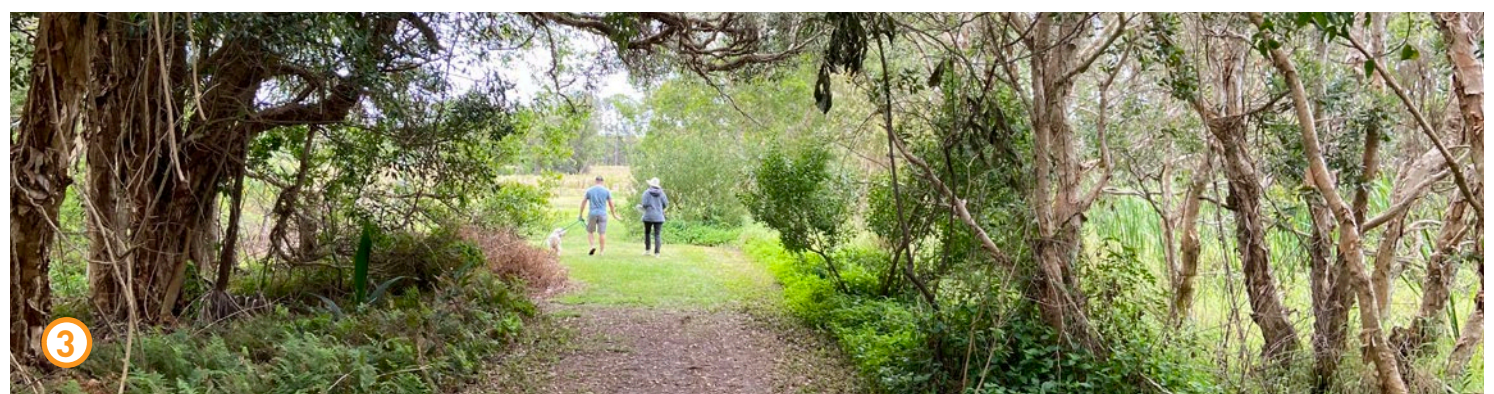
PERIMETER ACCESS

Provide direct access from Holiday Park on the western side of cells and restrict access along south and eastern side of the ponds, enforcing a dog exclusion zone here.

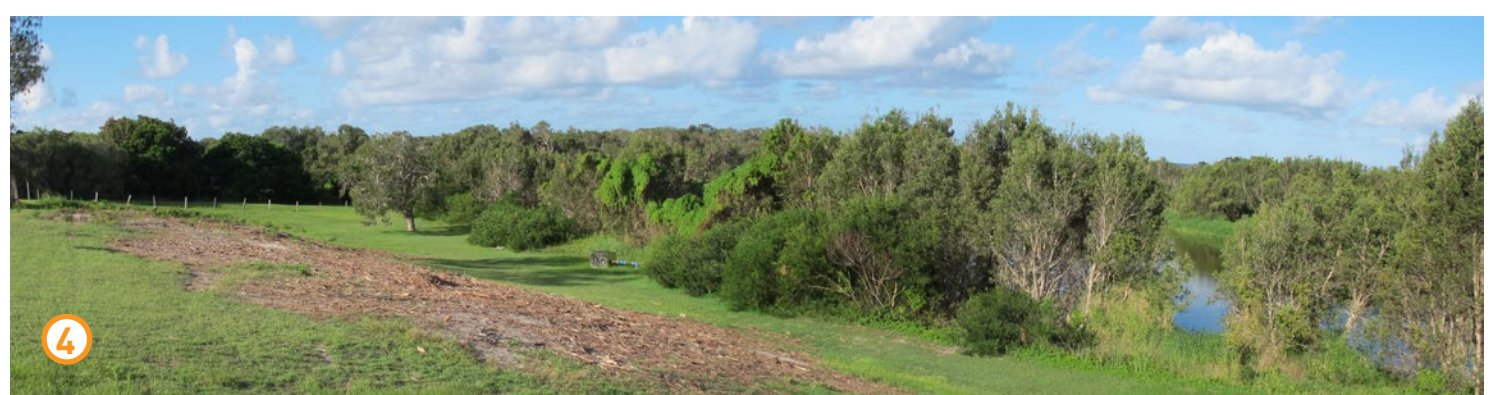
SIGNIFICANT VIEW-LINES

Height restricted plantings to be used to maintain view-lines.

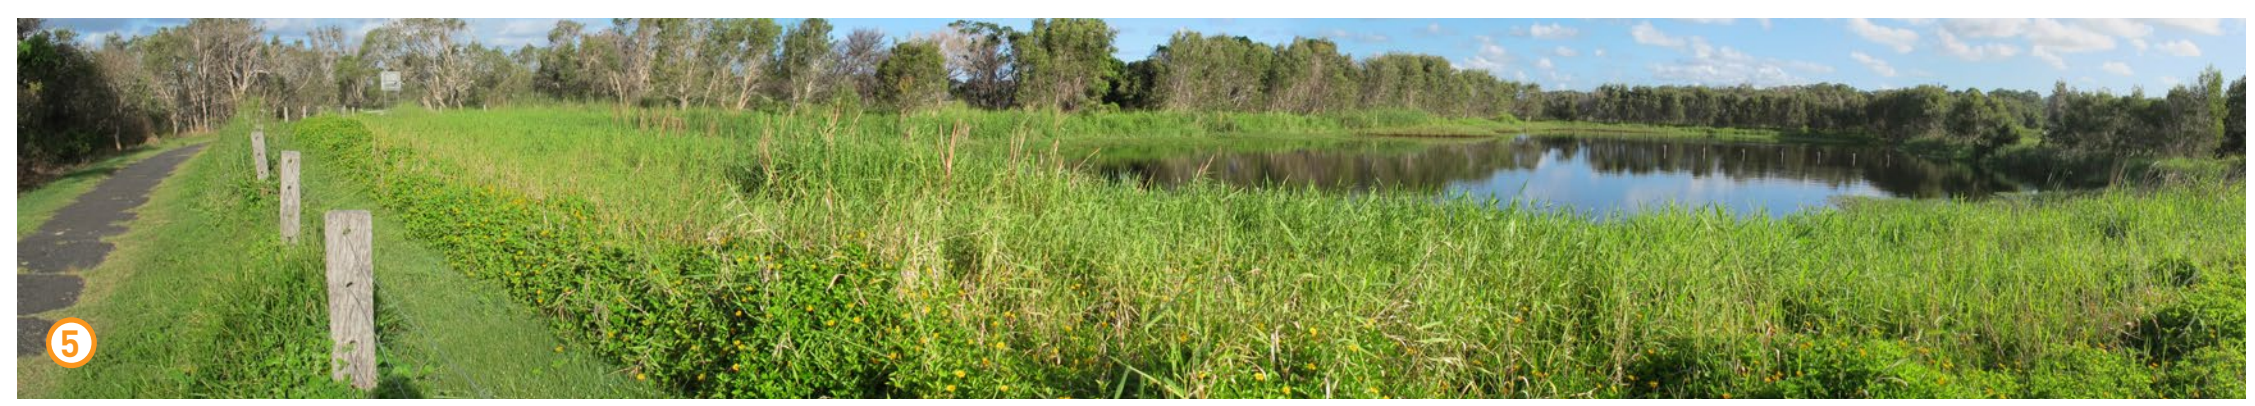
INTERFACE WITH EXISTING PATH

- Weed control
- Construct dog proof fence within vegetation
- Removal barb wire and retain posts as a feature
- Planting to strengthen vegetative barrier
- Construct safety bench
- Designated dog access point to Tallows Beach

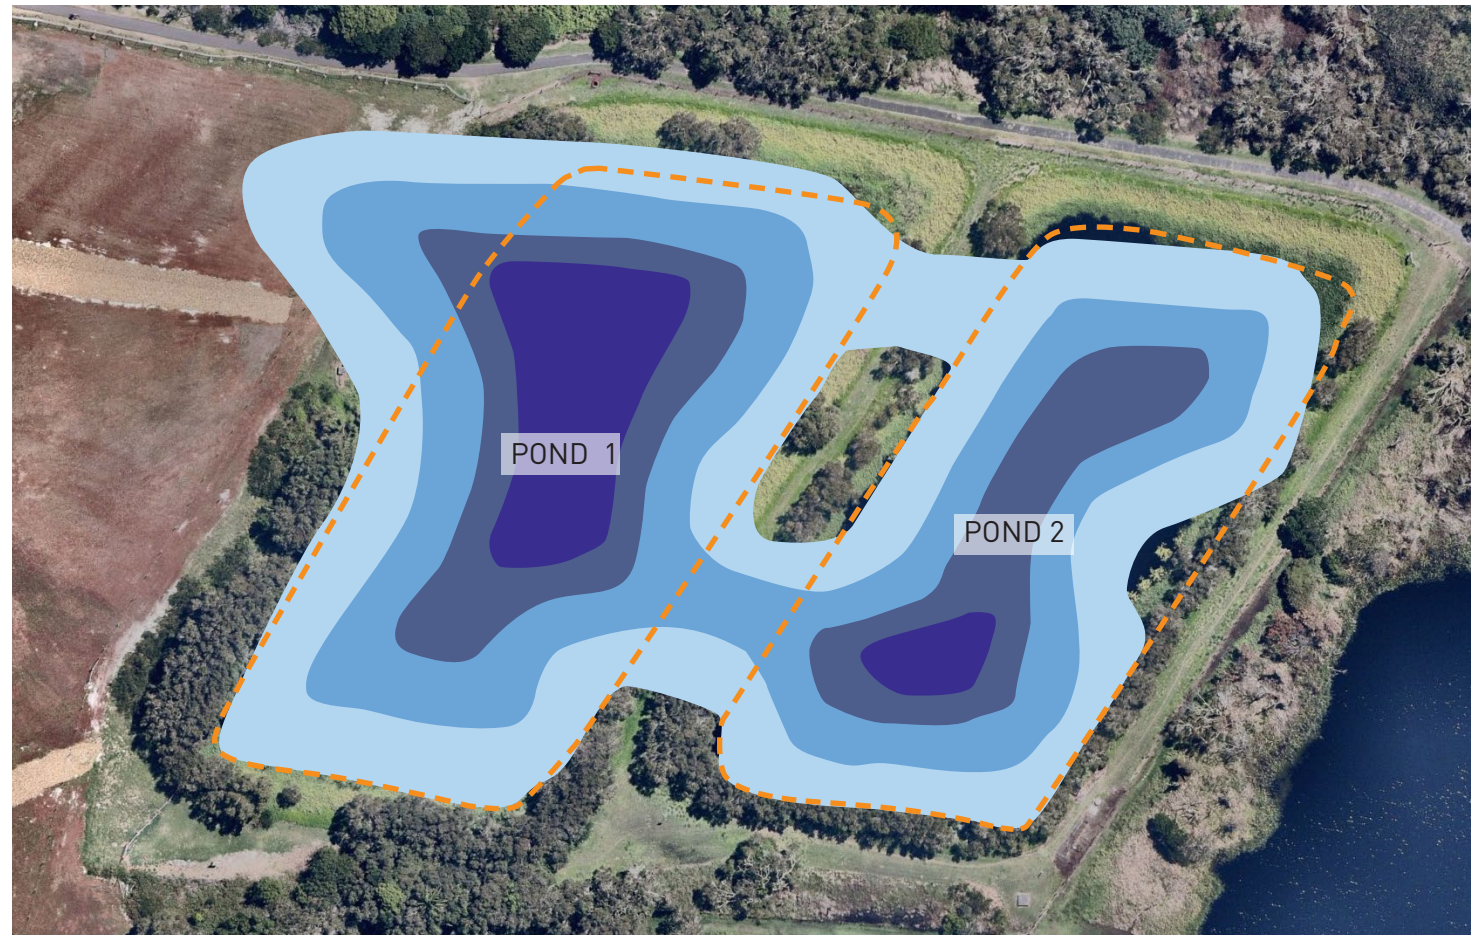
OPTION 1 - NATURALISATION OF PONDS PLAN

### OPTION 1 - NATURALISATION OF PONDS

The key drivers behind this option was to disguise the former treatment ponds into a more natural form, moving away from the unified form of the ponds.

- A cut and fill neutral ratio could be achieved by expanding the ponds extent and removing parts of the central bund.

- The process of reshaping the ponds would stir up contaminants that are currently dormant in sediments.
- Have significant impacts on fauna currently living within the ponds.
- The construction of this design would be challenging working within the pond to minimise impacts to surrounding vegetation.

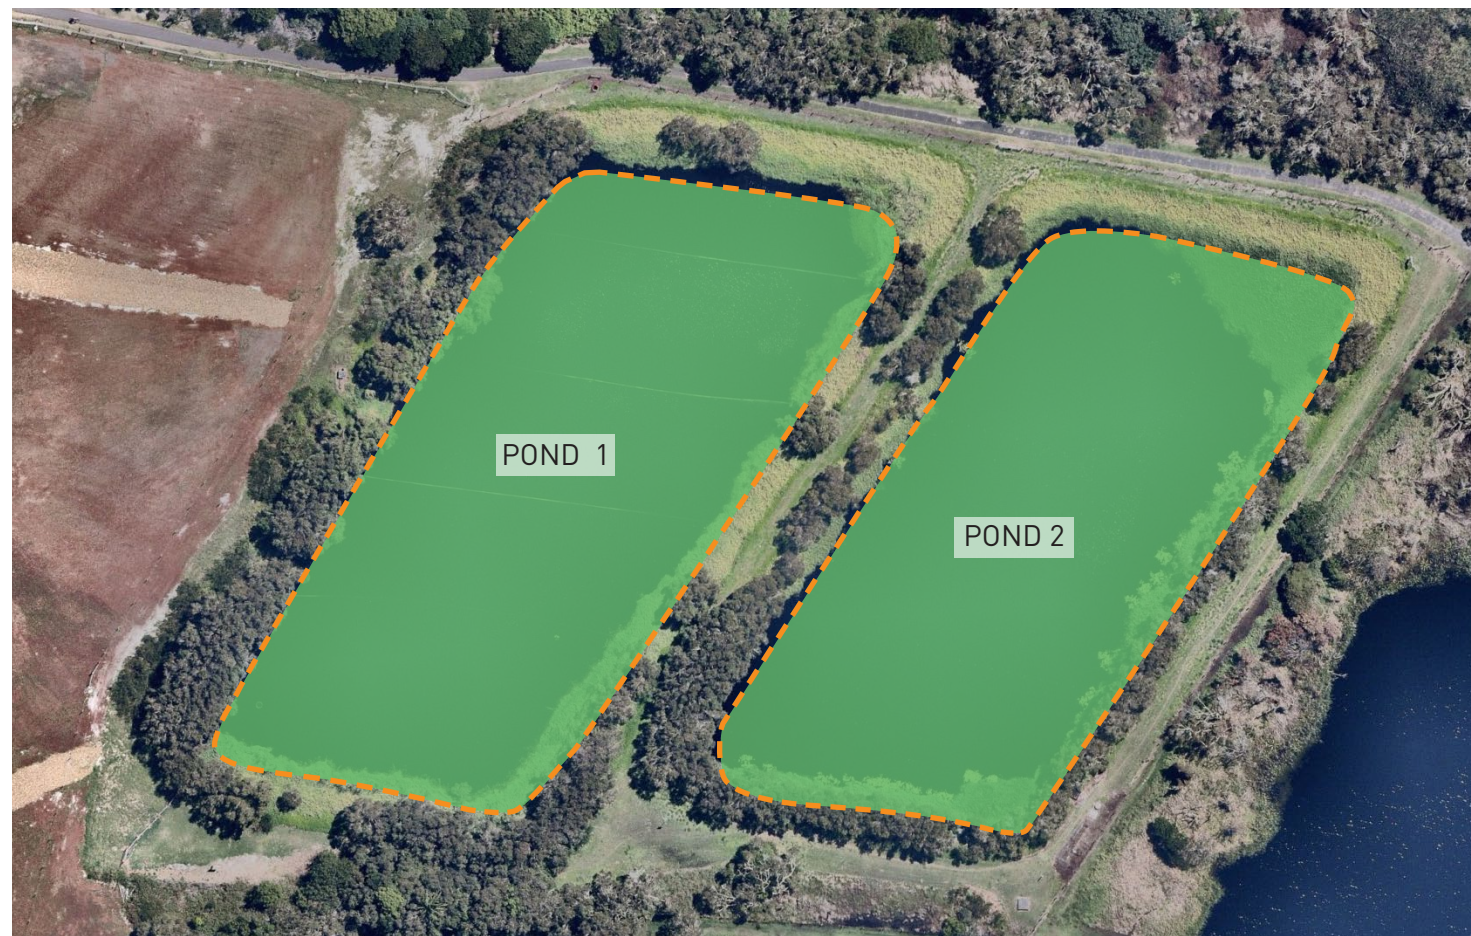
OPTION 2 - FILL POND AND RECLAIM LAND PLAN

### OPTION 2 - FILL POND AND RECLAIM LAND

An option to fill the ponds entirely was discussed early on in the process. This land could then be re-purposed for potential public use, as per the previously rehabilitated site upslope.

- Provide public space beside the Tallows estuary foreshore.
- Remove risk factor of people becoming sick from swimming in ponds.

- Massive impacts on fauna living in water bodies. Loss of a fresh water source for animals living in the vicinity.
- Impacts to the surrounding native vegetation.
- Extensive costs to truck and install fill from off site.
- Loss of bird viewing for local bird watching enthusiasts.

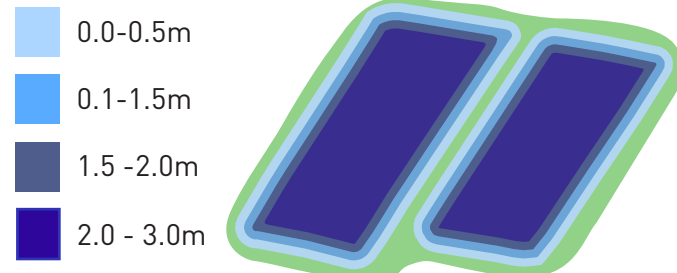
### WATERBODY BATHYMETRY

**Cell 1 - West**  
Area = 9600m<sup>2</sup>  
Volume = 24,000m<sup>3</sup>  
Calculation are approximate

**Cell 2 - East**  
Area = 8300m<sup>2</sup>  
Volume = 20,750m<sup>3</sup>  
Calculation are approximate

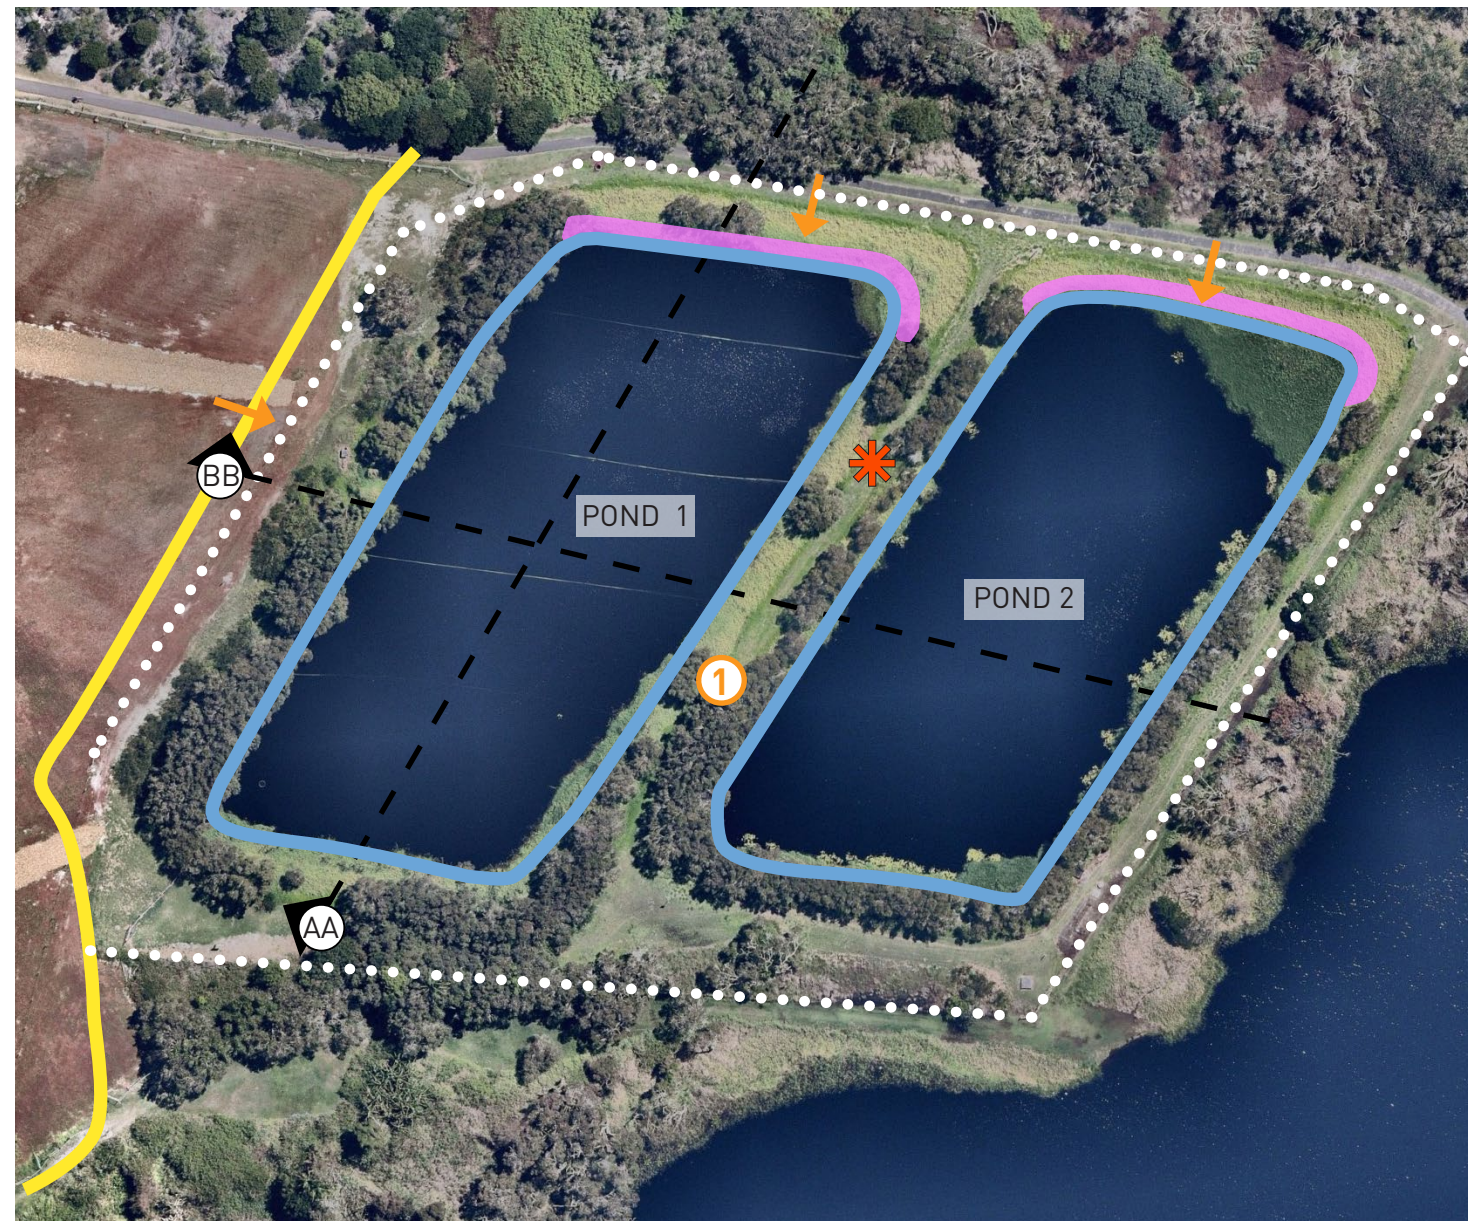
**POND 1 = 140m long**

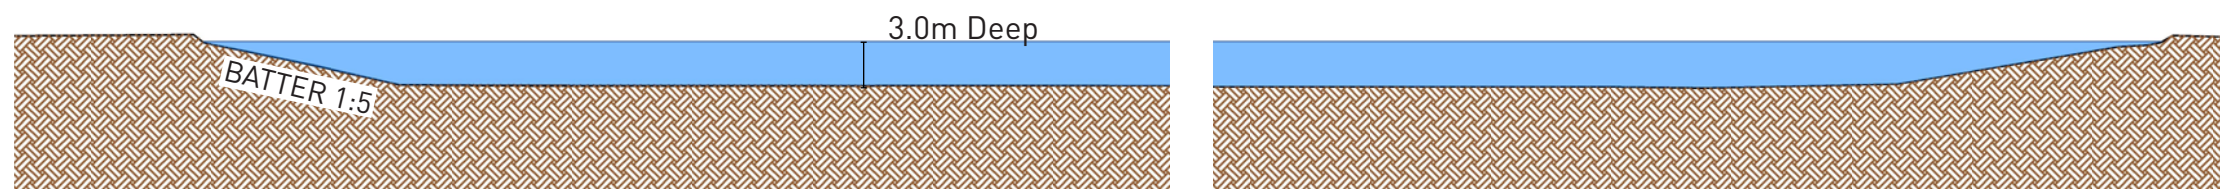
**SECTION AA- POND 1 - EXISTING**

**Cell 1 = 76m wide**

**Cell 2 = 73m wide**

**Central Bund  
10m wide**

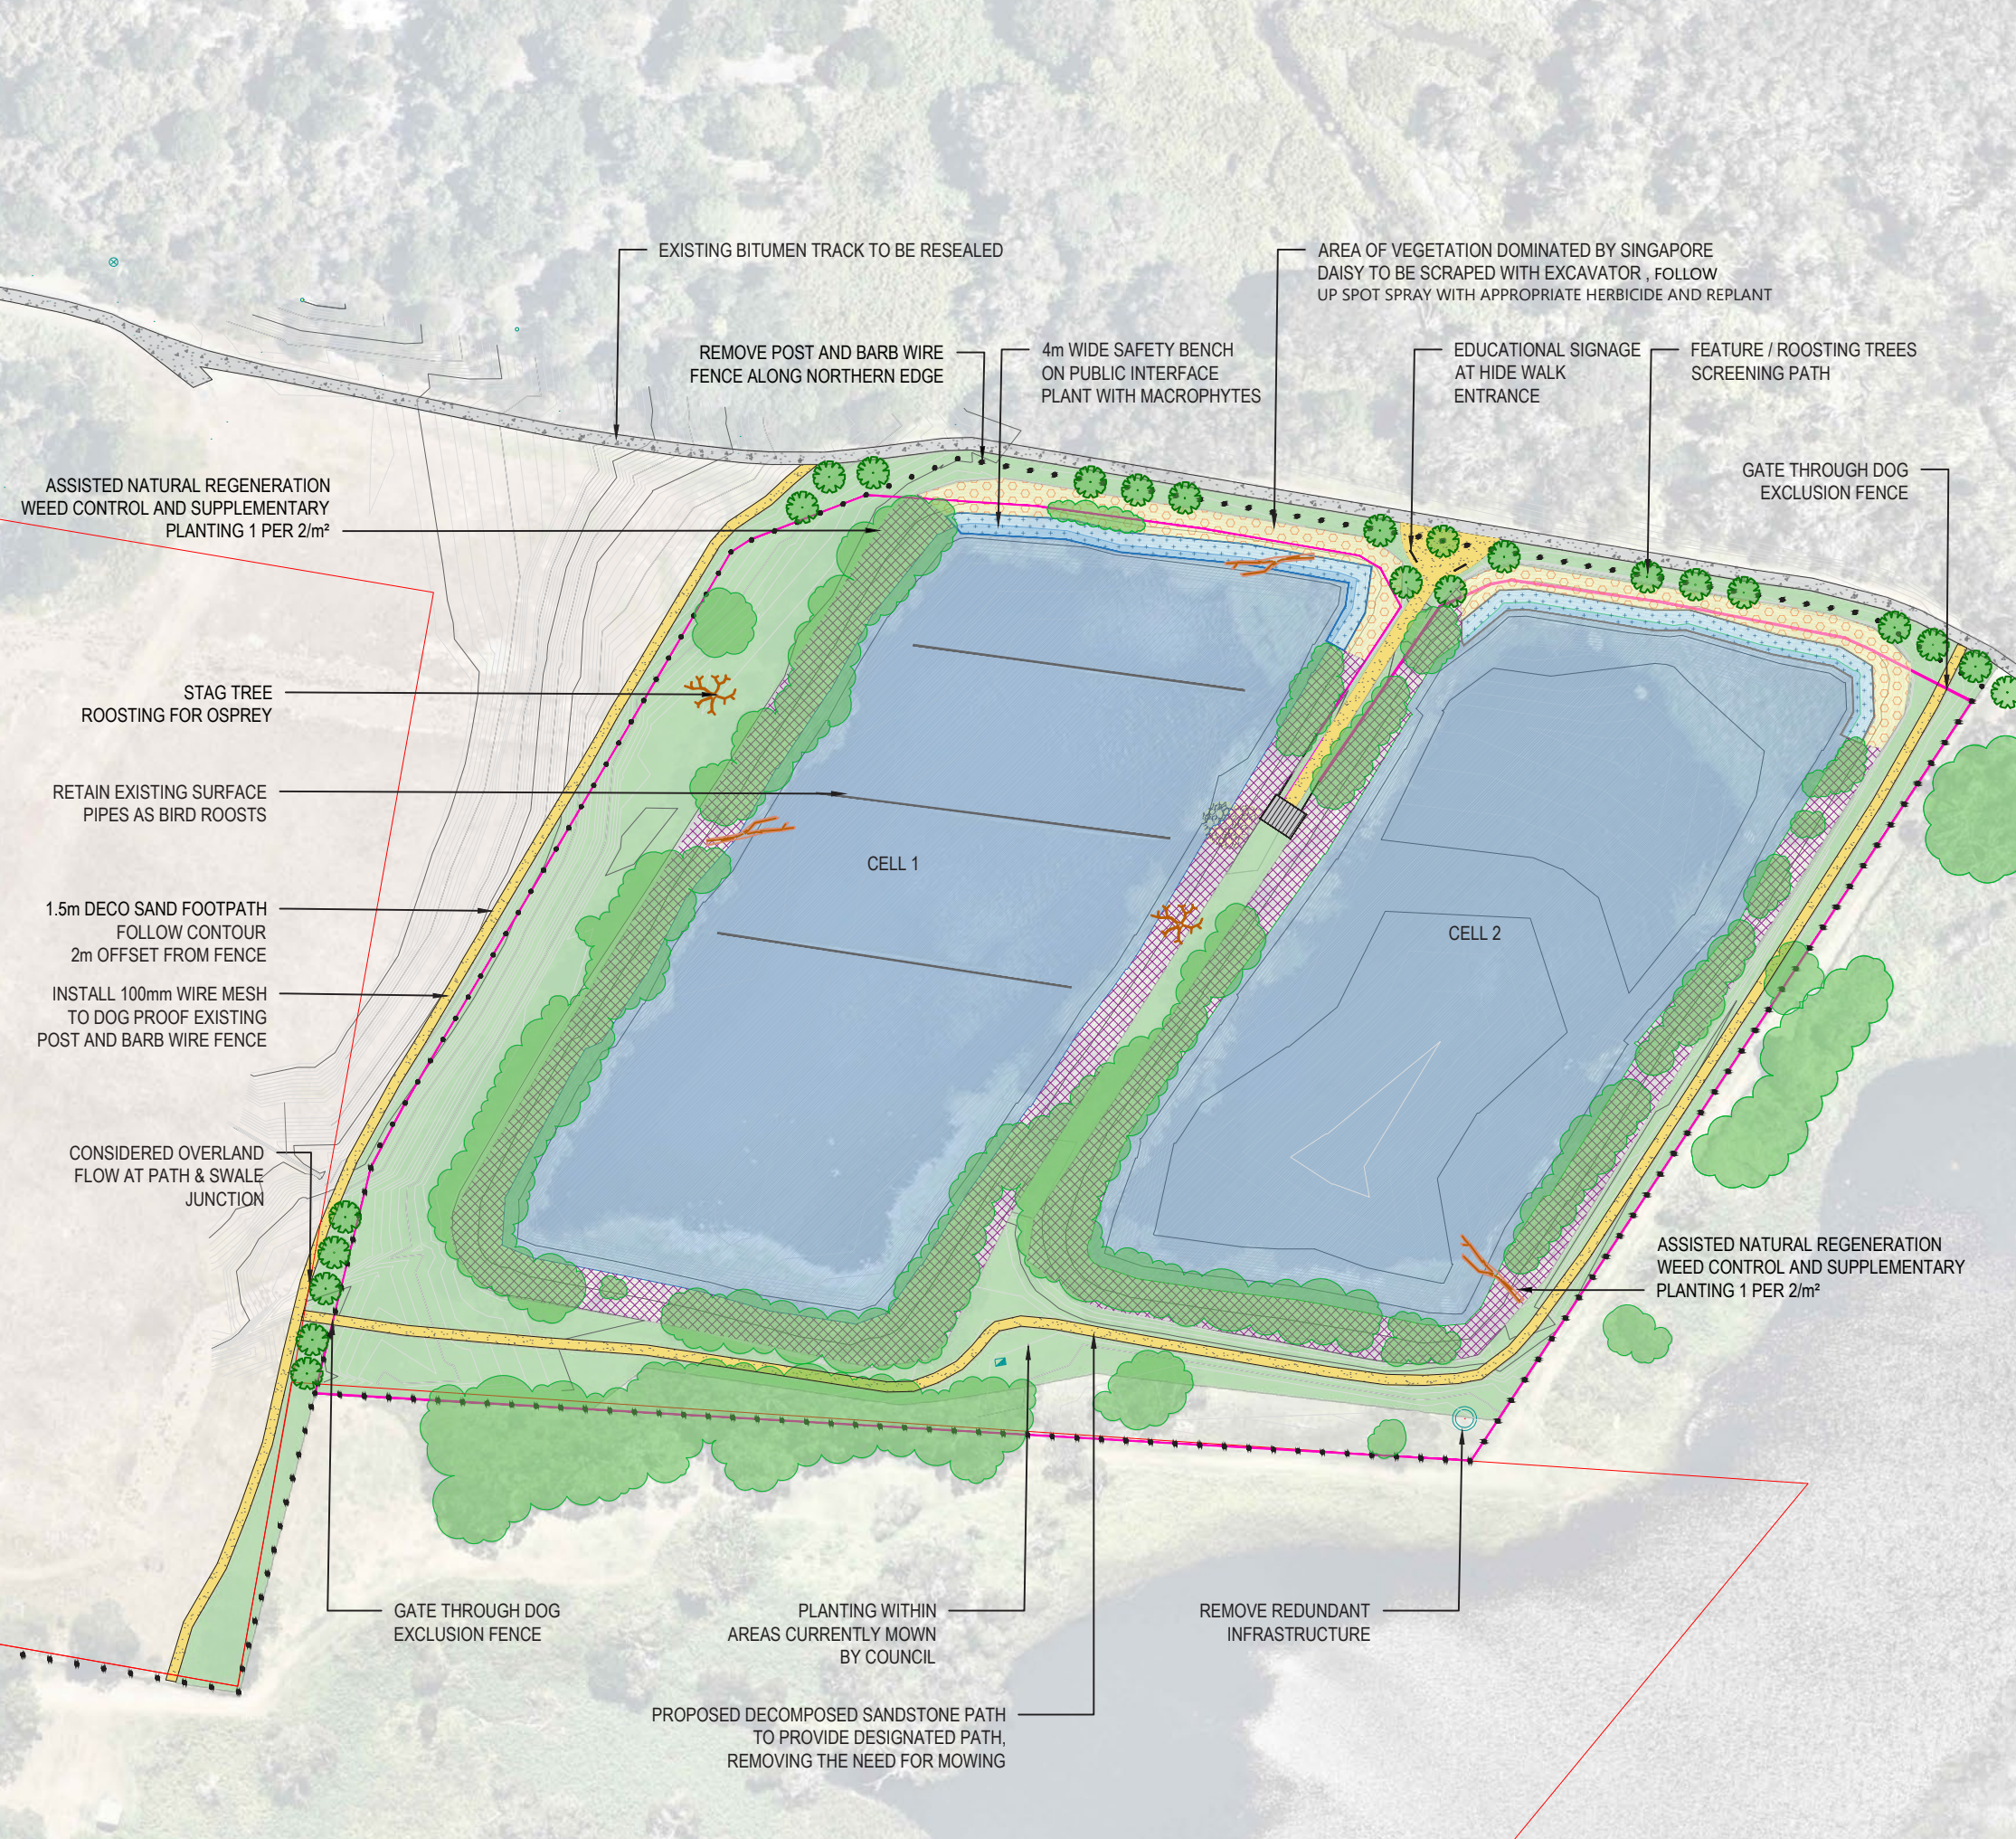
SELECTED DESIGN PLAN

A bird hide is proposed on the central berm, providing sight lines to both cells. Positioning of the proposed bird hide on the Northern side, achieving passive surveillance by passing pedestrians. Consultation with Byron Bird Buddies has been undertaken to confirm location.

Barbed wire fence doesn't stop people or dogs. To be removed and replaced with a dog exclusion fence alignment to be confirmed. Fence must consider fauna movement.

The northern batter is considered to present the greatest risk to visitors with access intended to be mainly at this end. In response a 4m wide safety bench is proposed.

A central island previously included in design iteration has been abandoned minimising disturbance to sediments and preventing bird degradation of overpopulating roosting birds, like the island within the Baywood Chases lakes island.

Addressing the current link from Holiday Park to Beach by providing a formalised path on the western side of cells. Minimising pedestrian activity and creating a dog exclusion zone around the cells leading to Tallows Creek.

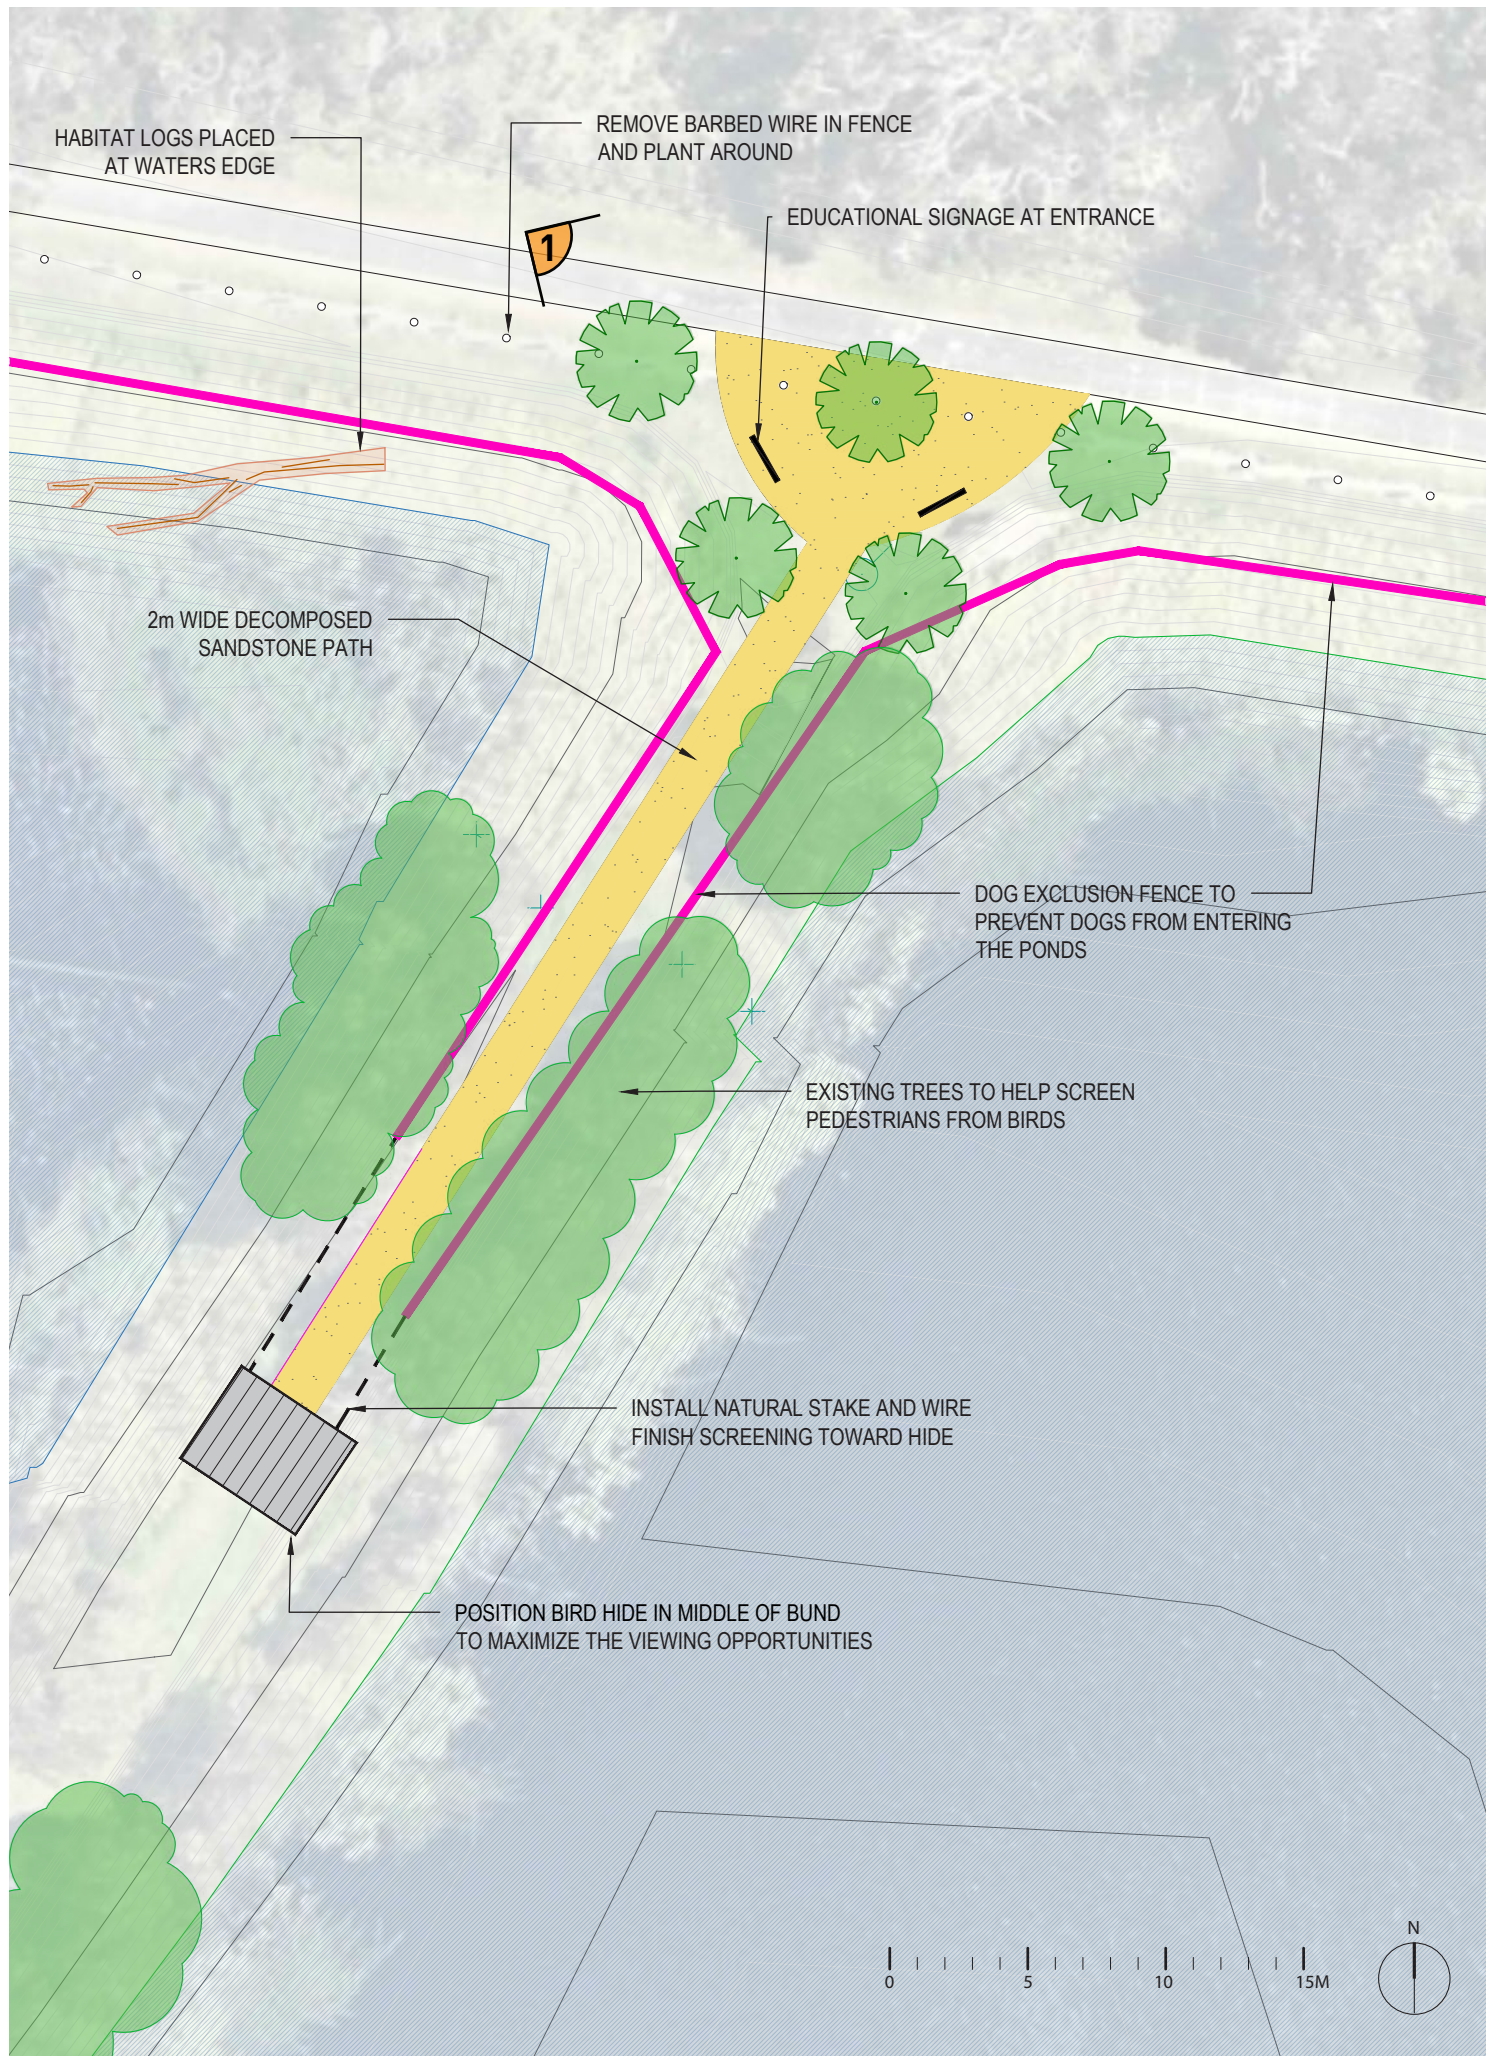
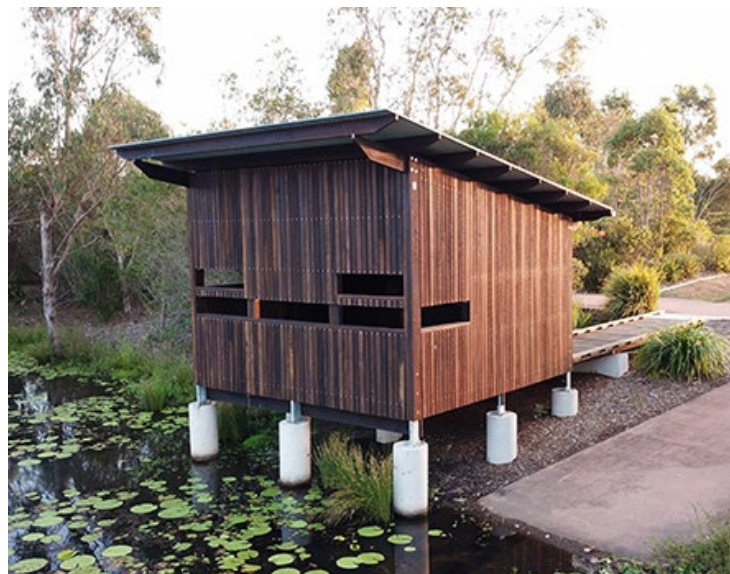
**BIRD HIDE PRECEDENT**

The Bird hide above and below was designed by Landmark for Sunshine Coast City Council.

Following consultation with Byron Bird Buddies, a location for a Bird hide has been selected on the central bund between the two ponds.

Located at the northern end of the berm, it's proximity to the shared cycle path will ensure pedestrians are aware of the bird hide and ensure its use.

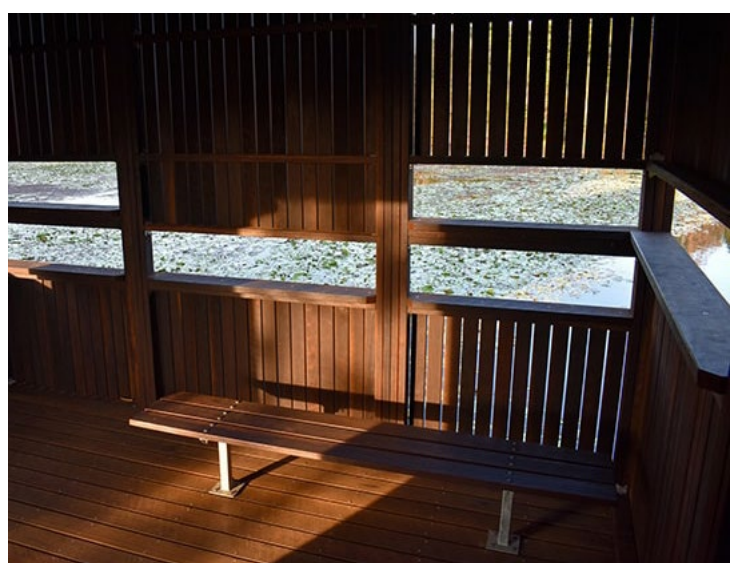
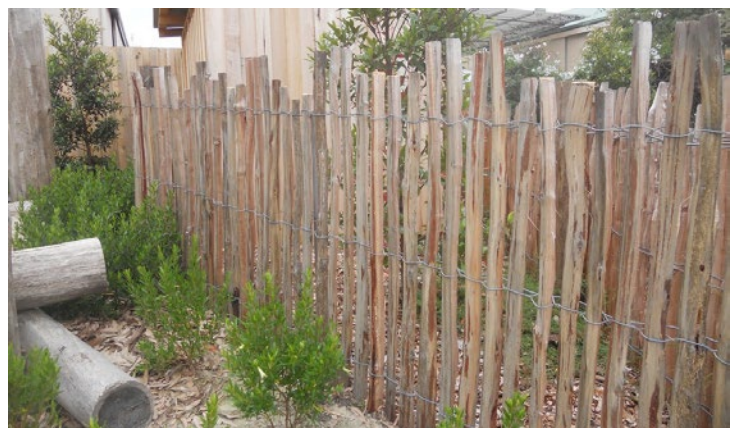
**SCREENING EXAMPLE**

Stake and wire fencing is a simple natural looking material to screen users from birds when on the central bund.

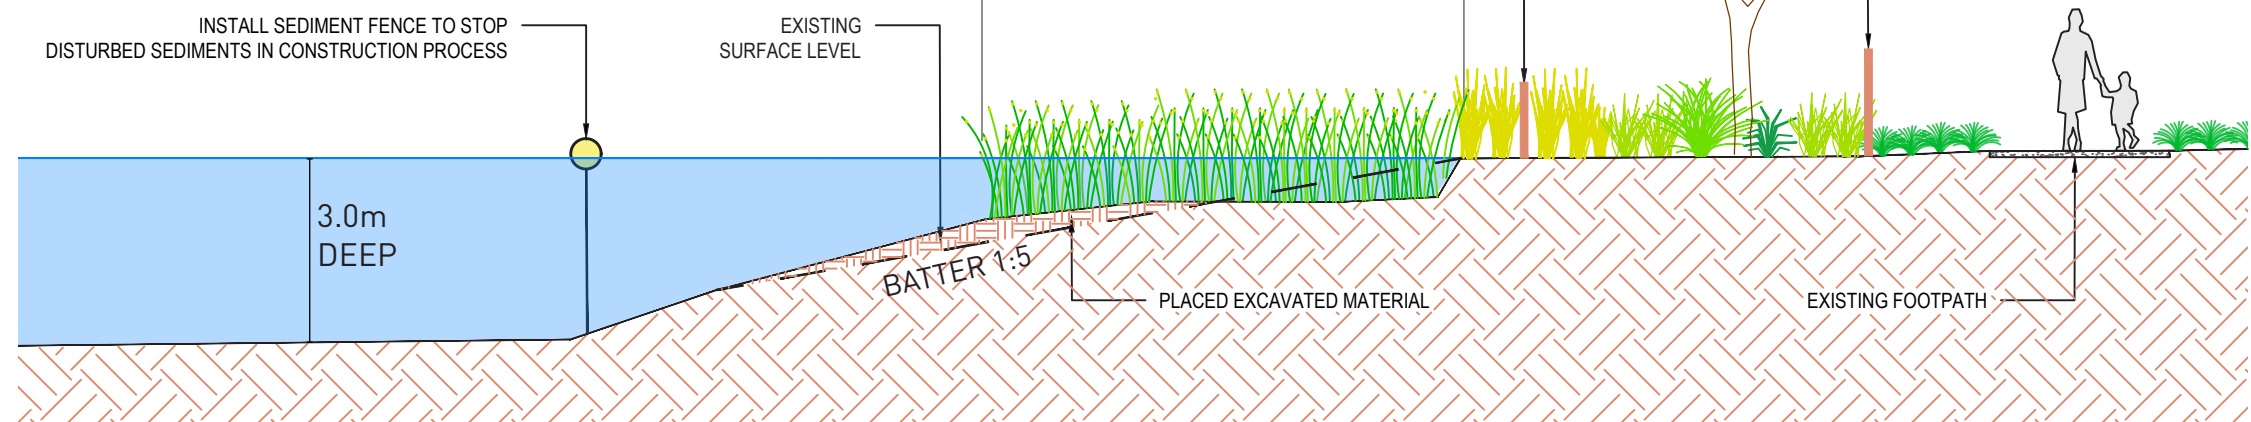
## BATTER PROFILE / MACROPHYTE SAFETY BENCH

The ponds at the STP are approximately 3m deep. The average batter is a grade of 1:5. Due to the dense vegetation and fencing surrounding the ponds, the risk of a person accidentally falling into the waterbody is considered low

A macrophyte safety bench is proposed along the waters edge along the northern side of the ponds due to close proximity to the pedestrian path. This will require cutting into the batter and filling within the water body to create a 4m wide bench approx 0.2m deep.

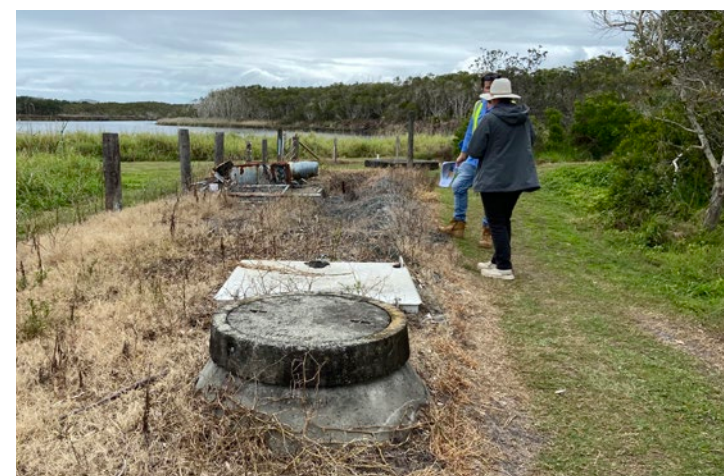
Redundant and degrading infrastructure will be removed in the rectification process. Consultation with councils water management team is required to confirm the items for removal.

Refer image right for an example of the redundant infrastructure in the south east corner of the site.

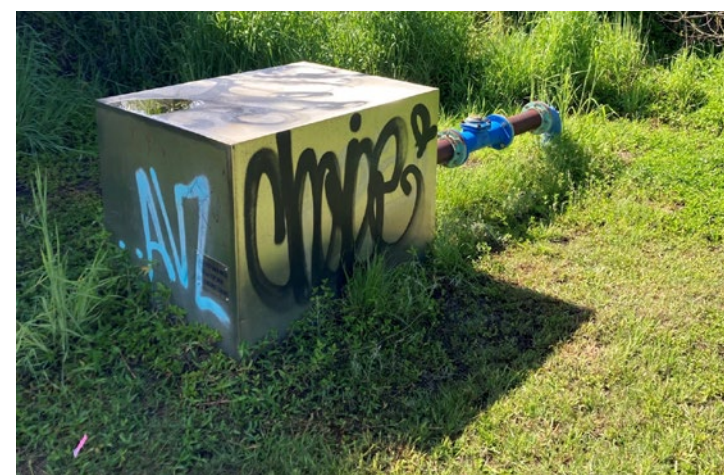
As this is a closed system with small, localised catchment, existing recycled water (RW) pipes from the current West Byron STP should be retained. In the event of an algal bloom it is proposed that recycled water can be used to flush the system.

See image right for recycled water valve housing.

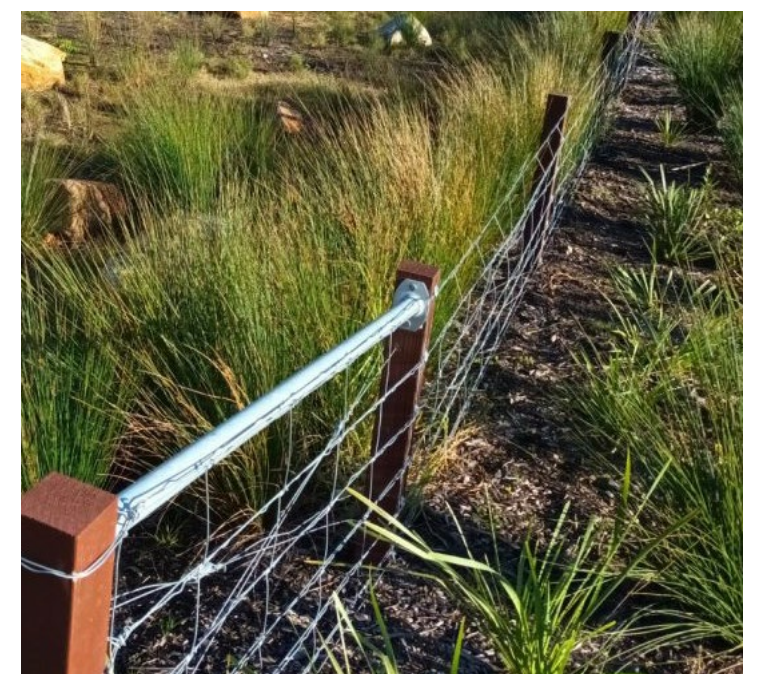
### DOG EXCLUSION FENCE

As a habitat protection measure a 1m high fence is proposed in order to keep dogs out of the ponds. This will be used in combination with the existing fence being upgraded with wire mesh as well.

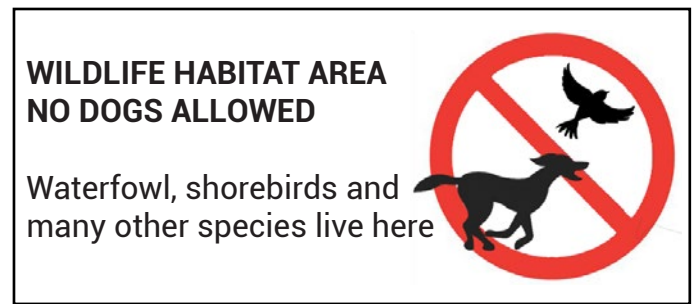
Dog restricted area sign mock-up

- Dog exclusion zone
- No swimming / Dangerous Water

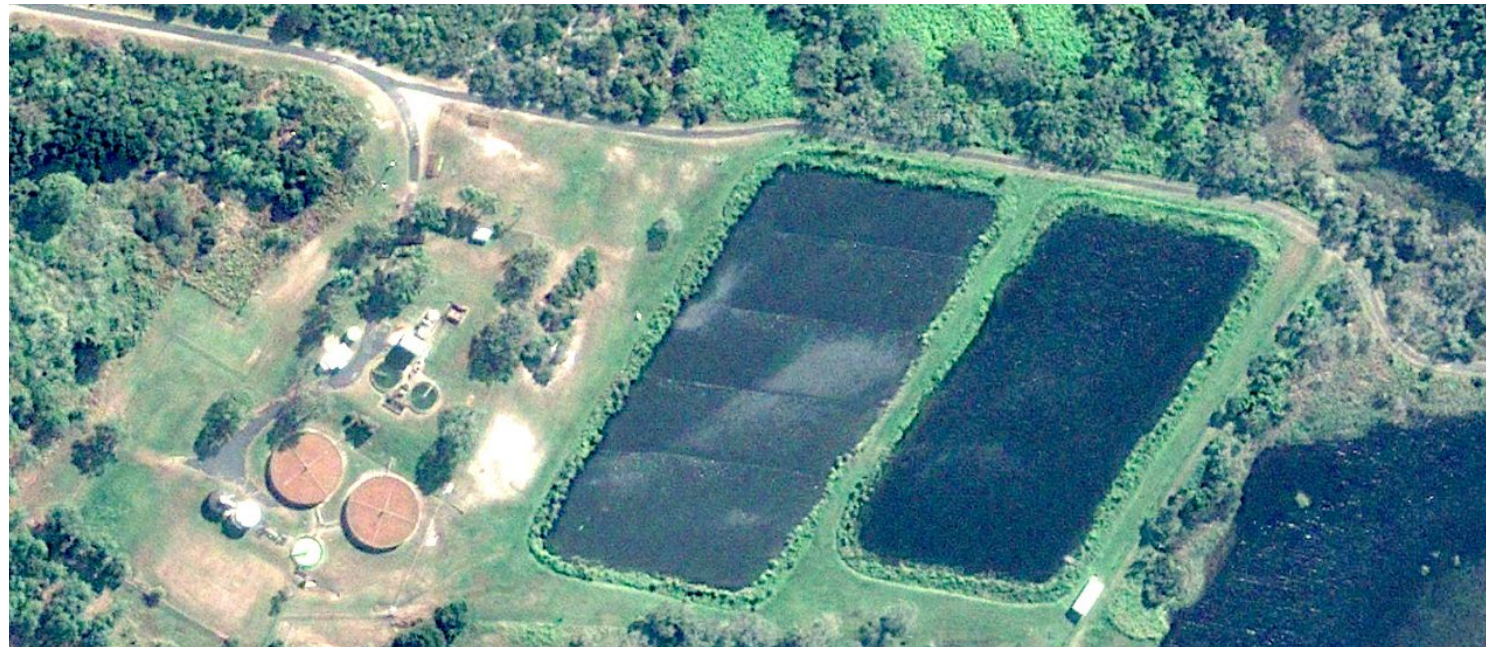
Historic aerial from google earth 2009, prior to remediation of site.

With the use of historic aerials and site photos of the Former STP a sign can be created, educating the public about the sites previous industrial use, the reasoning behind the cells creation and the hazards of swimming in the water bodies.

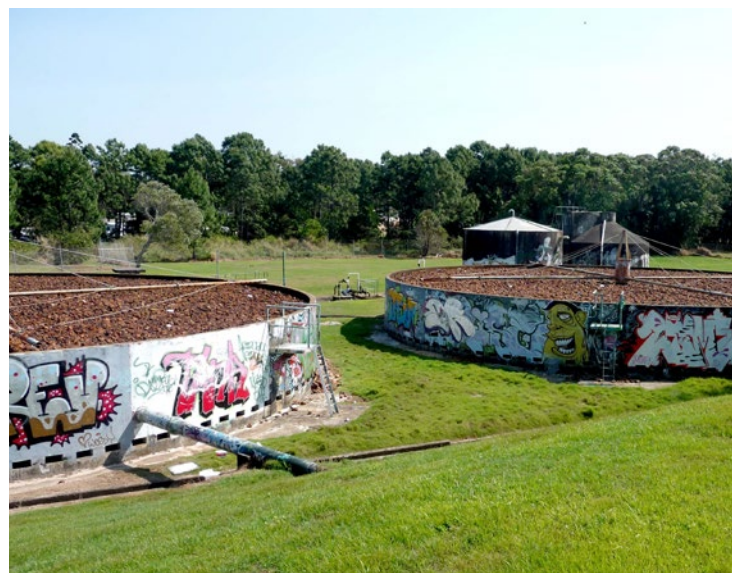
Images of the STP in 2012 post decommissioning of STP
