## Preliminary Acid Sulfate Soil Investigation

Proposed Additional Flow Path for  
Byron Sewage Treatment Plant

Byron Bay NSW

HMC 2019.053

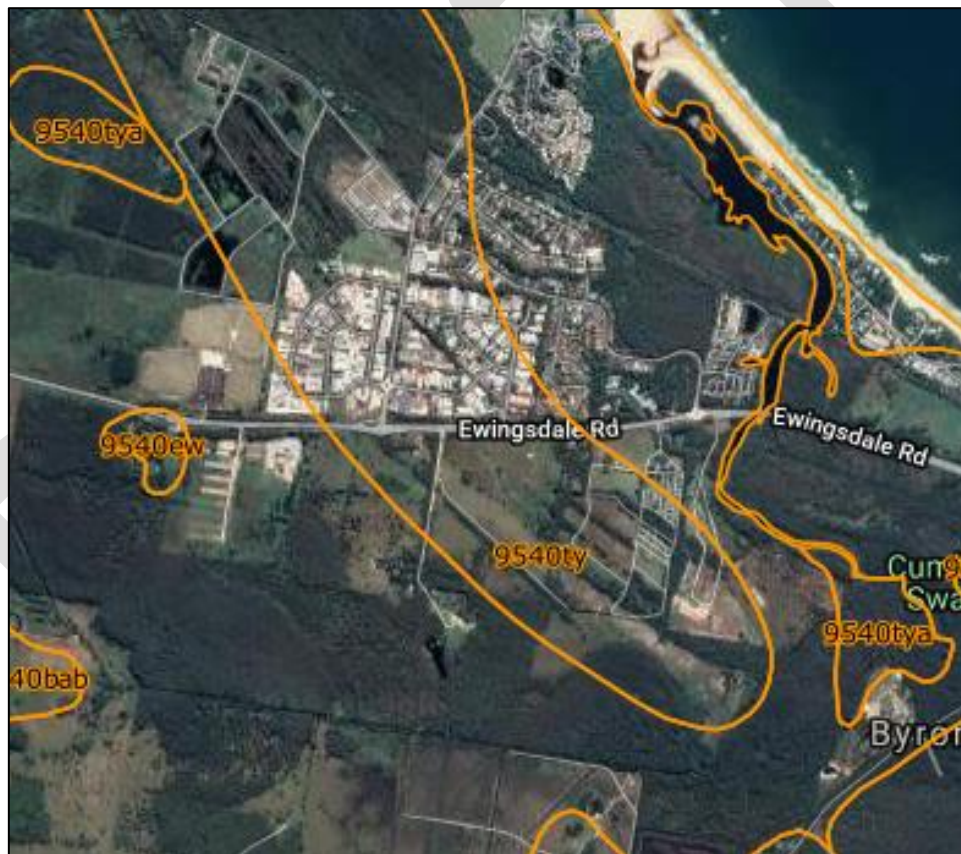
Figure 4 - Soil landscape map (Source: <http://www.environment.nsw.gov.au/eSpadeWebApp/>)

The NSW Department of Conservation and Land Management “Soil Landscape of the Lismore-Ballina 1:100 000 Sheet” (Morand, 1994) shows the subject site lies within a “Tyagarah” (ty) soil landscape which is found within sediment basins of mixed estuarine and aeolian origin within the inland margins of the Tweed-Byron Coast. Soil relationships are varied in this soil landscape due to the complex origin of the landform.

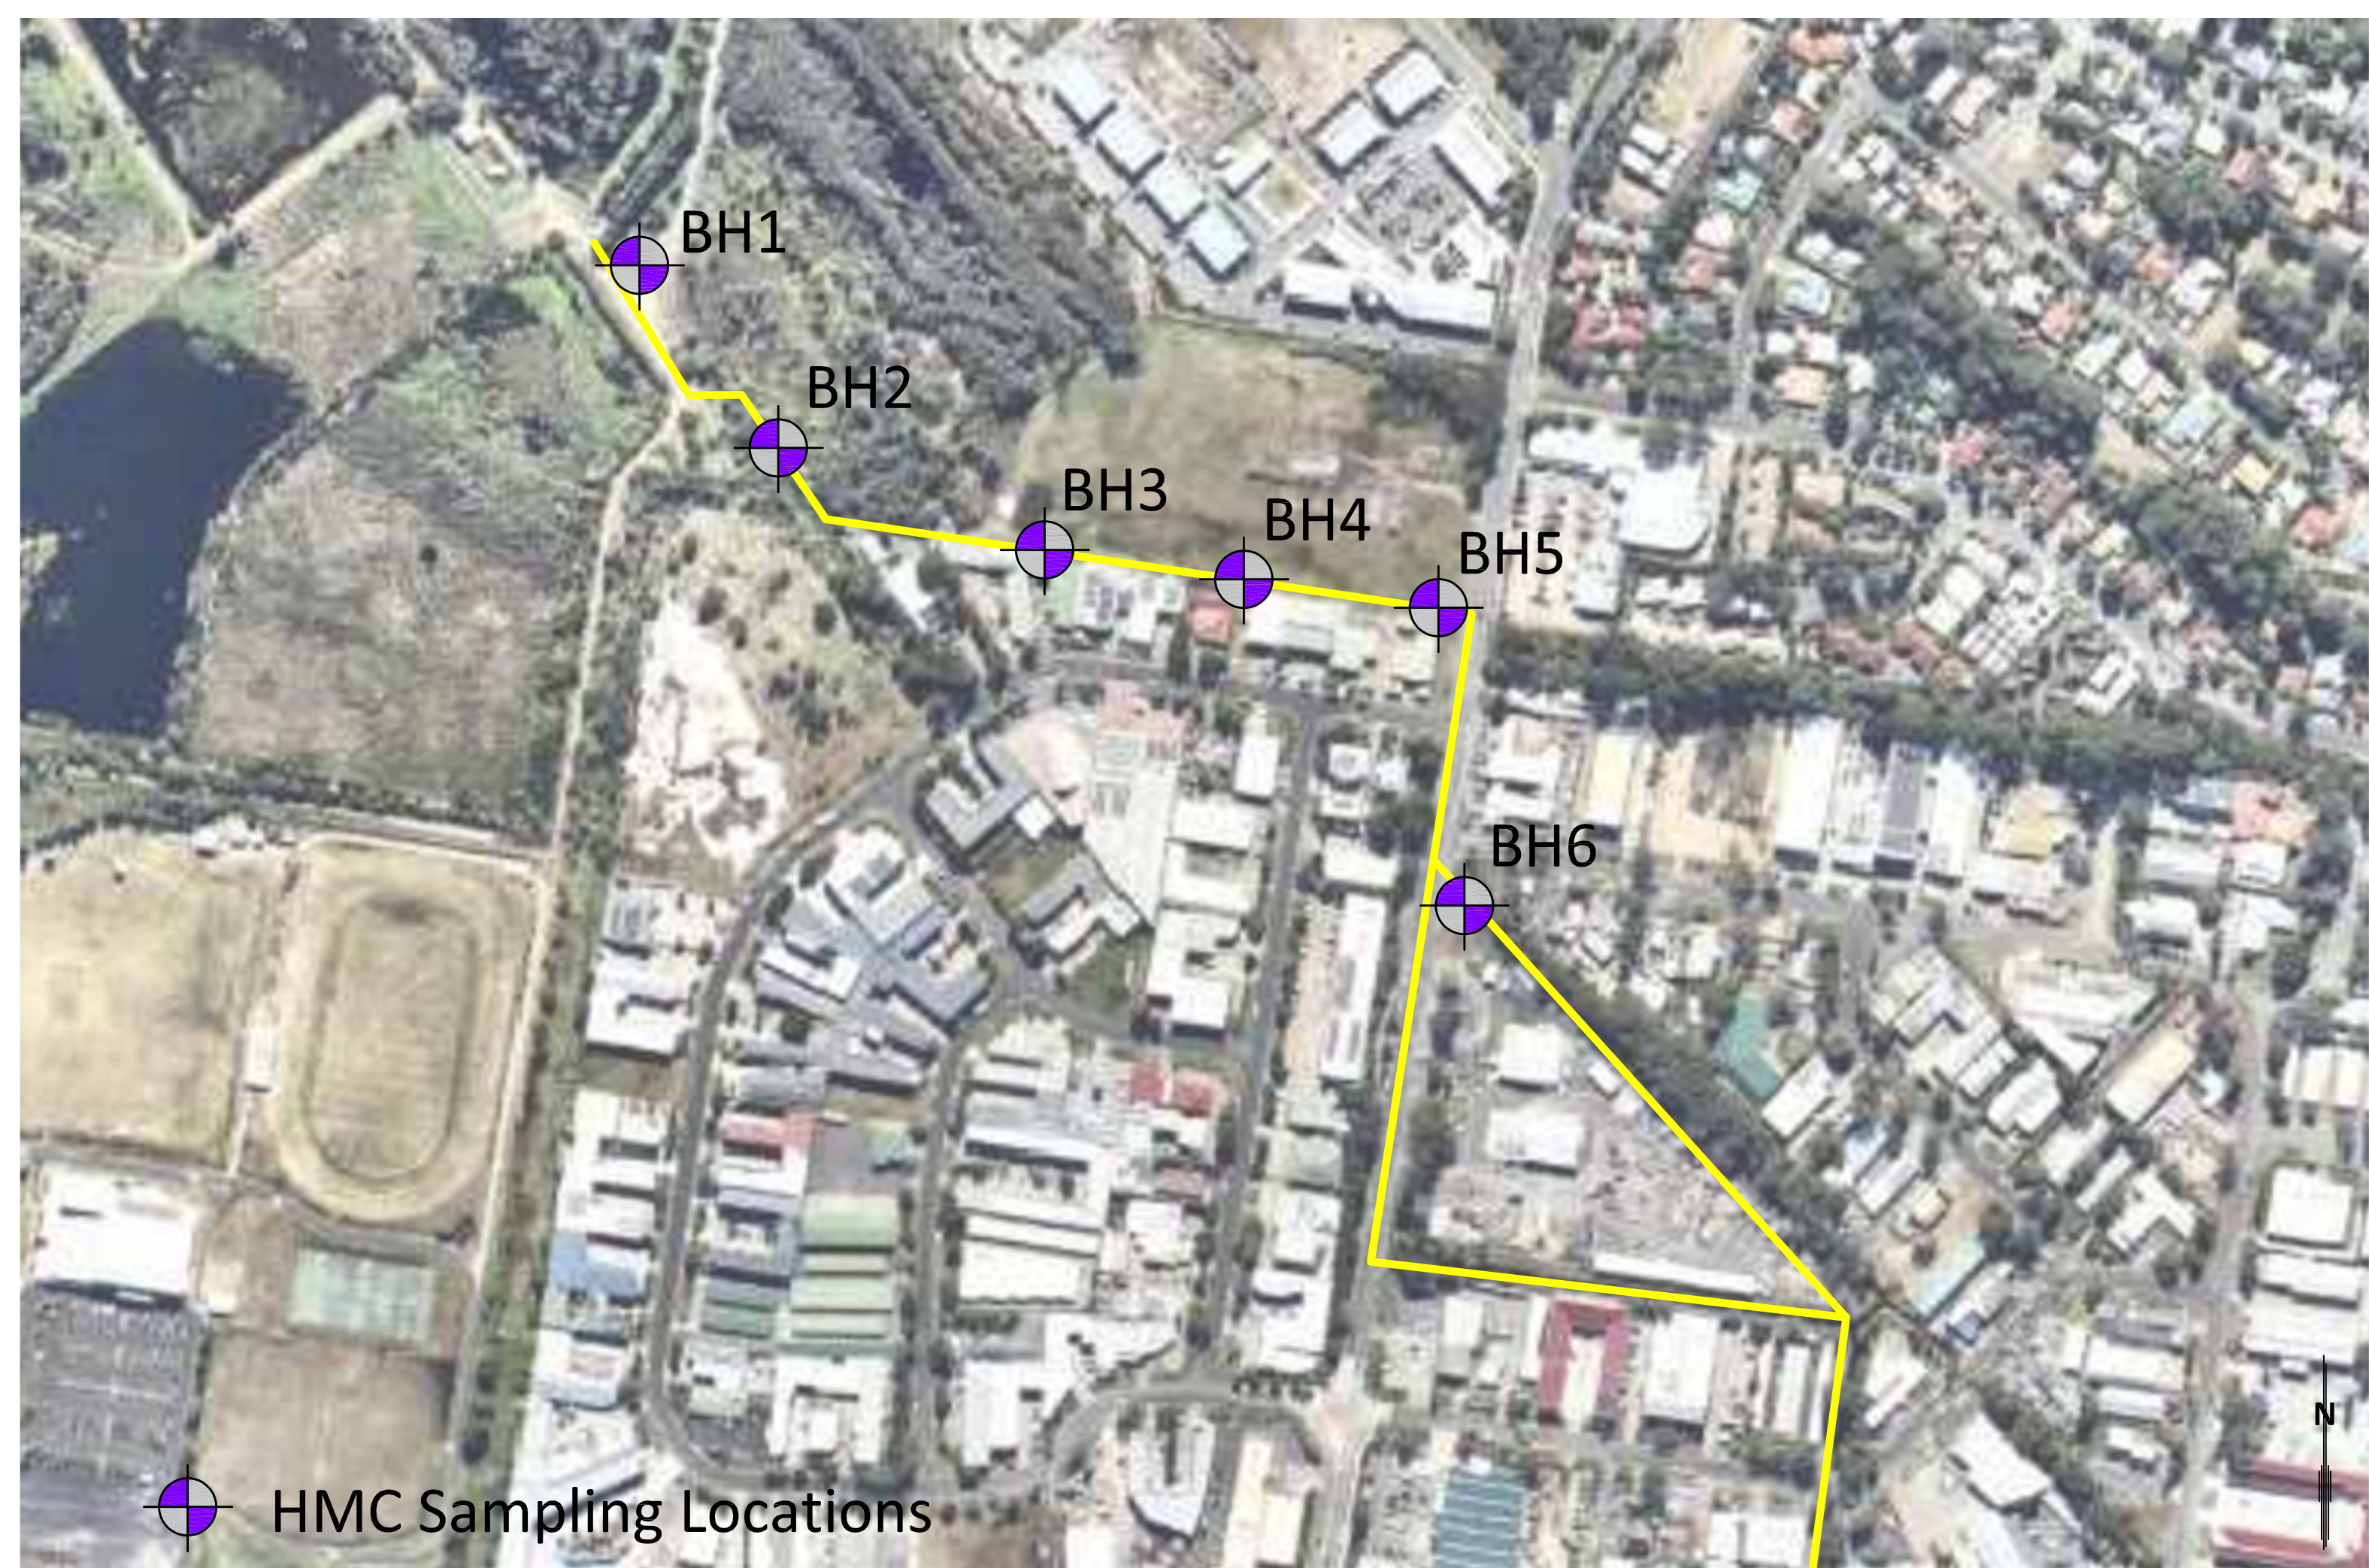
HMC Sampling Locations

Six (6) boreholes (BH1 – BH6) were drilled by Mazlab drilling contractor on site by HMC on 19 March 2019 ranging from 1.5m up to 2.5m depth in the locations shown in Appendix 1. The soil profile was generally sand/silty sand throughout the depth of investigation. This would be classed as a coarse texture soil.

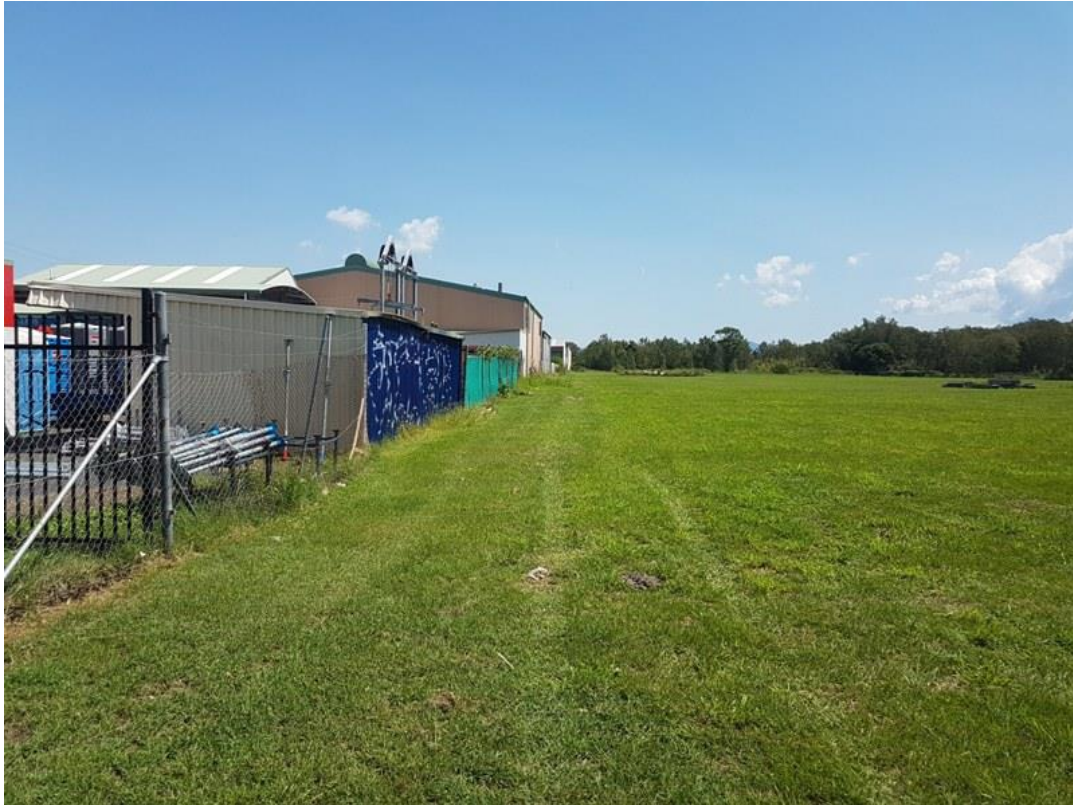
Photo 1 – View west along proposed pipeline alignment

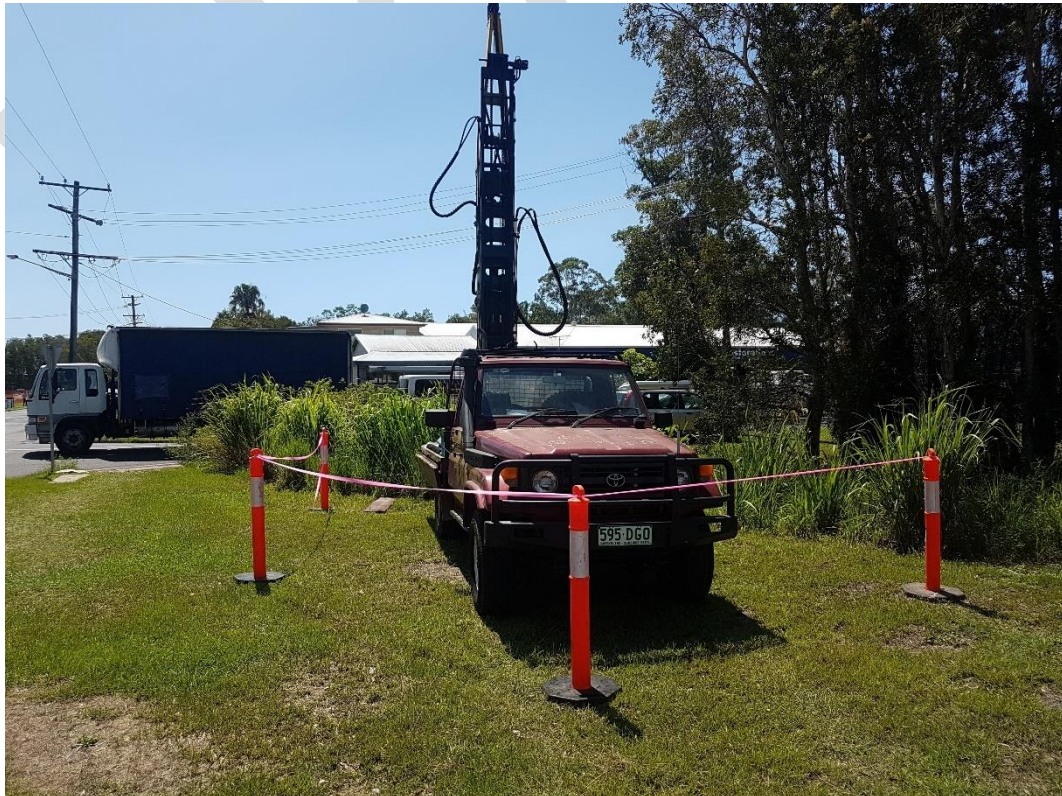
Photo 2 – Drilling rig located at BH6

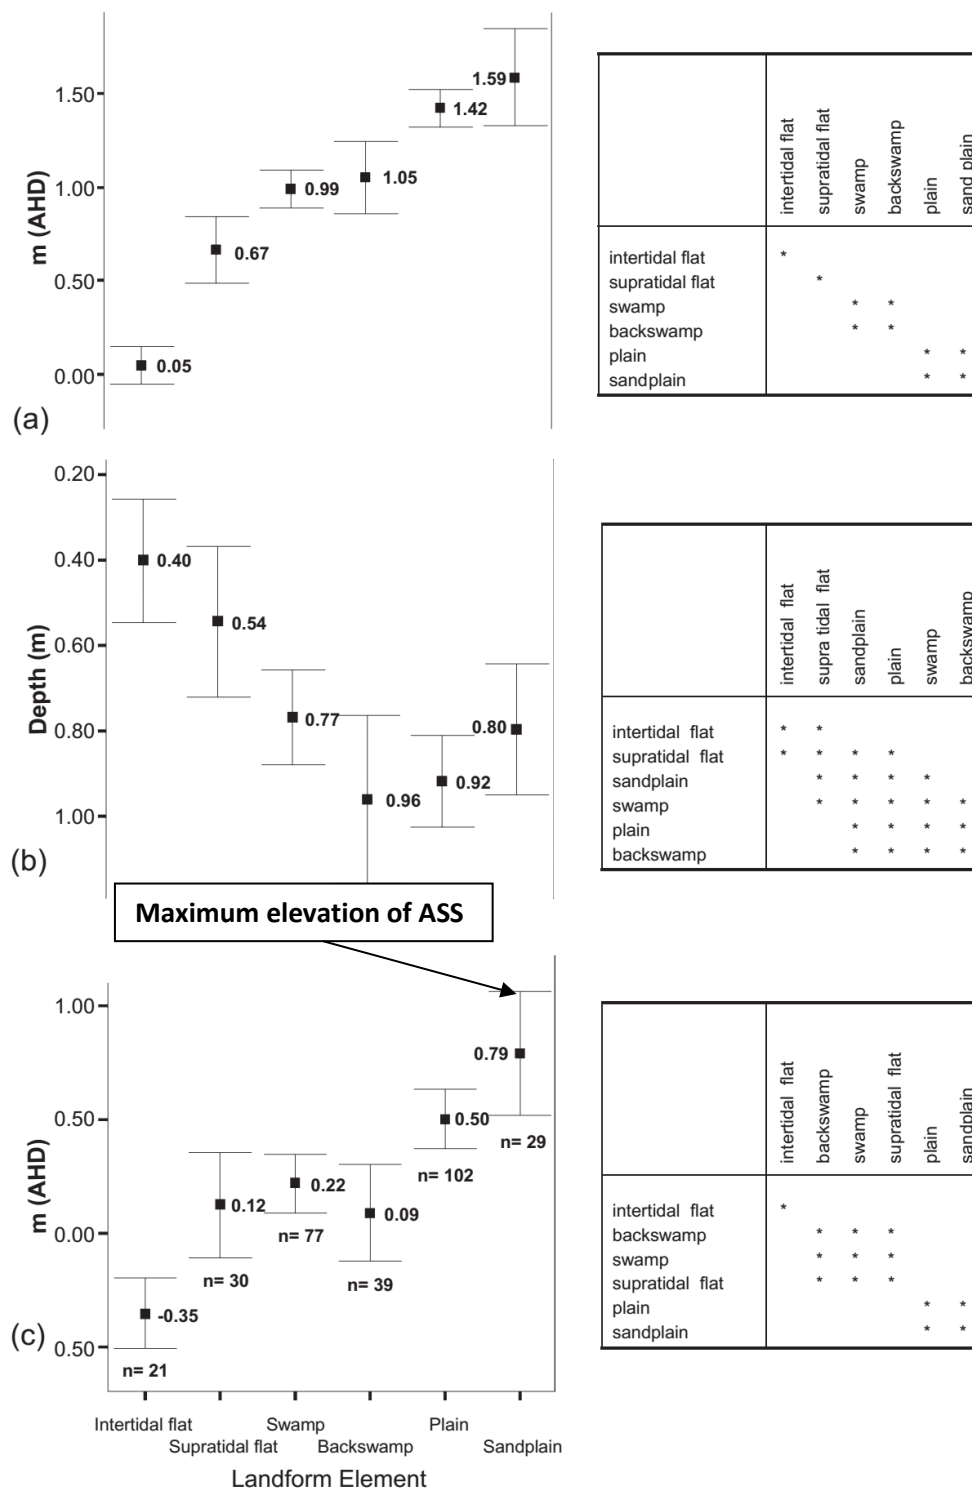
Appendix 5 NSW ASS Elevation (extract from Wilson, 2005)

Fig. 2. Stratigraphic characteristics of all ASS profiles. Surface elevation (a), depth to sulfurous materials (b), and elevation of sulfurous materials (c). Error bars are 95% confidence interval of the mean. An asterisk (\*) in similarity matrices indicates that mean difference between landforms is not significant ( $P < 0.05$ ).

Wilson (2005) also reports a maximum elevation of ASS of 1m AHD after reviewing soil investigation results for the NSW ASS mapping program (see appendix 5).
