Technical Memorandum

Preliminary response to potential causes of Melaleuca dieback within the Belongil Catchment

Job ref: 1-211444

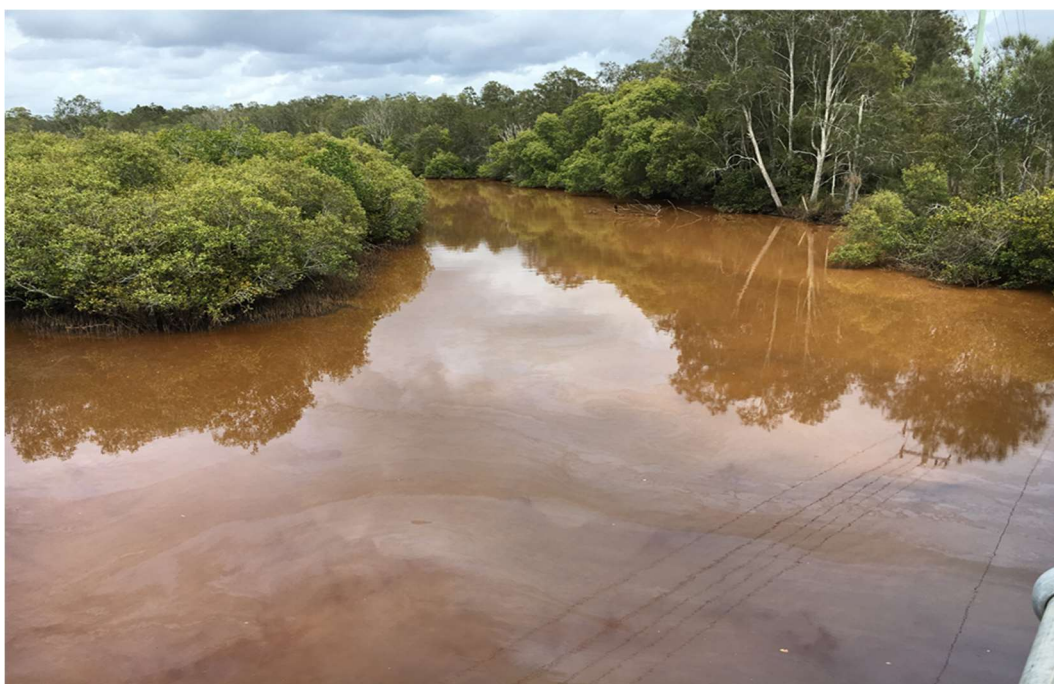
Wetting and drying of potential and actual acid sulfate soils will move sulfuric acid to the soil surface and laterally through soils, leading to export downstream. These two pathways are shown in *Figure 2*. These processes are accelerated when floodplains are drained and developed for agriculture and urban development (Anorov et al., 2008). It appears that a prolonged dry period in 2018-2019 in which the watertable lowered and oxidised acid layers, followed by rain mobilised large quantities of sulfuric acid and dissolved iron which turned Belongil Creek a reddish colour (See Plate 1). Review of aerial imagery

Plate 1: Belongil Creek at Ewingsdale Bridge in May 2019, with iron rich flows

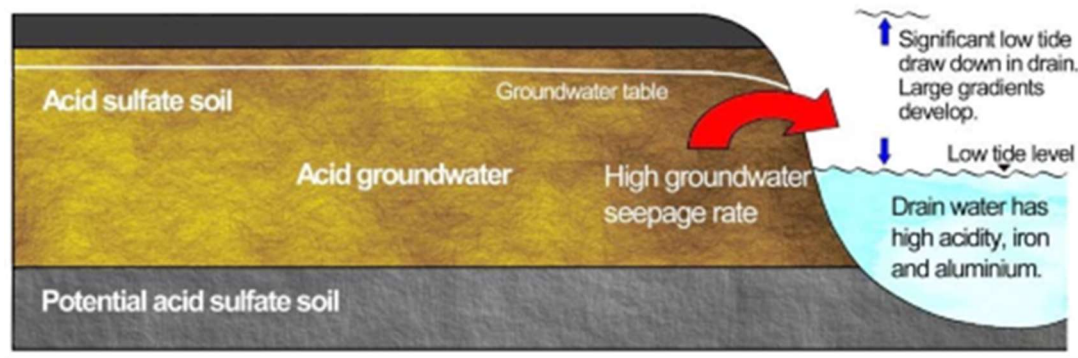
- Seepage occurs when the groundwater level is higher than the drain water level.
- Most of the seepage occurs when the groundwater level is between the surface and the minimum low tide level in adjacent drains.
- This can lead to frequent, chronic acid discharge and high acid export rates.
- *This is an important pathway at high hydraulic conductivity sites.*

- Shallow groundwater and evaporation leads to accumulation of acid salts on the surface.
- Rainfall saturates the soil profile and causes surface run-off to the drain.
- Acid discharge events are usually more infrequent, with lower acid export rates.
- *This is a more important pathway at sites with low hydraulic conductivity or very low elevation.*

Figure 2 Two pathways for acid export – lateral groundwater seepage and surface run-off. Processes occurring within the dieback area require confirmation. (Source, Tulau, 2007).

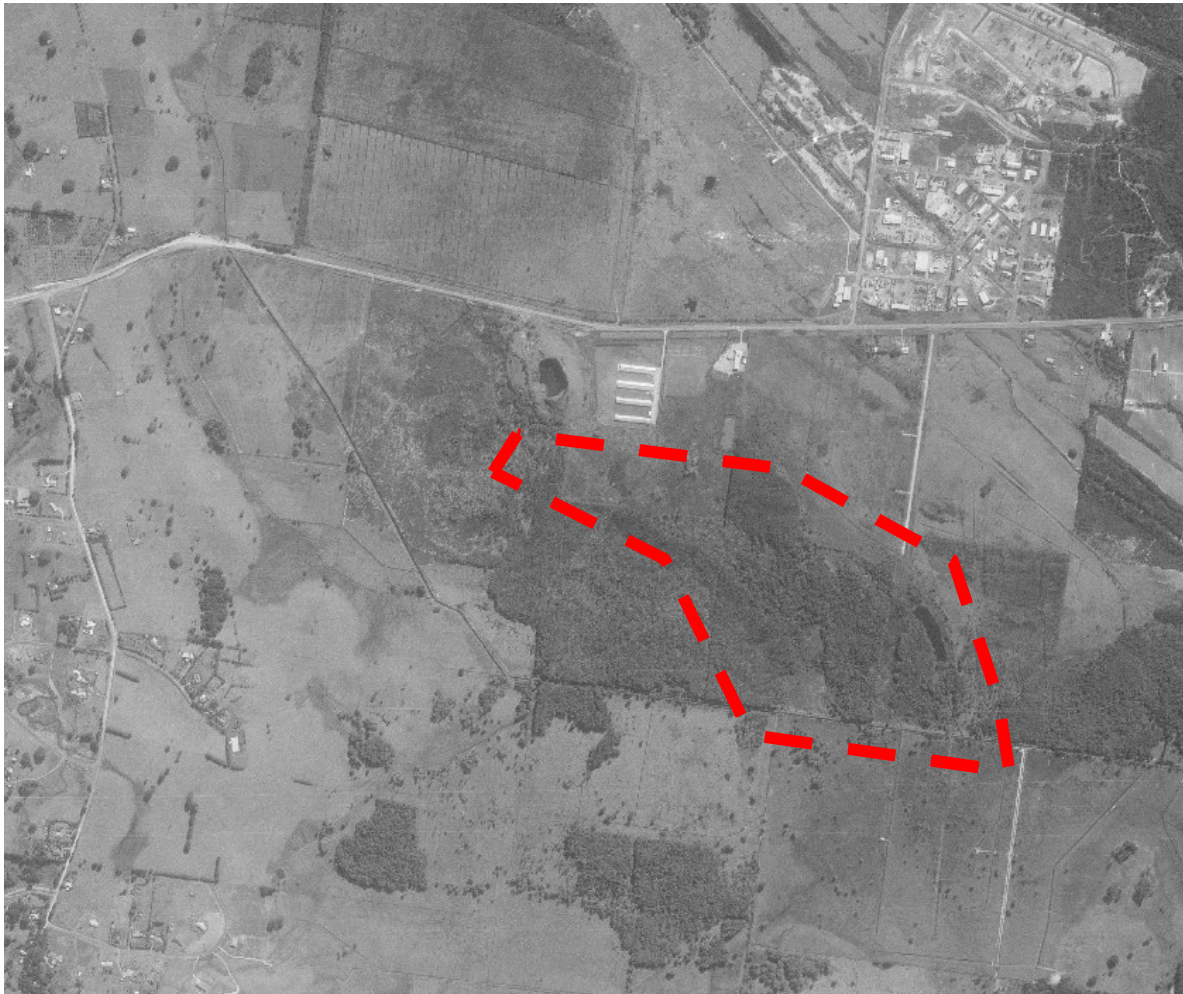
A review of historical imagery suggest that tree dieback has been occurring through this location for at least 30 years. Attachment 1B shows the subject area in 1997 with the same general pattern of impact being visible. Attachment 1C shows the area in 1987 with the same shape of dieback clearly identifiable.

Attachment 1C: The subject area in 1987 showing the same extent and regenerating vegetating
