Heritage Referral DA 2021.839.1

Longfield' 175 Wilsons Creek Rd

April 2022

Prepared by
CLARENCE HERITAGE
for Byron Shire Council

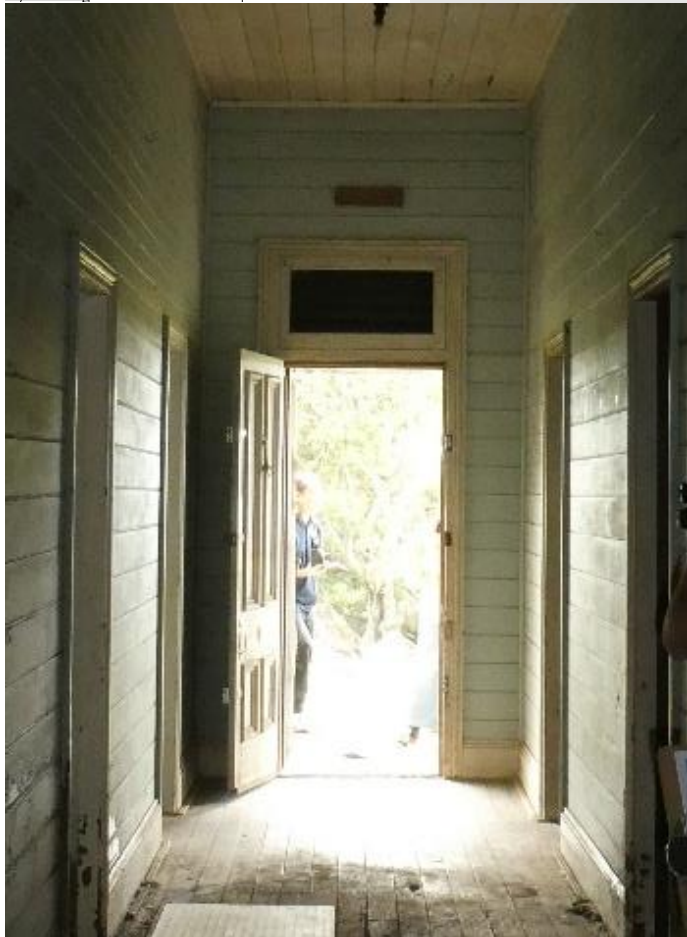
4.1 Removal of entry door, replacement of door and widening of walls to insert side lights.

Original 4 panel entry door, transom light above and hallway.

The removal of this door, architraves and skirtings and transom to insert a new door and side lights, removes original historic fabric, and alters the original historic detail and authenticity of the farmhouse.

Retention and conservation of the original fabric of the existing entry door, transom light, and walls is recommended.

- Retention of the original front door and wall unchanged.
- Retention of end hallway doorway and nib walls
- Reconsideration of the detailed layout to minimise alteration to the historic layout, and loss of original fabric.
- Further research on the hipped roof possible early kitchen section.

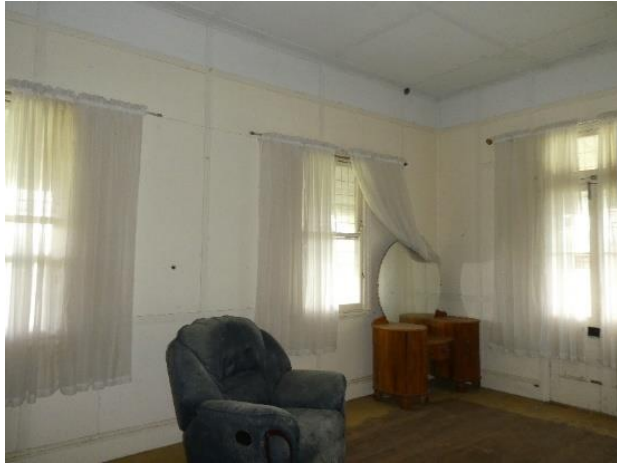
Front living room with later altered linings.

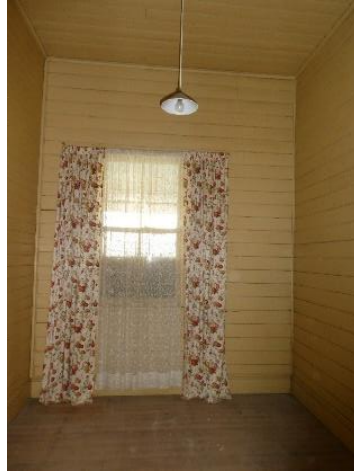
Simple quad profile around top of walls.

7.6 Decorative details which are not evident in the original structure, should not be introduced, to maintain the historic details, authenticity and simple vernacular style of the house. For example, there are no significant cornices, only simple quad. Decorative cornices or ceiling linings should not be installed

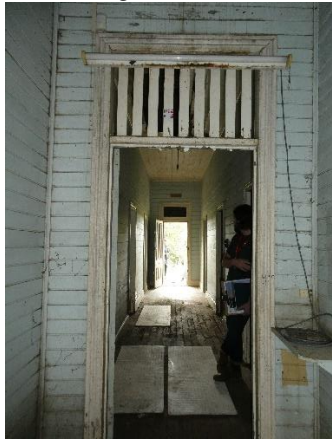
Hallway doorway opening

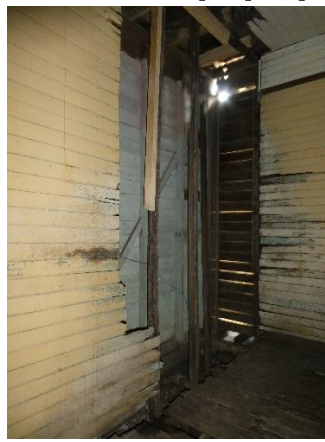
Southern side of bedroom wall behind frame.

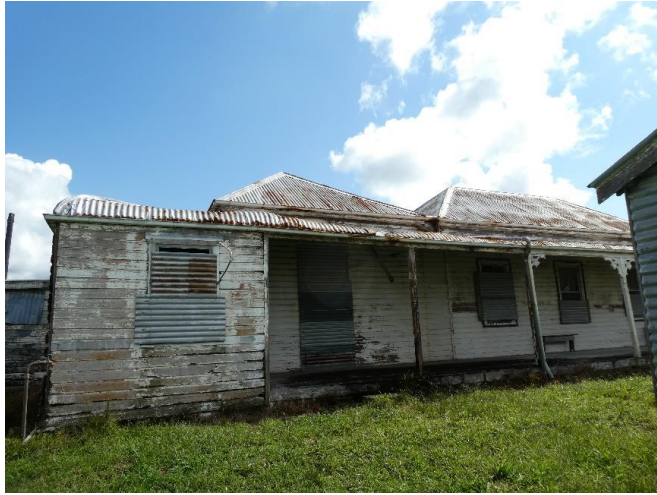
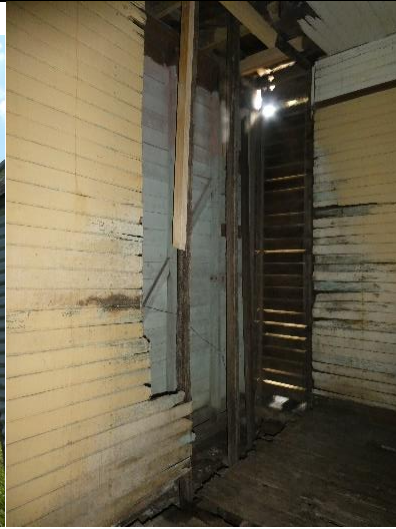
4.3 Demolition of Rear Section

The small hipped roof over the eastern side rear room is indicative of a possible former detached kitchen. This is historically significant fabric and the extension on the side of the verandah is also evident in the early photograph.

Reconstruction of this historic roof form over the outdoor proposed kitchen would provide reference to the existing former structure., however the drainage issues of a box gutter are acknowledged and would need to be considered and addressed. Further research is recommended. The water damage and deterioration of this space is noted. The proposed retention of this element as an open walled outdoor kitchen is acceptable in principle continuing the likely former use. Reconstruction of the fireplace is positive. Further details /photos of existing fireplace footings should be included in the archival report.

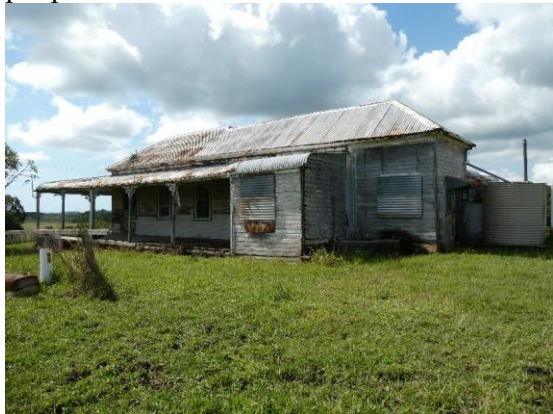
Western side

The rear section on the western side also constitutes a historic component of the dwelling and the side extension under the bullnose verandah matches that of the other side and this proposed demolition also removes historic elements of the dwelling.

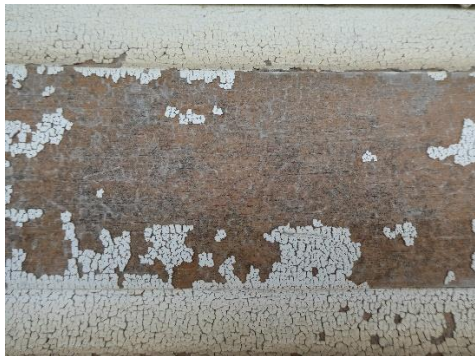
Early paint layers of red brown oxide.

7.7 A colour scheme based on historic evidence of the original paint scrapes should be used to maintain the historic and aesthetic significance of this dwelling. It is noted that the earliest wall colour layers are a red brown red oxide which is consistent with early photos of this tonality of the wall. Contemporary colour schemes of grey, black and white should be avoided for a historic dwelling of this era.
