Bangalow Public School

Heritage Impact Statement For FKG Group May 2021

Document Verification	
Project	Bangalow Public School – School Upgrades
Project Number	21087
Document Title	Bangalow Public School – Heritage Impact Statement
File Location	Projects/21087 BANGALOW Public School HIS/Reporting
Client	FKG Group

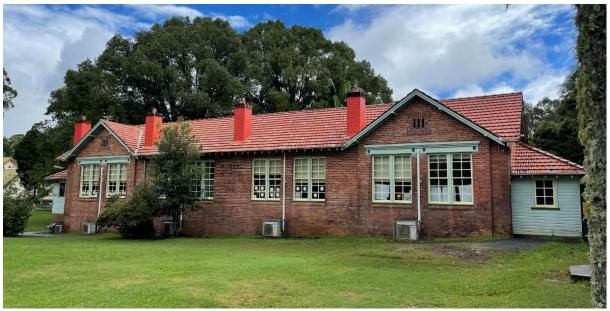
Figure 13: Block A, the early 1925 school building (AHS, 2021).

Block A, located to the south-east of the site, is predominantly viewed from Byron Street and is a prominent structure along this streetscape. Block A is the early 1925 brick school building. It is rectangular in plan with a terracotta gabled roof with transverse gables and chimneys. It remains largely intact with original brickwork, multi-pane double hung windows (with associated lintels and sills), vents, and picture rails. In between the gables are decorative slots.

There are two, original timber chamferboard skillions to the east and west, however the western portion has alluminium framed windows as opposed to the original timber framed windows.

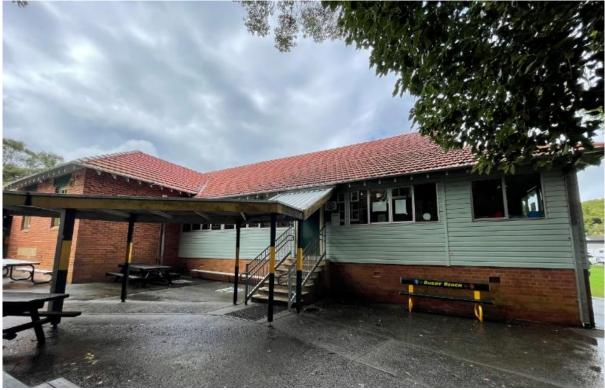
Figure 14: Block A, rear enclosed verandah (AHS, 2021).

The rear / northern façade has an enclosed verandah and a central, brick extrusion. The steps to the verandah have an enclosed walkway which connects to Block A's roof. The verandah was originally an open verandah with covered roof but was then enclosed with timber boards (made to match the eastern and western extrusions) and has had aluminium framed windows installed.

The northern elevation has also had an accessibility ramp installed and think walkway canopies that cannot to the external roof and walls. The central brick extrusion contains a separate terracotta tiled roof, timber windows, and a single, large sandstone block incorporated between the face brickwork.

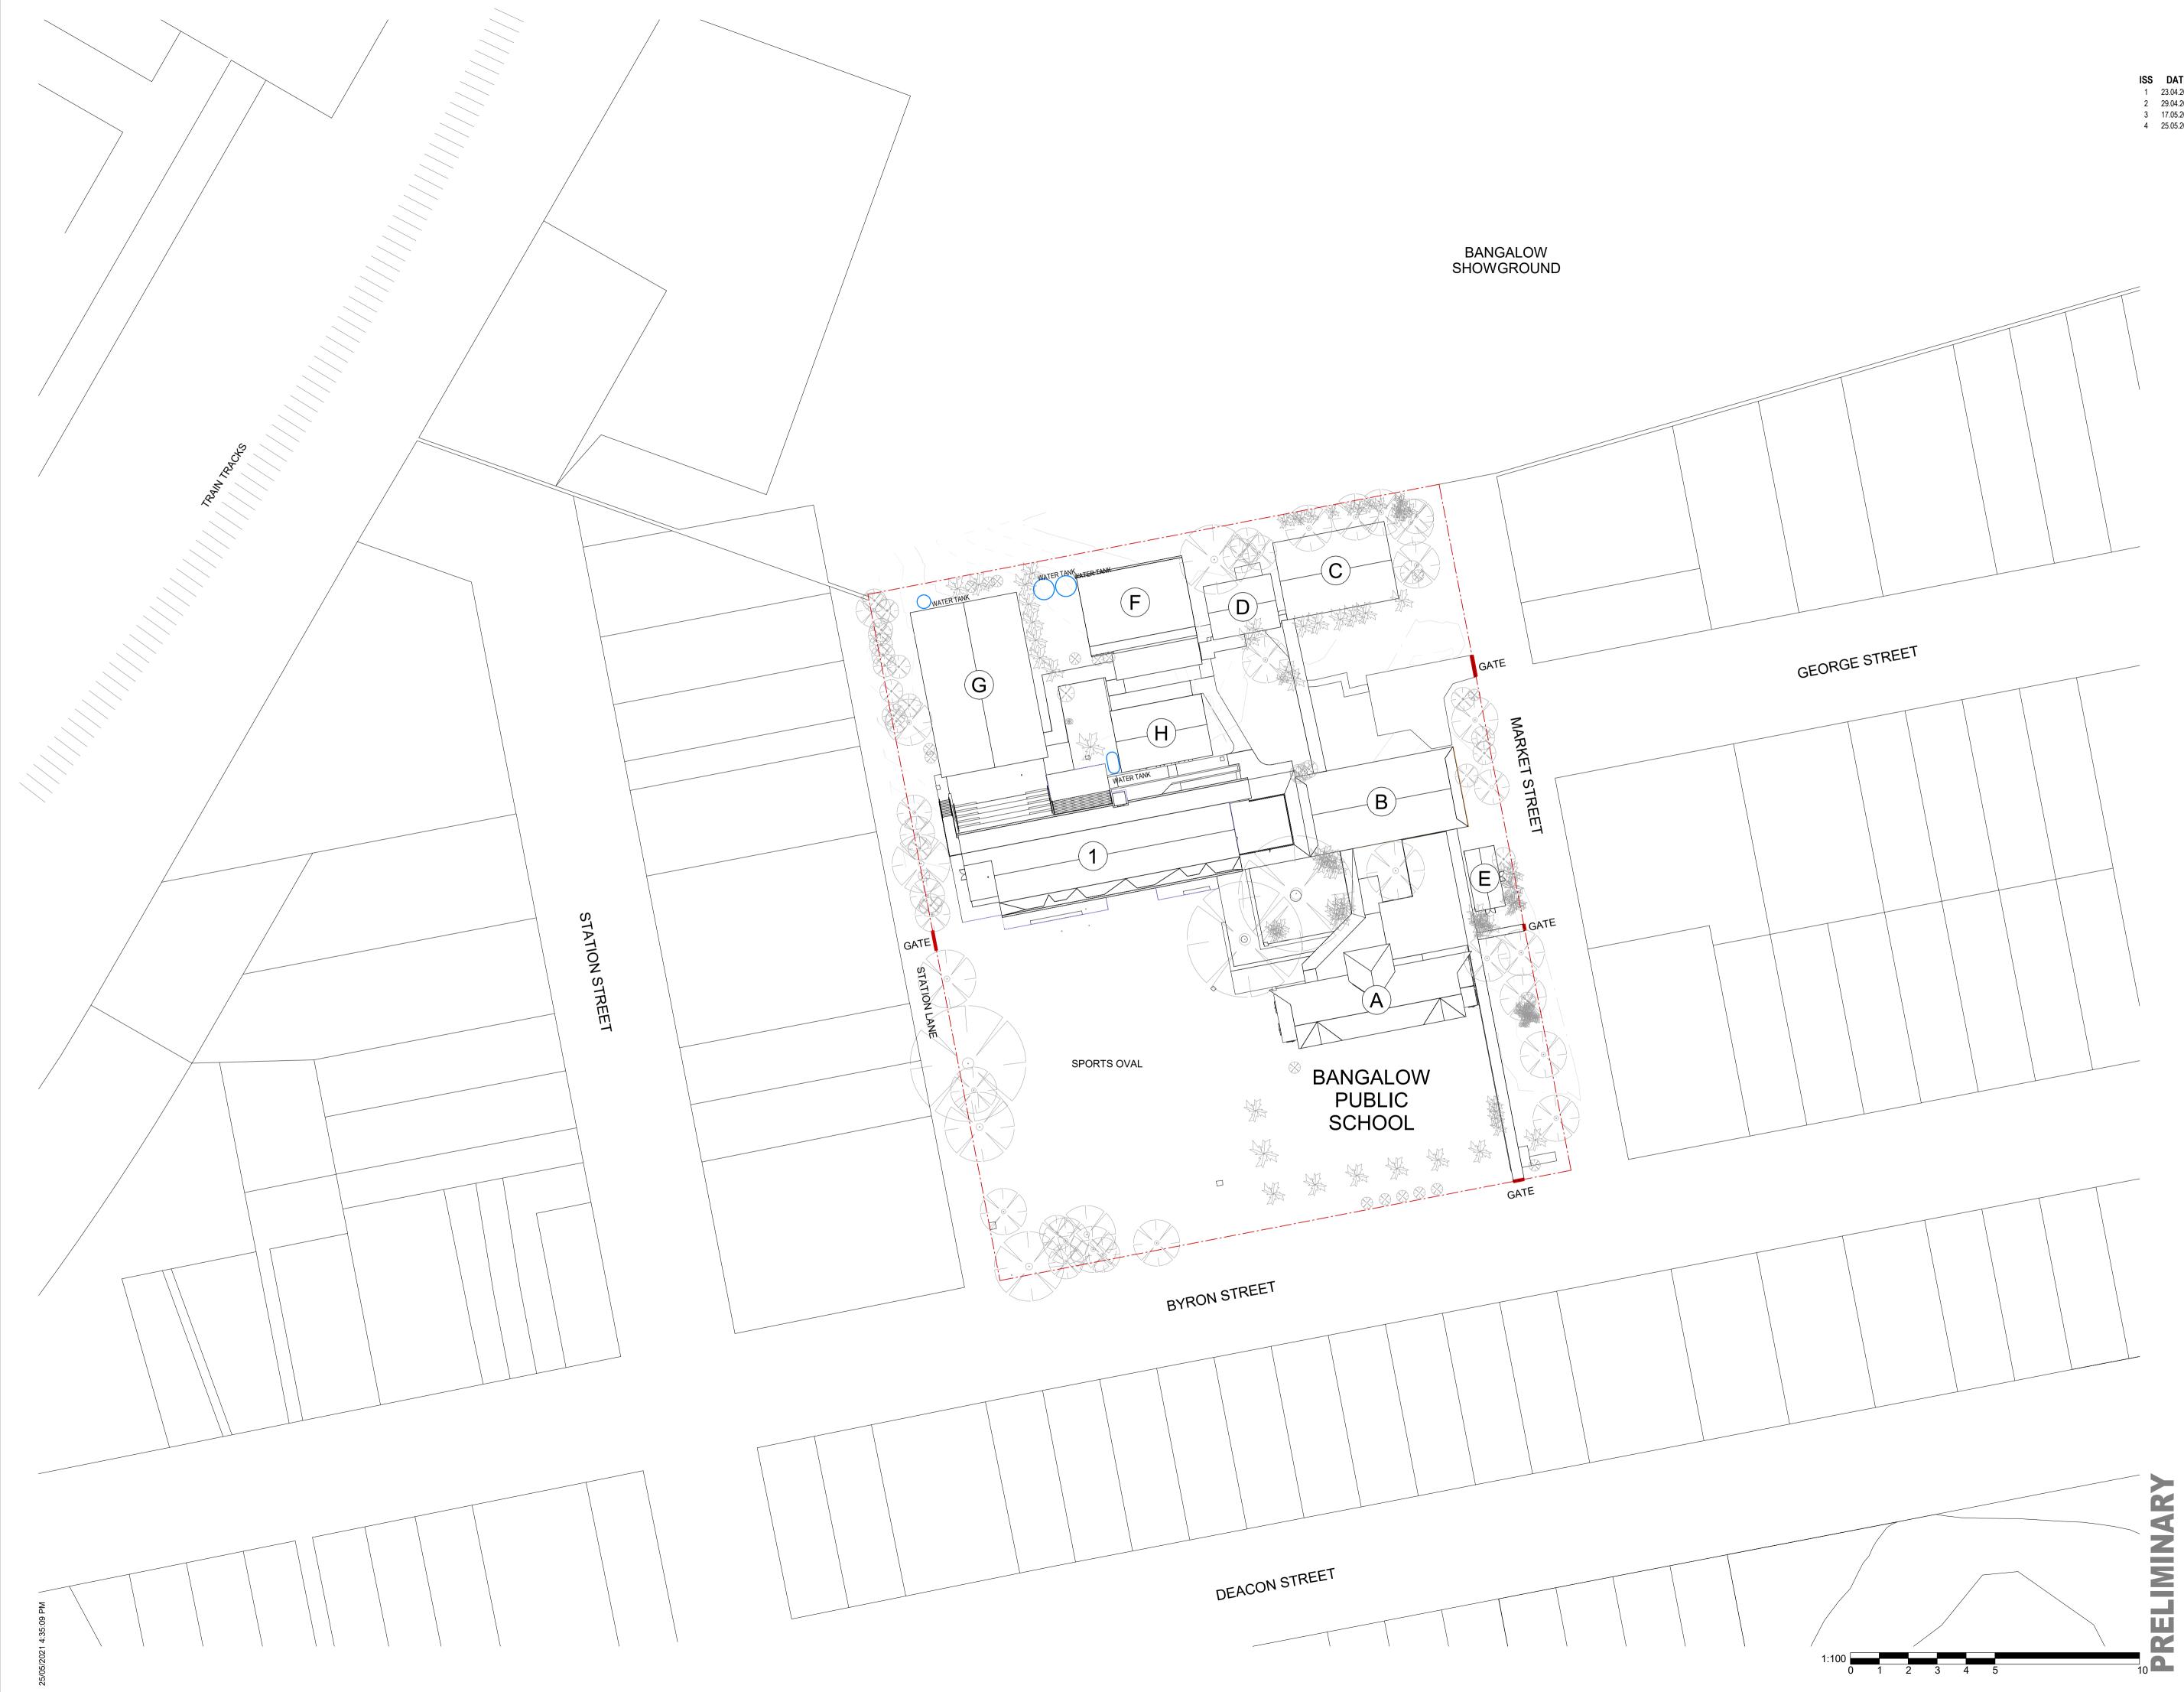
<u>Please see over for existing, demolition, and proposed plans which provide further detail to the Scope of Works. A full, detailed drawing package provided by Williams Architects is attached in Appendix B.</u>

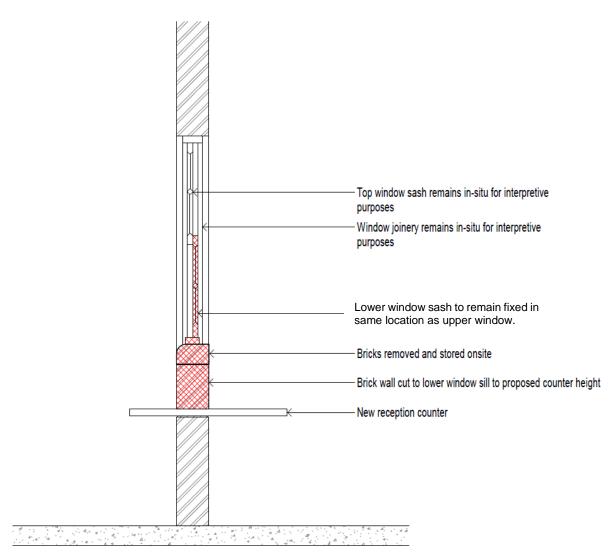
Figure 20: Sash window modification section detail for new reception counter (Williams Architects, 2021).

As indicated and abovementioned, the existing sash window will have the bottom window left in-situ with the above window sash, and the brick sill will be lowered, to facilitate the new reception counter. The windows and associated joinery will remain in-situ for interpretation. Salvaged will be protected and stored on-site. The storage of these elements allows for their future re-installation should it be required, resulting in these proposed works largely being reversible and meeting *Burra Charter* initiatives.
