PRELIMINARY CONTAMINATED LAND ASSESSMENT

**Planning Proposal for a Dwelling
Entitlement**

103 Yagers Lane, Skinners Shoot

For:	M. Schreiber
Report no:	21421-CL.docx
Date:	May 2022

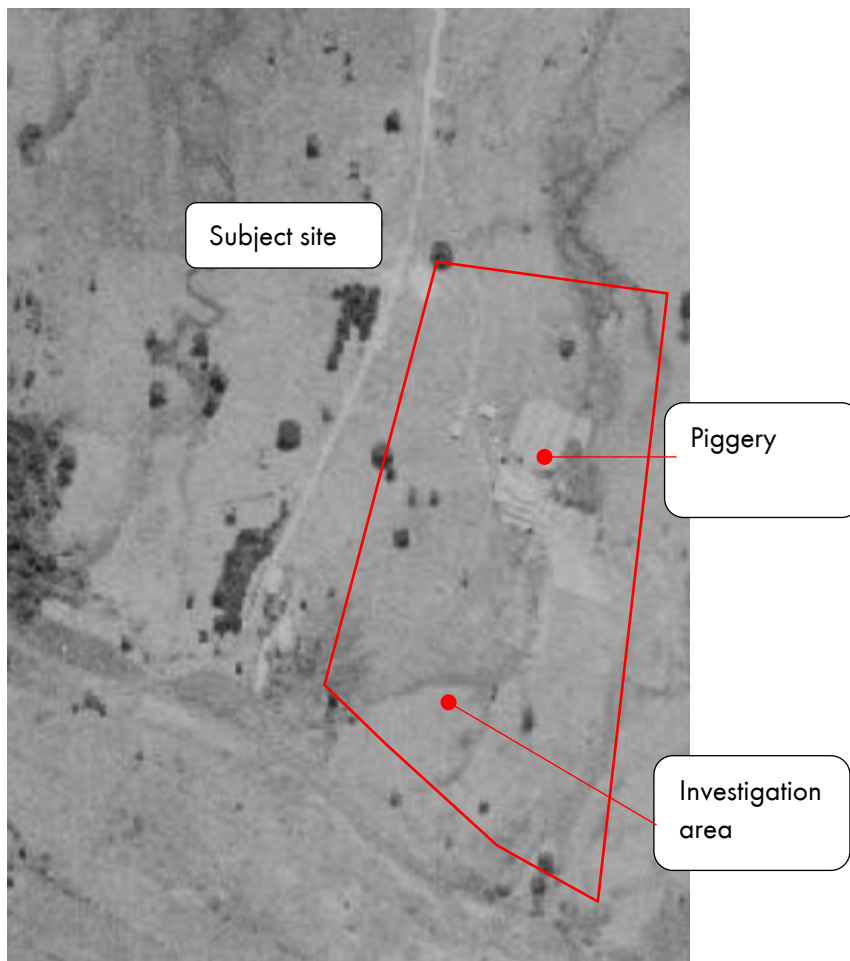
Figure 3. 1958 Historical aerial image (Source: NSW Spatial Collaboration Portal, 2021). Approximate boundaries

Year	Description
1958	Site is relatively clear apart from buildings in the northern portion of the allotment, most likely for the piggery. No buildings in the investigation area. Buildings observed to the west, being the dwelling.
1966	Similar to 1958, additional buildings at piggery. No buildings in the investigation area
1971	Additional buildings at piggery, large sheds towards the eastern boundary. Large effluent ponds to the north of buildings and water catchment to the south of buildings. No buildings in the investigation area. Another building, presumably a dwelling on property to the west.
1979	Additional buildings at piggery. Changes to effluent ponds to the north of buildings and additional water catchment to the south of buildings adjacent to investigation area. No buildings in the investigation area
1987	Similar to 1979. No buildings in the investigation area
1991	Similar to 1987. No buildings in the investigation area.

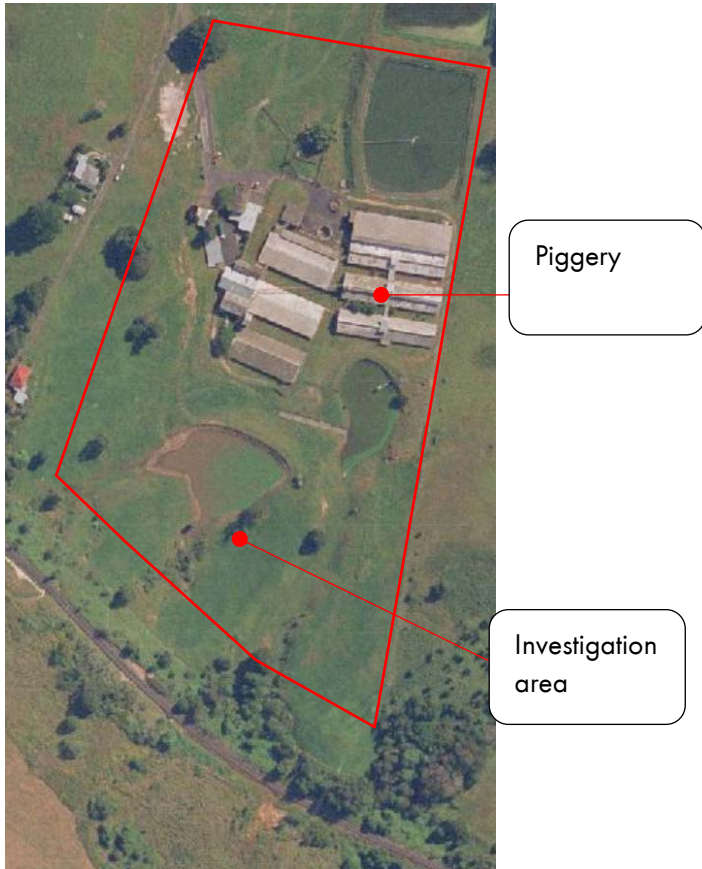
Figure 9. 1997 Historical aerial image (Source: NSW Spatial Collaboration Portal, 2021). Approximate boundaries

1997	Similar to 1991. No buildings in the investigation area.
2009	Similar to 1991. No buildings in the investigation area.
2014	Building to the south in the investigation area. Regrowth vegetation occurring.
2016	Building to the south and north in the investigation area. Regrowth vegetation occurring.
2021	Building to the south and north in the investigation area. Regrowth vegetation more dense.

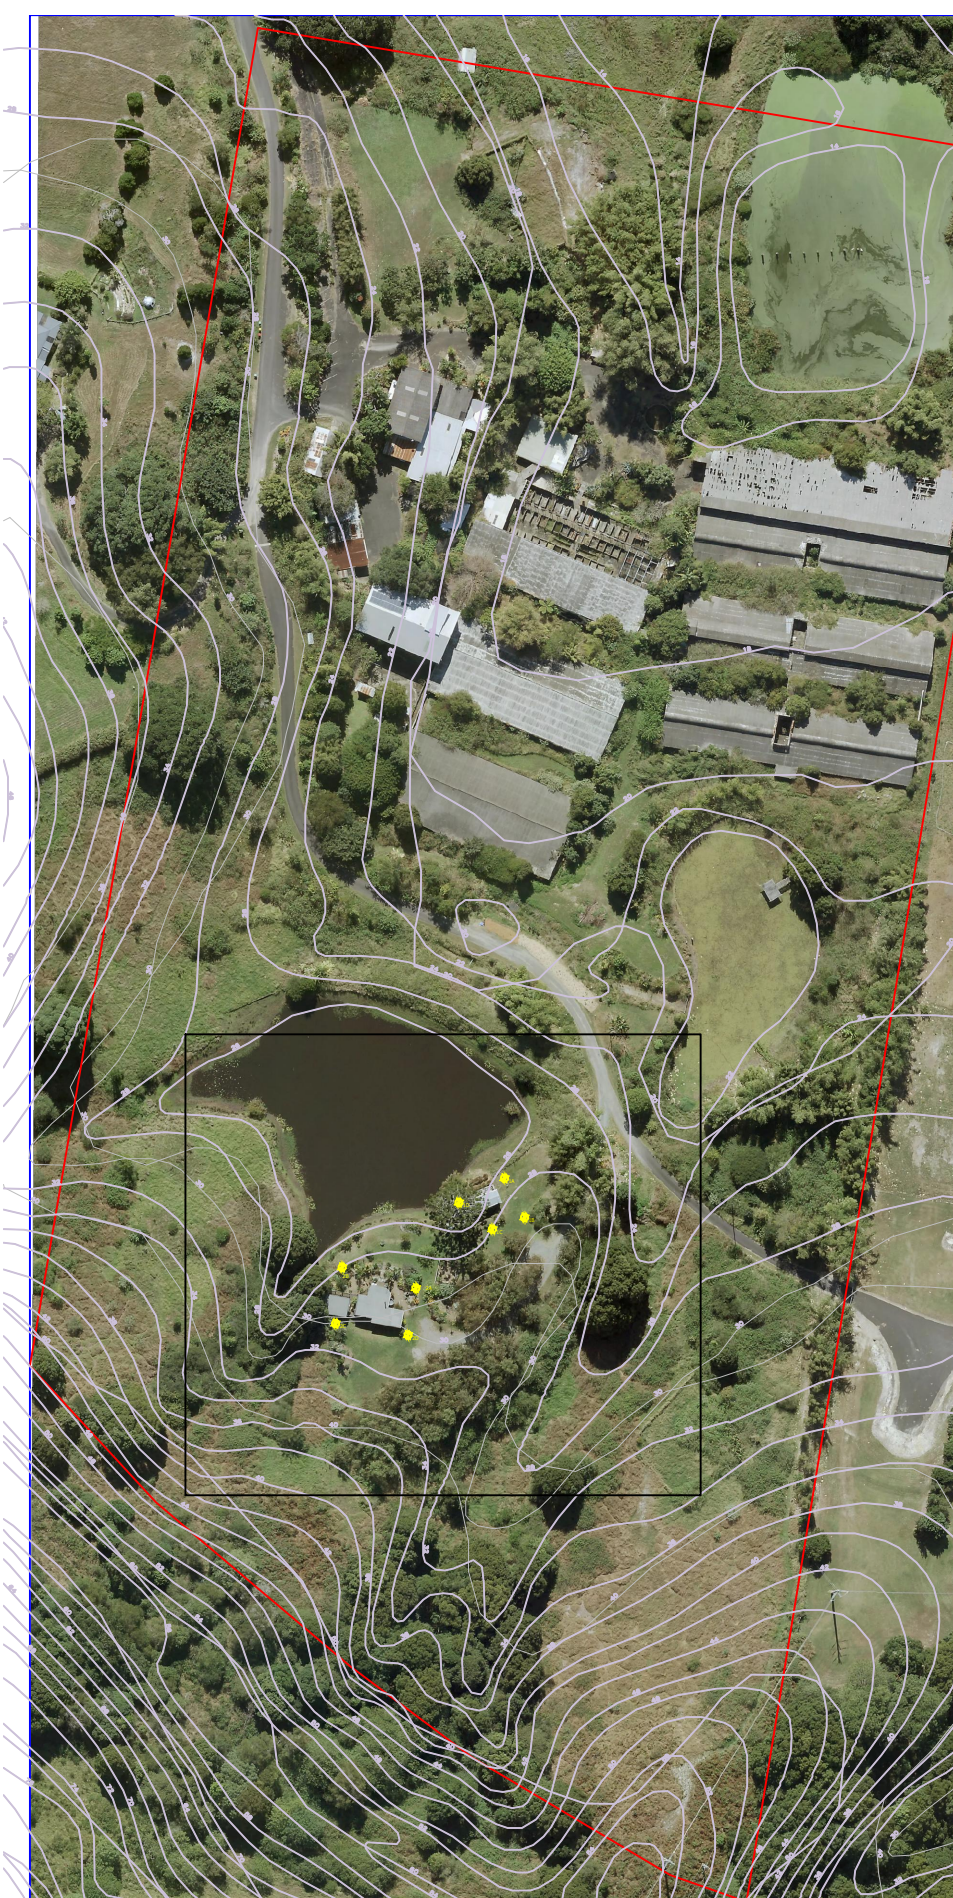
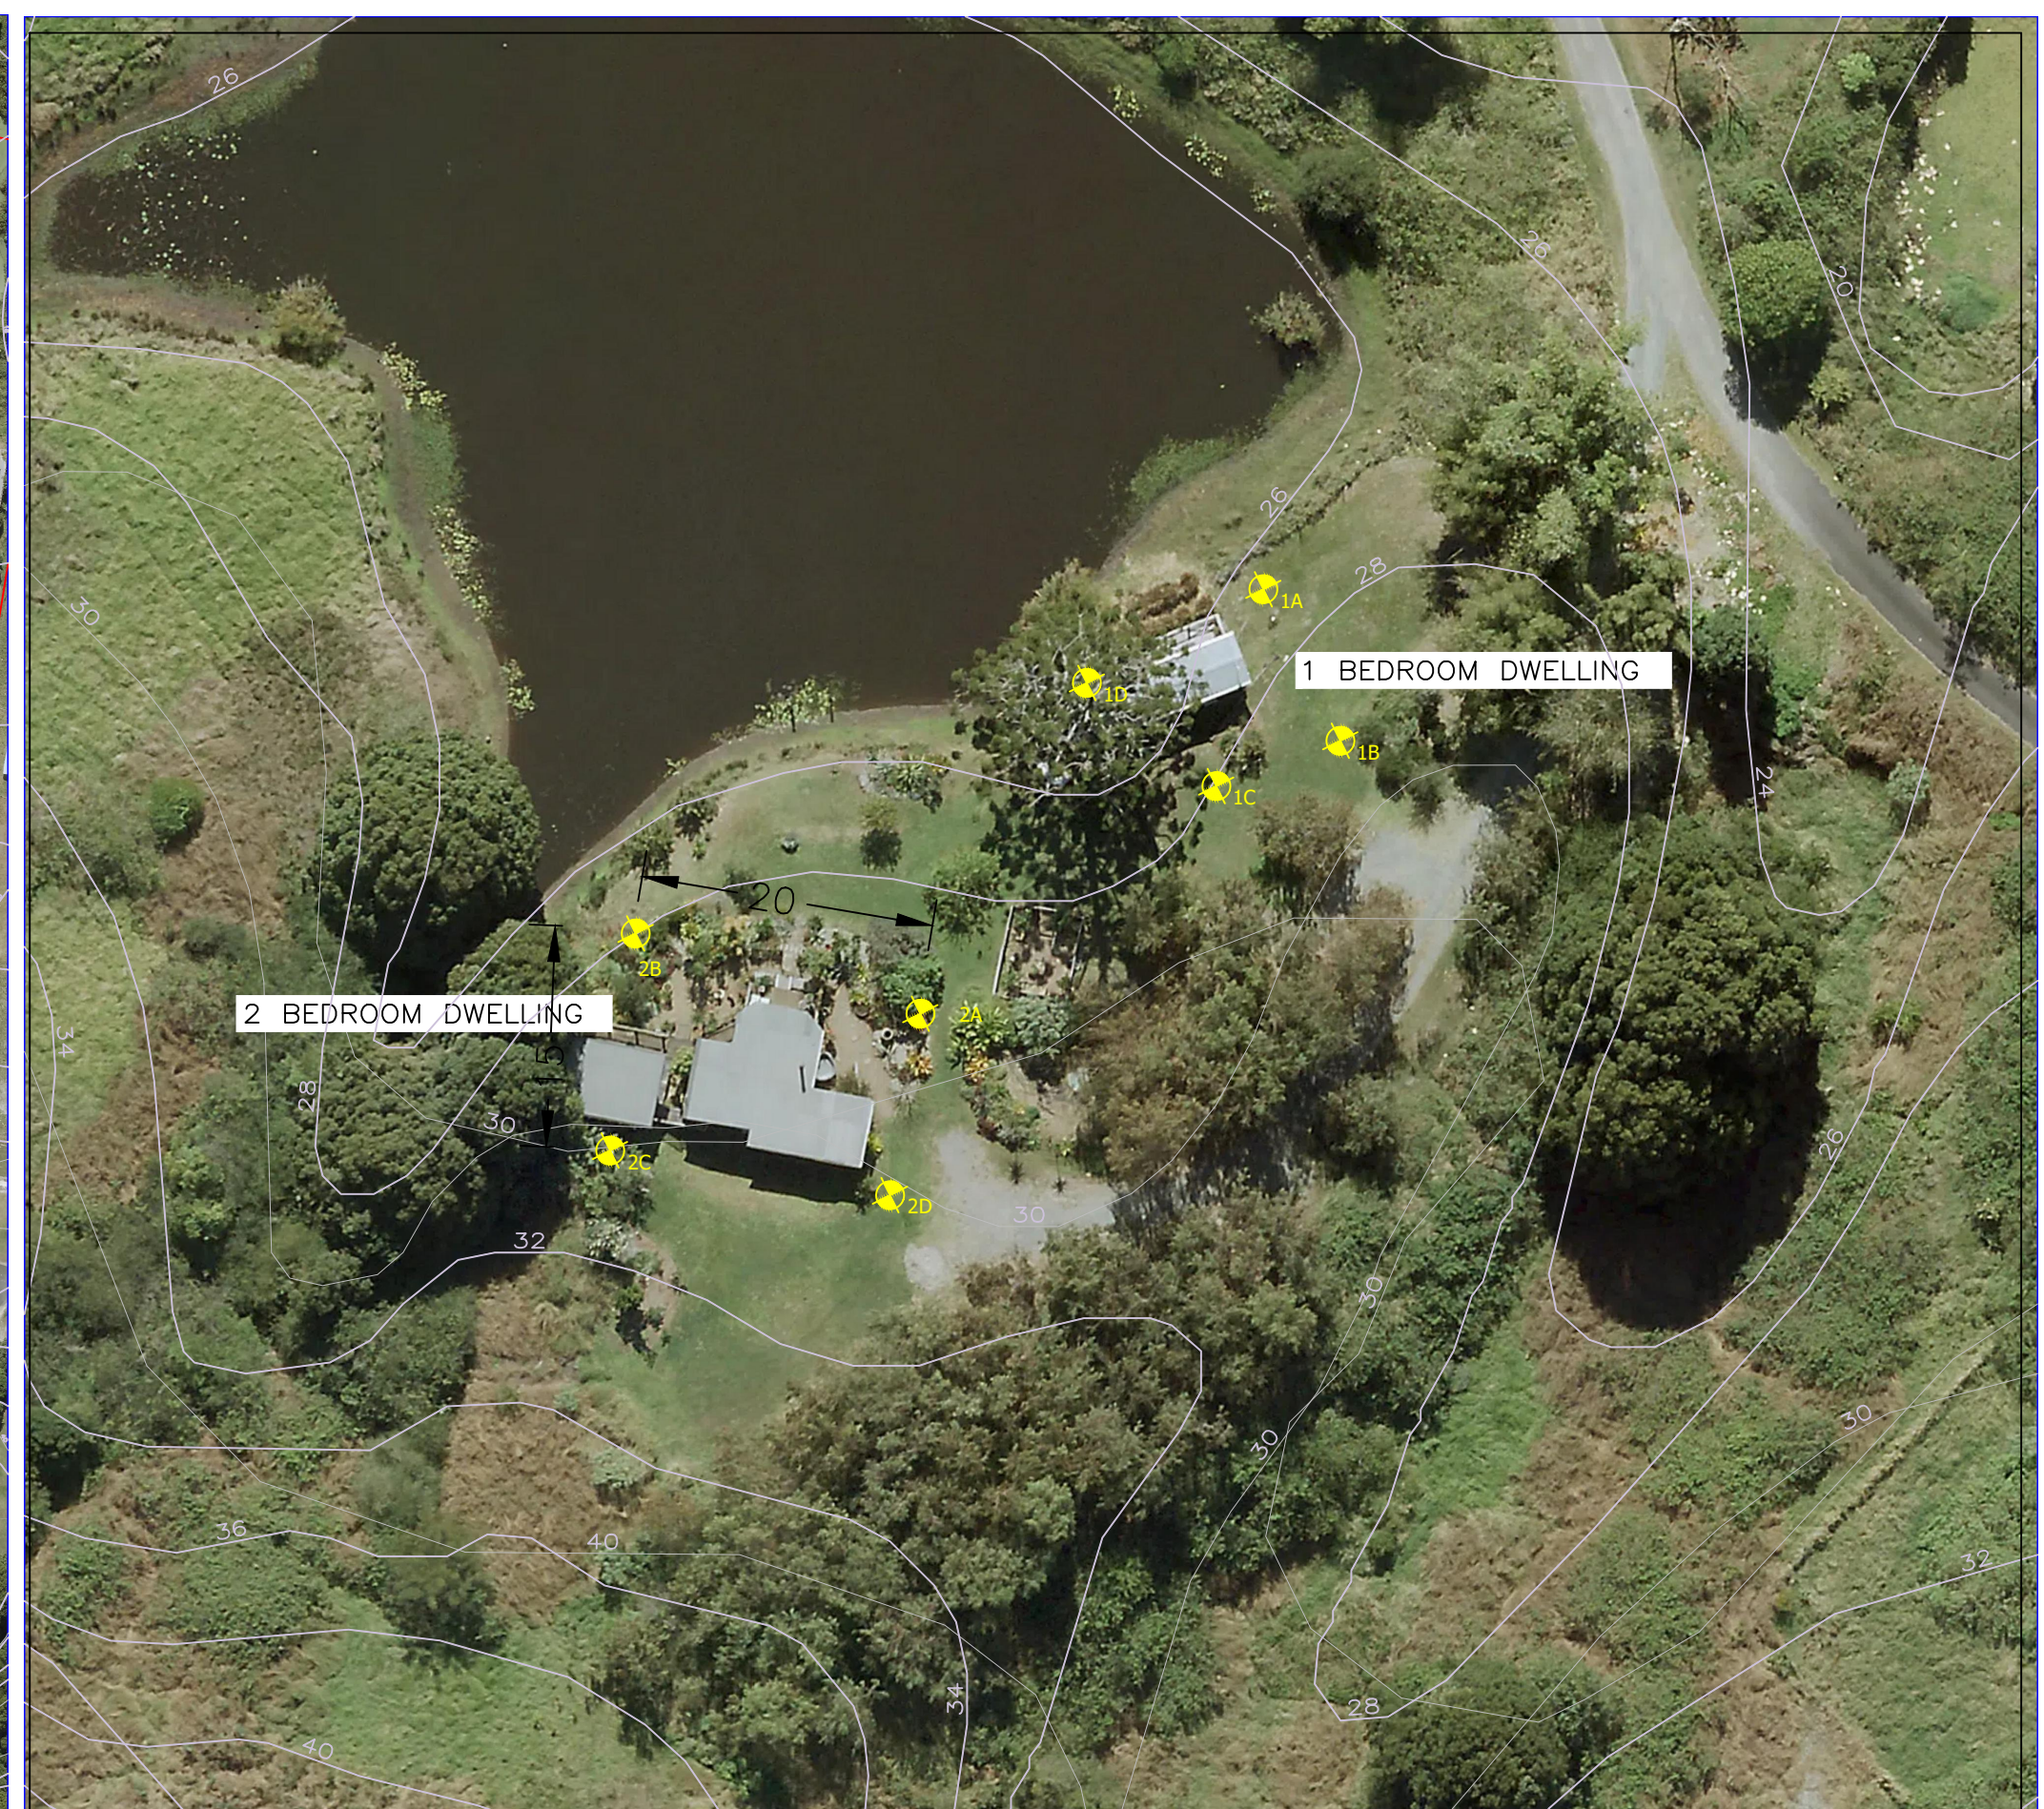
Composite 1 – Consisting of samples 1A, 1B, 1C and 1D. These samples were located around the northern dwelling and within the landscaping area to the south, up to 20 m apart.

Composite 2 – Consisting of sample points 2A, 2B, 2C and 2D. These samples were located around the southern dwelling and the landscaping area to the north of the dwelling, up to 20 m apart.

Exhibit No.2 presents the soil sample locations.
