**Re: Dilapidation Report  
Lots 12-14, Section 6, DP 4358, 68 Byron Street, Bangalow**

## DILAPIDATION REPORT

PROPERTY: LOTS 12-14, SEC 6, DP 4358  
68 BYRON STREET  
BANGALOW NSW 2479

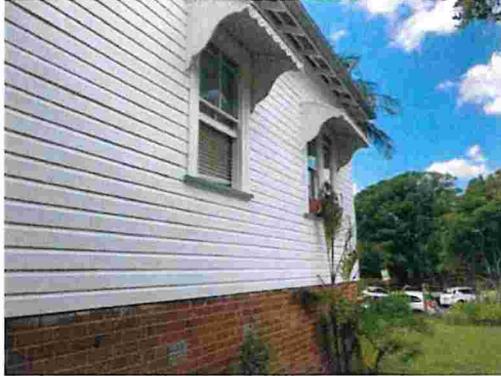
10. Clean metal window awnings to remove mould and dirt and repaint exposed surface areas 25m<sup>2</sup>. Paint with 2 coats to match existing colours.

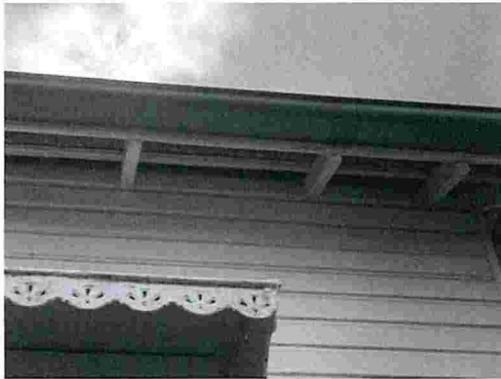
11. Remove debris in gutter and wash down (internal and external) with detergent. Use 'truck wash' or similar. 15m length.

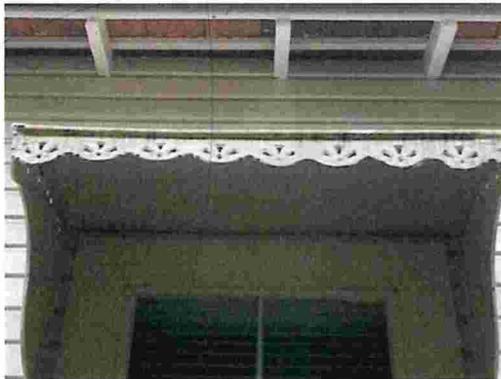
12. Exposed eave rafters to be lightly sanded and repainted, 27 rafters 125mm x 50 x 500mm long. Repaint with suitable exterior paint to match existing colours (minimum 2 coats).

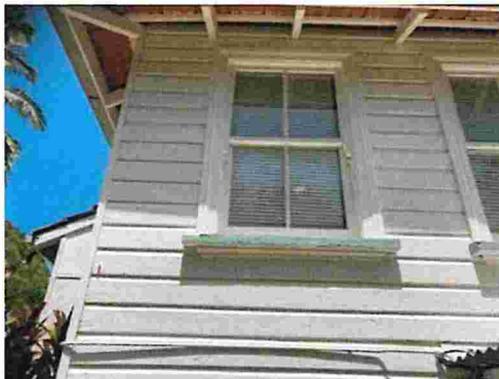
38. Eave and rafters – Lightly sand and repaint with 2 coats of external paint to match existing colour. Rafters – 75mm x 50mm x 500mm x 21 rafters. Eave area – 7m<sup>2</sup>.

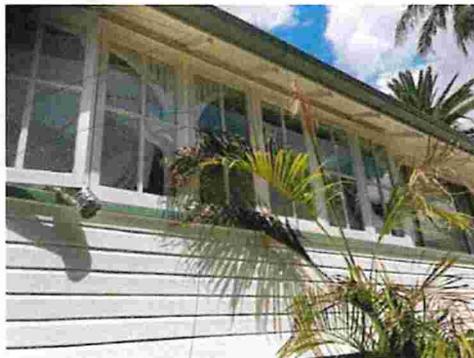
39. Eave and rafters – Lightly sand and repaint with 2 coats of external paint to match existing colour. Rafters – 75mm x 50mm x 500mm x 21 rafters. Eave area – 7m<sup>2</sup>.

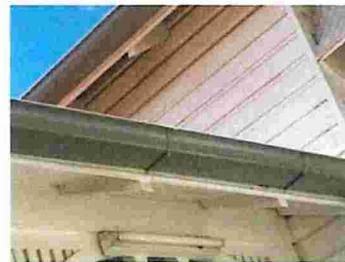
44. Wall ventilation openings – Install vermin proof mesh to prevent access to wall and roof space. Combined area 12m x 250mm.

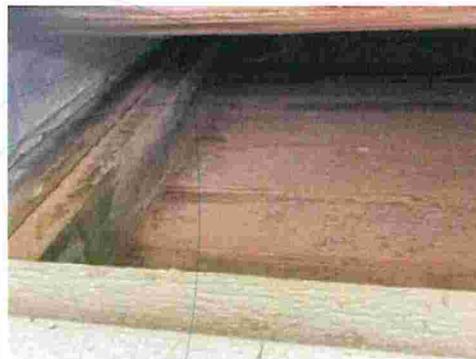
45. Cladding and verandah boards – 55m<sup>2</sup>. Wall cladding to be washed down with wall detergent wash. Lightly sand and repaint with 2 coats of external paint to match existing colour.

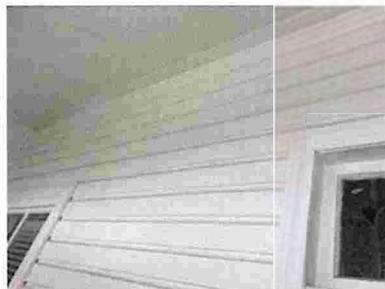
50. Remove and replace damaged concrete tread 1200mm x 500mm x 50mm to entry steps.

Remove and replace damaged chamfer board wall cladding adjacent to stairs 2m length to match existing. Paint with 1 coat of primer and 2 coats of external paint to match existing colour.

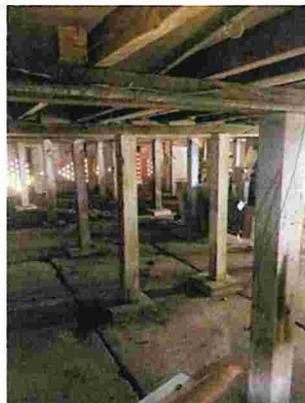
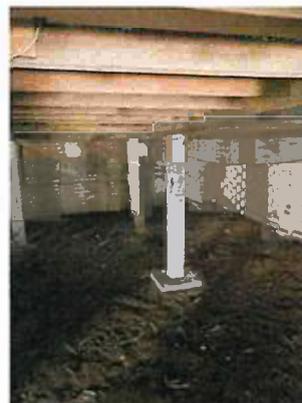
54. The inspection noted posts approximately 1.8m high, no cross bracing provided compliance with timber frame code and BCA is recommended. Structural Engineer to be engaged to provide subfloor-bracing solution.

Post missing and required to South West corner 2150mm high. 145mm x 145mm HWD with ant cap. Concrete pad on existing concrete slab 600mm x 600mm x 200mm high.
