30 October 2017

WRL Ref: WRL2017065:DH:JTC LR20171030

## **Clarkes Beach Access**

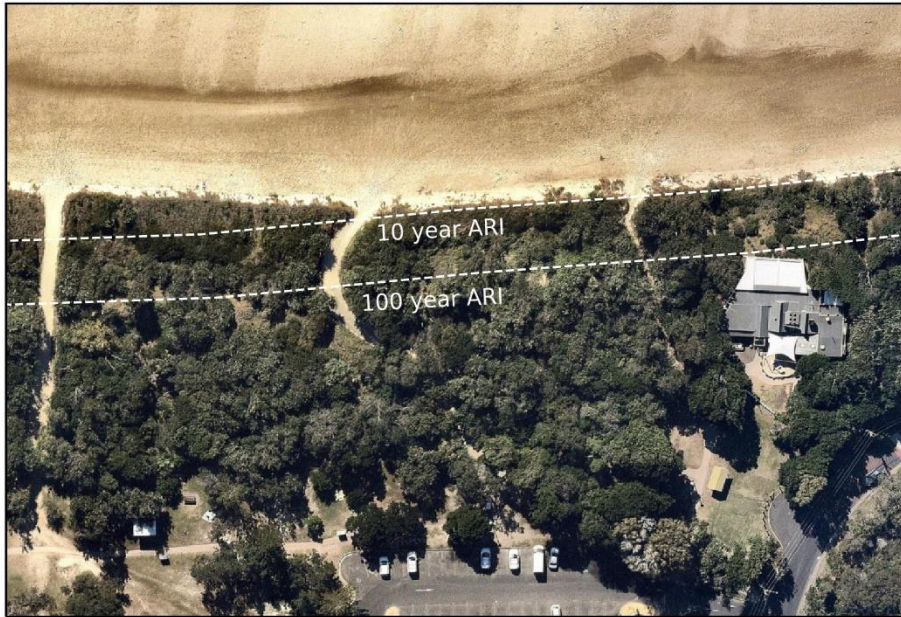
**Figure 4. Approximate storm erosion hazard lines (image: Nearmap)**

Depending on the final design of the beach access path, it may be exposed to waves and/or dune reshaping from storm events. This section of Clarkes Beach is active, and the historical photogrammetry beach profiles show large variation in the past 70 years (Figure 3). The access path is within the 100 year ARI erosion hazard line (Figure 4). Erosion hazard lines for this study are based on the "zone of slope adjustment" calculated using the Nielsen (1992) method, on the 1999 surveyed beach profile, with erosion volumes based on guidance from Gordon (1987).

- Landward of the 100 year ARI erosion zone:
  - Any option can be pursued, noting that elevated structures can allow vegetation growth and fauna passage;
- Between the 100 year ARI and 10 year ARI erosion zone:
  - A rigid option founded on piles will allow the continuation of a planar ramp with only occasional interaction with coastal processes. Such piles will need to be founded on bedrock or designed with sufficient foundation friction.
- Seaward of the 10 year ARI erosion zone:
  - A board and chain structure with a maximum gradient of 1V:4H is recommended.
  - Minor local beach scraping and adjustments to the boards will be needed to retain beach access following storm erosion events.
