## Terrace Holiday Park: Southern Precinct Arboricultural Impact Assessment

**Terrace Holiday Park  
Brunswick Heads, NSW**

**March 2018**

**C91119**

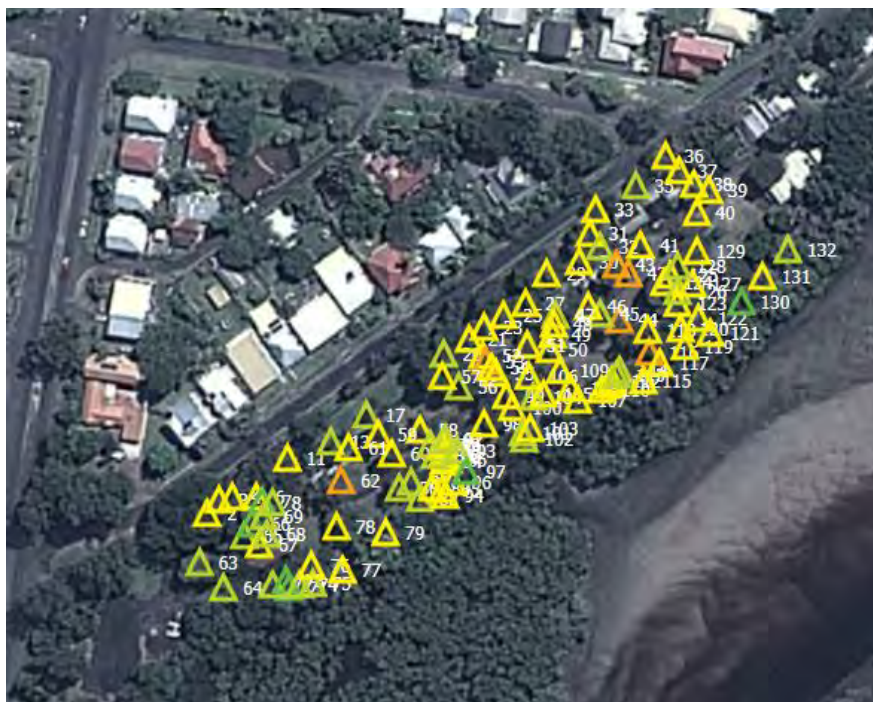
Figure 2. Aerial image showing icons representing the existing trees situated within the Terrace Holiday Park Southern Precinct. ArborSite, March 2018.

5.5.3 The health of the 115 existing trees located within the Southern Precinct have been rated as good (79), fair (39) or poor (3), during the most recent 2017 ArborSafe assessment (refer to Appendix B – Explanation of Tree Assessment Terms).

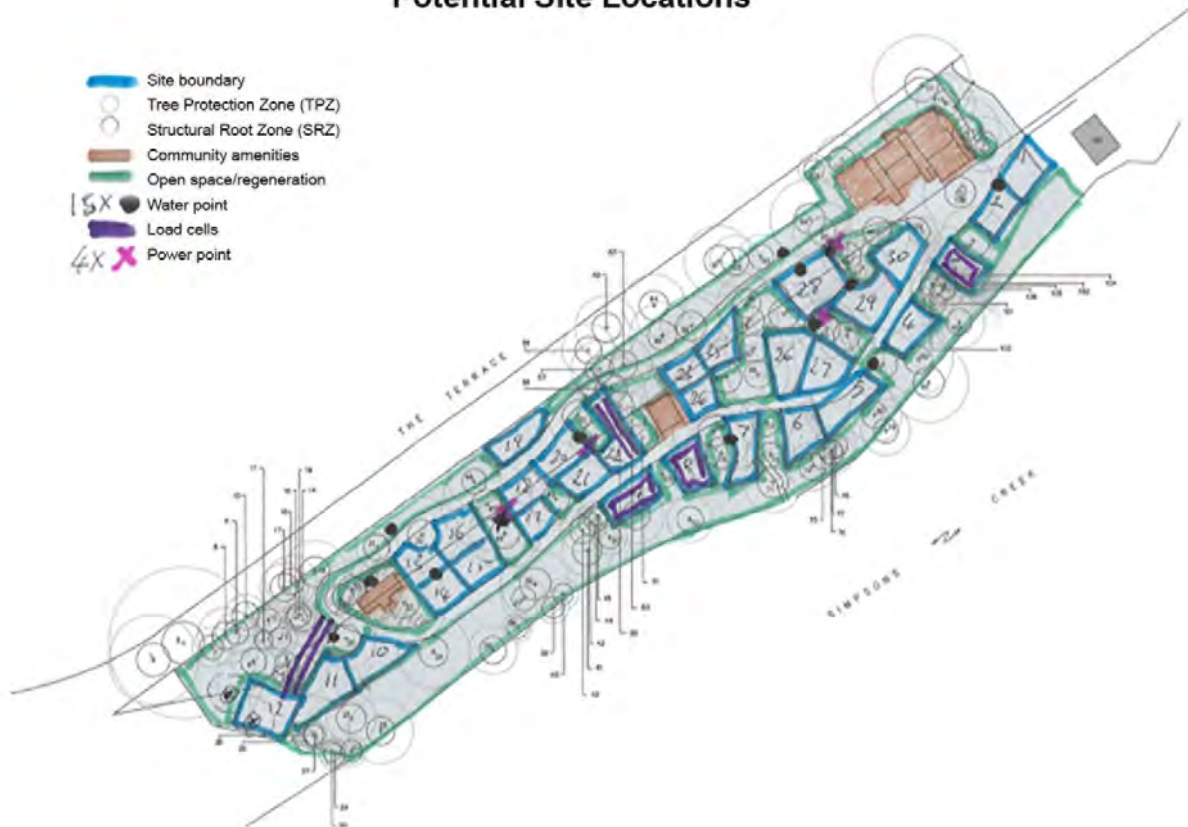
Figure 4. Site sketch showing potential site locations, regeneration/open areas, load cell installation sites, water and power points, tree positions with TPZ and SRZ. Source: ArborSafe 2018

- 8.6.4 The TPZ and SRZ for each tree situated within the Terrace Holiday Park Southern Precinct has been calculated and is shown on the proposed site location diagram Figure 4 and within the individual tree data as Appendix F.

- 9.5.2 New/additional areas for planting can be found in small pockets of land and mulched areas in and around the existing camping areas situated within the Southern Precinct along with the newly formed buffer zone (see Figure 4).

- 9.5.3 By defining individual camping sites, potential planting and regeneration locations will become apparent in the unused open areas and the larger of the mulched, interlocking TPZ zones with species relevant to the CCPF. (see Figure 4).
