Site Audit Statement

Site audit statement no. **0503-1904**

Title **Site Audit Report Former South Byron Sewage Treatment Plant Broken Head**

Byron Shire Council
Former South Byron STP
Long Term Environmental Management Plan
1 Broken Head Road, Byron Bay

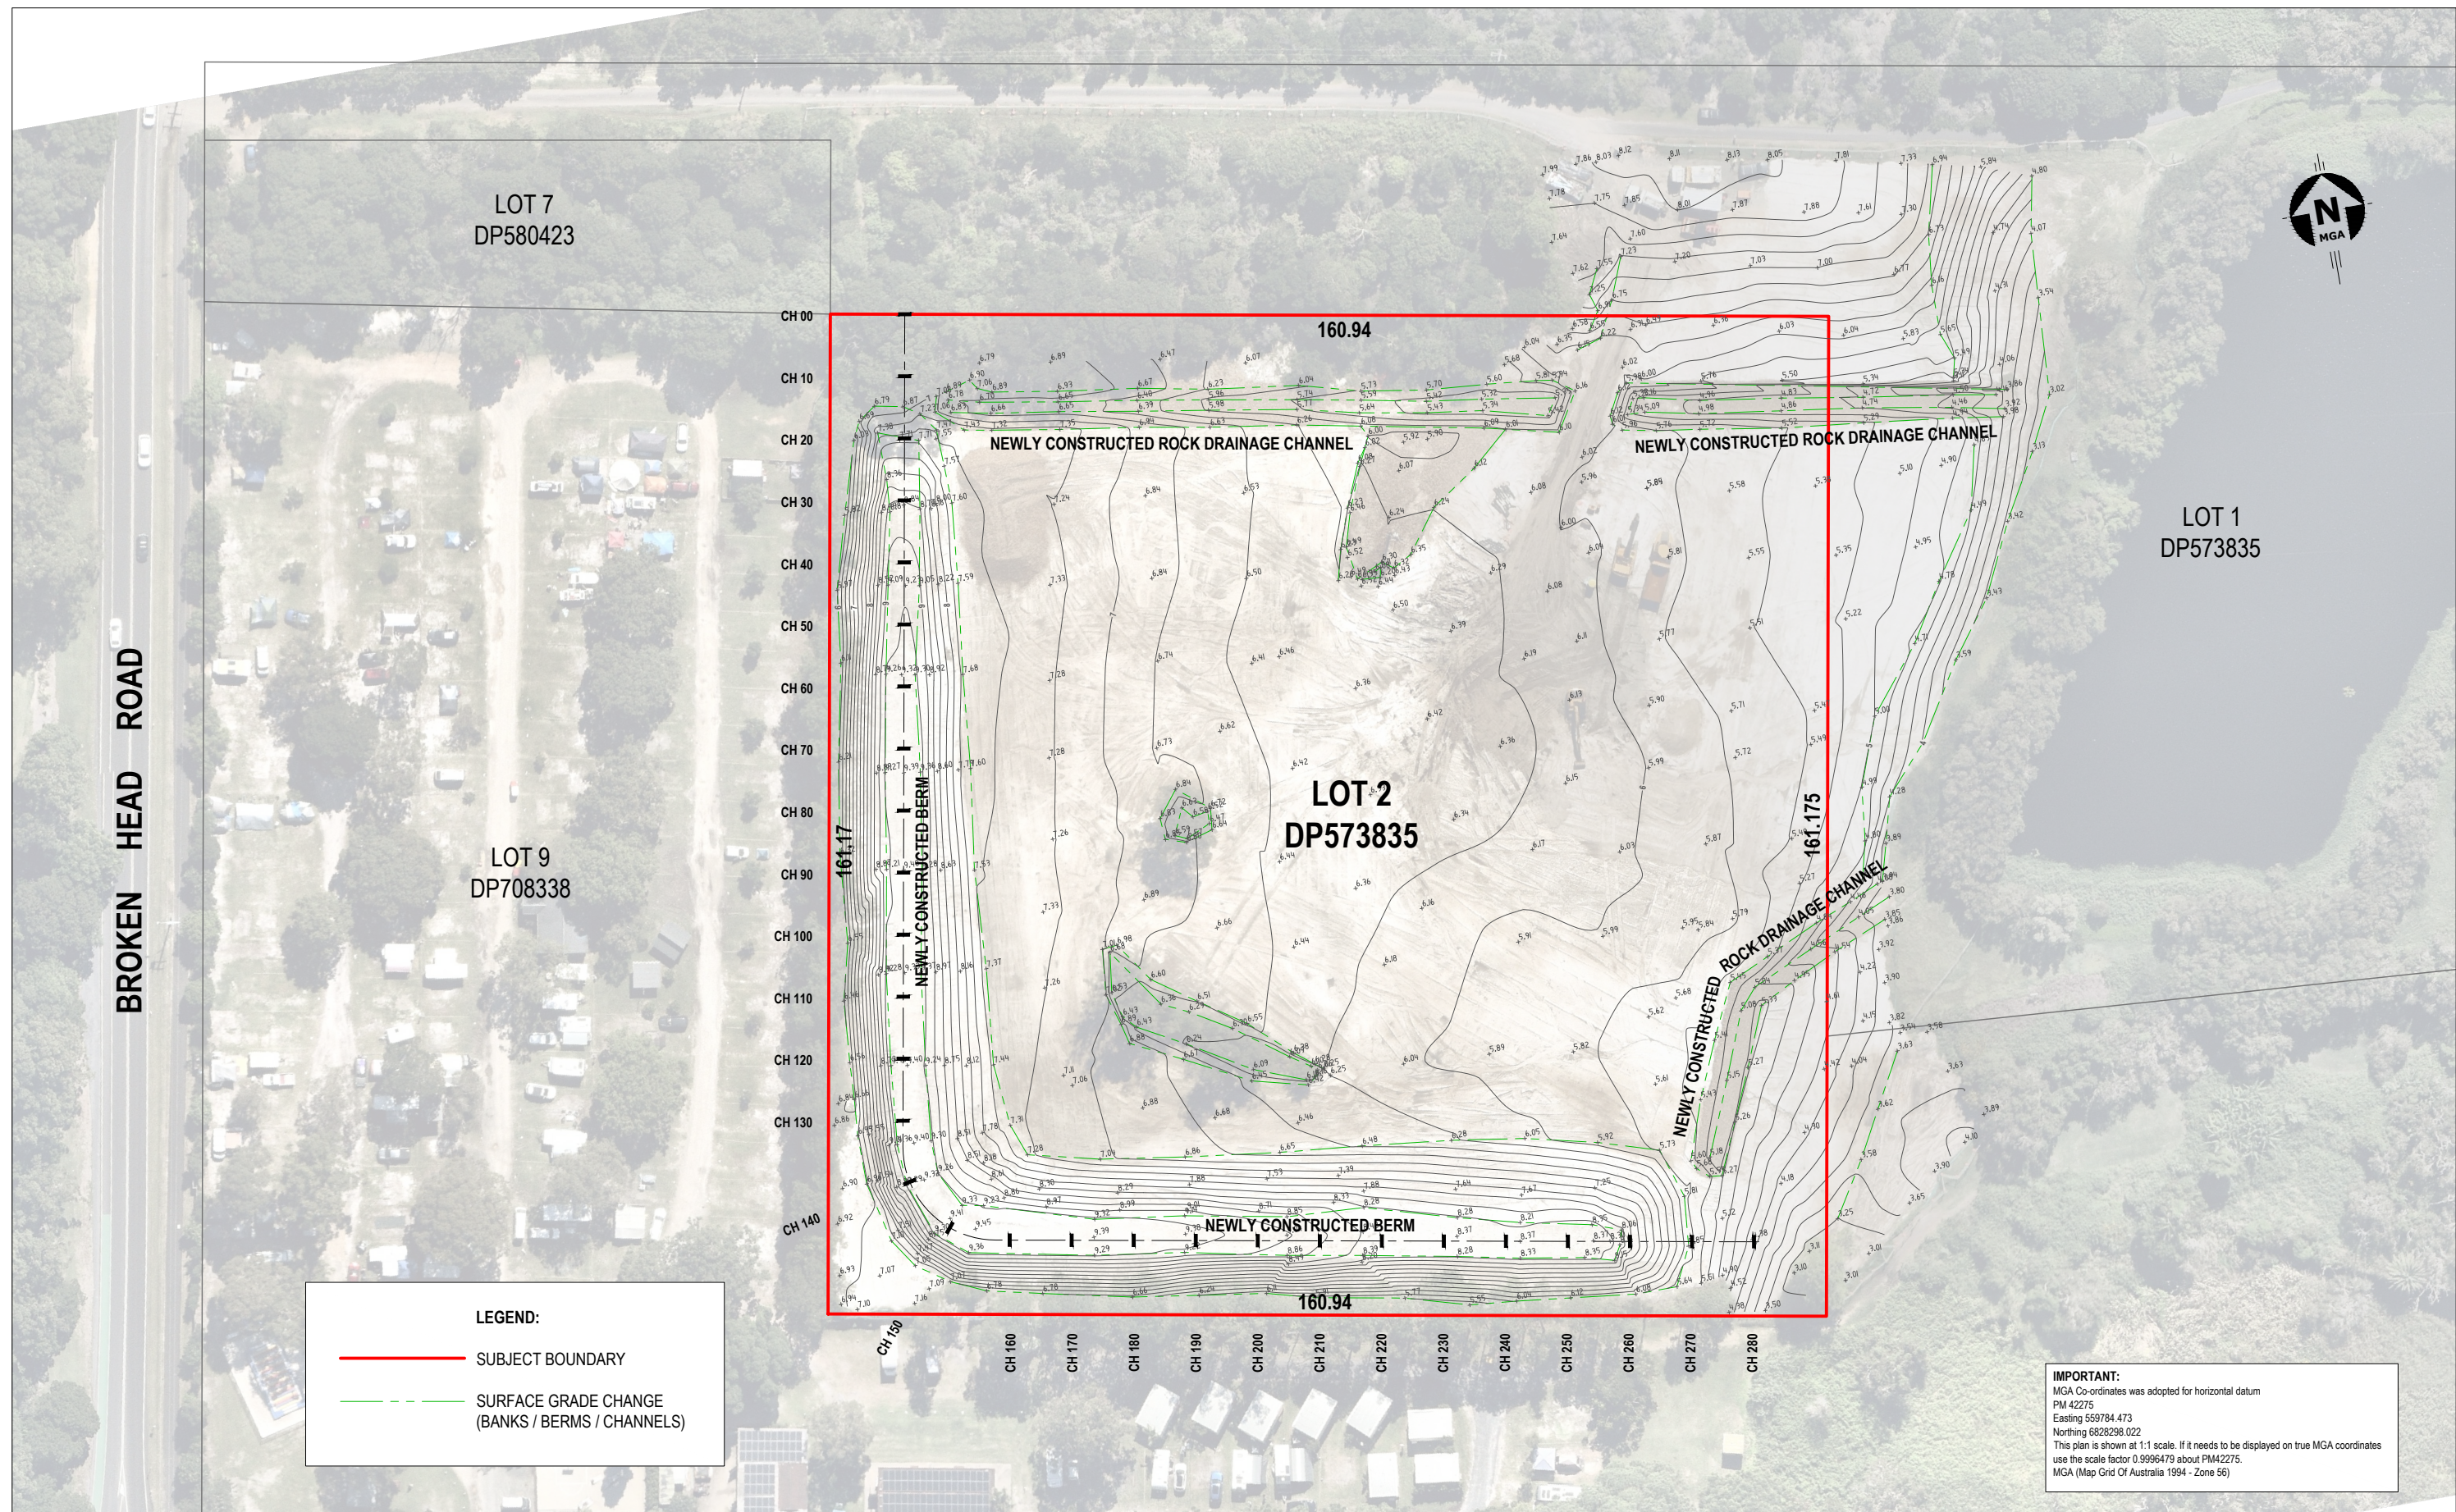
FIGURE 2A

The berm occupies the western and southern boundary of the site, as shown on Figure 2, Appendix A. The berm comprises:

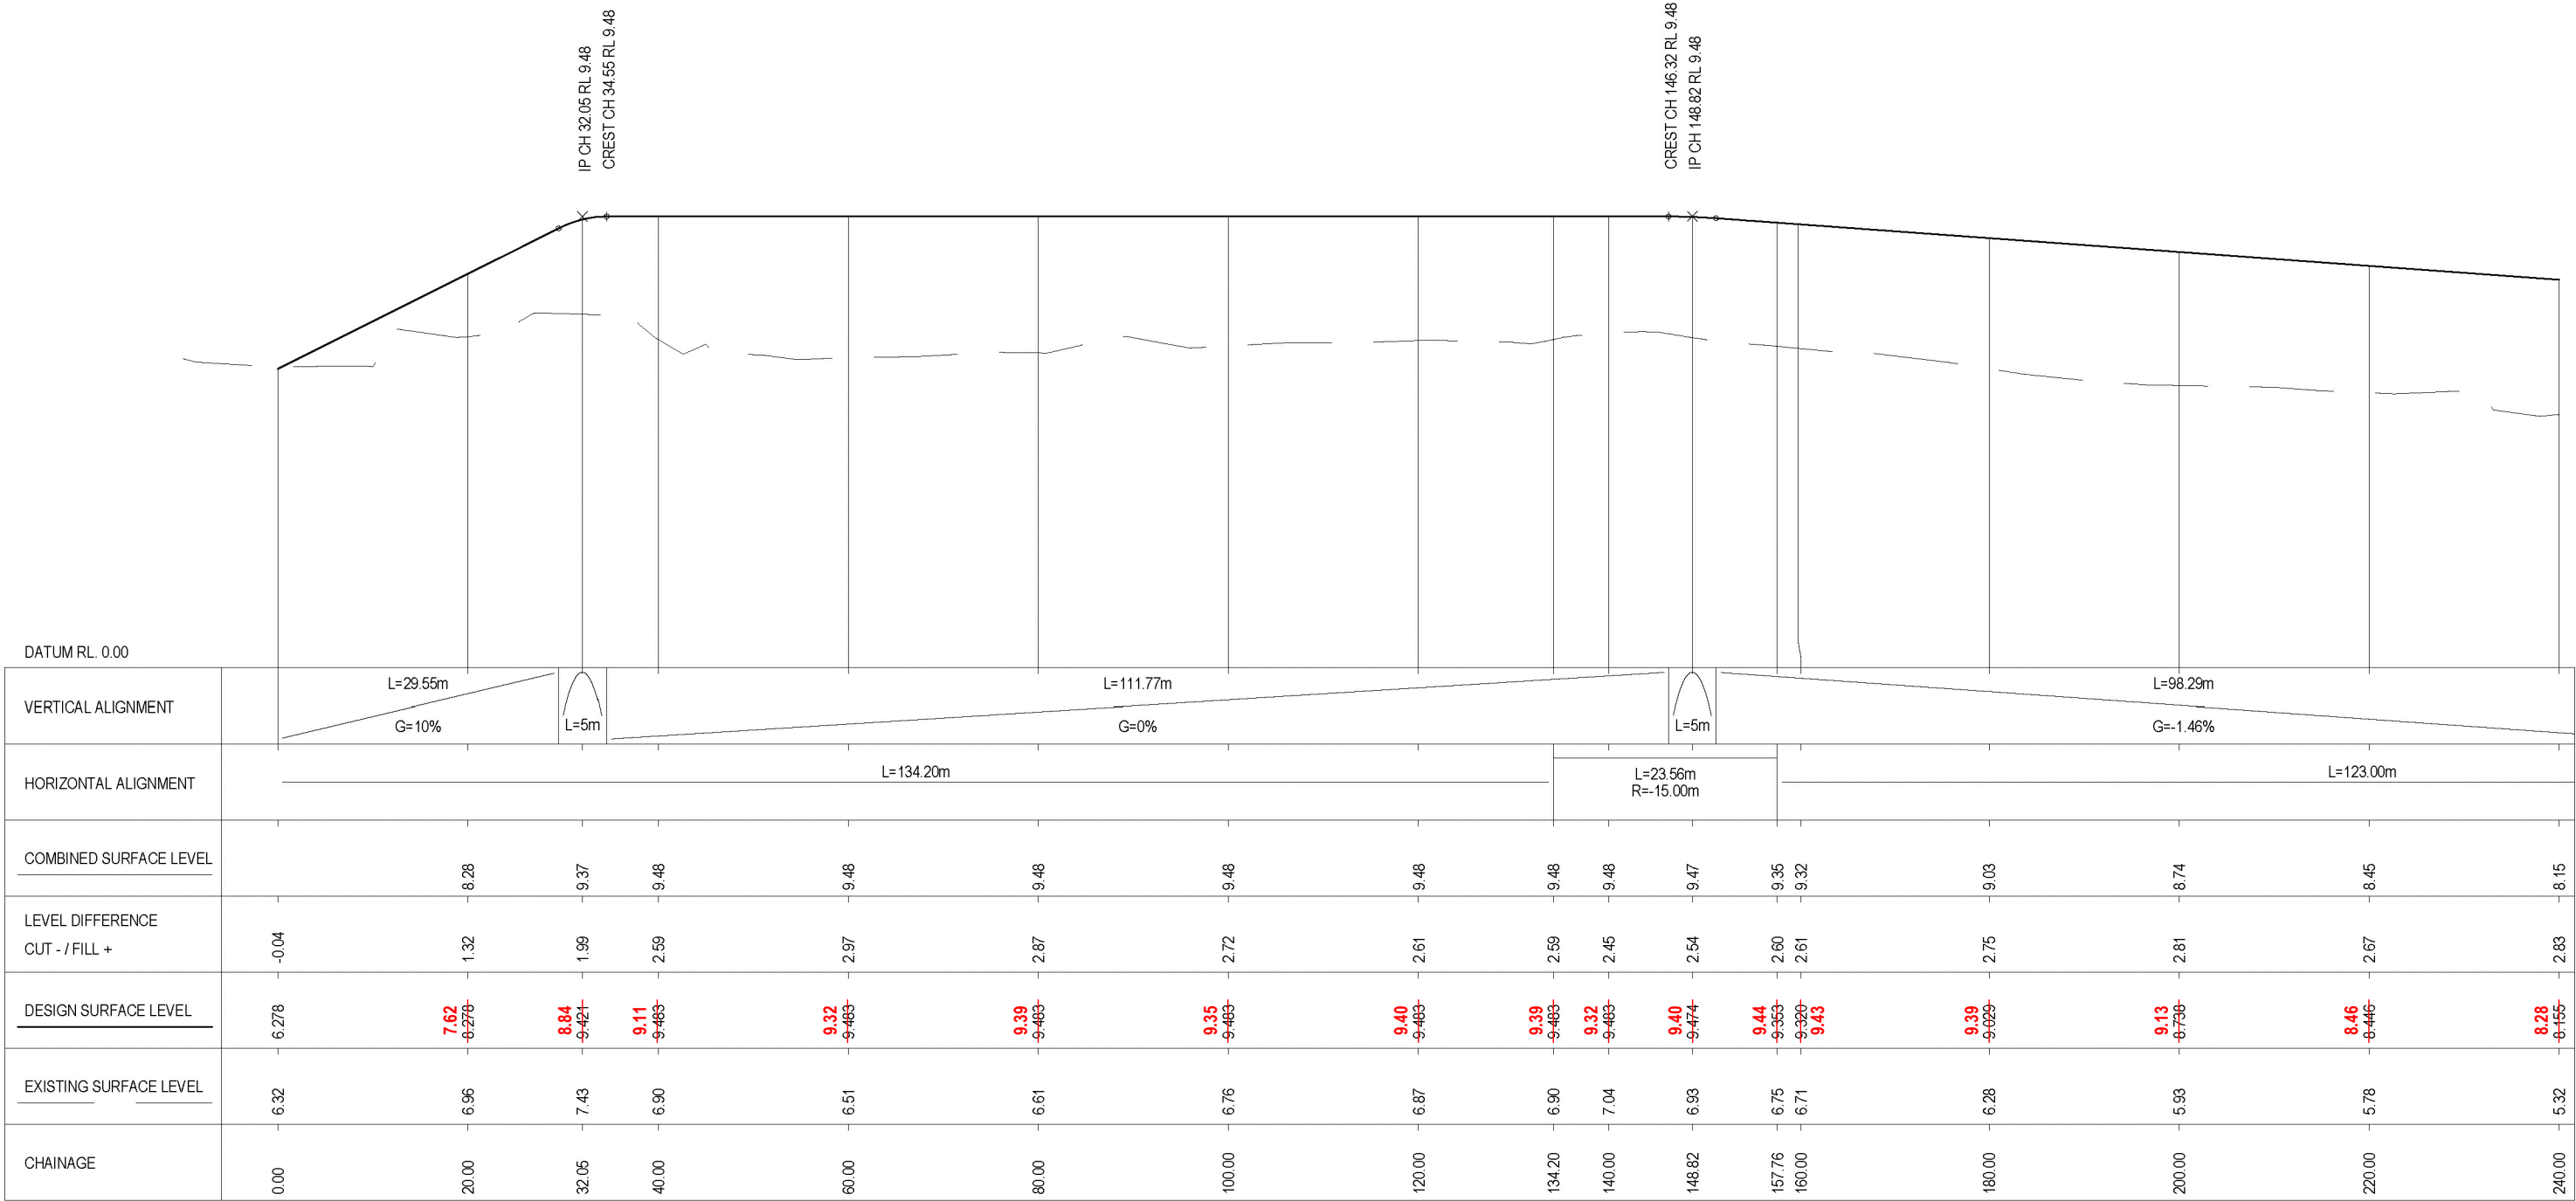
LONGITUDINAL SECTION - BERM01
SCALE H 1:500 V 1:100

- The berm core, which was filled with physical and chemical contaminated soil (as shown in Figure 2C to 2G, Appendix A).
- A layer of geofabric, which extends around the physical and chemical contamination in the berm core.
- A layer of capping material (minimum of 1 m thickness) above the physical and chemical contaminated soil and geofabric.
- Topsoil (200 mm thickness).
