# Arboricultural Impact Assessment Report

STP West Byron Byron Bay.

Client: Byron Shire Council.

PO Box 81, Burringbar NSW 2483. Ph 0414186161 3rd February, 2020.

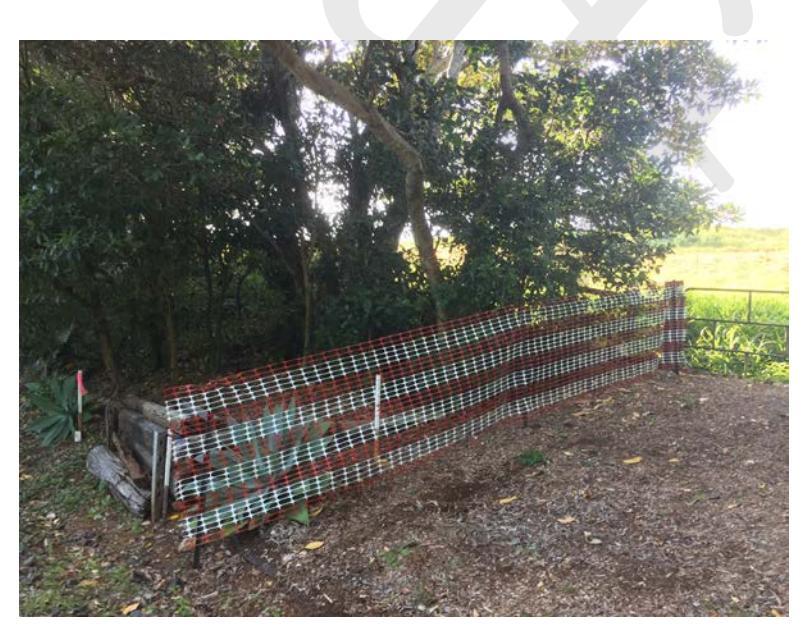
Figure 1. Example of high visibility temporary fencing.

The Standard recommends a temporary 1.8 m high fence to be placed around the TPZ. In this development some works will be required to be undertaken near trees that are to be retained. It is recommended that the trees be protected by the installation of a 1 m high visibility plastic mesh fence. An example of high visibility protective fencing is shown in Figure 1 below. The location of the fence is shown in Attachment
