# WATER, WASTE AND SEWER ADVISORY COMMITTEE MEETING

Report No. 4.1 Inflow and Infiltration - Sewer Asset Management

Mullumbimby - 4001 Gravity Sewer Condition Assessment

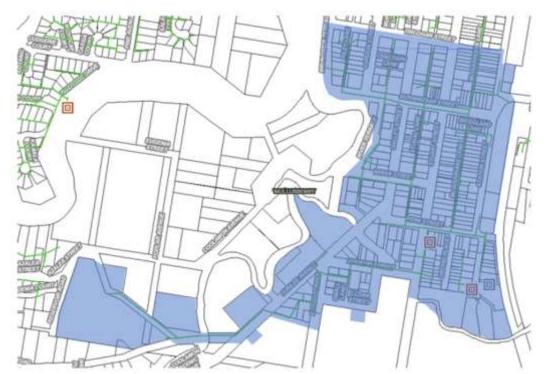
Figure 1 - Mullumbimby Condition Assessment Scope Extent

The current scope of works for this project has focused on a small catchment of the gravity sewer network upstream of sewer pump station (SPS) 4001 within Mullumbimby including the stormwater network encompassed by the blue hatch in the below map. Mullumbimby is a low lying town that is located adjacent to the Brunswick River. This portion of the sewer catchment consists largely of Vitrified Clay (VC) pipe which is prone to brittle failure (cracking) and is therefore subject to high rates of I&I.

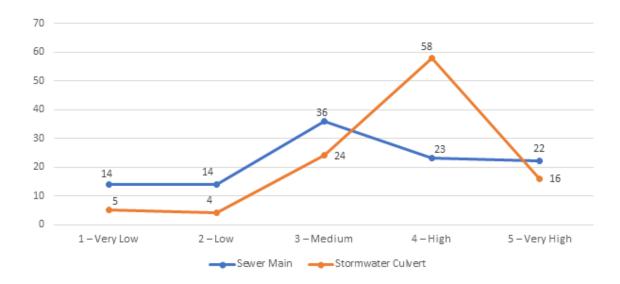
Figure 3 – Risk Score Summary

Figure 3 presents the overall risk score summary for both the sewer mains and stormwater culverts.

From Figure 3, it can be determined that 41% of the sewer network and 69% of the stormwater network within the project extent is either a high or very high risk of failure.

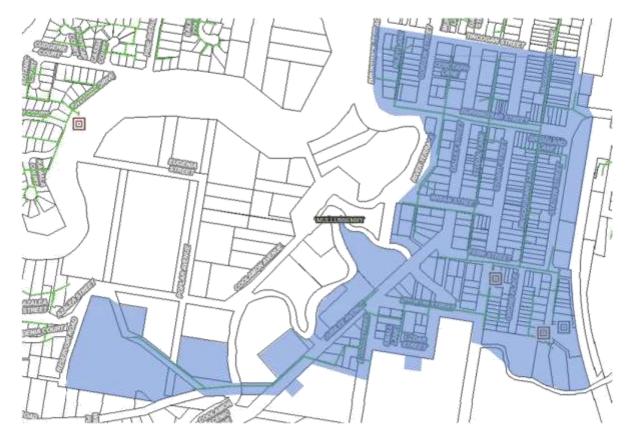
Figure 1 | Gravity sewer catchment 4001 - Mullumbimby, NSW, Source: Byron Shire Council GeoCortex 2019

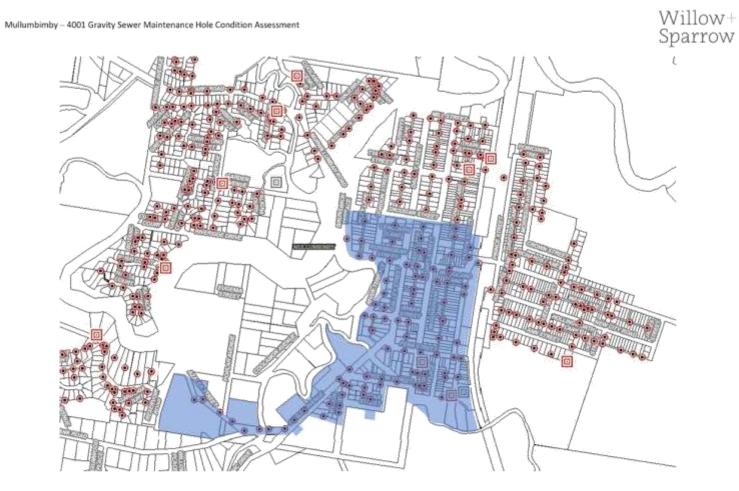
Figure 1 | Gravity sewer catchment 4001 - Mullumbimby, NSW, Source: Byron Shire Council GeoCortex 2019

This Condition Assessment report has been prepared for the gravity sewer catchment as shown in Figure 1. The Mullumbimby catchment upstream of 4001 comprises a gravity sewer system that services hundreds of residential properties in addition to the Mullumbimby CBD. The MHs encompassed by the blue hatch in Figure 1 are the mains that have been addressed in this Condition Assessment report.

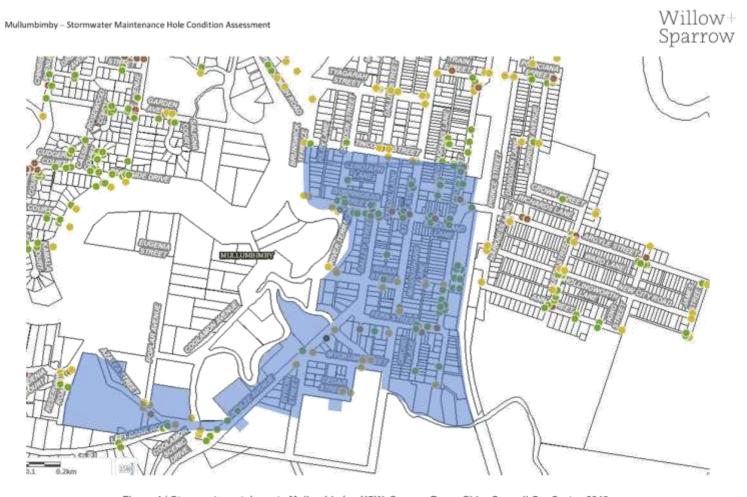
Figure 1 | Stormwater catchment- Mullumbimby, NSW, Source: Byron Shire Council GeoCortex 2019

This Condition Assessment report has been prepared for the stormwater catchment as shown in Figure 1. The Mullumbimby catchment comprises a stormwater network that services hundreds of residential properties in addition to the Mullumbimby CBD. The red MHs encompassed by the blue hatch in Figure 1 are the MHs that have been addressed in this Condition Assessment report.

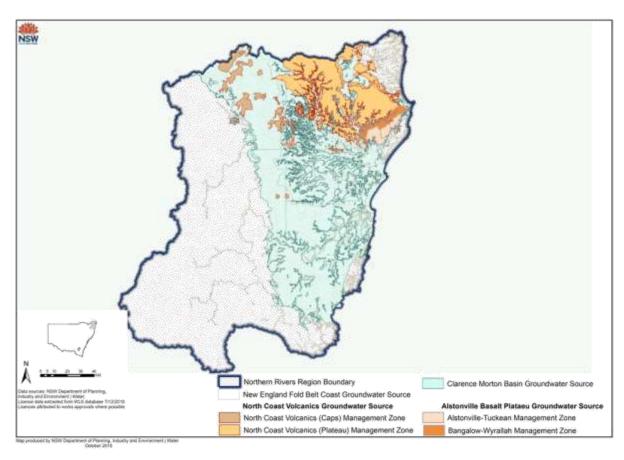
Figure 1: Map of Northern Rivers region showing boundaries of the four groundwater systems

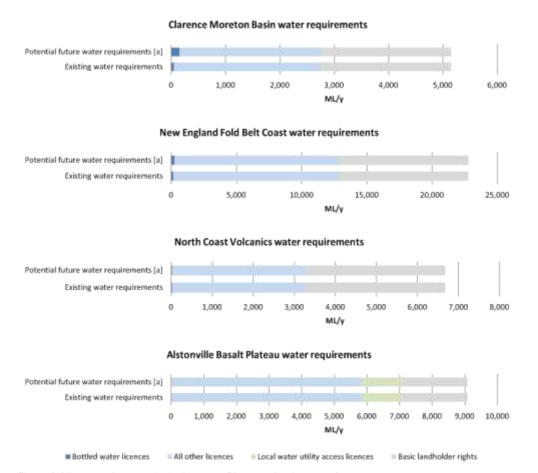
Figure 5: Water requirements in the Northern Rivers region by groundwater source
[a] Potential future water requirements includes proposals for water extraction for water bottling where the proponent (1) has already obtained water allocations or works approval; and (2) is seeking, or has indicated that they will seek a development application, or will commence operation. This analysis assumes that no additional non-bottled water industry water requirements are created – however if this occurred, then the fraction of water requirements associated with the water bottling industry would be even smaller.

Water licences associated with the current and proposed future expansions in the bottled water industry represent a very small portion of the overall water requirements <sup>10</sup> from groundwater sources in the Northern Rivers region (Figure 5). These licences represent an even smaller portion of total groundwater recharge in the Northern Rivers region, as most groundwater recharge is reserved for the environment or is not licenced (Figure 6).

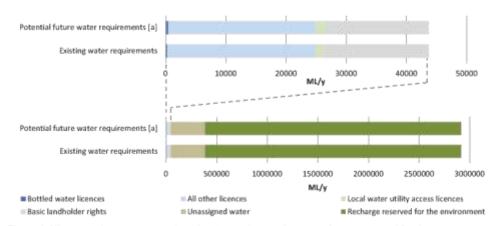
Figure 6: Water requirements, unassigned water, and groundwater recharge reserved for the environment in the Northern Rivers region

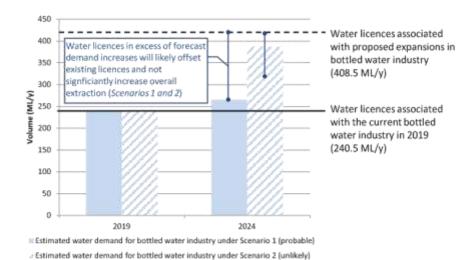
Figure 7: Bottled water industry growth scenarios 1 (probable) and 2 (unlikely)

As discussed, the most likely scenario for growth in bottled water production in Australia is that it is likely to slow to less than 2% per annum, representing a 10% increase to 2024 (Scenario 1). Based on this forecast, and assuming that the 240.5ML/y of water allocated to the current bottled water industry in the Northern Rivers region are fully utilised, then 2% growth in demand for water extraction is likely to be approximately 265 ML/y by 2024 (Figure 7).

Under this scenario, the 168 ML/y of water licences associated with proposed expansions in the bottled water industry are well in excess of the approximately 25 ML per annum necessary to meet anticipated demand in 2024. Therefore, these water licences would likely be underutilised and/or offset approximately 145 ML/y of water licences associated with the existing bottled water industry in the region (Figure 7).

An unlikely scenario would be that growth in the bottled water industry in the Northern Rivers region will be 10% per annum, representing a 60% increase to 2024 (*Scenario* 2). Under this high growth scenario, the 168 ML/y of water licences associated with proposed expansions in the bottled water industry will still be sufficient to fully meet growth in demand of approximately 150 ML/y in the region by 2024 and no additional expansions would be expected (unless they offset existing extractions) (Figure 7).

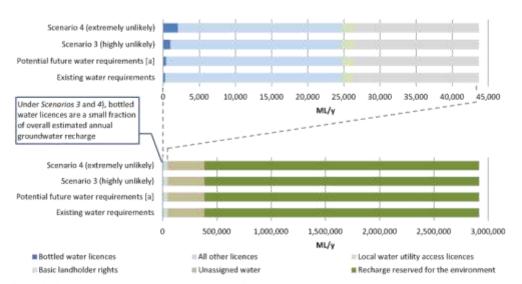
Figure 8: Bottled water industry growth scenarios 3 and 4

Note 1: Northern Rivers region comprises Alstonville Basalt Plateau, Clarence Moreton Basin, New England Fold Belt Coast, and North Coast Volcanics groundwater sources.

Scenario 3 assumes that the bottled water industry in the Northern Rivers region grows at 10% per annum, reaching approximately 1,000 ML/y in 2034, but does not exceed this level (Figure 8). Under this scenario, Australian bottled water consumption peaks at four times

Evian is one of the largest bottled water brands in the world and sells premium bottled water in more than 140 countries (Danone, 2019). The company has extracted and sold water from groundwater sources near a single bottling plant in Evian-les-Bains in France since 1826 (Evian, 2017). Evian produced 1,441 ML of bottled water in 1999 (Danone, 2000). Assuming this scenario occurred, and a brand of the scale of Evian (i.e. of approximate production of 1400 ML/y) was able to be established, it would still represent a small fraction of groundwater extraction, unassigned water and total estimated groundwater recharge in the region (Figure 8).

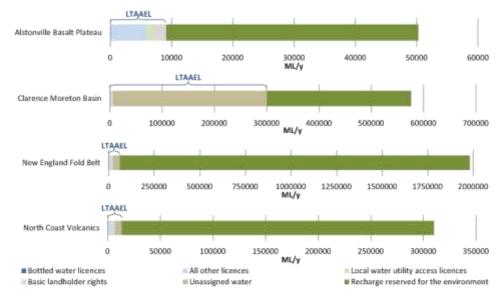
Figure 9: Breakdown of total estimated annual aquifer recharges in the Northern Rivers region by water requirements, unassigned water, groundwater recharges reserved for the environment and LTAAELs

Figure 9 illustrates the total estimated annual aquifer recharge for each relevant groundwater source in the WSP, the amounts of the recharge that are reserved for the environment in the WSP and the long-term annual average extraction limit (LTAAEL), including the breakdown by licence, Basic Landholder Rights and unassigned water. This figure does not consider the Upper Extraction Limit (UEL), which in the case of the New England Fold Belt Coast and the North Coast Volcanics, as shown in Table 5, are higher than the LTAAEL.

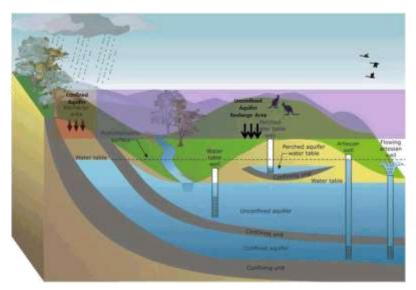
Figure 10: Recharge areas of confined and unconfined aquifers Note: confined in red highlights; unconfined in purple highlights Source: UNSW Sydney (2017)

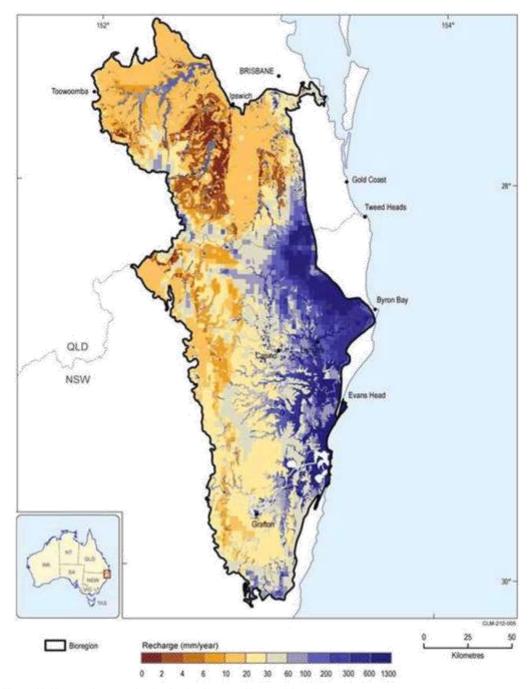
Figure 11: Mean recharge estimates for the Clarence Moreton bioregion Source: Raiber et al. (2016)

The Bioregional Assessment of the Clarence Moreton Bioregion used the chloride mass balance method to produce long-term average recharge estimates. The results from the Bioregional Assessment of the Clarence Moreton Bioregion are provided in Figure 11 (Raiber et al., 2016). The results are based on 3632-point estimates of groundwater chloride at points shown in Figure 12 below. The recharge estimates developed for these points are interpolated and extrapolated spatially over the bioregion, based on the identified relationship between long-term average recharge and long-term average rainfall, as detailed in Figure 13.

Averaging the 172 point estimates of recharge available for the Lamington Volcanics within the Bioregional Assessment data set, results in a 16% recharge rate. Based on Figure 11 and Figure 13, this appears to represent the spatially interpolated average for the Lamington Volcanics (the actual spatially interpolated value is not available from the report or the publicly accessible data set).

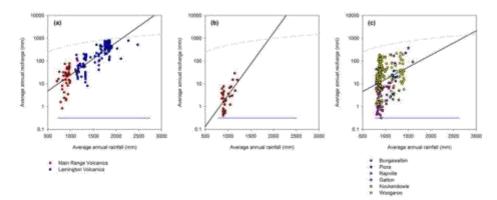
Figure 13: Relations between long-term average rainfall and chloride mass balance estimates of recharge for the hydrogeological units of the Clarence Moreton bioregion - (a) the Cenozoic Volcanics (Lamington Volcanics and Main Range Volcanics), (b) Walloon Coal Measures, (c) other sedimentary rock formations. Note: The black line is the line of best fit through the data points, the dashed grey line is recharge as half of rainfall and the blue line is the range of annual average rainfall within the bioregion for the surface geology class Source: (Raiber et al., 2016).

It is worth noting that the chloride measurements shown in Figure 13 provide minimal coverage of the groundwater sources of interest. Although 16 % is likely to be the best available estimate for the North Coast Volcanics and Alstonville Plateau groundwater sources, it cannot be used with confidence. Furthermore, while the chloride mass balance method is an established approach for approximating recharge. However, various assumptions inherent within the method mean that it is not generally considered an accurate approach. As such, these results are best complemented with alternative methods and should not be used as a single line of evidence.

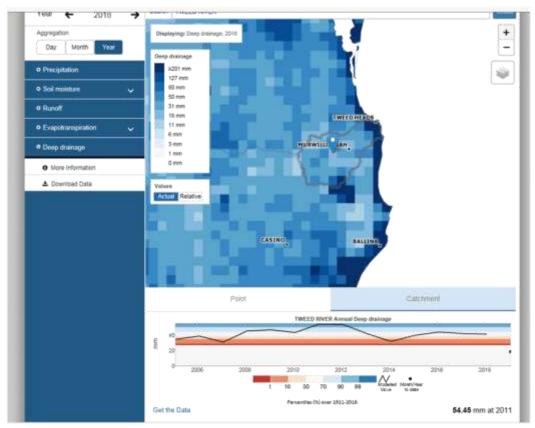
Figure 14: Screenshot of AWRA-L deep drainage results, showing map for typical year 2018 Source: BOM (2019)

Deep drainage results for the Tweed River catchment and surrounding region are shown in Figure 14. The mapped results are for 2018, which has a modelled deep drainage close to the long-term median value, therefore may be considered typical. The modelled median deep drainage for the catchment is approximately 40 mm/year, or 2.2% of long-term average rainfall. Due to the grid sizes, it is not practical to pick out particular values for the groundwater sources of interest.

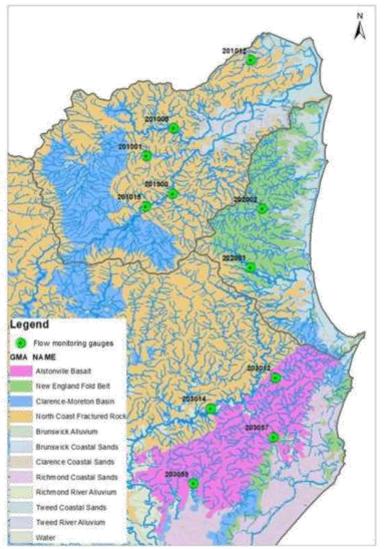
Figure 15: Flow monitoring points in the Northern Rivers region and groundwater management areas

Baseflow filtering was used to estimate groundwater recharge at a number of flow gauging stations within the area of interest. The filtering method used is described in Appendix 4. Figure 15 shows the location of flow monitoring points and groundwater sources.

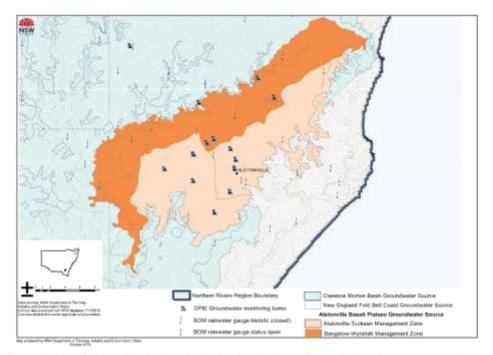
Figure 16: Map of Alstonville showing the 13 sites for the Alstonville monitoring piezometer network :

A basic analysis of the data from the previous thirteen years (2006-2019) has been undertaken by the Review to provide insight into the state of the Alstonville aquifer today and the impact of environmental variables (e.g. rainfall and seasons) on groundwater levels in the region. Data was accessed for all 29 monitoring piezometers in the Alstonville Plateau. The location of each piezometer (including depth) is summarised in Figure 16 and Table 12.

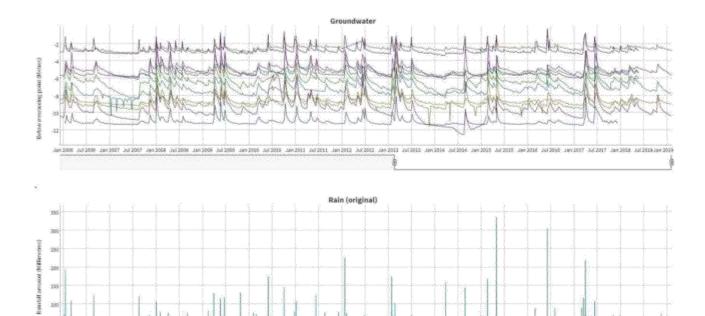
Figure 17: Hydrographs showing the levels of 12 'shallower' piezometers in the Alstonville Plateau from 2006 to present.

The vertical axis in the top panel shows the distance from measuring point to water for each piezometer while the x-axis shows date. The bottom panel shows daily rainfall associated with the Alstonville Tropical Research Station.

The analysis in this section is not intended to be an in-depth hydrogeological analysis, but rather an empirical statistical analysis to assess the long term changes in water levels in each piezometer. The water levels in the piezometers over the last decade are shown in Figure 17 and Figure 18. Piezometer levels here refer to the distance (in metres) from the measuring point to water.

Figure 17 and Figure 18 also shows interpolated rainfall sourced from the SILO database (Queensland Government, 2019) to improve the understanding of the relationship between rainfall and groundwater levels. As evident in these two figures, the groundwater level data is not continuous at every monitoring station, with several extended gaps in a number of the monitoring wells, especially in the earlier periods. There are also several notable dips in the levels from two deep pziemometer. The Review was unable to confirm the cause, but it was speculated that these may have been due to measurement error, periods when the data from the logger was being downloaded or the logger was down.

Figure 17 and Figure 18 were created using an on-line tool created by the Review team that can be used to interactively view hydrographs similar to those reported by Green (2006) and showing the piezometer levels over time, along with a graphical display of rainfall levels over the same time period. The online hydrograph tool allows the user flexibility in terms of which piezometers to plot as well as whether to display daily rainfall or lagged averages (discussed above). The hydrograph tool also allows flexibility in terms of zooming in to a particular time period of interest. While this tool does not offer the same breadth of information as available in Groundwater Explorer, it has the advantage of being simpler to use and is also much quicker to run. The Review will explore the possibility with DPIE Water of the interactive hydrograph tool being made more widely available.

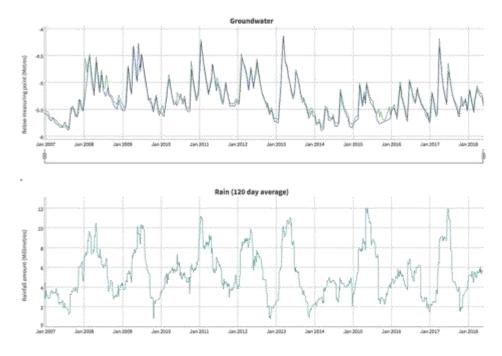
Figure 19: Hydrograph for Piezometer GW041008, Hole 1, Pipes 1 and 2 with 120 day rainfall average plotted in the lower panel.

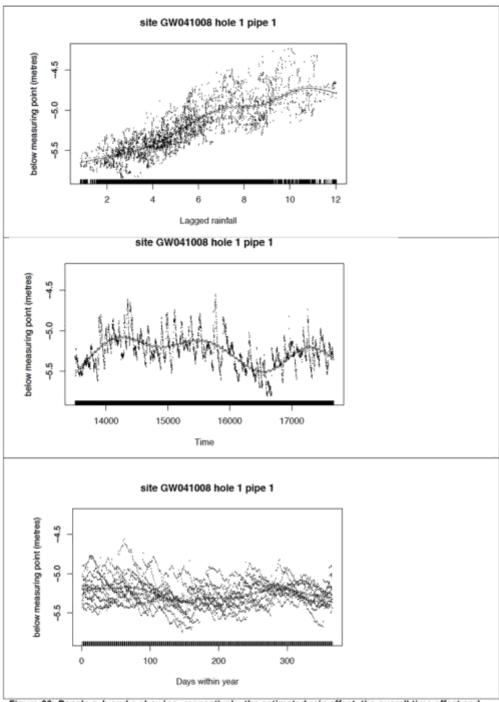
Figure 20: Panels a, b and c showing, respectively, the estimated rain effect, the overall time effect and the seasonal effect estimated from fitting a GAM model

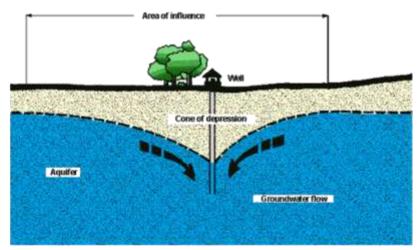
Figure 21: Area of influence and cone of depression in the aquifer due to groundwater pumping Source: Oregon State University (2019).

There is an extensive volume of literature detailing the impact mechanisms from a bore (or bore field) on the surrounding aquifer or connected waters. Readers are directed to Acworth (2019) for a recent and detailed description of processes in Australia. In brief, groundwater extraction from an aquifer (via a groundwater bore) reduces hydrostatic pressure heads at the bore, creating a differential pressure gradient that induces water flow towards the lower pressure area (i.e. towards the bore). The area influenced is called the 'zone of influence' or 'cone of depressurisation' or 'cone of depression' surrounding the bore (Figure 21). The size of this zone, and the nature and degree of the pressure head change and resultant flow paths, depends on the hydrogeological properties of the rock or soil matrix, as well as on the rate and duration of the extraction(s).

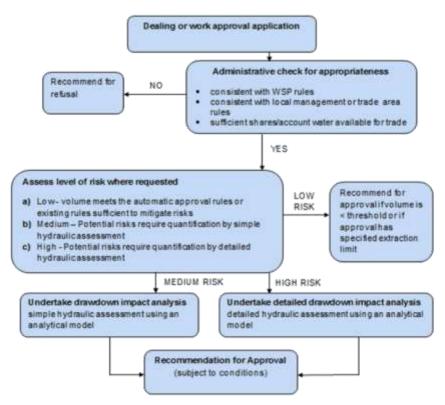
Figure 22: Process for assessing applications for new water supply works approvals and water licence dealings

Applications for water access licence dealings or water supply works approvals are lodged with WaterNSW. WaterNSW may refer these applications to DPIE Water for hydrogeological assessment if required. DPIE Water has the necessary expertise to conduct hydrogeological assessments of applications as required. Figure 22 outlines the DPIE Water process for assessing applications for water access licence dealings or water supply works approvals.

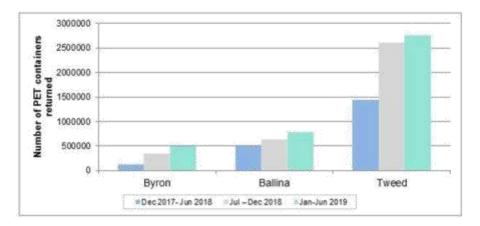
Figure 23: Return and Earn collection volumes of sorted PET plastics in select areas

Note: data includes Reverse Vending Machine, Automated Depot return volumes and disaggregated Over The Counter weekly return volumes collected through the Network Operator Exchange for Change

The NSW Government is currently developing a NSW Plastics Plan as well as a 20 Year Waste Strategy. In 2017, the NSW Government Return and Earn Container Deposit Scheme was introduced, resulting in the return of 750 million drink containers and a 33% reduction of eligible containers in the litter stream in one year (Blue Environment, 2018). Over January to June 2019, sorted PET plastic containers made up 28.1% of the volume collected across NSW, while HDPE made up 1.4%. A number of collection points are located in the Northern Rivers and there has been an increase in the return of containers since 2017 (Figure 23).

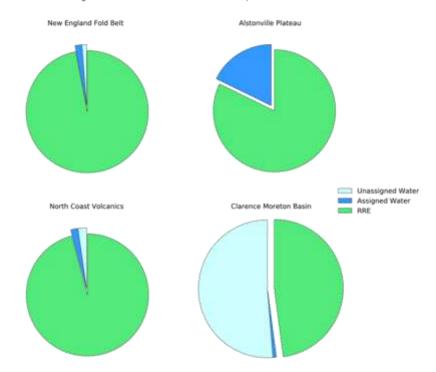
Figure 24: Allotment of estimated recharge to Recharge Amount Reserved for the Environment (total volumes differ between aquifers) as reported in February 2019 (Initial Report)

Table 31 shows the RRE for the four groundwater sources of interest. The allotment of total estimated recharge is illustrated graphically in Figure 24.

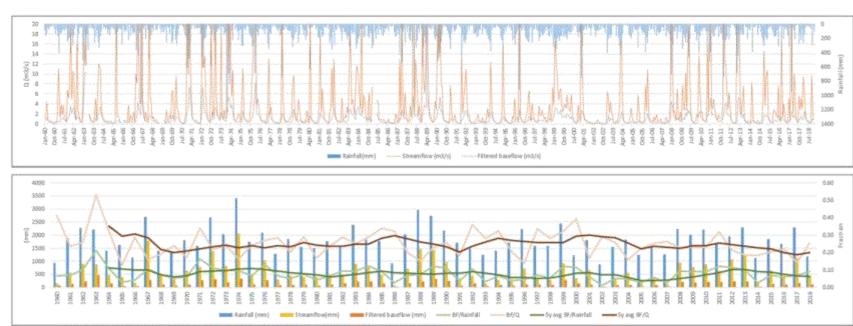
Figure 25: Baseflow filtering results - monitoring point 201001: Oxley River at Eungella

Although the technique has no physical basis, it is objective and reproducible and has been successfully compared with graphical (manual) methods of baseflow separation (Arnold et al., 1995; Mau & Winter, 1997) and with measured field estimates (Arnold & Allen, 1999). For this study the filter was passed three times; forward, backwards and forward for smoothing the baseflow hydrograph based on the dataset length.

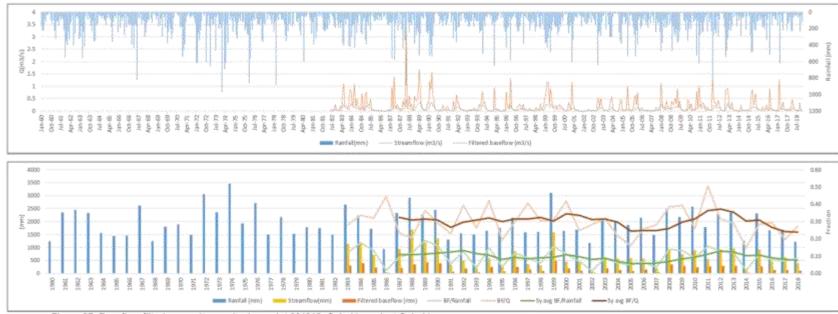
Figure 27: Baseflow filtering results monitoring point 201012: Cobaki creek at Cobaki

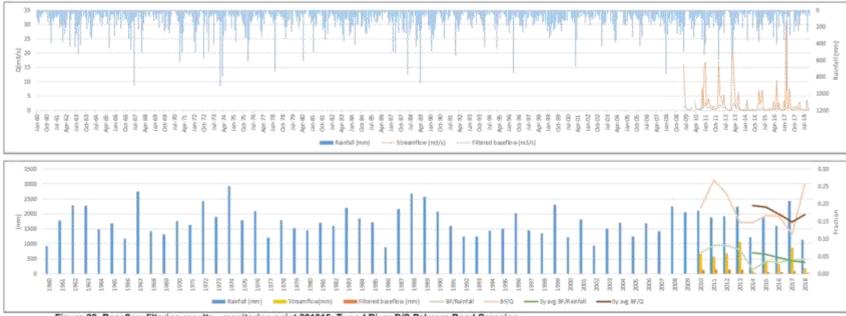
Figure 28: Baseflow filtering results - monitoring point 201015: Tweed River D/S Palmers Road Crossing

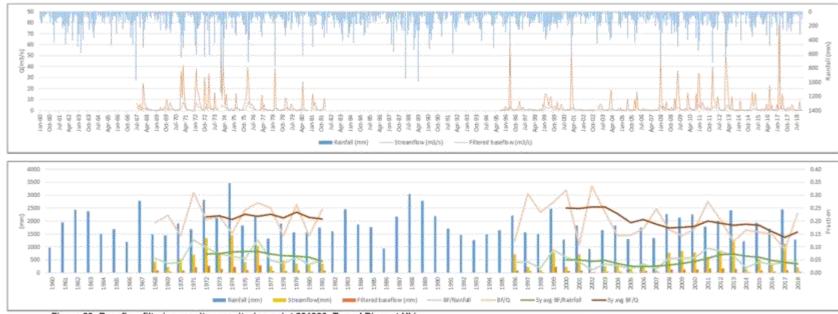
Figure 29: Baseflow filtering results - monitoring point 201900: Tweed River at Uki

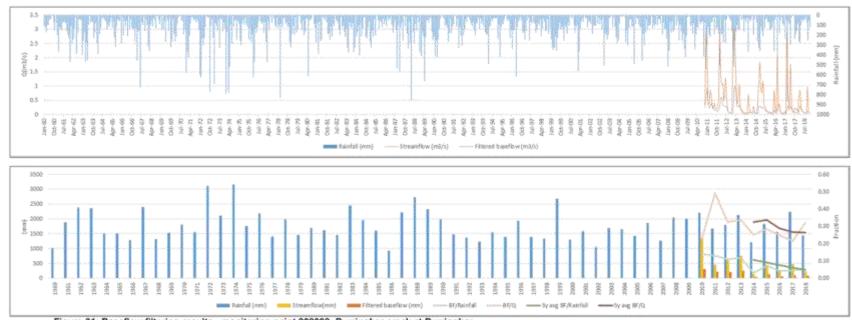
Figure 31: Baseflow filtering results - monitoring point 202002: Burringbar creek at Burringbar

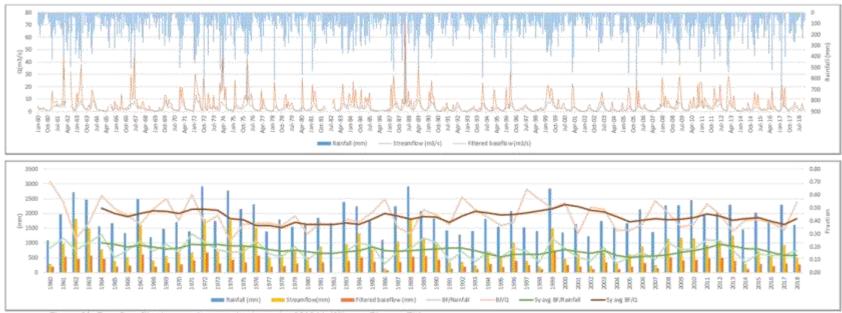
Figure 33: Baseflow filtering results - monitoring point 203014: Wilsons River at Eltham

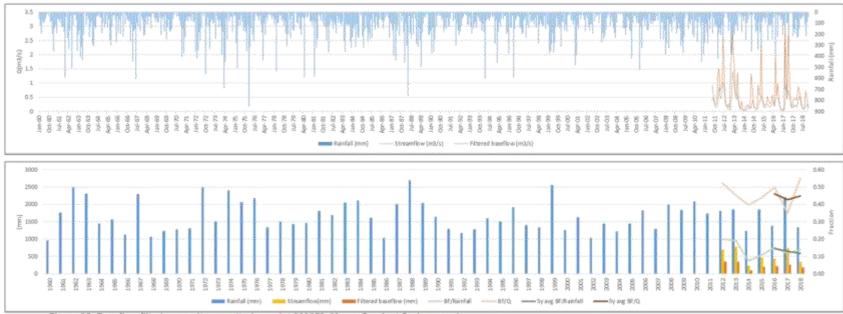
Figure 35: Baseflow filtering results - monitoring point 203059: Maron Creek at Graham road

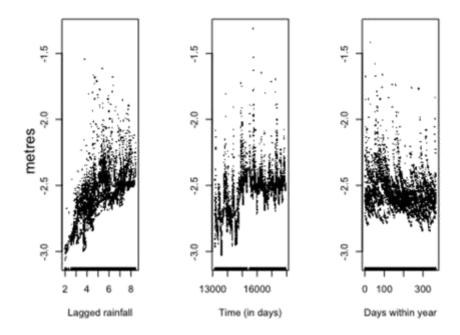
# site GW036701 hole 1 pipe 1

There were statistically significant non-linearities in the time effect (p= 0.018).

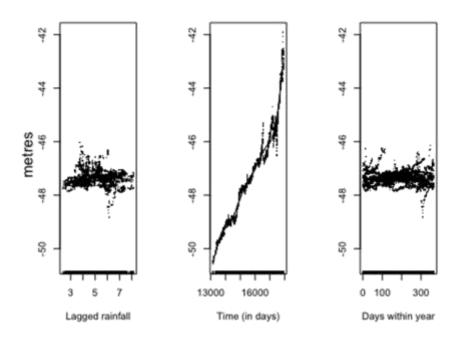
# site GW036701 hole 2 pipe 2

The highest percent variation explained was given by lagging rain over 280 days. Adding rain into the model explained an additional 7.6 percent of variability compared with a model that included just time and season. But this increase was not statistically significant (p= 0.217).

There was no statistically significant non-linearity in the time effect (p= 0.106).

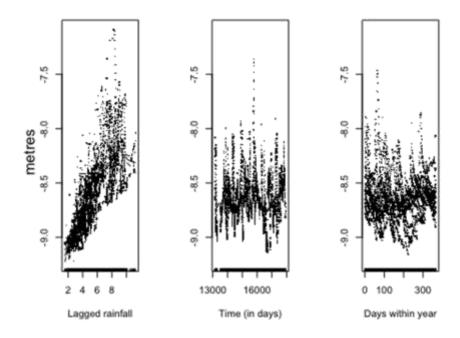
# site GW036702 hole 3 pipe 1

The highest percent variation explained was given by lagging rain over 150 days. Adding rain into the model explained an additional 49.42 percent of variability compared with a model that included just time and season. This effect was statistically significant (p<.001).

There was no statistically significant non-linearity in the time effect (p= 0.058).

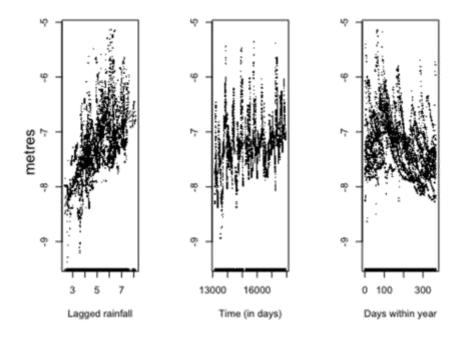
# site GW036702 hole 2 pipe 2

The highest percent variation explained was given by lagging rain over 280 days. Adding rain into the model explained an additional 28.9 percent of variability compared with a model that included just time and season. This effect was statistically significant (p<.001).

There was no statistically significant non-linearity in the time effect (p= 0.193).

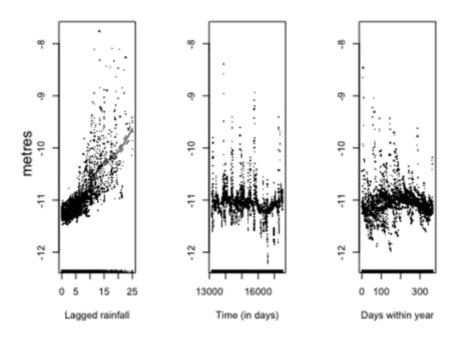
# site GW040999 hole 1 pipe 1

The highest percent variation explained was given by lagging rain over 30 days. Adding rain into the model explained an additional 57.37 percent of variability compared with a model that included just time and season. This effect was statistically significant (p<.001).

Adding time into the model explained an additional 10.62 percent of variability compared to a model with just rain and season. This effect was statistically significant (p= 0.002). There were statistically significant non-linearities in the time effect (p= 0.007).

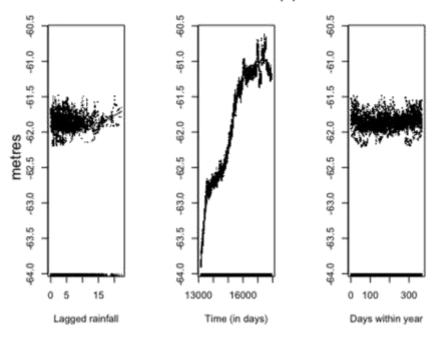
# site GW040999 hole 2 pipe 2

The highest percent variation explained was given by lagging rain over 40 days. Adding rain into the model explained an additional 1.46 percent of variability compared with a model that included just time and season, but this increase was not statistically significant (p= 0.734).

Adding time into the model explained an additional 98.24 percent of variability compared to a model with just rain and season. This effect was statistically significant (p<.001). There were statistically significant non-linearities in the time effect (p= 0.016).

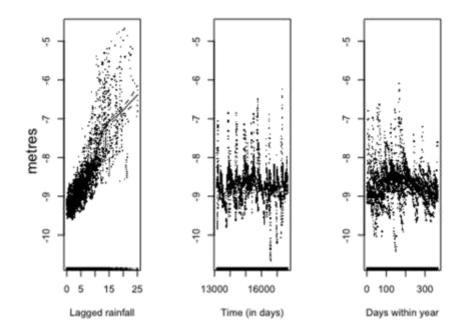
# site GW041001 hole 1 pipe 1

There were statistically significant non-linearities in the time effect (p= 0.018).

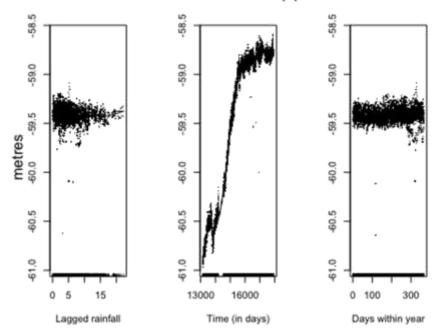
# site GW041001 hole 2 pipe 2

The highest percent variation explained was given by lagging rain over 40 days. Adding rain into the model explained an additional 2.7 percent of variability but this increase was not statistically significant (p= 0.406).

There were statistically significant non-linearities in the time effect (p<.001).

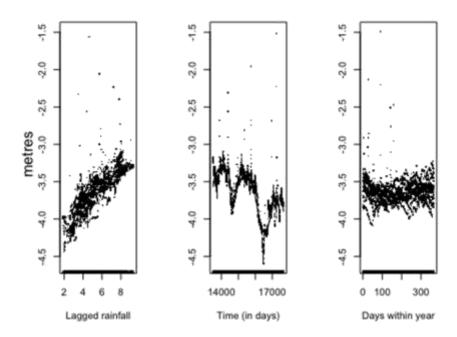
# site GW041002 hole 1 pipe 1

The highest percent variation explained was given by lagging rain over 200 days. Adding rain into the model explained an additional 61.02 percent of variability compared with a model that included just time and season. This effect was statistically significant (p= 0.001).

There were statistically significant non-linearities in the time effect (p= 0.016).

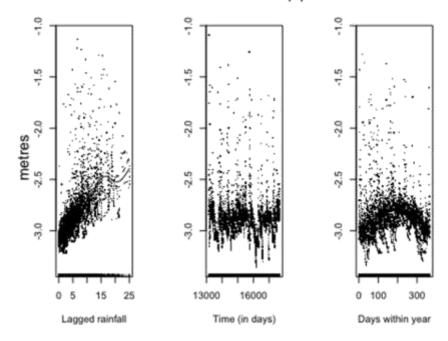
# site GW041003 hole 1 pipe 1

The highest percent variation explained was given by lagging rain over 30 days. Adding rain into the model explained an additional 38.81 percent of variability compared with a model that included just time and season. This effect was statistically significant (p<.001).

There was no statistically significant non-linearity in the time effect (p= 0.228).

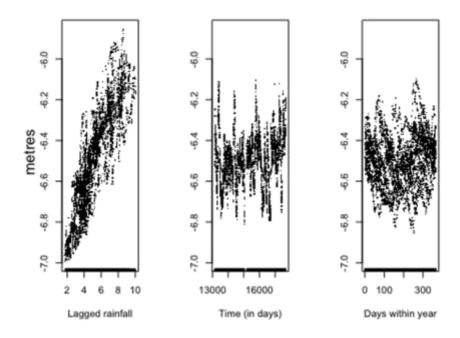
# site GW041003 hole 2 pipe 2

The highest percent variation explained was given by lagging rain over 180 days. Adding rain into the model explained an additional 63.43 percent of variability compared with a model that included just time and season. This effect was statistically significant (p= 0.001).

There were statistically significant non-linearities in the time effect (p= 0.023).

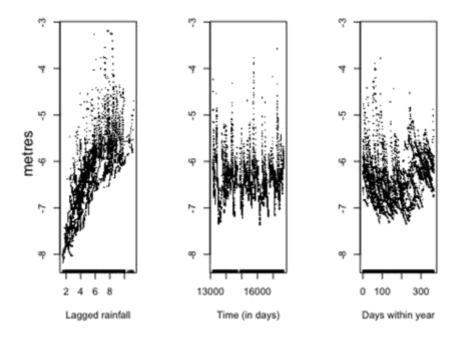
## site GW041004 hole 1 pipe 1

The highest percent variation explained was given by lagging rain over 150 days. Adding rain into the model explained an additional 50.21 percent of variability compared with a model that included just time and season. This effect was statistically significant (p= 0.001).

There was no statistically significant non-linearity in the time effect (p= 0.07).

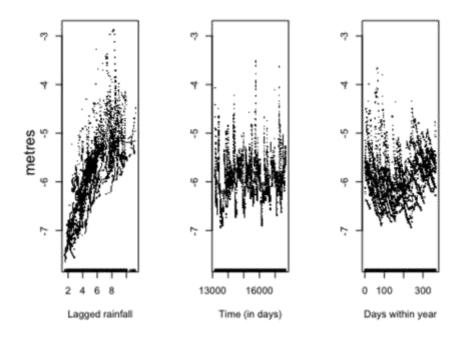
### site GW041004 hole 2 pipe 2

The highest percent variation explained was given by lagging rain over 150 days. Adding rain into the model explained an additional 50.63 percent of variability compared with a model that included just time and season. This effect was statistically significant (p<.001).

There was no statistically significant non-linearity in the time effect (p= 0.178).

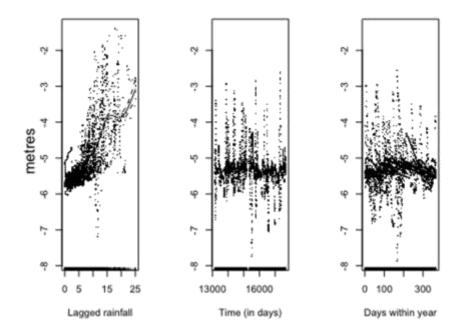
## site GW041005 hole 1 pipe 1

The highest percent variation explained was given by lagging rain over 30 days. Adding rain into the model explained an additional 53.08 percent of variability compared with a model that included just time and season. This effect was statistically significant (p<.001).

There were statistically significant non-linearities in the time effect (p= 0.028).

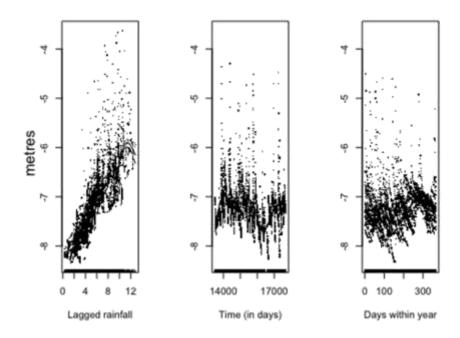
## site GW041007 hole 1 pipe 1

The highest percent variation explained was given by lagging rain over 100 days. Adding rain into the model explained an additional 54.98 percent of variability compared with a model that included just time and season. This effect was statistically significant (p<.001).

There were statistically significant non-linearities in the time effect (p= 0.008).

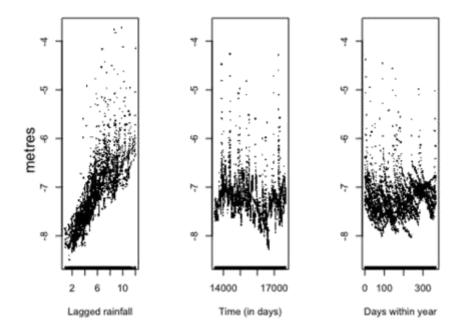
## site GW041007 hole 1 pipe 2

The highest percent variation explained was given by lagging rain over 120 days. Adding rain into the model explained an additional 50.81 percent of variability compared with a model that included just time and season. This effect was statistically significant (p<.001).

There were statistically significant non-linearities in the time effect (p= 0.003).

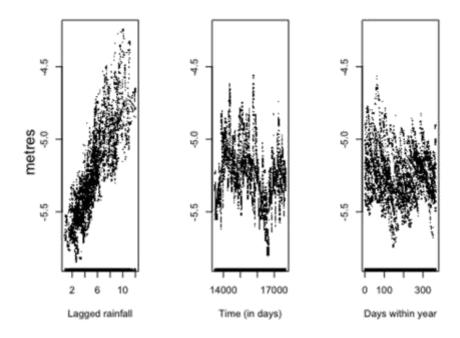
## site GW041008 hole 1 pipe 1

The highest percent variation explained was given by lagging rain over 120 days. Adding rain into the model explained an additional 56.38 percent of variability compared with a model that included just time and season. This effect was statistically significant (p<.001).

There were statistically significant non-linearities in the time effect (p= 0.01).

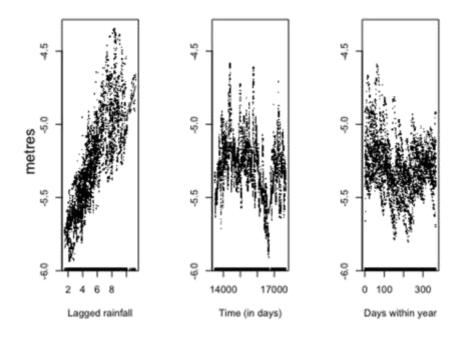
## site GW041008 hole 1 pipe 2

The highest percent variation explained was given by lagging rain over 150 days. Adding rain into the model explained an additional 57.62 percent of variability compared with a model that included just time and season. This effect was statistically significant (p<.001).

There were statistically significant non-linearities in the time effect (p= 0.006).

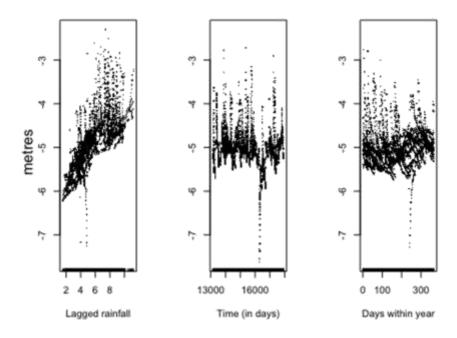
## site GW081000 hole 1 pipe 1

The highest percent variation explained was given by lagging rain over 150 days. Adding rain into the model explained an additional 46.88 percent of variability compared with a model that included just time and season. This effect was statistically significant (p<.001).

There was no statistically significant non-linearity in the time effect (p= 0.07).

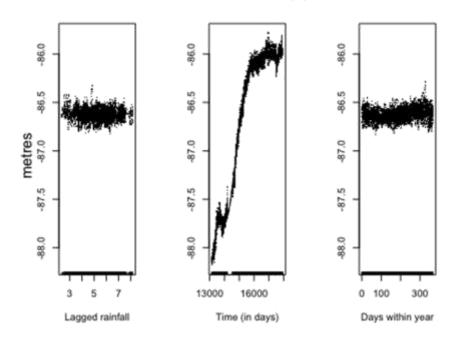
## site GW081001 hole 1 pipe 1

The highest percent variation explained was given by lagging rain over 280 days. Adding rain into the model explained an additional 2.46 percent of variability but this increase was not statistically significant (p= 0.421).

There were statistically significant non-linearities in the time effect (p<.001).

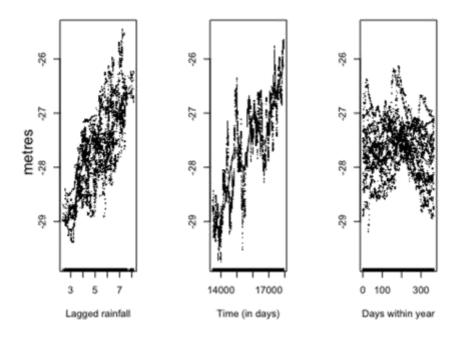
## site GW081002 hole 1 pipe 1

The highest percent variation explained was given by lagging rain over 280 days. Adding rain into the model explained an additional 44.91 percent of variability compared with a model that included just time and season. This effect was statistically significant (p= 0.001).

There was no statistically significant non-linearity in the time effect (p= 0.277).

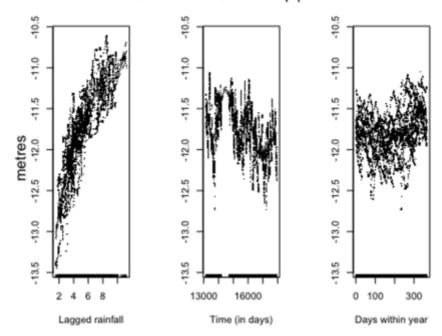
## site GW081005 hole 1 pipe 1

There were statistically significant non-linearities in the time effect (p<.001).

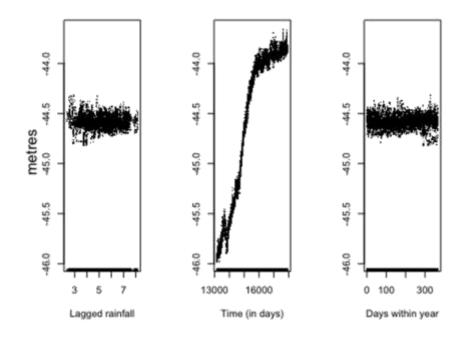
## site GW081006 hole 1 pipe 1

The highest percent variation explained was given by lagging rain over 120 days. Adding rain into the model explained an additional 43.52 percent of variability compared with a model that included just time and season. This effect was statistically significant (p<.001).

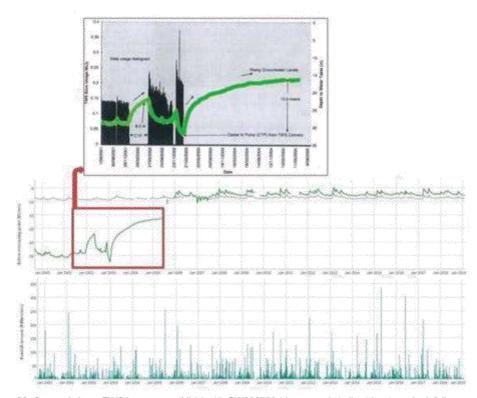
Figure 36: Convery's Lane TWS bore usage (ML/y) with GW036702 (deeper and shallow) levels and rainfall data.

The Convery's Lane usage shows gaps in extraction in 2001-2002 and from 2003. The bore usage is shown in subset graph in black columns. Figure modified from (Parsons Brinckerhoff, 2011). The nearby bores shows a response from the deeper monitoring bore (depth to groundwater shown as below measuring point in green), while the monitoring bore GW036702.3.1 (shallow) may be associated with rainfall (nearby Bureau of Meteorology rainfall stations, shown in blue columns). Data source: WaterNSW and BoM

In 2006 a comparison was made of the Convery's Lane TWS bore pumping data with the deeper groundwater levels at the nearby DPIE Water monitoring bore GW036702 around one km away. At the time, investigations found that the pressure heads in the deeper groundwater system dropped significantly when the Convery's Lane TWS bore was pumping, indicating that pumping was not sustainable. Once these pumps ceased it took several years for pressure heads to recover (Green, 2006) (Figure 36). In 2003, Rous County Council ceased using the Convery's Lane bore due to its effect on the deeper groundwater levels (Rous Water, 2014). Further investigation would be required to ascertain the hydrogeologic relationship between the deep level pumping, the shallow water levels and rainfall.

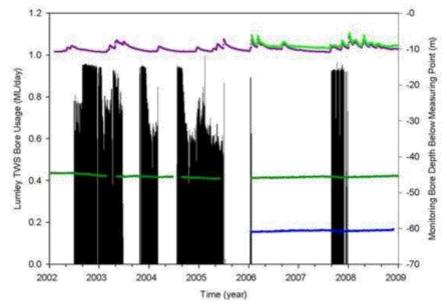
Figure 37: Lumley Park TWS bore usage (black columns) and water level and/or pressure observed at DPIE monitoring bores GW081006 (shallow) and GW081005 (deeper) from 2002 to 2009.

Source: Rous County Council (2019a) and WaterNSW data register (WaterNSW, 2019)

Previous analysis indicated that groundwater pressure heads within the TWS bore at Lumley Park, or in close proximity to it, were likely to be temporarily lowered during the period it was operational (2002-2006) (Parsons Brinckerhoff, 2011). However, the deeper groundwater levels at the monitoring bore in proximity remained around 45 m below ground level (Parsons Brinckerhoff, 2011) (Figure 37). The TWS bore was used again for a period in

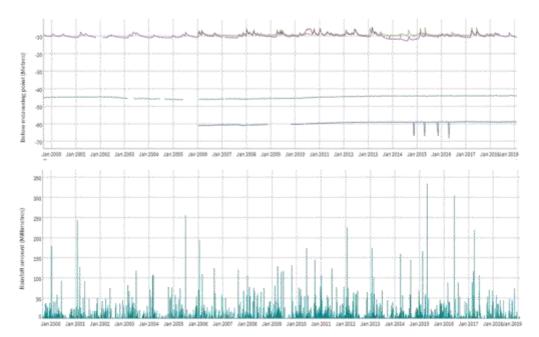
Figure 38: Groundwater levels from DPIE monitoring bores near Lumley Park plotted with rainfall Groundwater levels from DPIE monitoring bores near Lumley Park: GW081006 (shallow, purple line) and GW081005 (deeper, green line) and two more recent monitoring bores GW041001.1.1 (shallow, light green line) and GW041001.2.2 (deeper, light blue line, note the four dips are most likely associated with logger servicing); and the rainfall amount (nearby Bureau of Meteorology rainfall stations, shown in blue columns). Data source: WaterNSW and BoM

Additional monitoring piezometers were installed in 2005-2006 (GW041001\_1 and \_2) near the TWS bore at Lumley Park (~10-20 m away) and Lumley Cutting (~50-100 m away). The deeper levels during this period were generally stable, with the four dips potentially attributed to measurement error, periods when the data from the logger was being downloaded or the logger was down (Figure 37 and Figure 38). Small rises in the shallow levels seem to follow the significant rainfall events. It was previously reported that groundwater levels in the shallow aquifer are rapidly recharged with rainfall events (Green, 2006), which can be seen in Figure 38.

At Lumley Park, the monitored levels did not appear to support an immediate link between extraction and the deeper and shallow levels nearby; whereas at Convery's Lane there appeared to be a link between extraction and drawdown from the deeper aquifer. This example highlights the complexity of the spatial and temporal variation across the fractured rock aquifers despite monitoring of the deeper and shallow aquifers over extended periods. However, these investigations also highlight the value of properly conducted investigations, which include field investigations, conceptual model development, and bore testing.

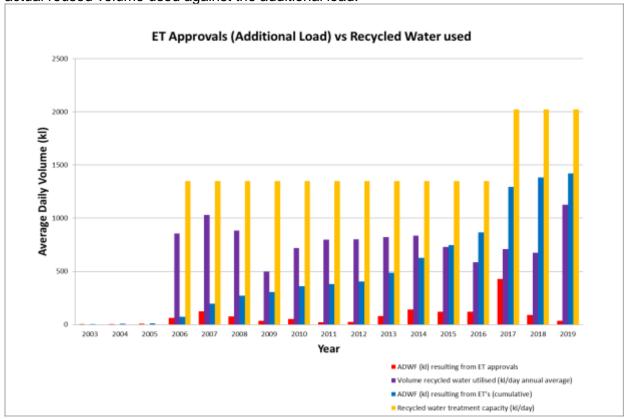
It is important to note the difference between actual use of the reuse system and the capacity of the system. Actual use is dependent on environmental conditions – factoring in rainfall and drought. The number of users is the other large factor in taking up the reuse effluent volume - more customers obviously increases demand and consumption. The following graph shows the actual reused volume used against the additional load.

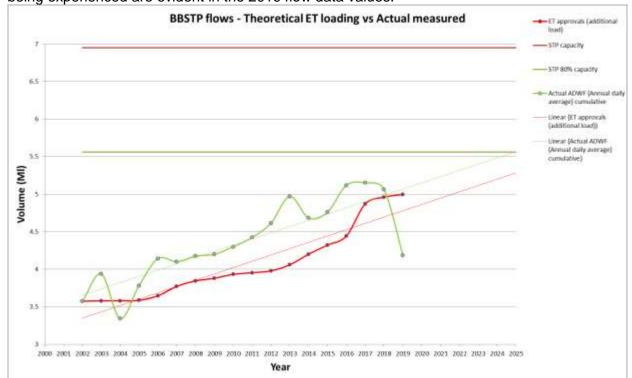
The following graph shows the flow trend for the Byron STP. The data points above and below the linear trend are an indication of wetter or dryer than average years. The current drought conditions being experienced are evident in the 2019 flow data values.

The actual ADWF figures are an average of the full years flow totalised daily at the Byron STP. The top 20% and bottom 10% of data was removed from the calculations to exclude rainfall effect and recording anomalies from the figures used. The result is the annual ADWF. Within Byron Bay the ADWF varies according to the season. There is a summer peak in Dec/Jan and over Easter; a winter low and the "shoulder period" during the remaining time. This creates a range that is not reflected in the graph or data. The actual flow reflected is an average of the year's data.

The data shows that the actual and derived (through ET calculations) ADWF trends over the past 15 years are tracking parallel to each other, indicating a level of certainty with the figures used. Based on the last 15 years of actual flow data, the Byron STP is expected to reach capacity in 2042.

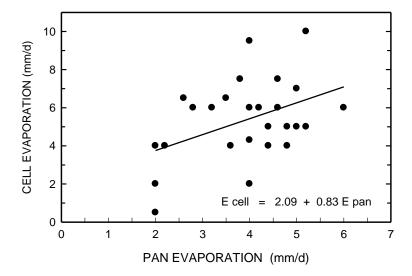
Figure 1 The relation between pan evaporation at Alstonville and cell evaporation.

5 The trend line had a slope of 0.83 and an intercept of 2.09 mm/d.

Figure 1 shows the scatter plot between pan evaporation at Alstonville and cell evaporation.
