# WATER, WASTE AND SEWER ADVISORY COMMITTEE MEETING

Date Thursday, 29 October 2020

Report No. 4.1	Byron STP Condition 9. Additional Load - Quarterly Report
	Directorate:	Infrastructure Services
5	Report Author:	Dean Baulch, Principal Engineer, Systems Planning
		Vivianne Lins, Environmental Planner
	File No:	I2020/1125

Inflow and Infiltration - quarterly update
Infrastructure Services
Jason Stanley, Inflow & Infiltration Project Manager
12020/1583

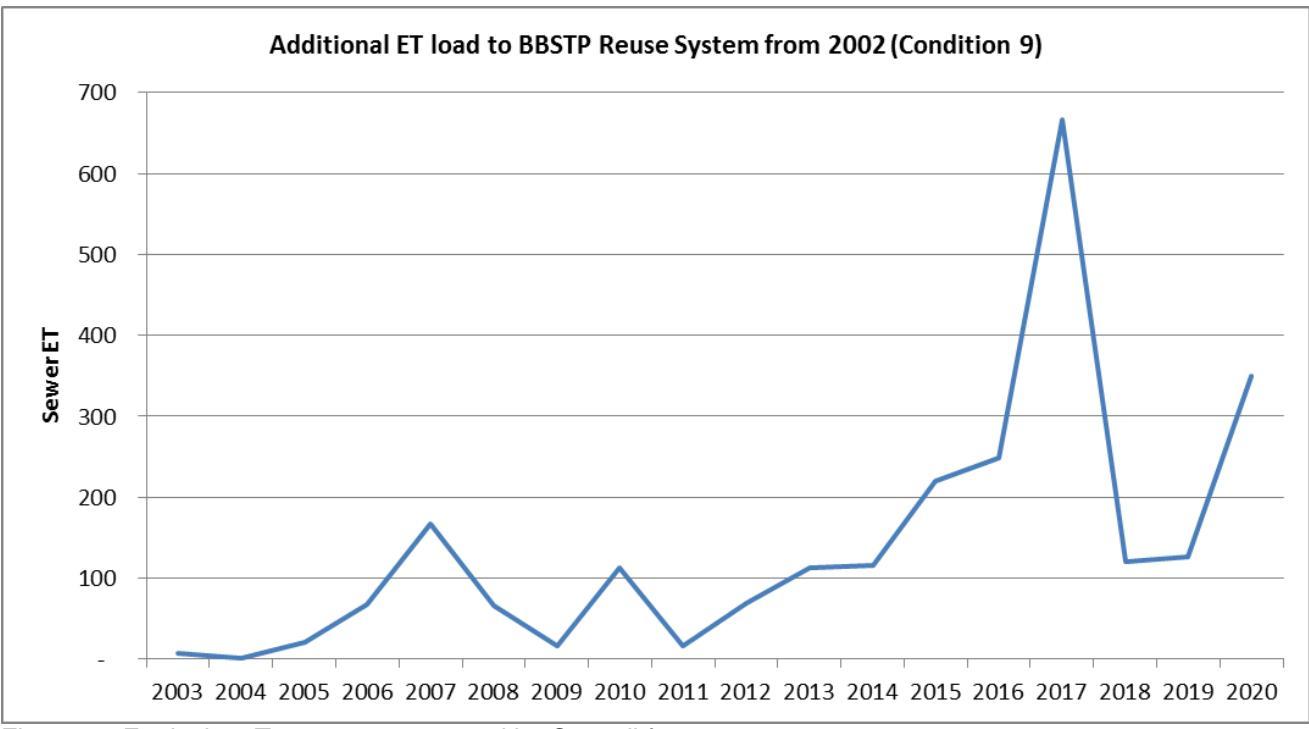
Figure 1 - Equivalent Tenements approved by Council from 2002-2020

Current Approved ET	Available Capacity (ET)
Condition 9(iii) Additional Load Calculation	2,508	-
Current effluent reuse system capacity 2020	3,427	919

Therefore, the existing reuse system provides sufficient capacity to accommodate the additional load as defined in the Conditions of Approval.

Committee Report Tracking Summary: Condition 9. Additional Load at Byron STP	Current Approved ET	Difference (ET)
30 January 2020	2,408	-
30 July 2020	2,478	70
29 October 2020	2,508	30

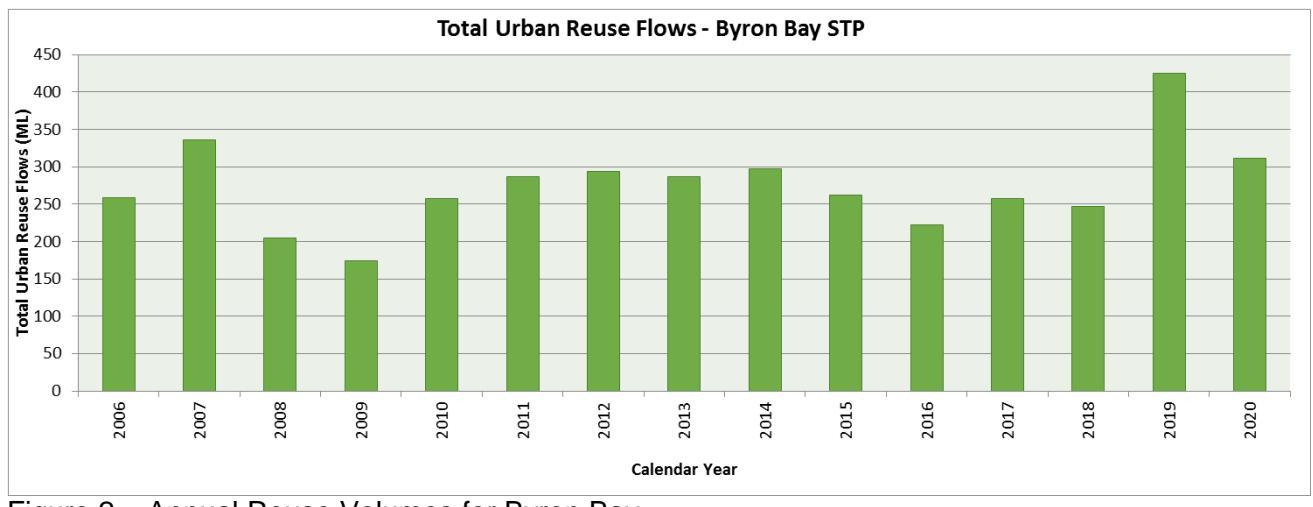
Figure 2 – Annual Reuse Volumes for Byron Bay

Calendar Year	Total Urban Reuse Flows (ML)			
	050.0			
2006	258.8			
2007	336.1			
2008	204.4			
2009	174.5			
2010	257.2			
2011	287.4			
2012	294.0			
2013	287.2			
2014	296.9			
2015	261.9			
2016	221.8			
2017	257.3			
2018	246.7			
2019	424.7			
2020	311.2

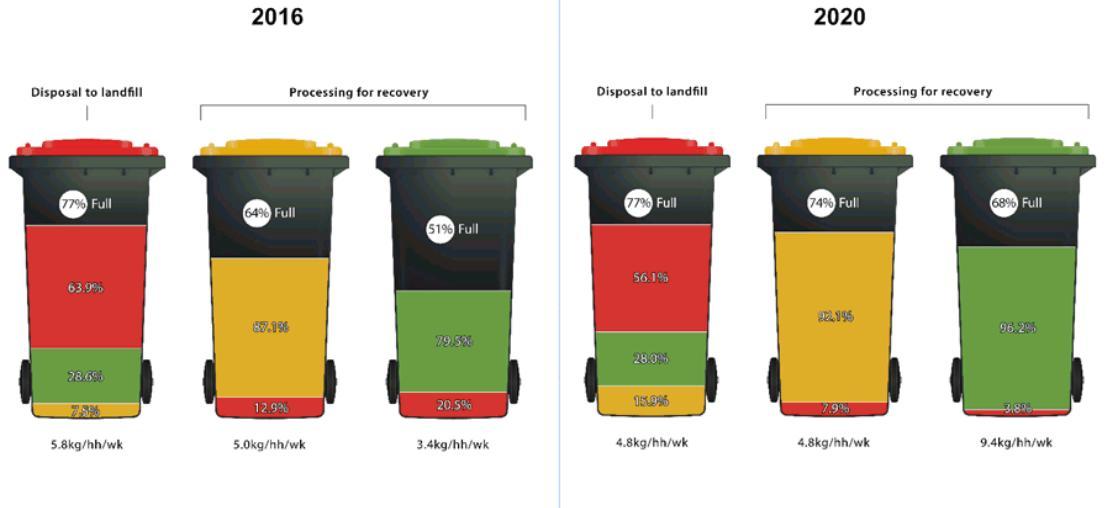
The residential three bin system performance comparison for the 2016 and 2020 audits:

Data indi	cator	Unit of measurement	2016	2020
		Waste stream	5.8	4.8
	By weight	Recycling stream	5.0	4.8
Concretion	(kg/hh/wk)	Organics stream	3.4	9.4
Generation		All streams	14.2	19.0
Tato	Buyolumo	Waste stream	77.2	77.2
	/hin % full)	Recycling stream	64.0	73.6
	(Bill / Julia)	Organics stream	51.4	67.9
	Percentage (% by weight)	Recyclables	7.5	15.9
Resources		Garden organics	2.1	2.9
in the waste stream		Food	15.7	16.8
		Other organics	10.8	8.3
	Weight	Recycling stream	0.6	0.4
Contomination	(kg/hh/wk)	Organics stream	0.6	0.4
Contamination	Rate	Recycling stream	12.9	7.9
	(% by weight)	Organics stream	20.5	3.8
Resource recovery	Rate	Recycling stream	76.4	85.6
rate	(% by weight)	Organics stream	58.0	86.6
Diversion rate	Rate (% by weight)	Kerbside diversion	51.0	70.8

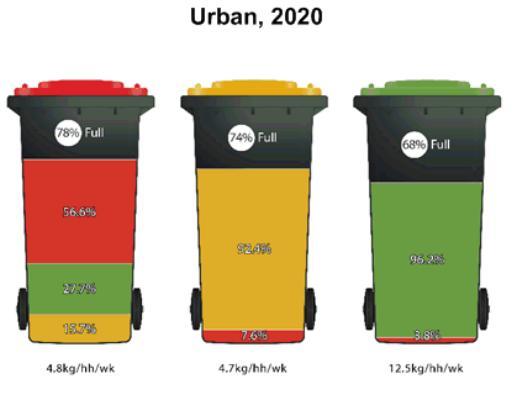
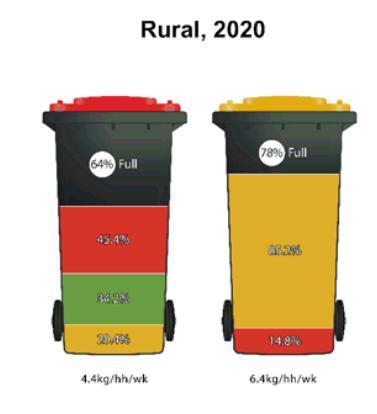
The 2020 audit also assessed and compared the urban and rural areas kerbside bin performance. **Urban areas achieved a higher diversion rate at 74.3% compared to rural areas at 50.7%.** This was mainly due to additional organics resources recovered via the kerbside organics bin collection services, a service provided at urban areas only.

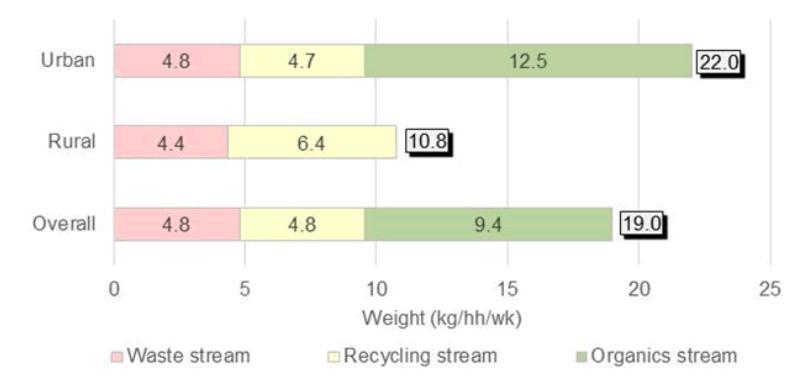
#### Generation rates by property type 2020

The usage of each bin type varies by type of property, with the weight of bin contents presented for collection shown below. Typically, the larger the property size, the more waste, recycling and organics bin contents presented for collection.

- Urban households present more overall kerbside bin contents than rural households.
- Urban households have the additional organics bin collection services.

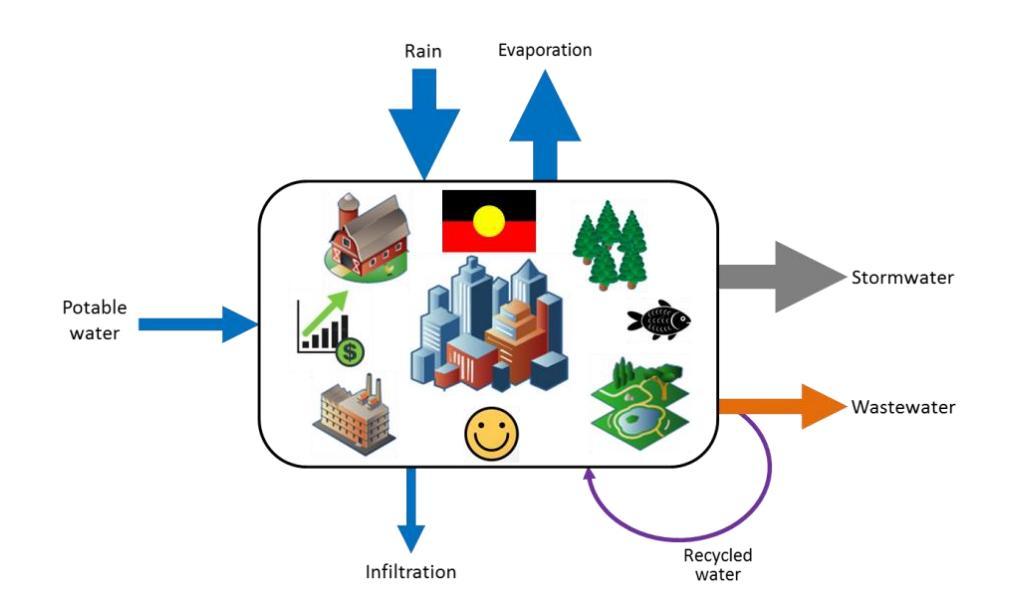
Figure 2: Conceptual water-mass balance of a city, including anthropogenic (e.g. potable water) and natural (e.g. rain) water flows, and the various water users within the system (e.g. social, economic and environmental).

- 10 Urban metabolism is a conceptual model which, at it simplest, uses a mass balance approach to quantify materials entering and/or leaving a city. The idea was first presented in 1965 with the aim of addressing contemporary urban resource issues. It is used for the analysis, critical assessment and management of urban areas as systems that `metabolise' material and energy inputs needed to sustain the city's inhabitants at home, work and play - ultimately releasing them back to the environment as waste.4,5 15
  - Figure 1: The urban metabolism concept, showing energy, water and material flows entering a city system as resources, and exiting as waste. Energy and water are shown to be closely interrelated<sup>t</sup>

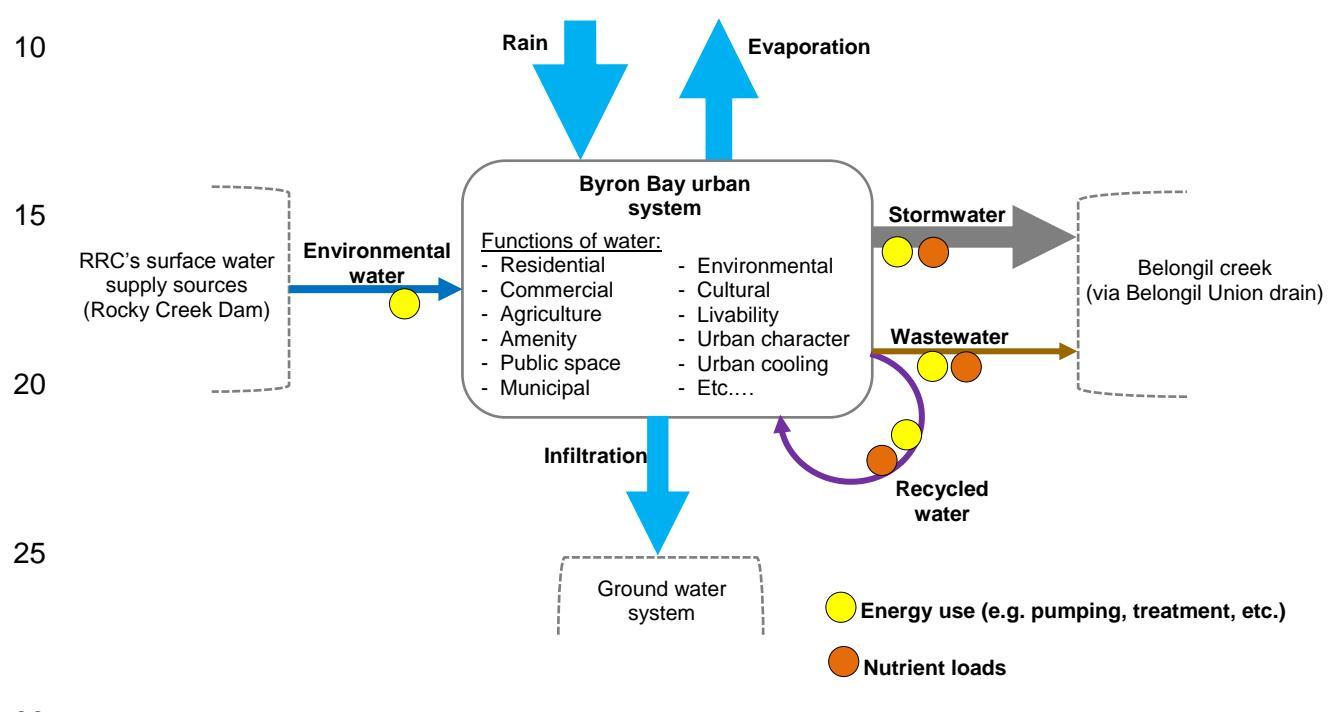
Figure 3: Conceptual water-mass balance model of Byron Bay. The thickness of the arrows broadly exemplifies the magnitude of the water flow. This model is only hypothetical and does not include all elements of the real systems.

> An urban metabolism model can also help assess the role of recycled water in the hydrological performance of the Shire, given it is currently supplied to environmental schemes (e.g. BBIWMR) that influence evaporation and infiltration rates, as well as having links to the Shire's drainage system.

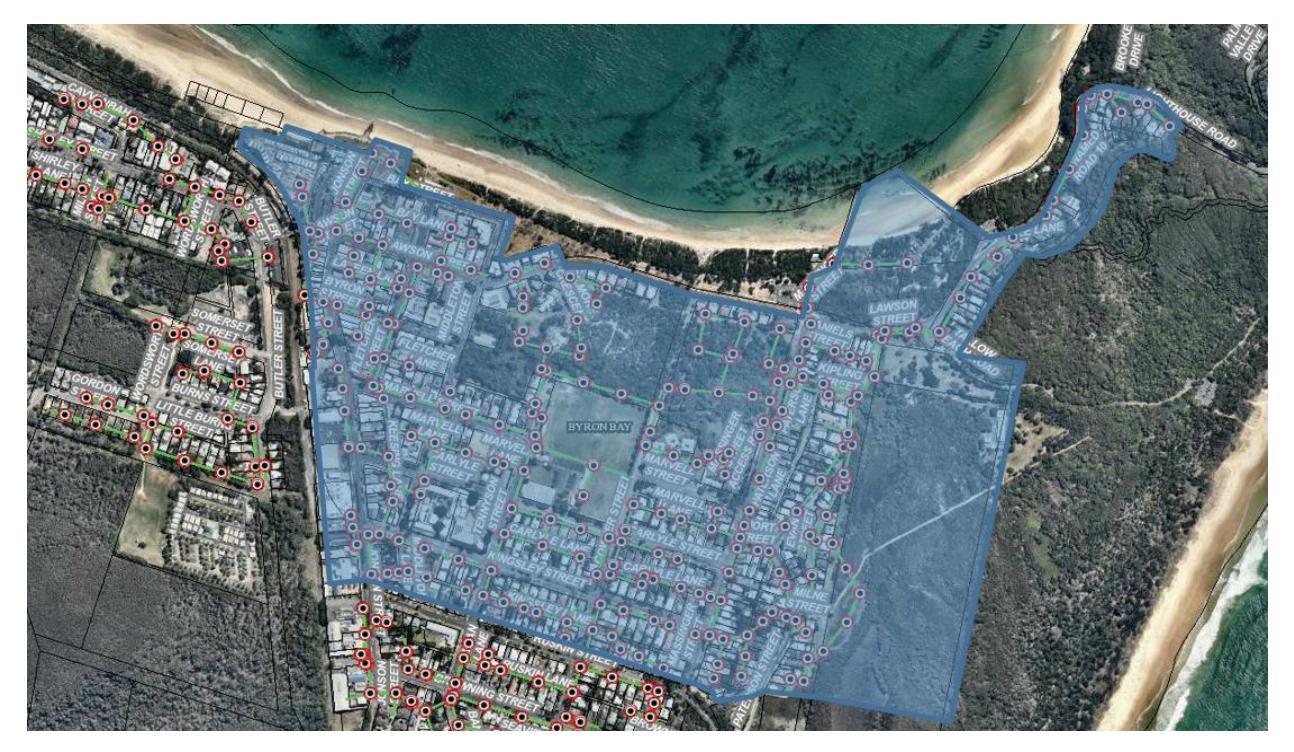
The 3002 gravity sewer catchment is located in Byron Bay and encloses the area shaded blue in Figure 1 below which includes the Byron Bay CBD. This catchment comprises a total of 329 gravity sewer mains and 262 maintenance holes. Despite the fact that council's sewer maintenance crews assisted with the location and uncovering of buried maintenance holes, not all were able to be undertaken within the time constraint of the project, hence 10 gravity sewer mains and 53 maintenance holes could not be assessed.

Figure 1 – Byron Bay 3002 Sewer Catchment, CCTV Works

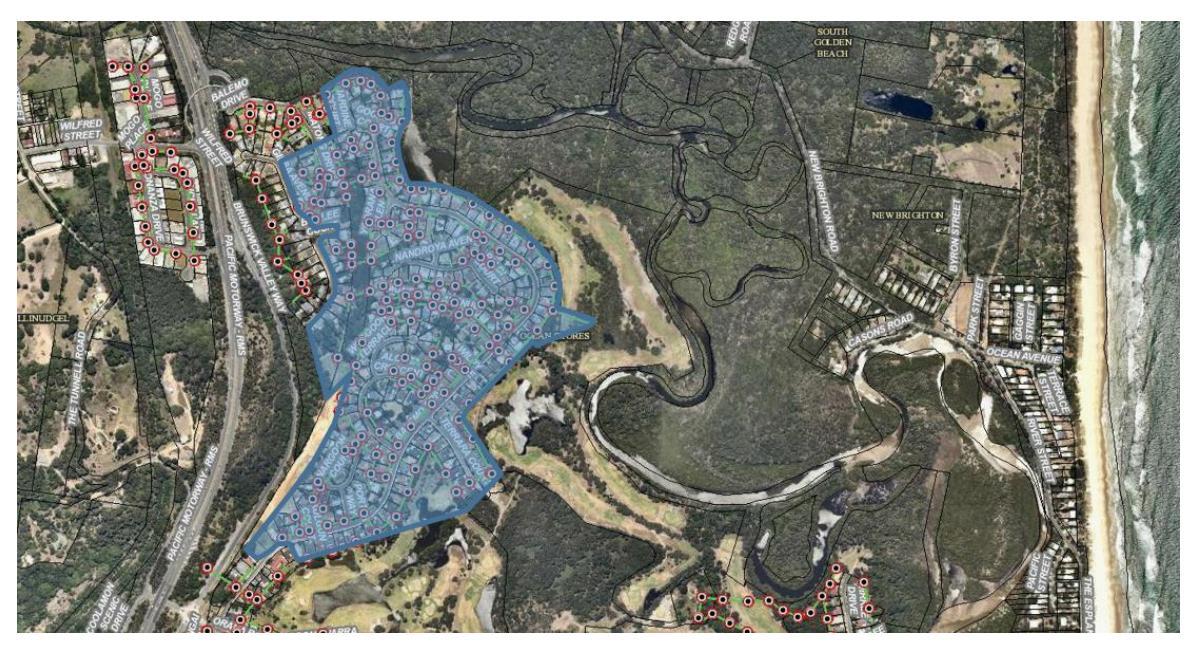
The 5012 gravity sewer catchment is located in Ocean Shores and encloses the area shaded blue in Figure 2 below. This catchment comprises a total of 223 gravity sewer mains and 159 maintenance holes. It should be noted that a large portion of the catchment was inaccessible prior to undertaking the assessments mainly due to the maintenance holes within this catchment being built over by residents constructing raised gardens, sheds, etc. Despite the fact that council's sewer maintenance crews assisted with the location and uncovering of

buried maintenance holes, not all were able to be undertaken within the time constraint of the project, hence 59 gravity sewer mains and 47 maintenance holes could not be assessed.

Figure 2 – Ocean Shores 5012 Sewer Catchment, CCTV Works

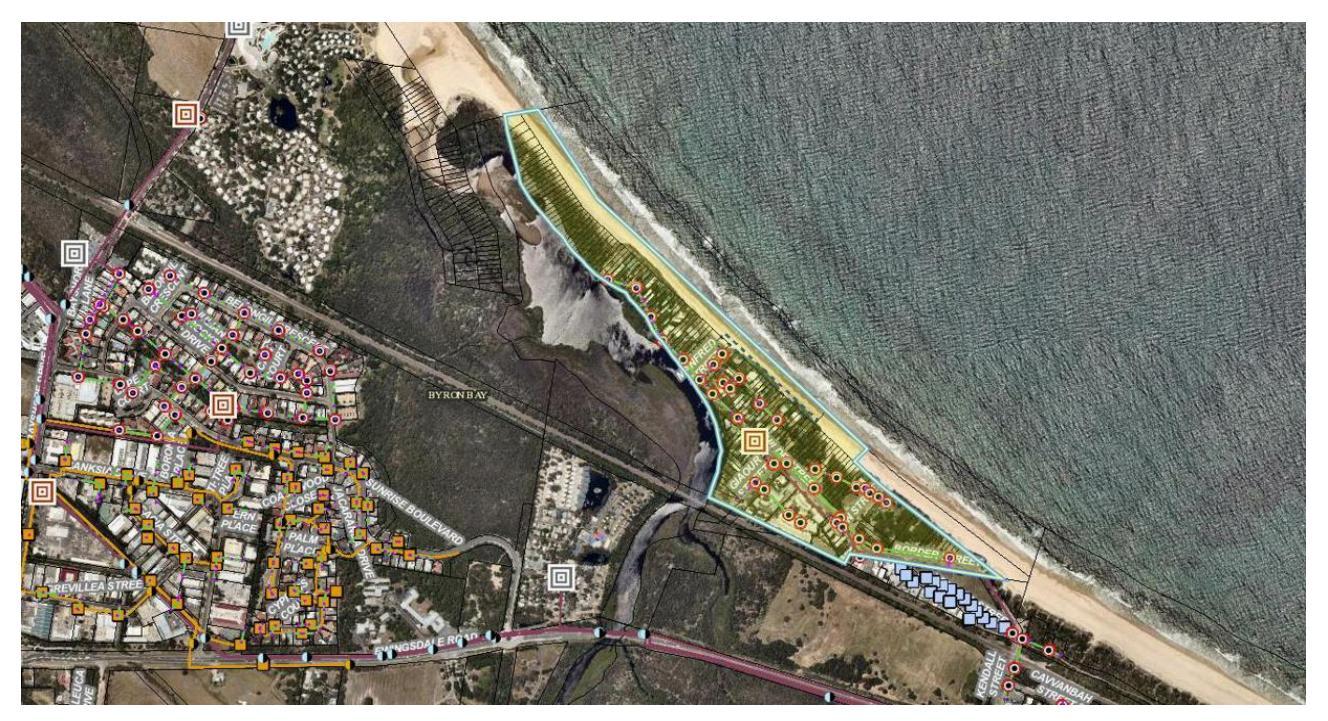
Figure 3 – Byron Bay 3005 Sewer Catchment

The proposed works for FY20/21 includes the condition assessment of the gravity sewer mains (29.2km) and maintenance holes (~550) within catchments 3005, 4002, 4003, 4004, and 5009 located within Byron Bay, Mullumbimby, and Ocean Shores respectively. Maps of these catchments are shown in the below figures. CCTV assessments are expected to cost in the order of \$150,000 in addition to the assessment of maintenance holes, contract management and reporting which will cost in the order of \$100,000.

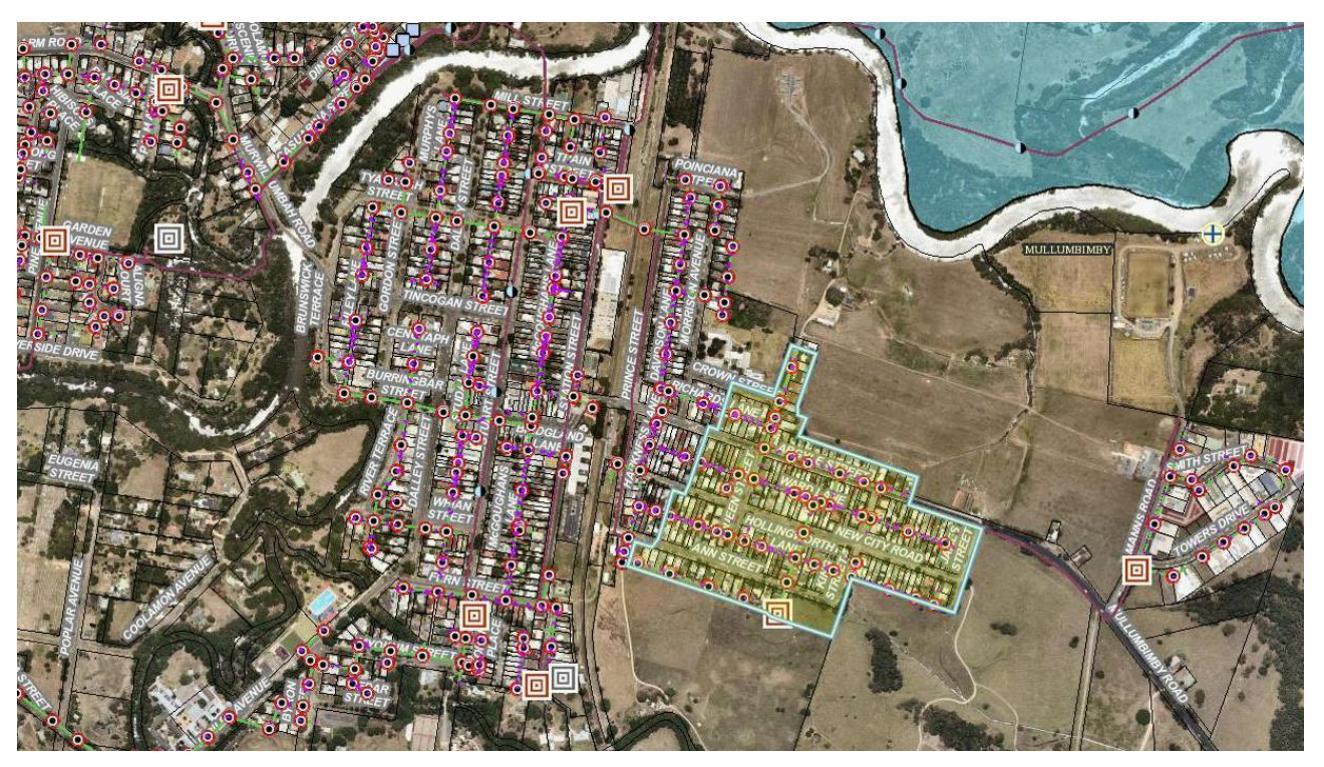
Figure 4 – Mullumbimby 4002 Sewer Catchment

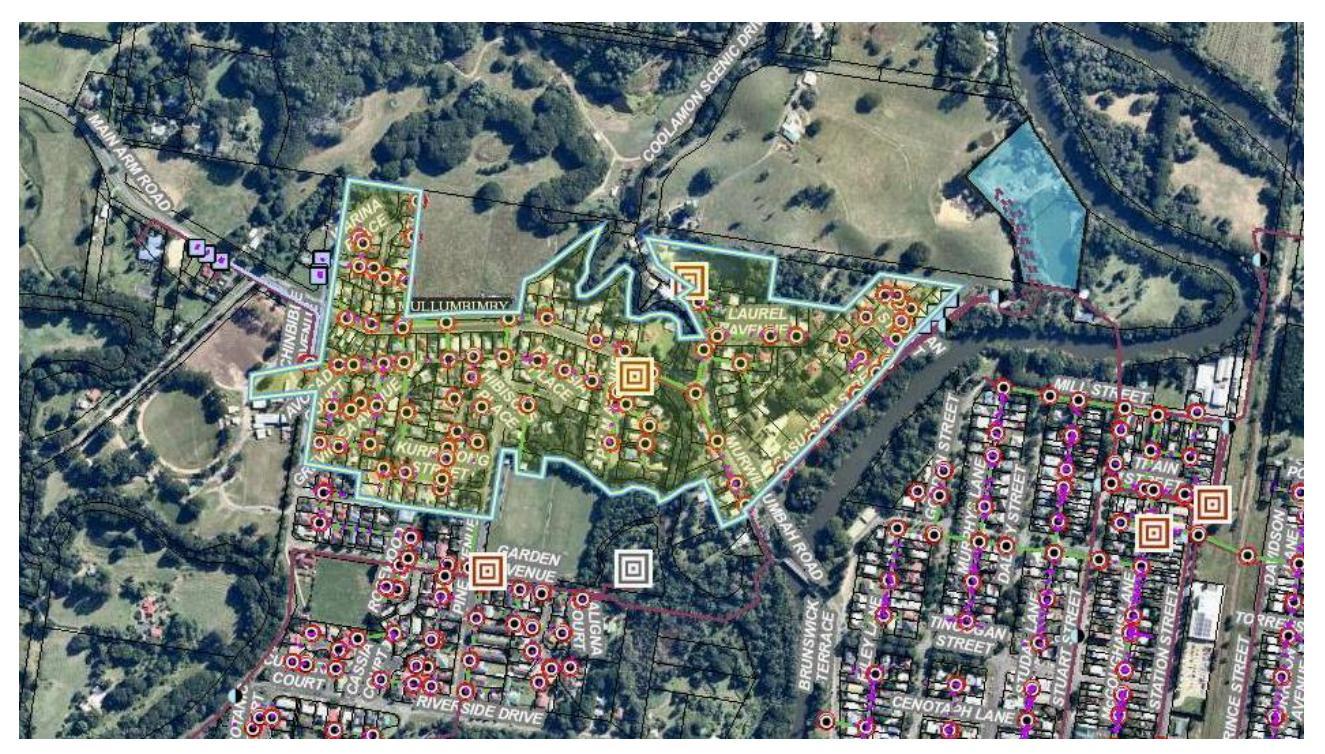
Figure 6 – Mullumbimby 4004 Sewer Catchment

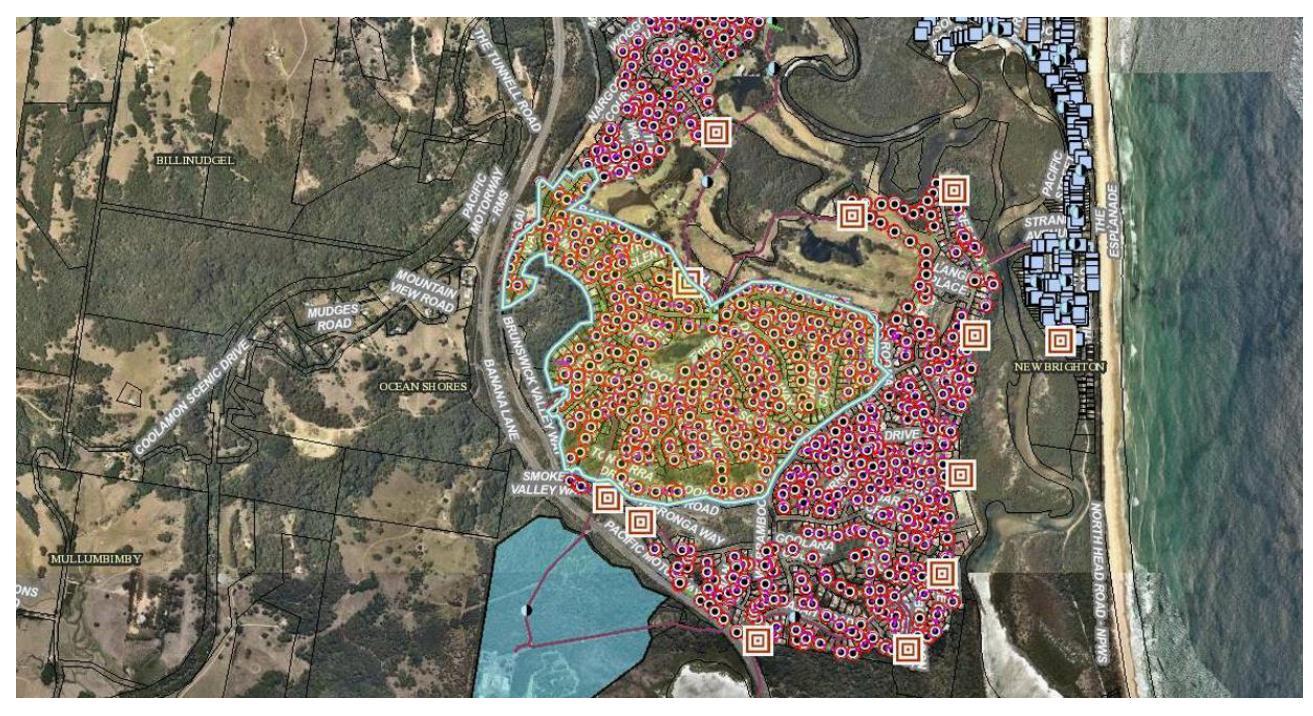
Figure 7 – Ocean Shores 5009 Sewer Catchment
