Draft Coastal Zone Management Plan for the Eastern Precincts of the Byron Bay Embayment

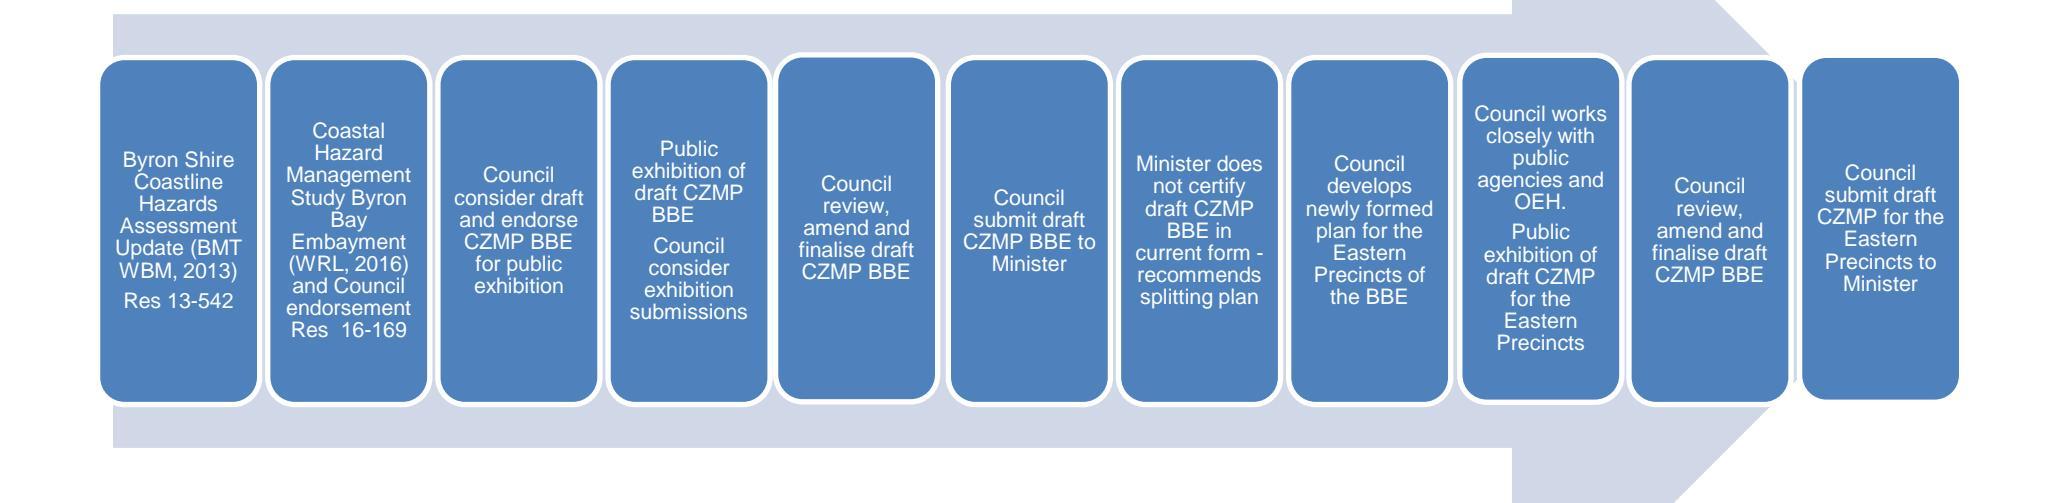
Figure 1 Process for preparing the draft CZMP in response to the Minister's Direction

The process for preparing this CZMP has been the result of a large body of previous studies and investigations. The most recent studies and key stages of developing this CZMP are depicted at Figure 1.

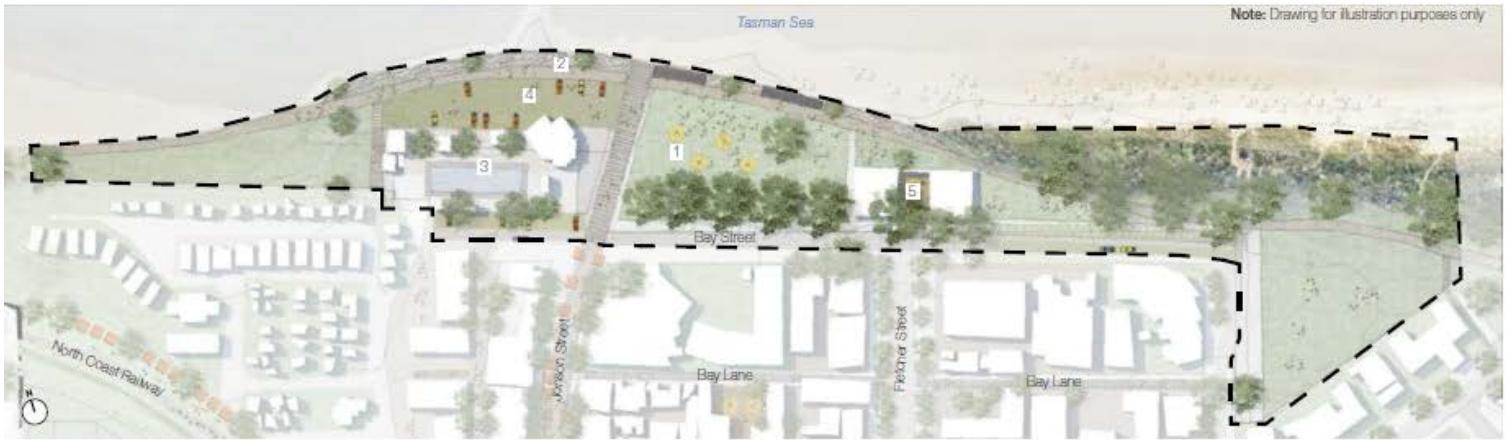
Figure 3 Main Beach precinct conceptual foreshore design outlined in the Masterplan.

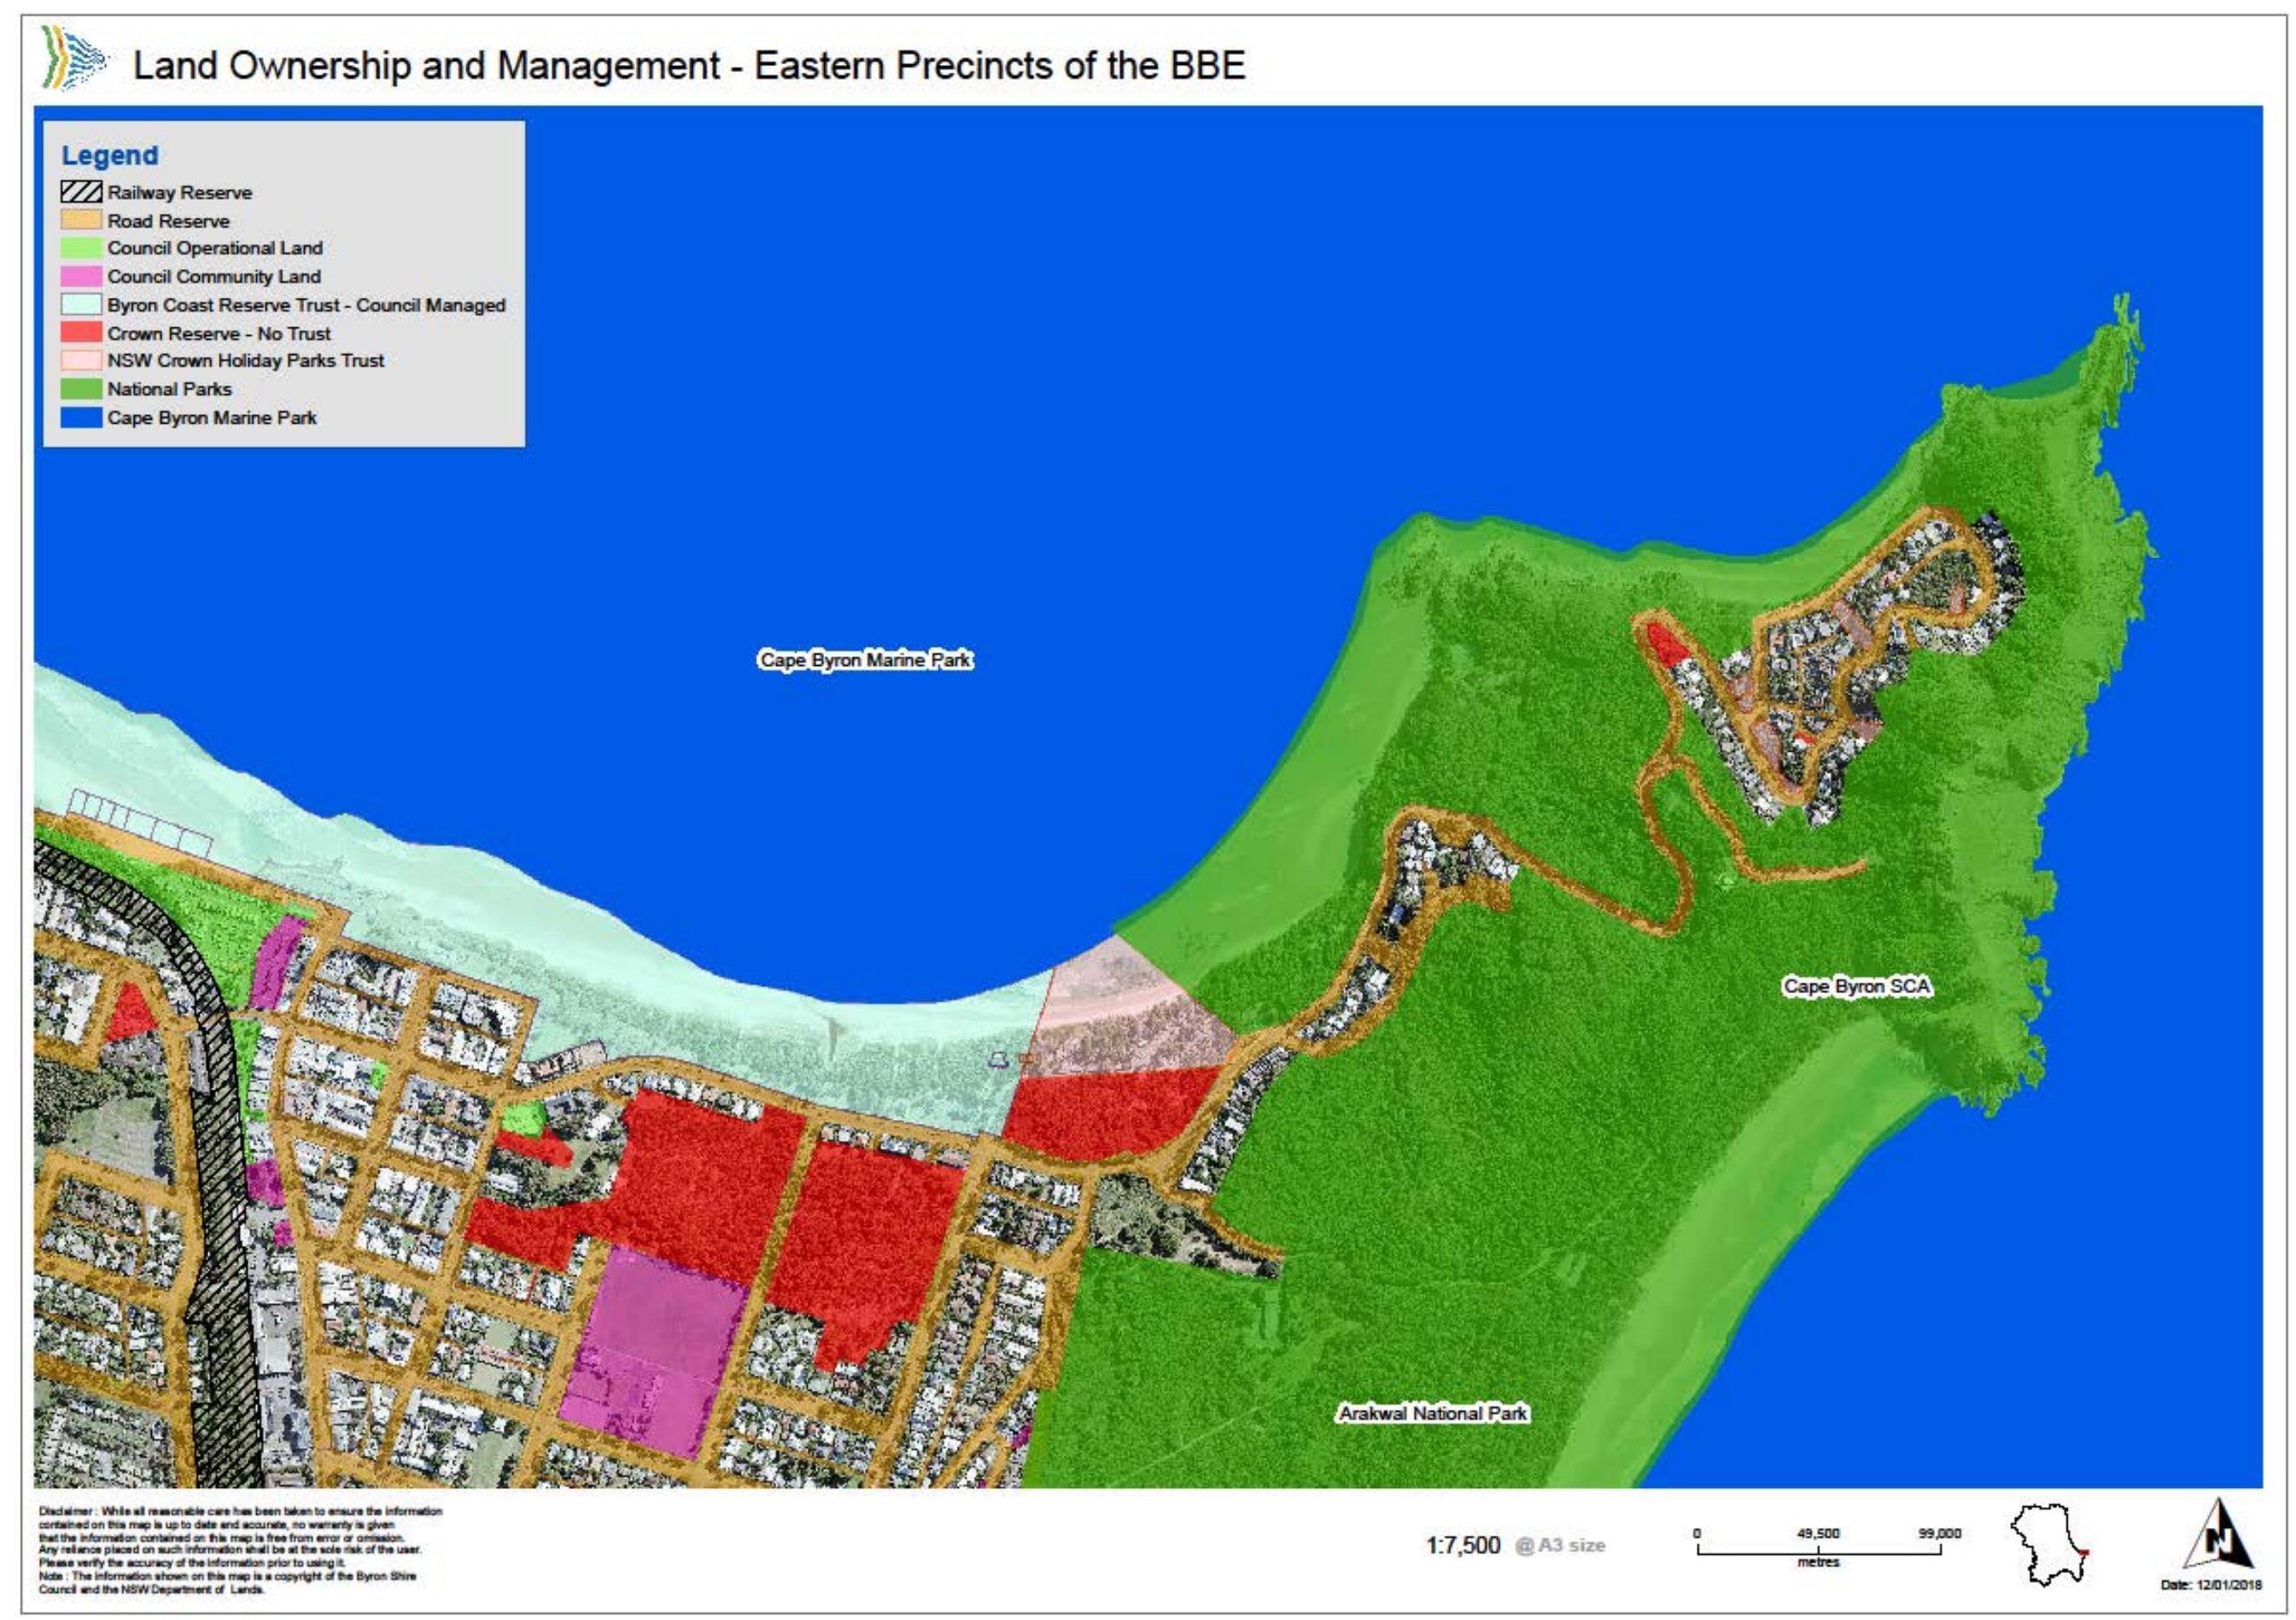
Figure 1 Land ownership and management arrangements for the Eastern Precincts of the Byron Bay Embaymen

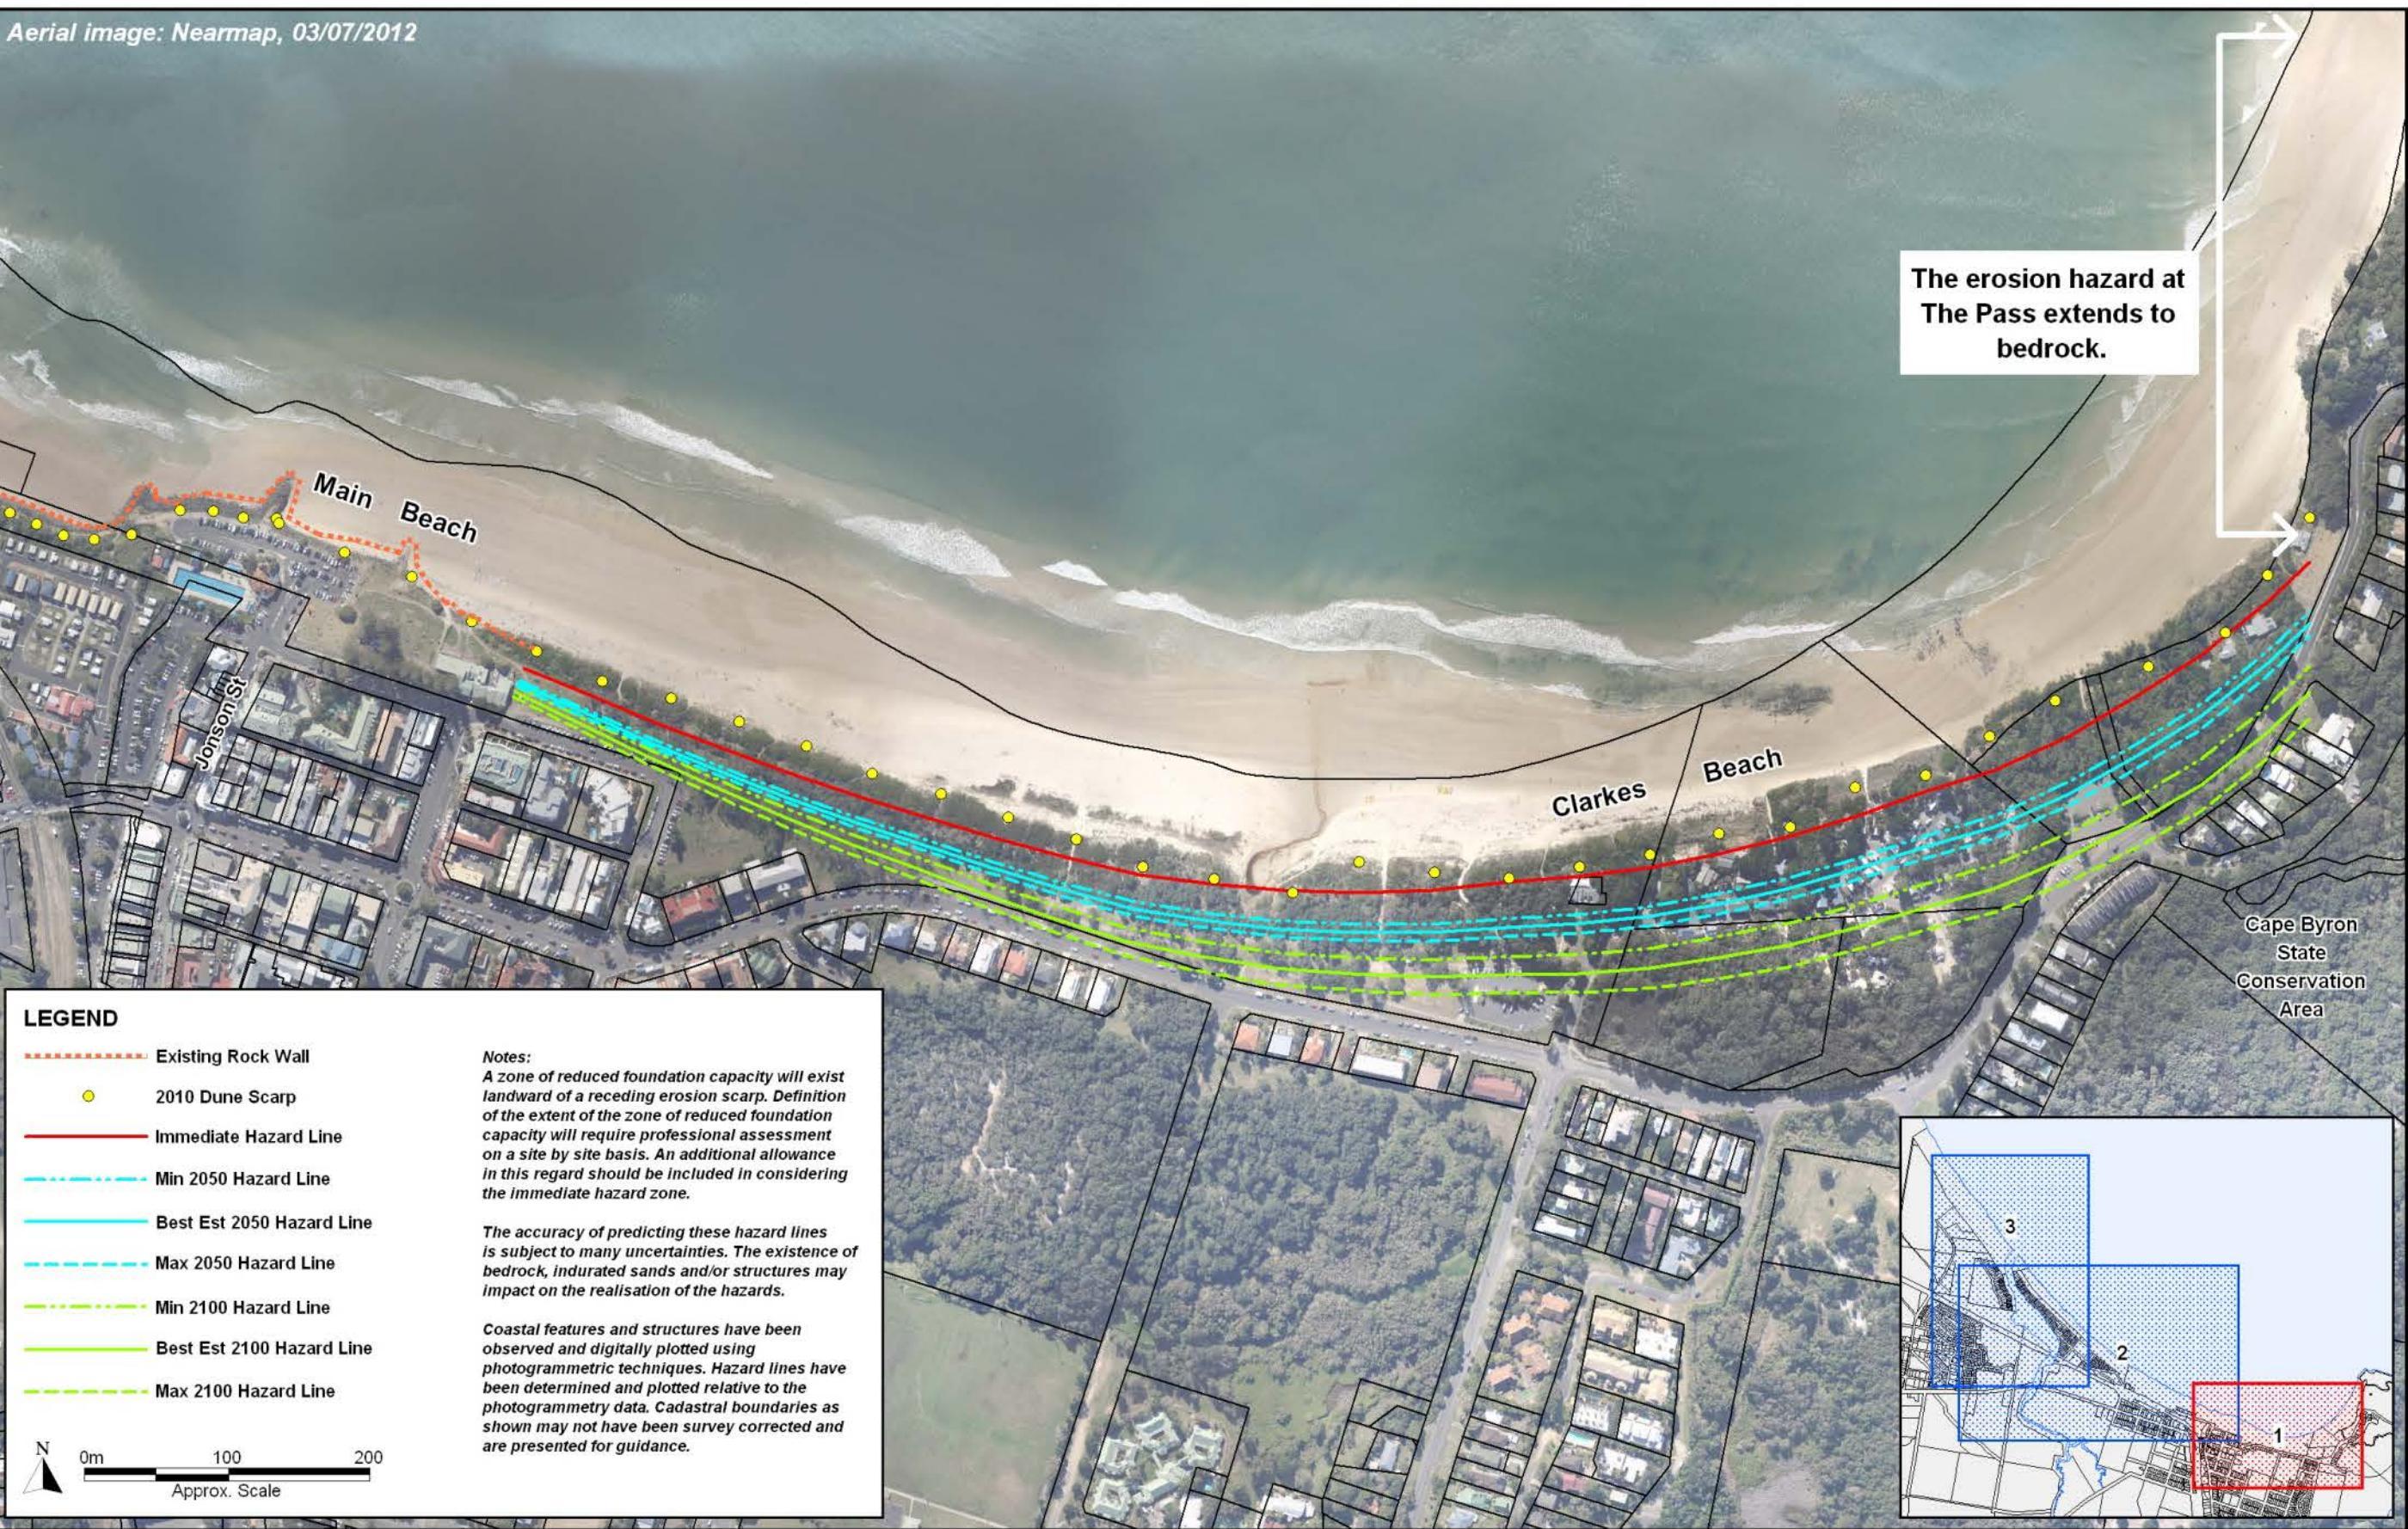
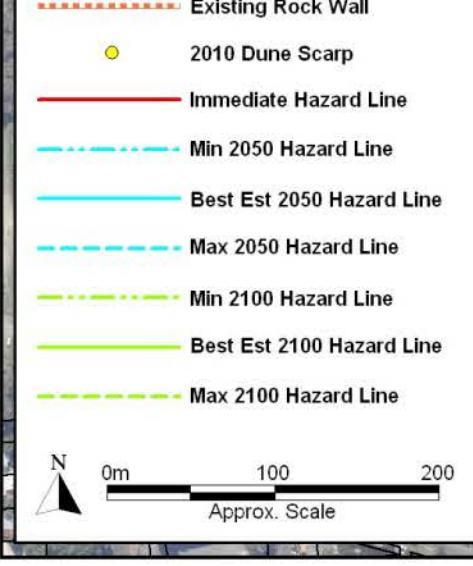
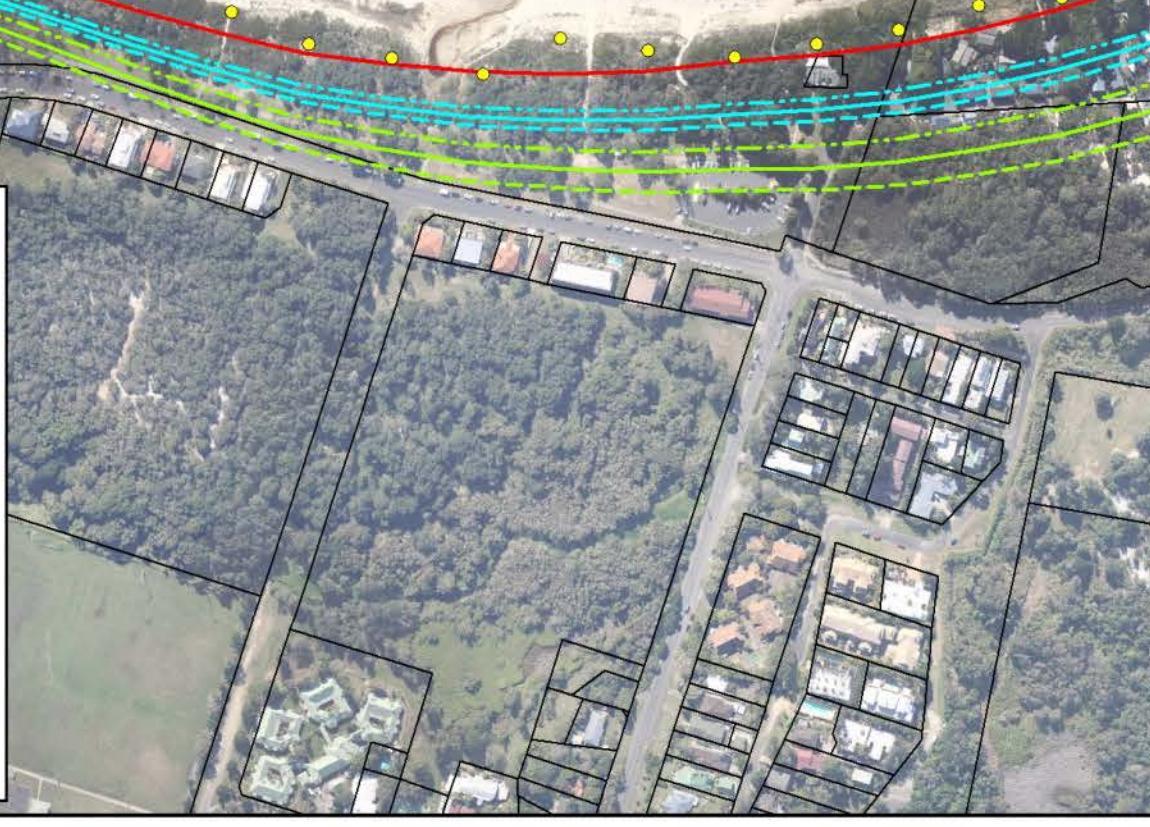
Figure 1 - Erosion Hazard Zones – Eastern Precincts – Main, Clarkes Beach and The Pass

The calculated Immediate, 2050 and 2100 hazard lines for the planning area are provided in Figure 1.

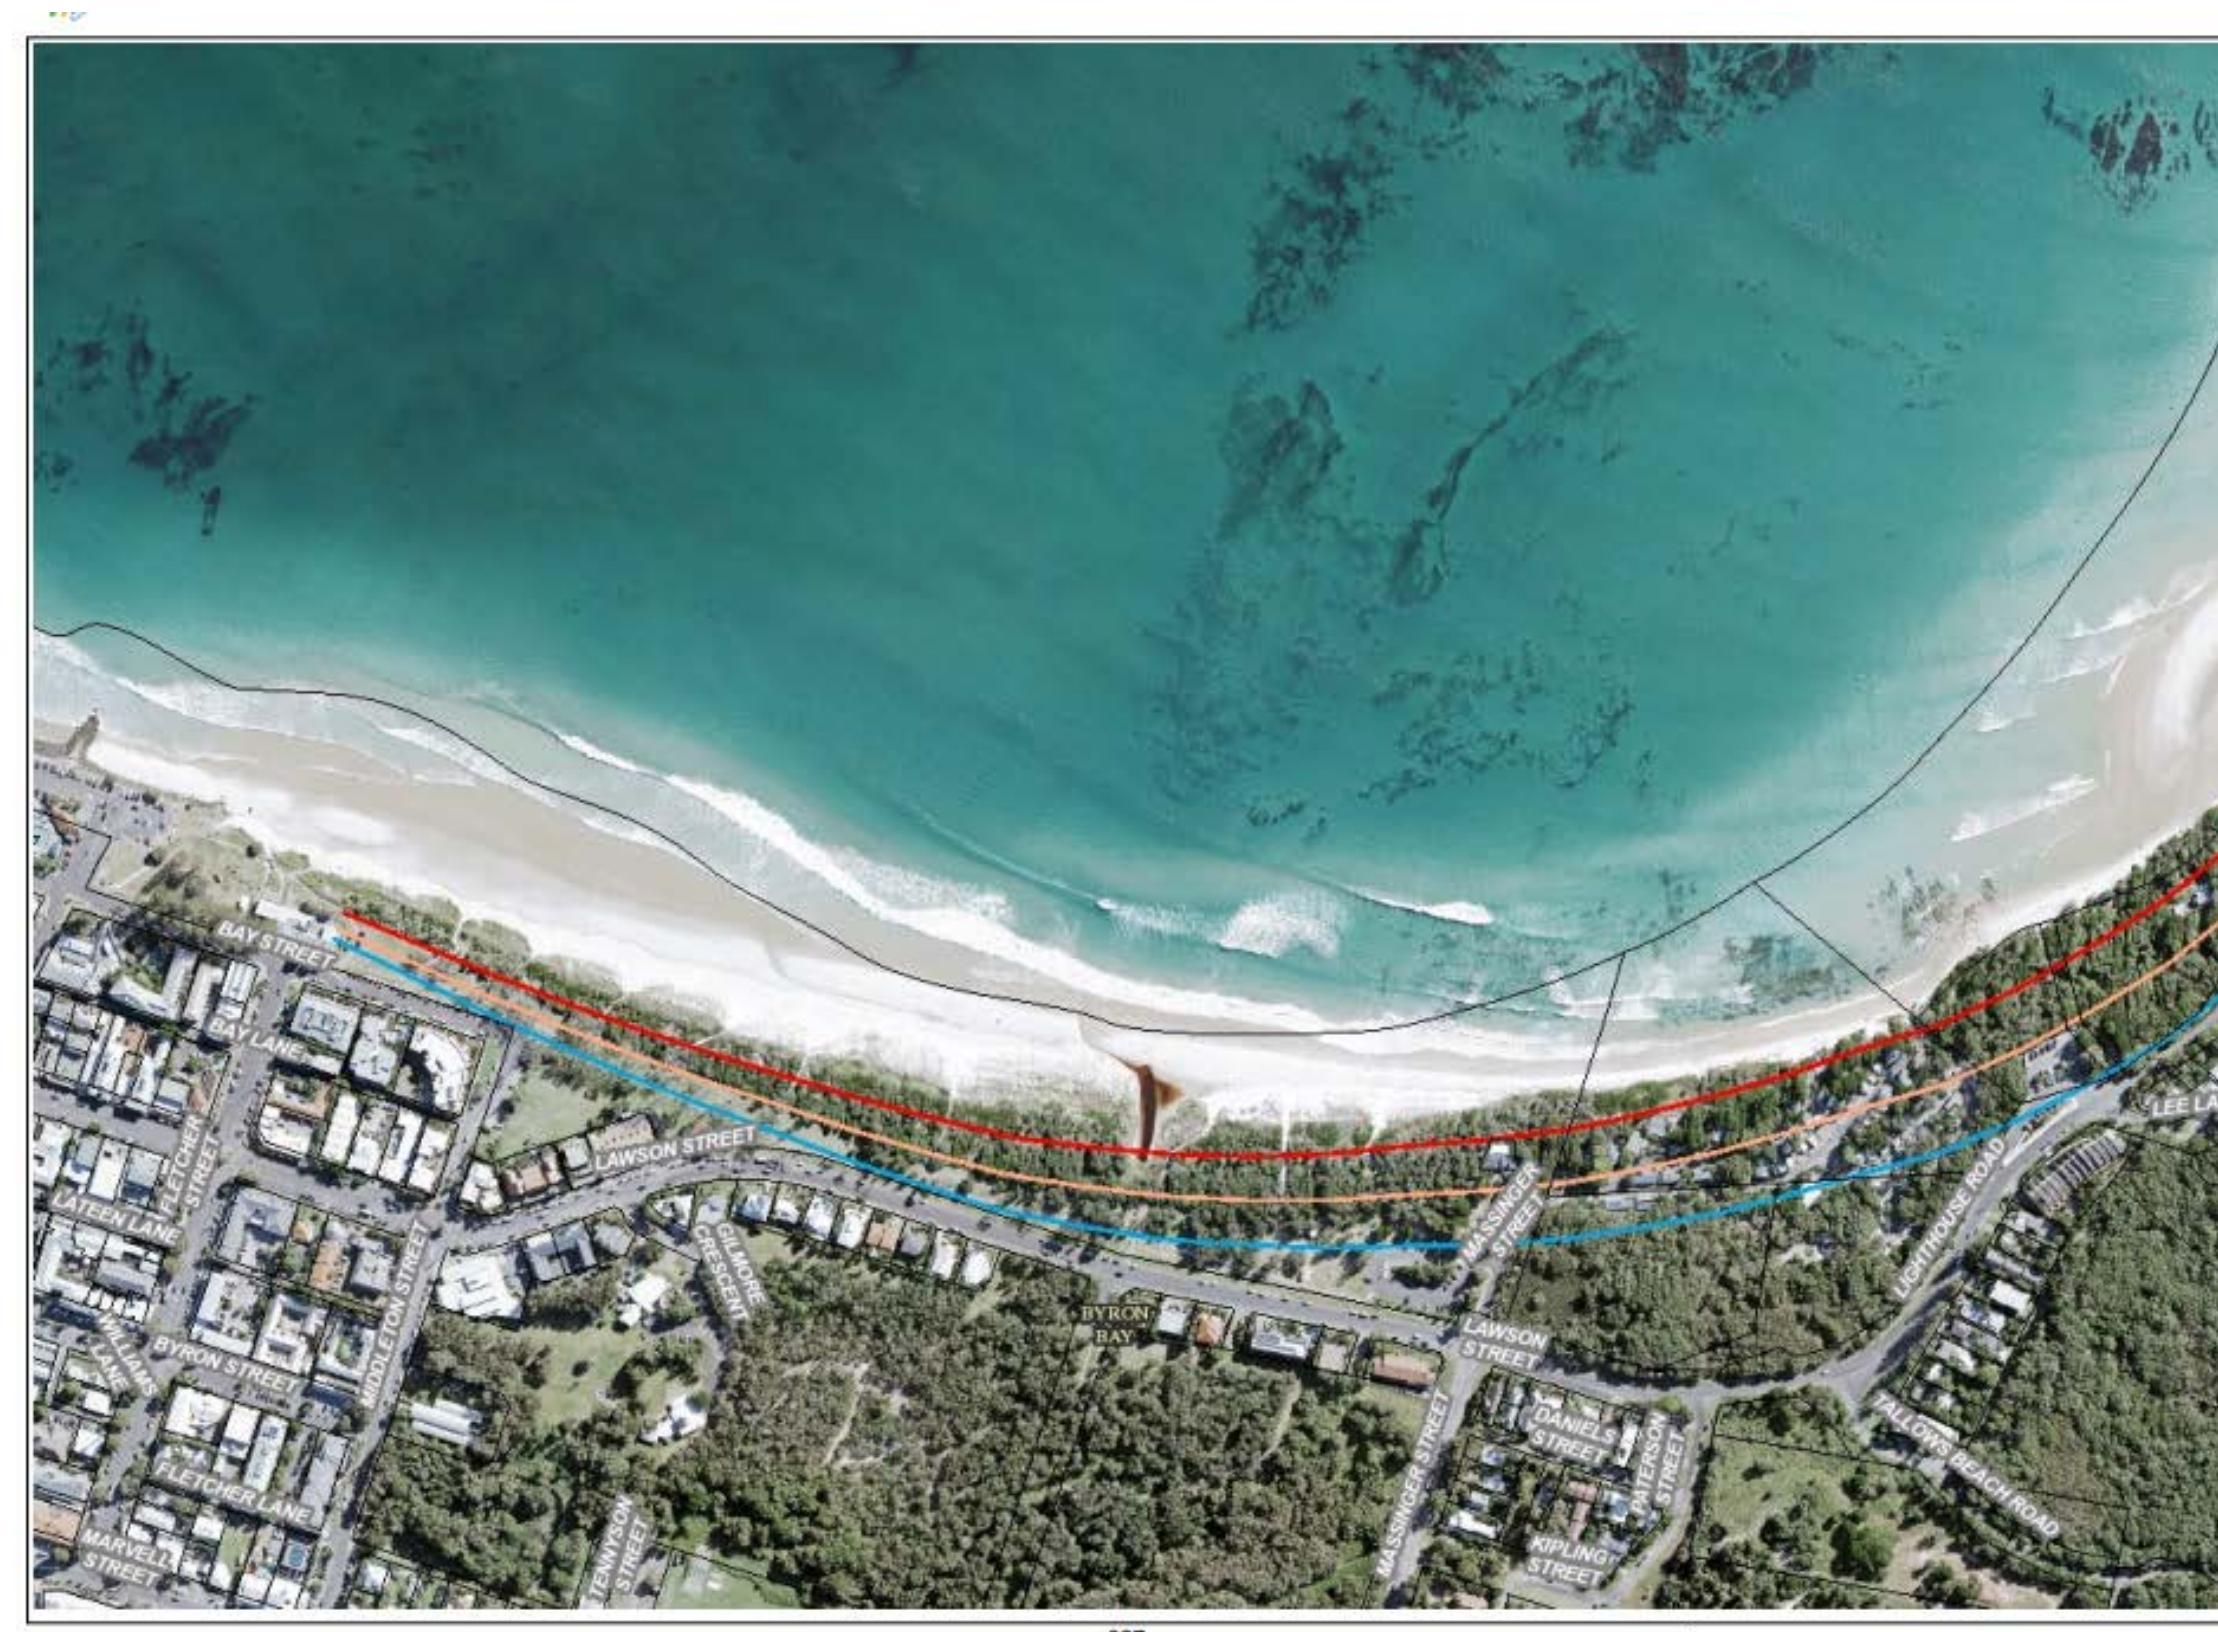
Figure 2
 Erosion Hazard Zones – Eastern Precincts – Main, Clarkes Beach and The Pass, showing 'best estimate' lines only.
 Interval

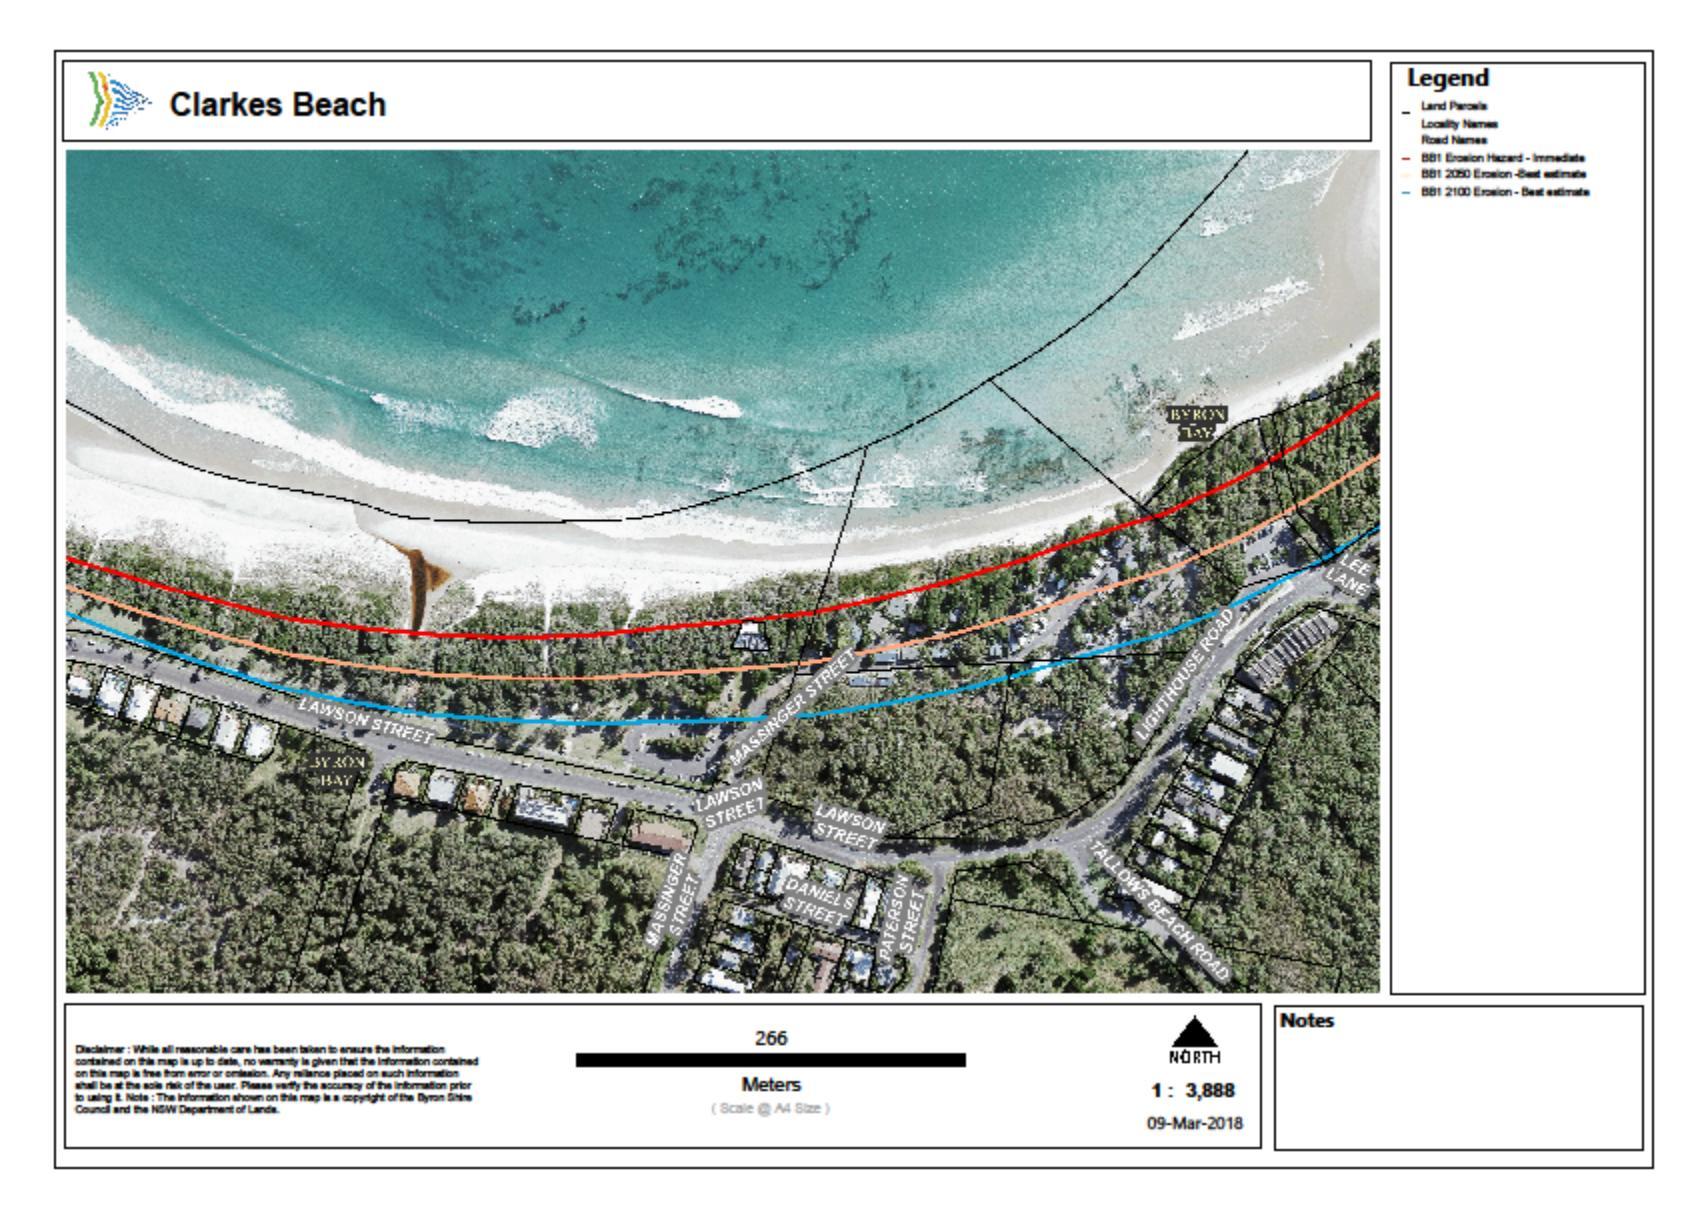
Figure 3 Erosion hazard zones at Clarkes Beach showing 'best estimate' lines only.

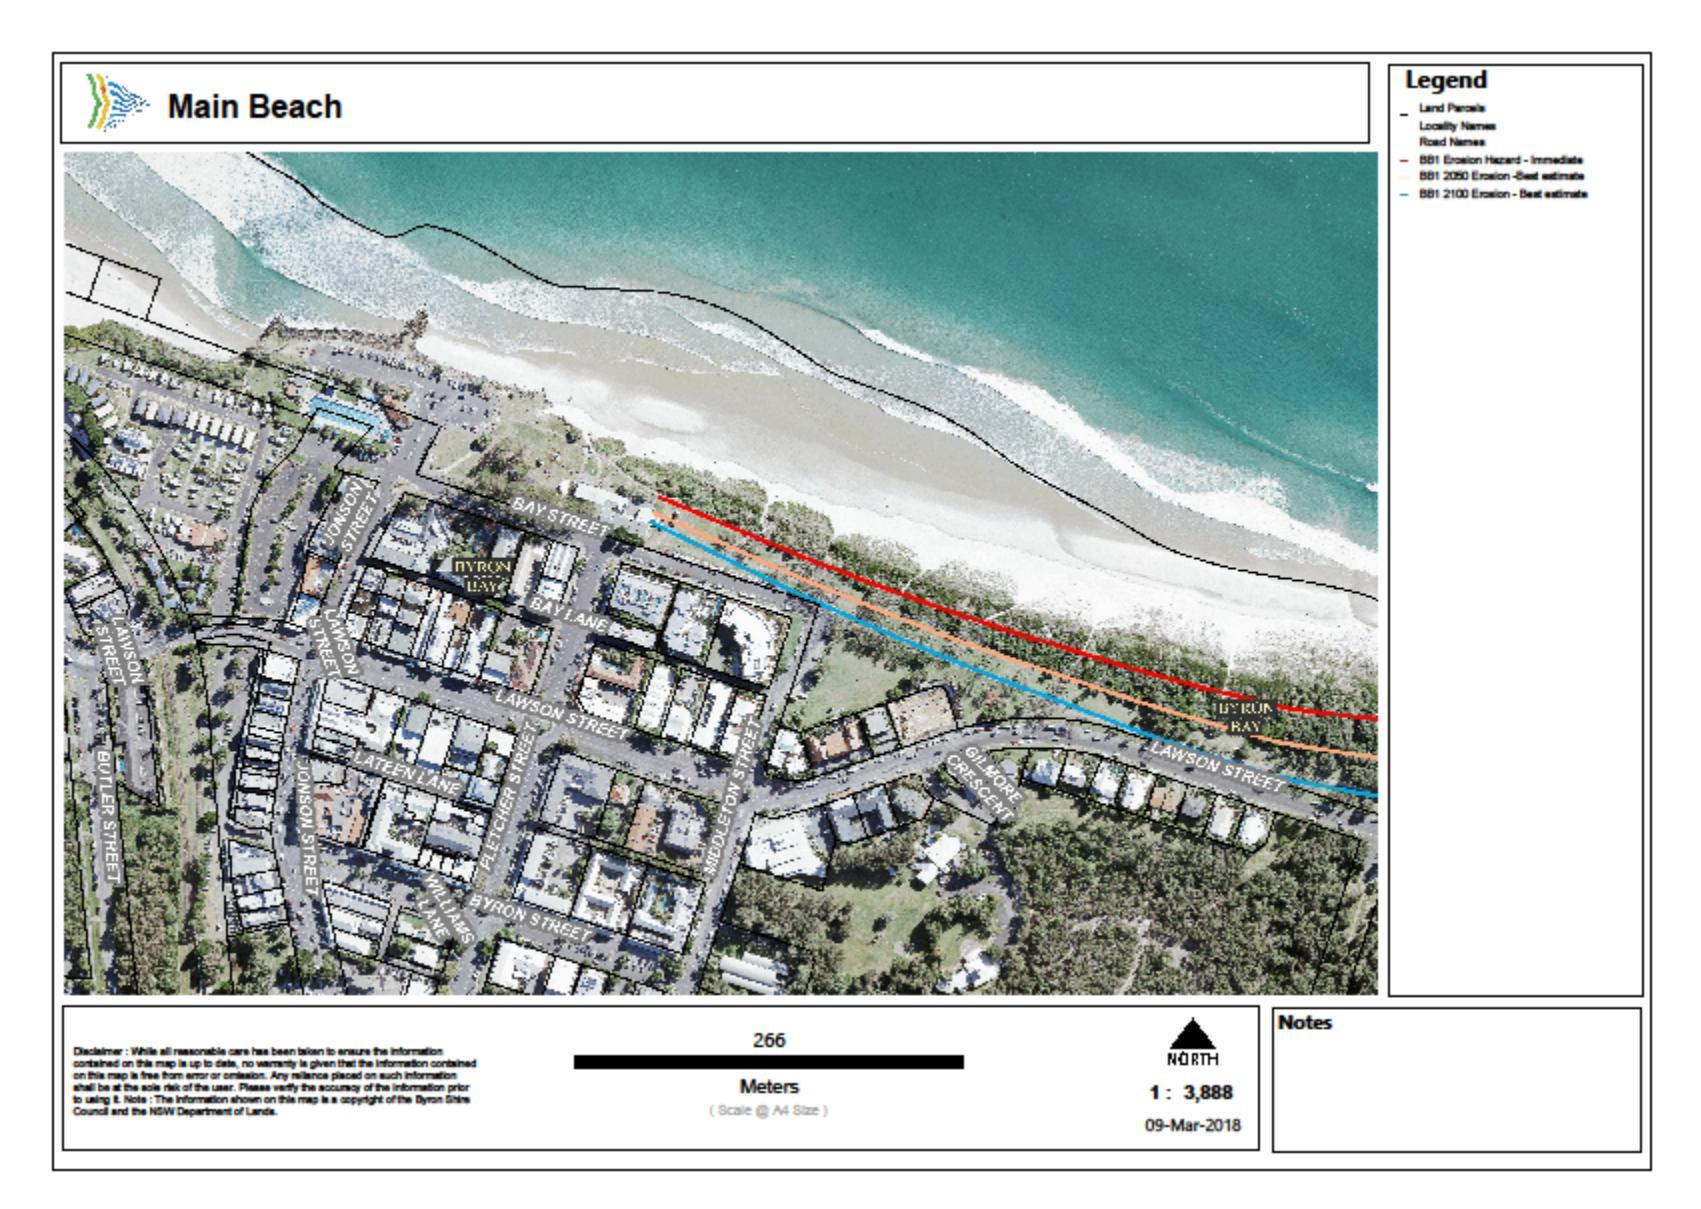
Figure 4 Erosion hazard zones at Main Beach showing 'best estimate' lines only.

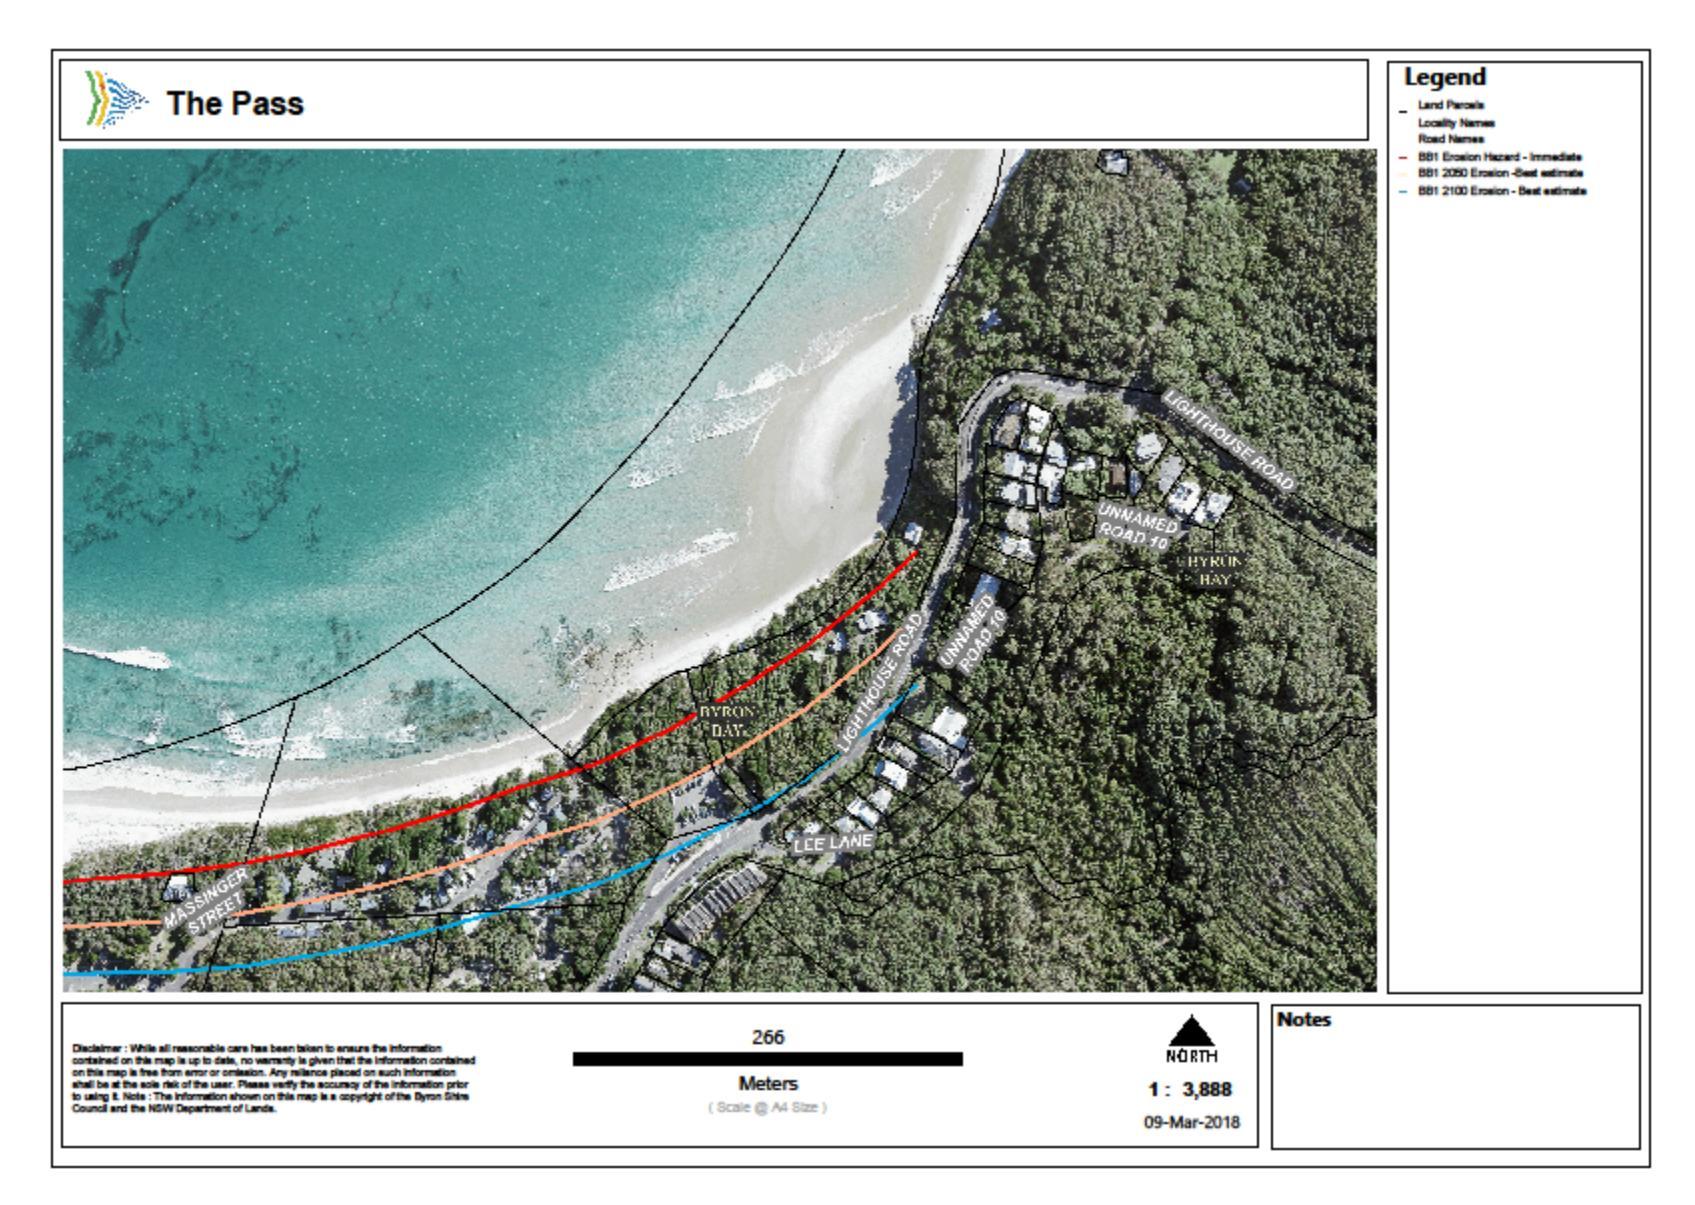
Figure 5 Erosion hazard zones at The Pass showing 'best estimate' lines only.

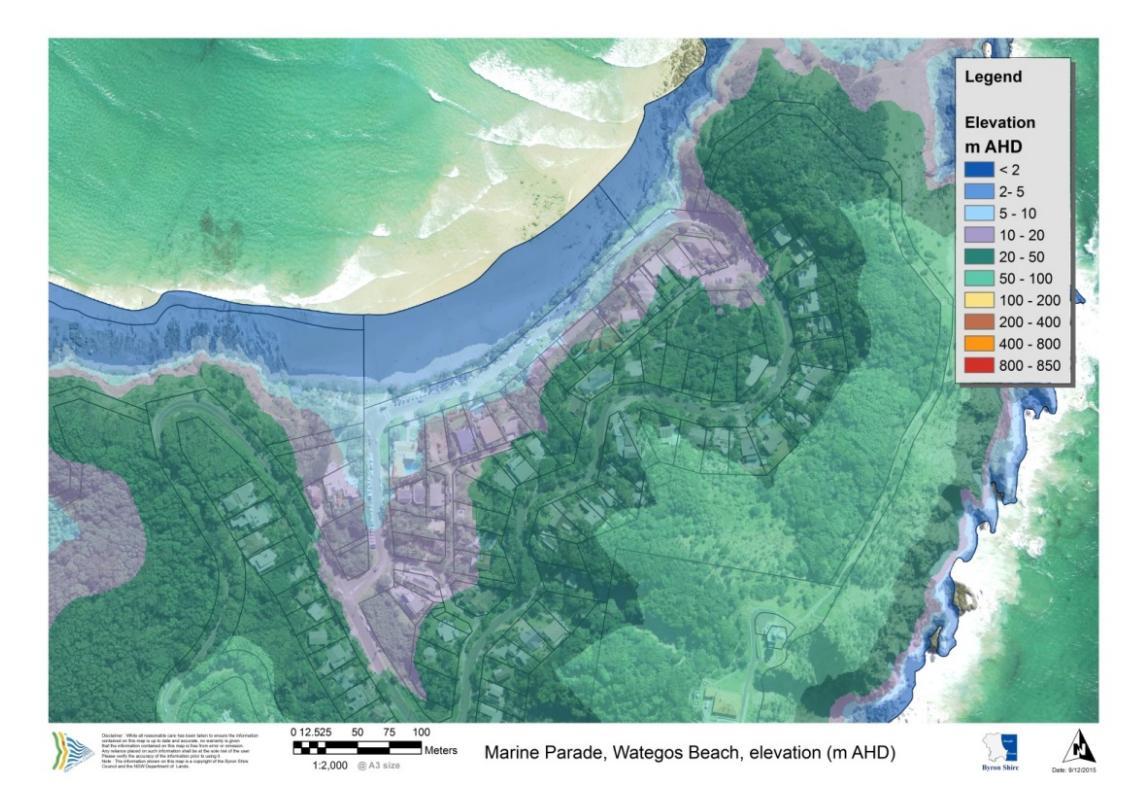
Figure 6 Elevations at Wategos Beach (elevation derived from NSW Land and Property Information, LiDAR data captured 28/08/10)

As shown in Figure 6, the elevation of Marine Parade is in the order of 5 to 10 m AHD for much of the road, increasing in height towards the east. Further investigation is warranted to determine the substrate composition of the Wategos sub-aerial foreshore with regard to its likely resistance to storm induced erosion events, and to assess the coastal inundation risk to the lower part of Marine Parade.
