Draft Coastal Zone Management Plan for the Eastern Precincts of the Byron Bay Embayment

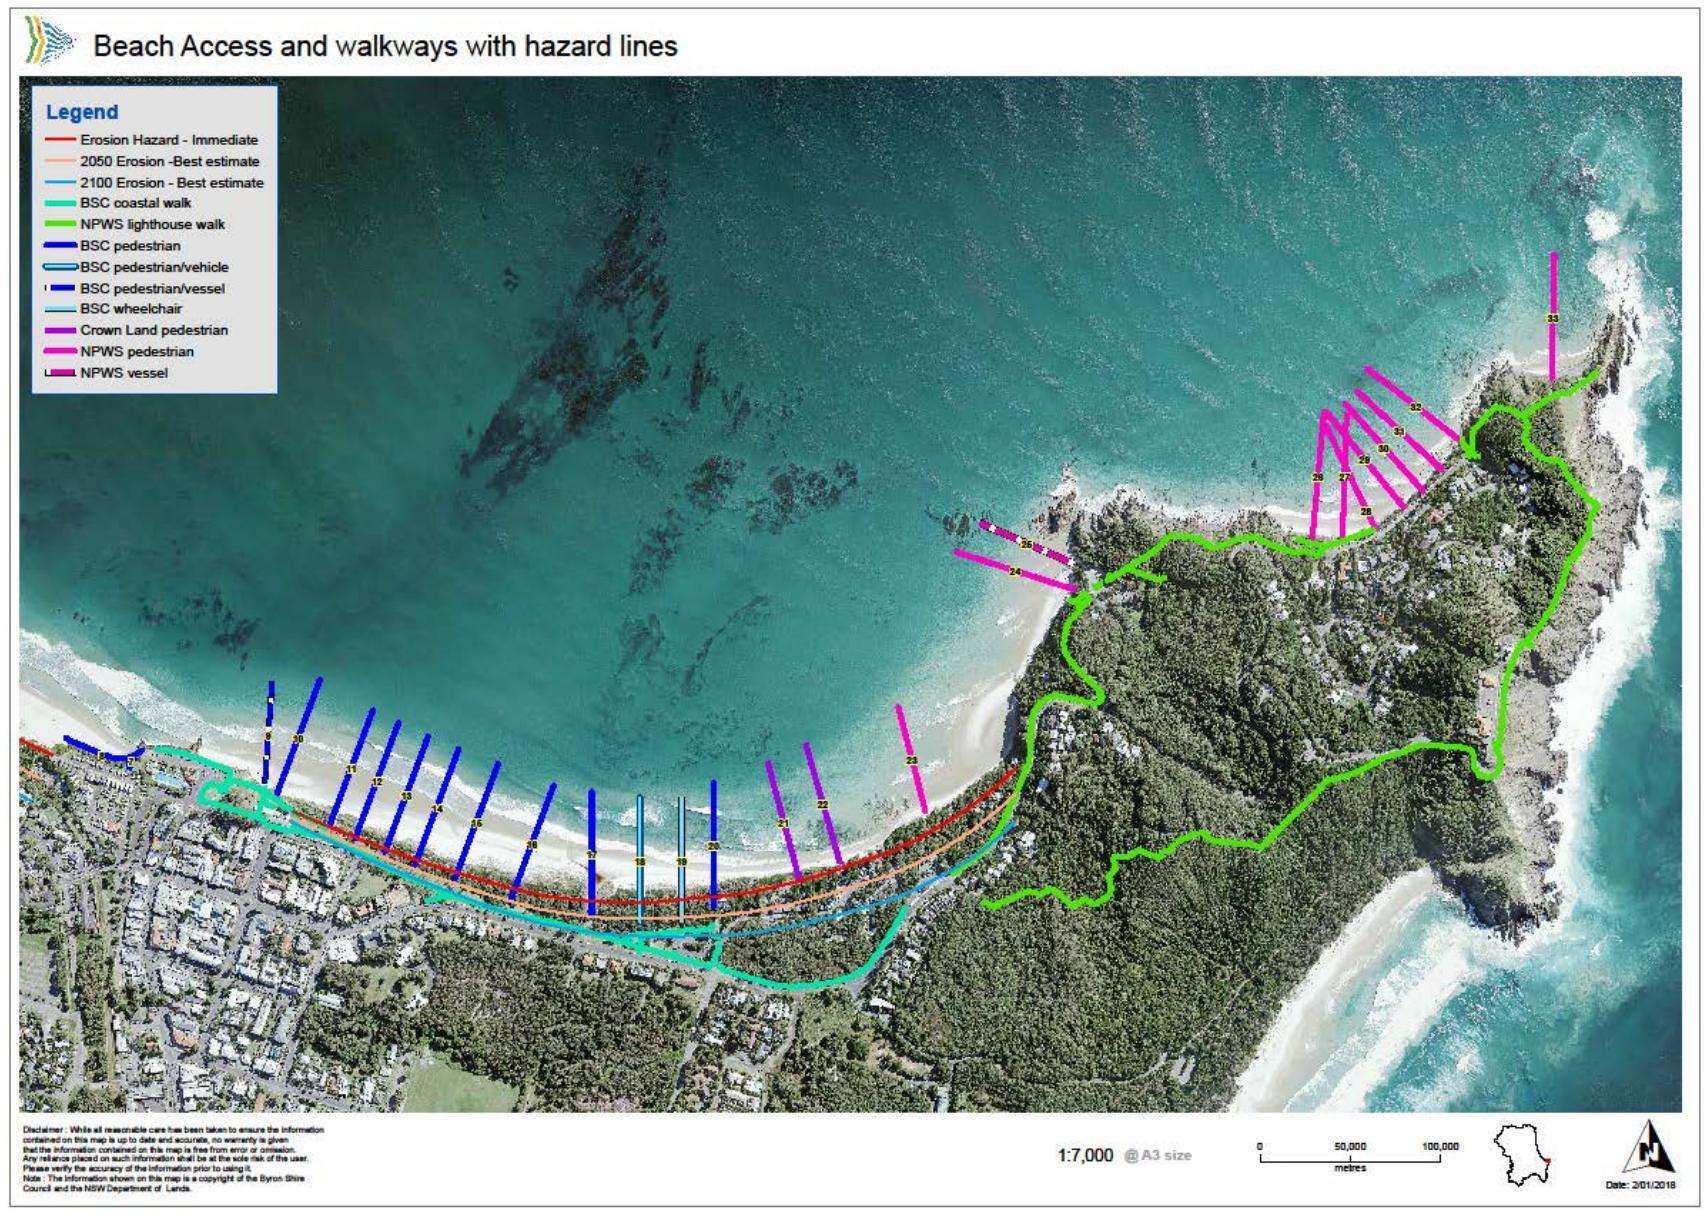
Figure 2 Coastal erosion hazard impact (BMT WBM, 2013) on beach access and walkways of the Eastern Precincts of the BBE (#8 to #33).

Coastal hazards currently impact beach accesses and are projected to increase impacts to accesses and walkways into the future. The coastal hazard lines prepared by BMT WBM (2013), and their positions relative to current public beach access arrangements, are depicted at Figure 2. The hazard lines represent the location of the shoreline for the immediate, 2050 year and 2100 timeframes. The hazard lines represent the projected "immediate" beach erosion hazard (from 100 year ARI storm event) and shoreline recession incorporating climate change induced sea level rise impacts.

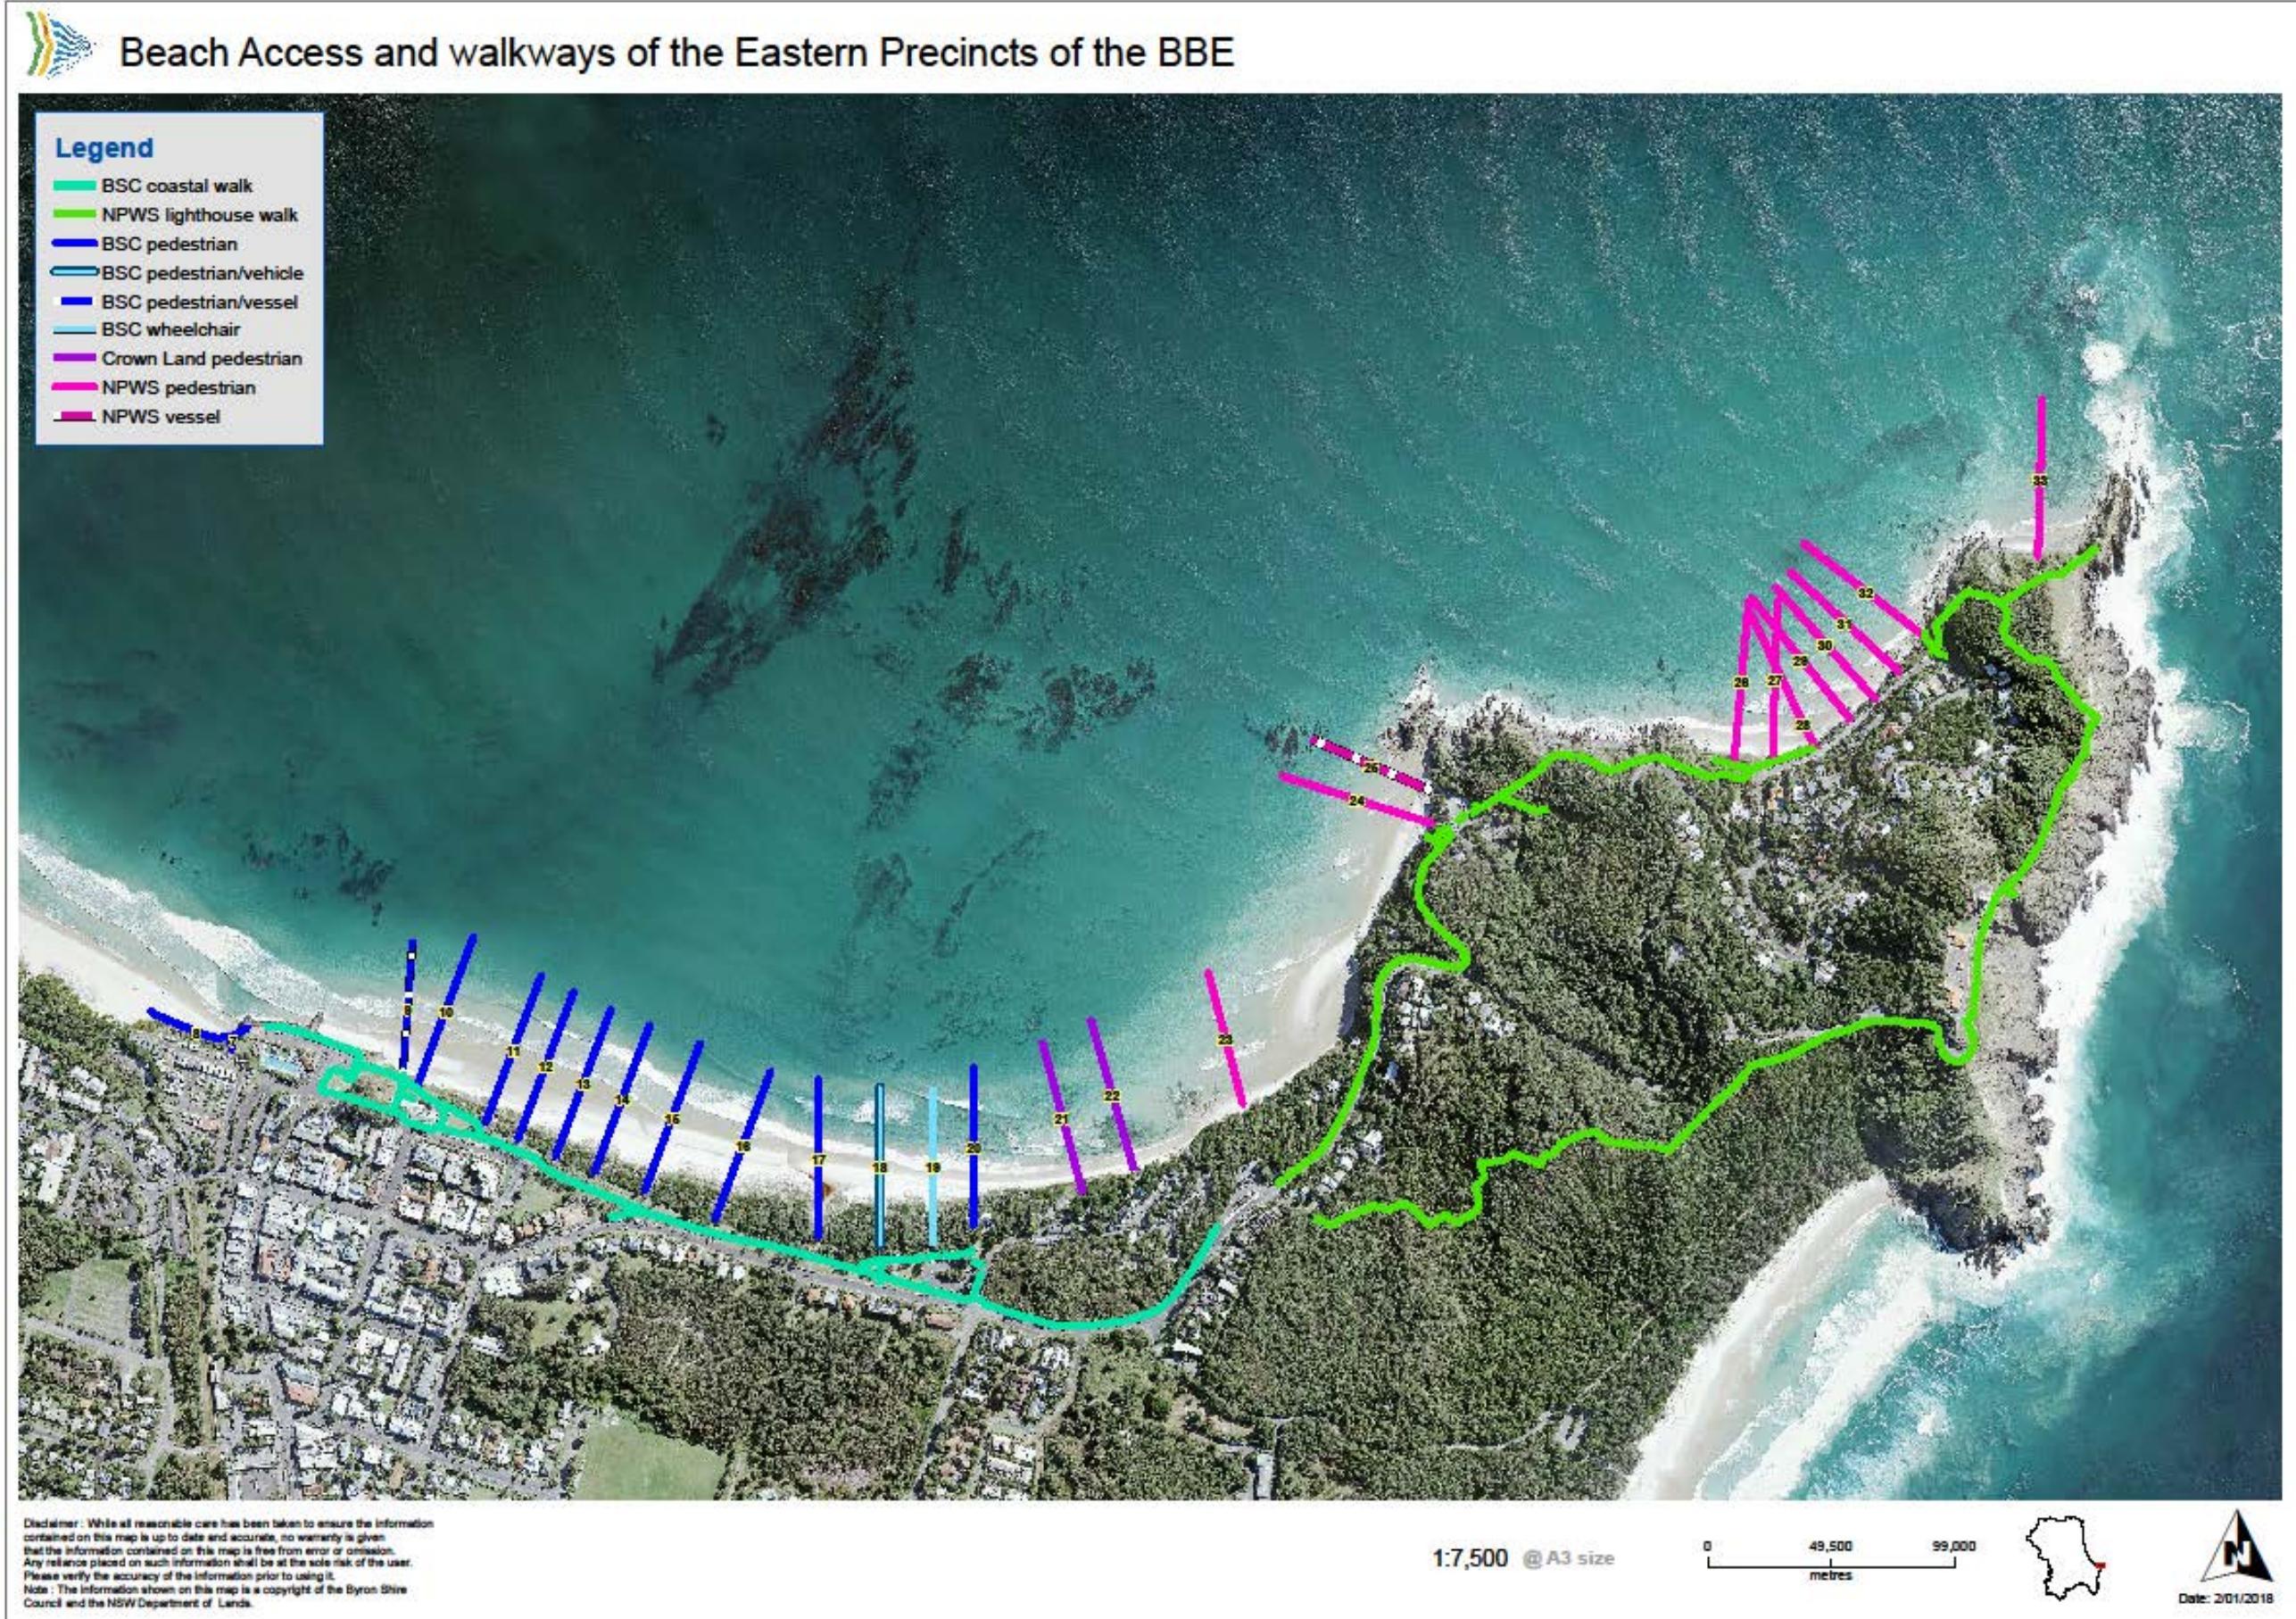
Beach accesses and coastal walkways of the Eastern Precincts of the Byron Bay Embayment (#8 to #33). Figure 1

A map depicting the beach access and walkway arrangements of the BBE is at Figure 1. Beach accesses and coastal walkways within the Eastern Precincts of the BBE are numbered 8 to 33.

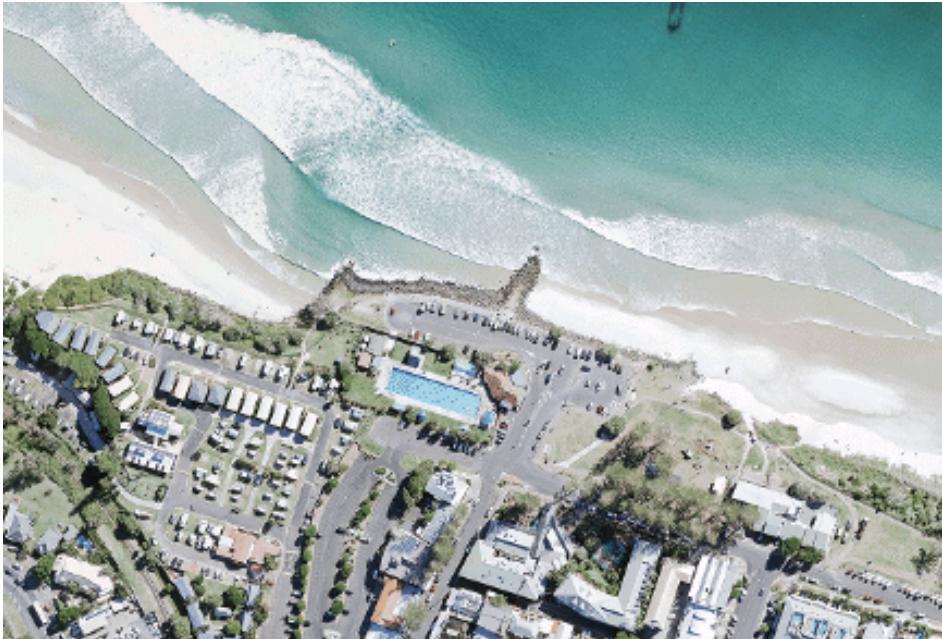
Jonson Street Protection Works Aerial View (Byron Shire Council, 2015)

The Jonson Street Protection Works (JSPW) provide protection and / or the structural foundation for beach accesses #7 to #9 (refer Figure 2). An aerial view of the JSPW is shown at Figure 2

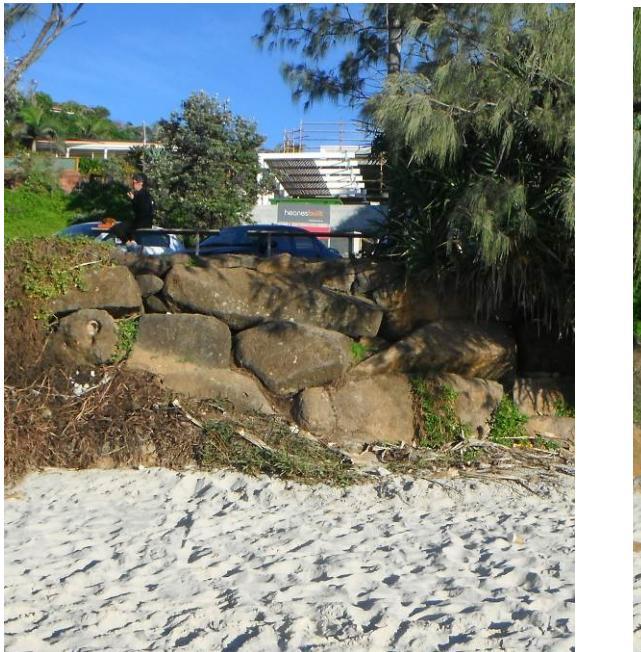
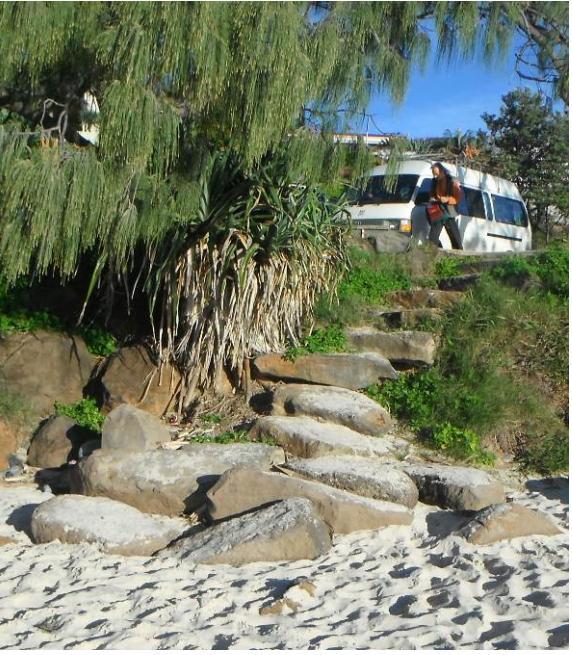
Figure 3 Rock ad hoc works Wategos Beach (24 June 2014)

The accesses and walkway at Wategos are, in various locations, supported by ad hoc works, as shown at Figure 3 and Figure 4. The efficacy and structural integrity of these works is unknown and it is unclear as to the extent of bedrock which may underlay these works and Marine Parade.

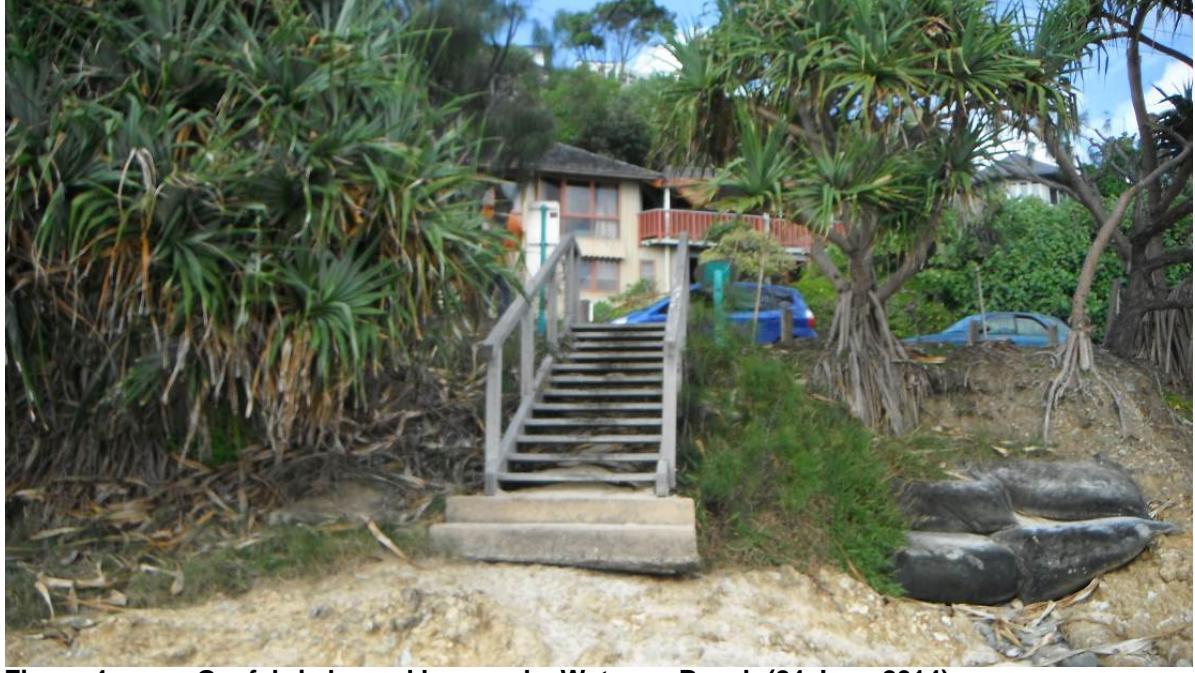
Figure 4 Geofabric bag ad hoc works Wategos Beach (24 June 2014)
