# The “Tripper wall”

## Tripper wall after 37 years

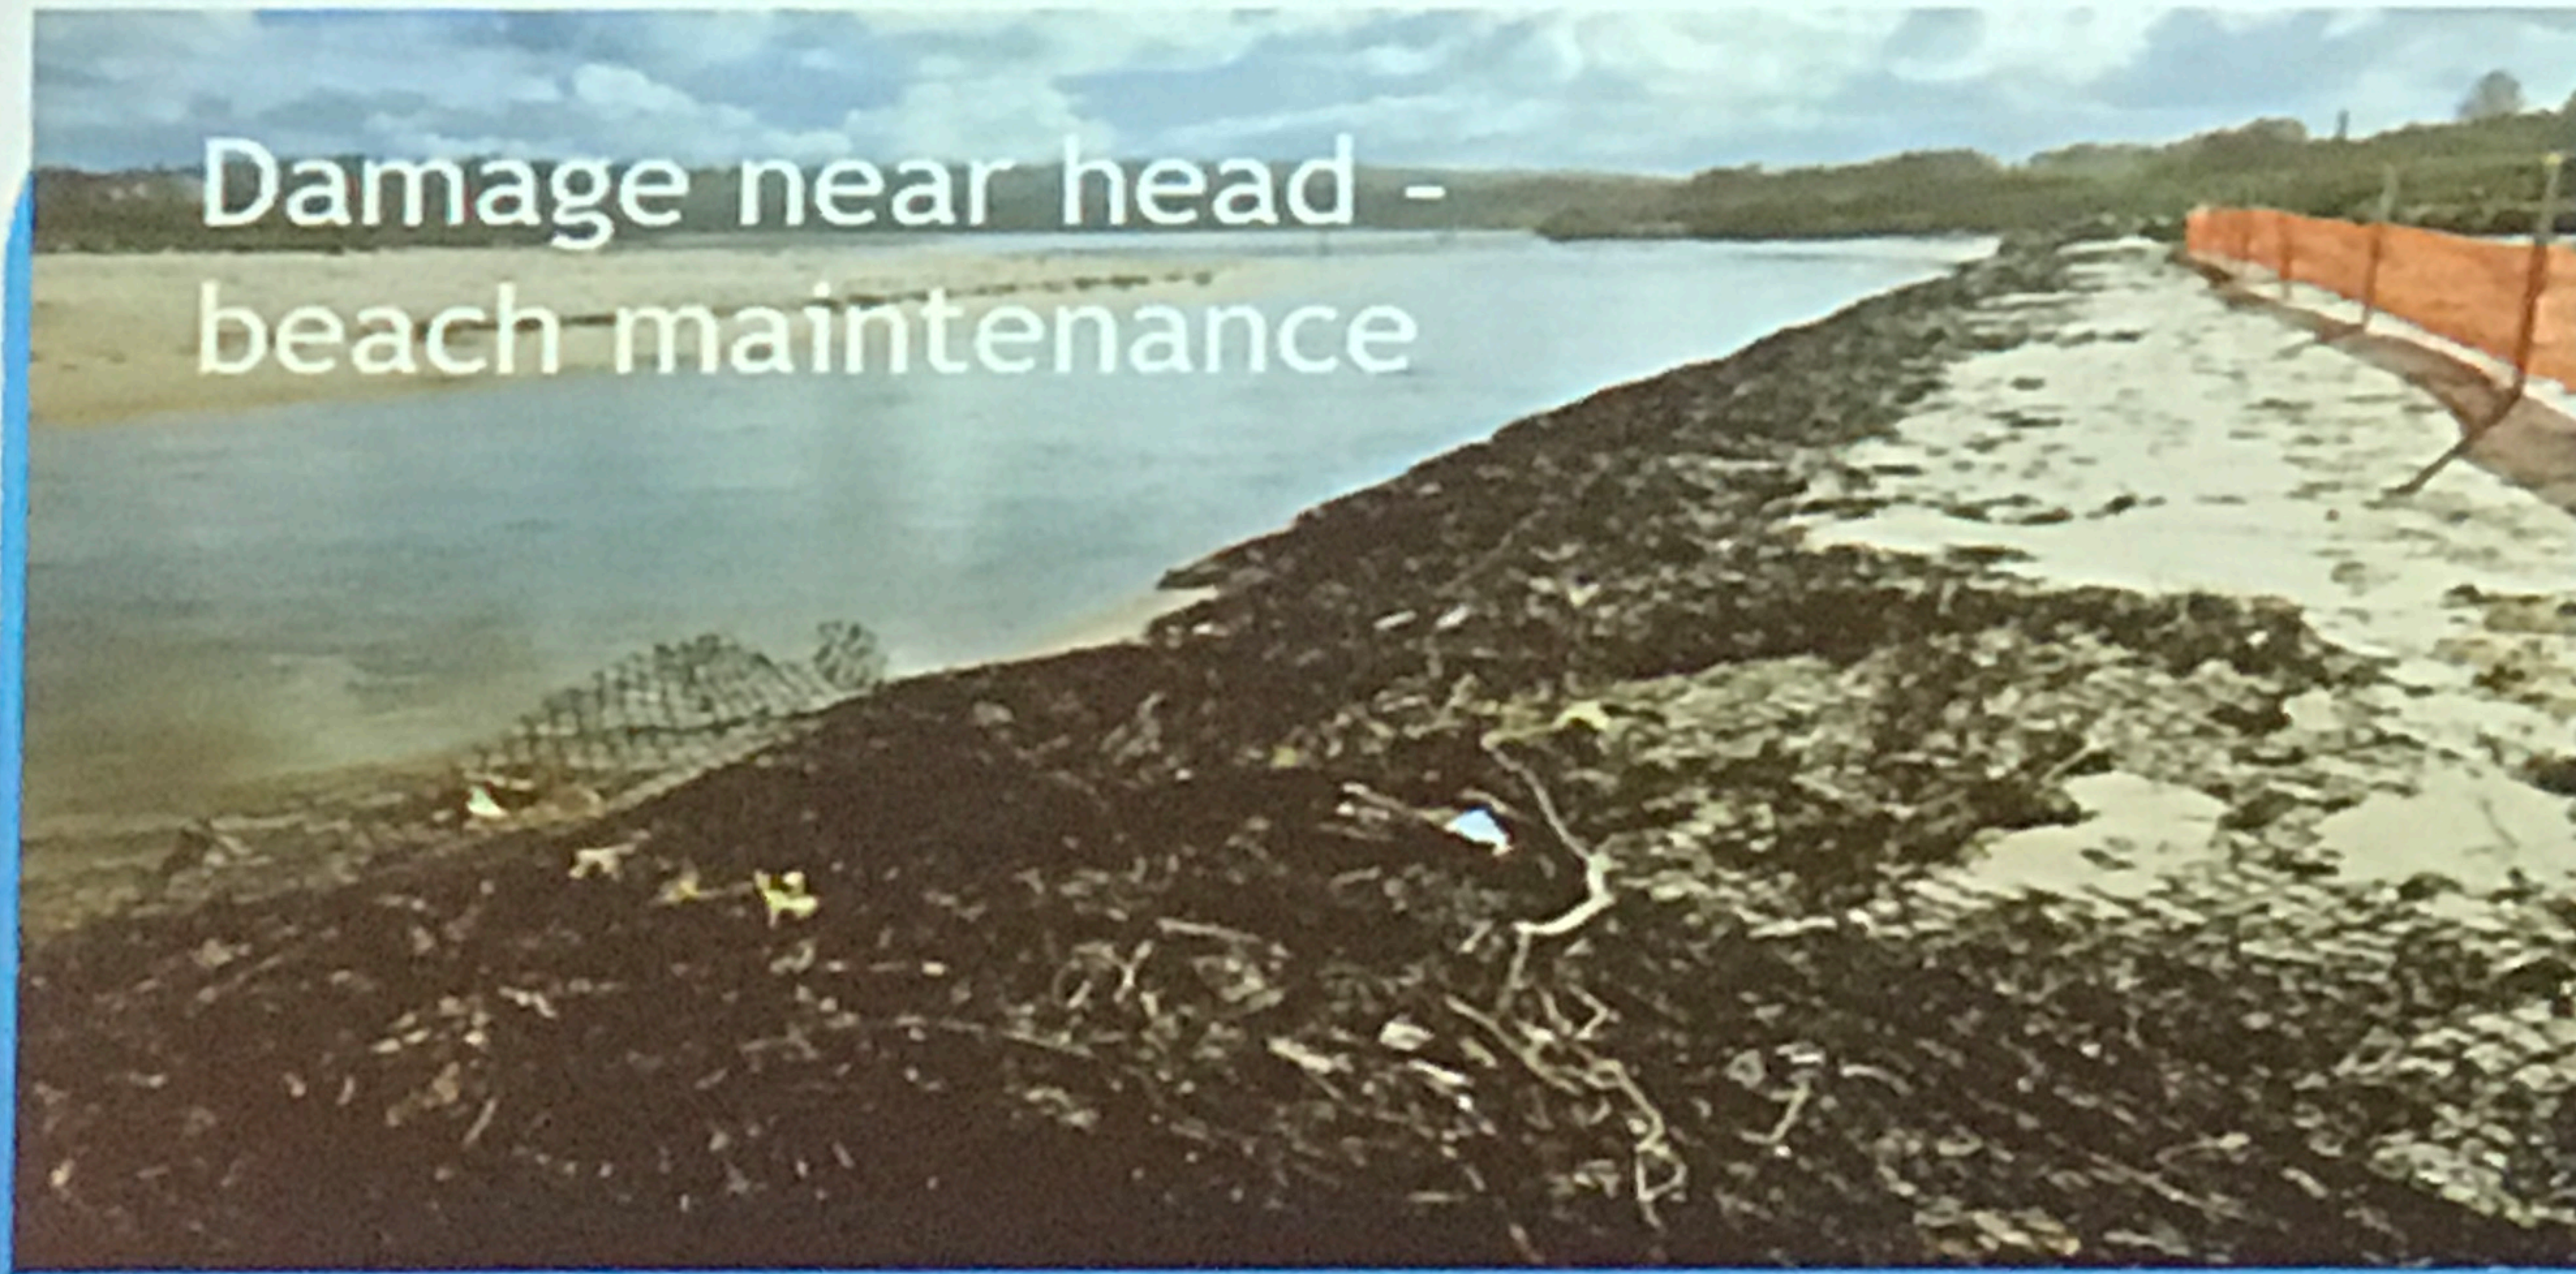
Damage near head -  
beach maintenance

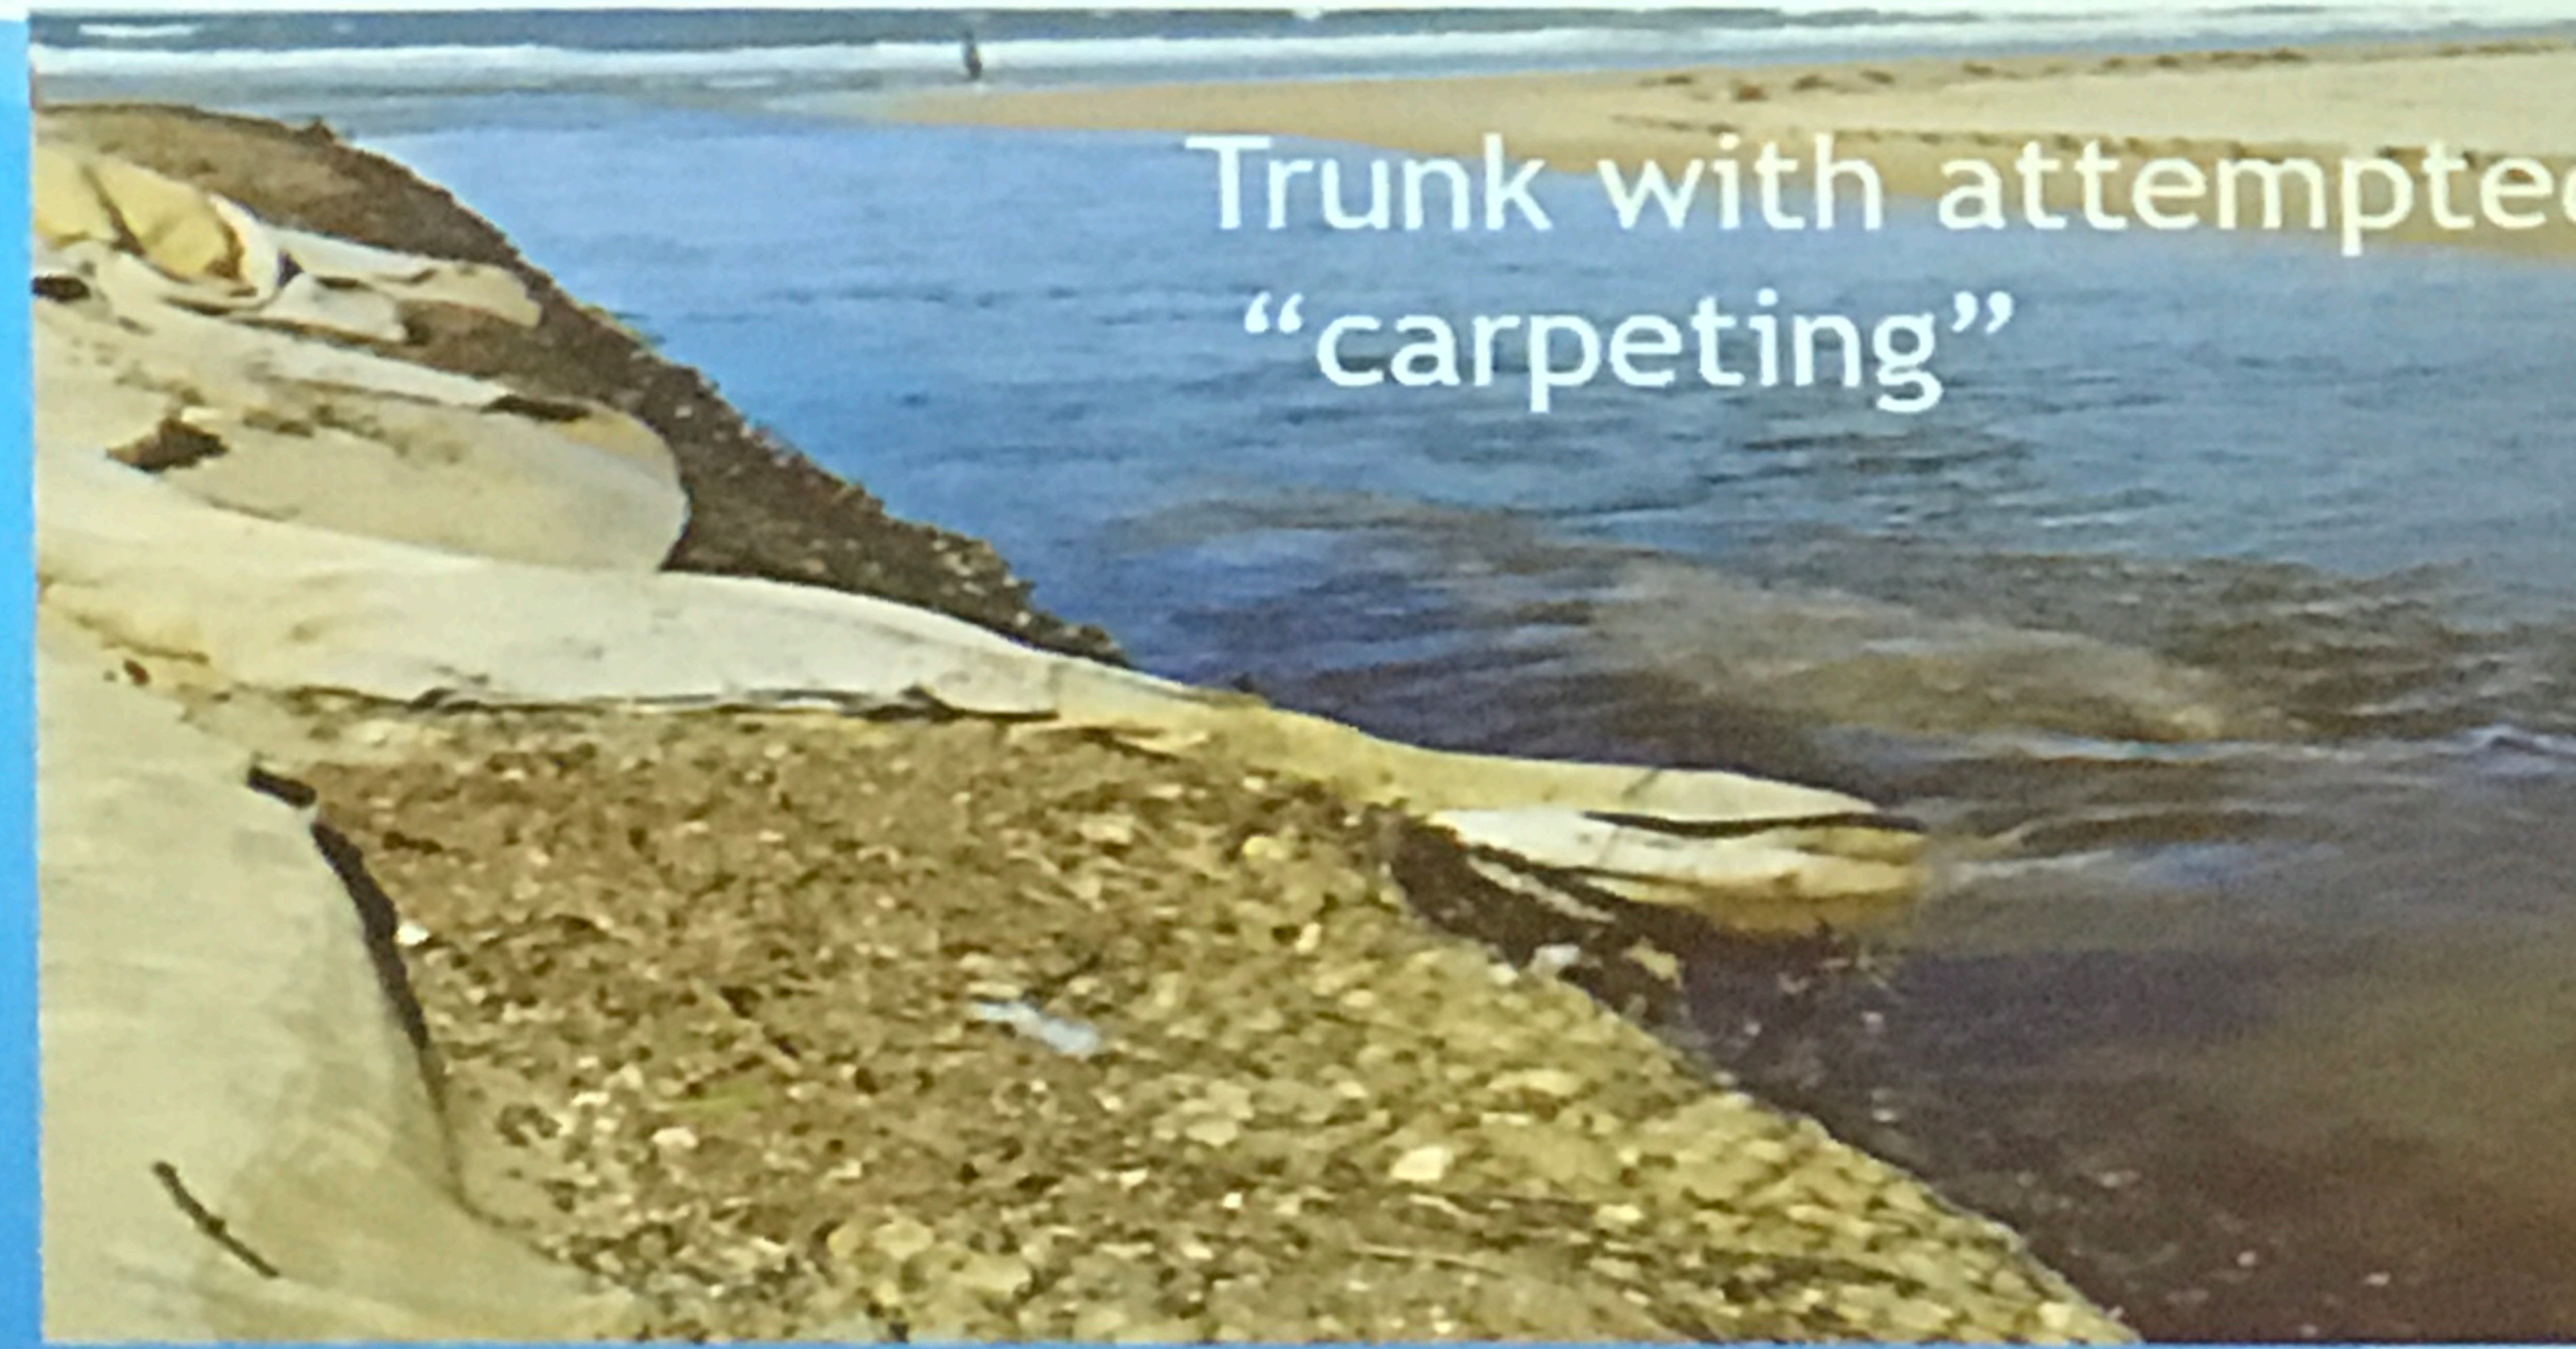
Trunk with attempted  
“carpeting”

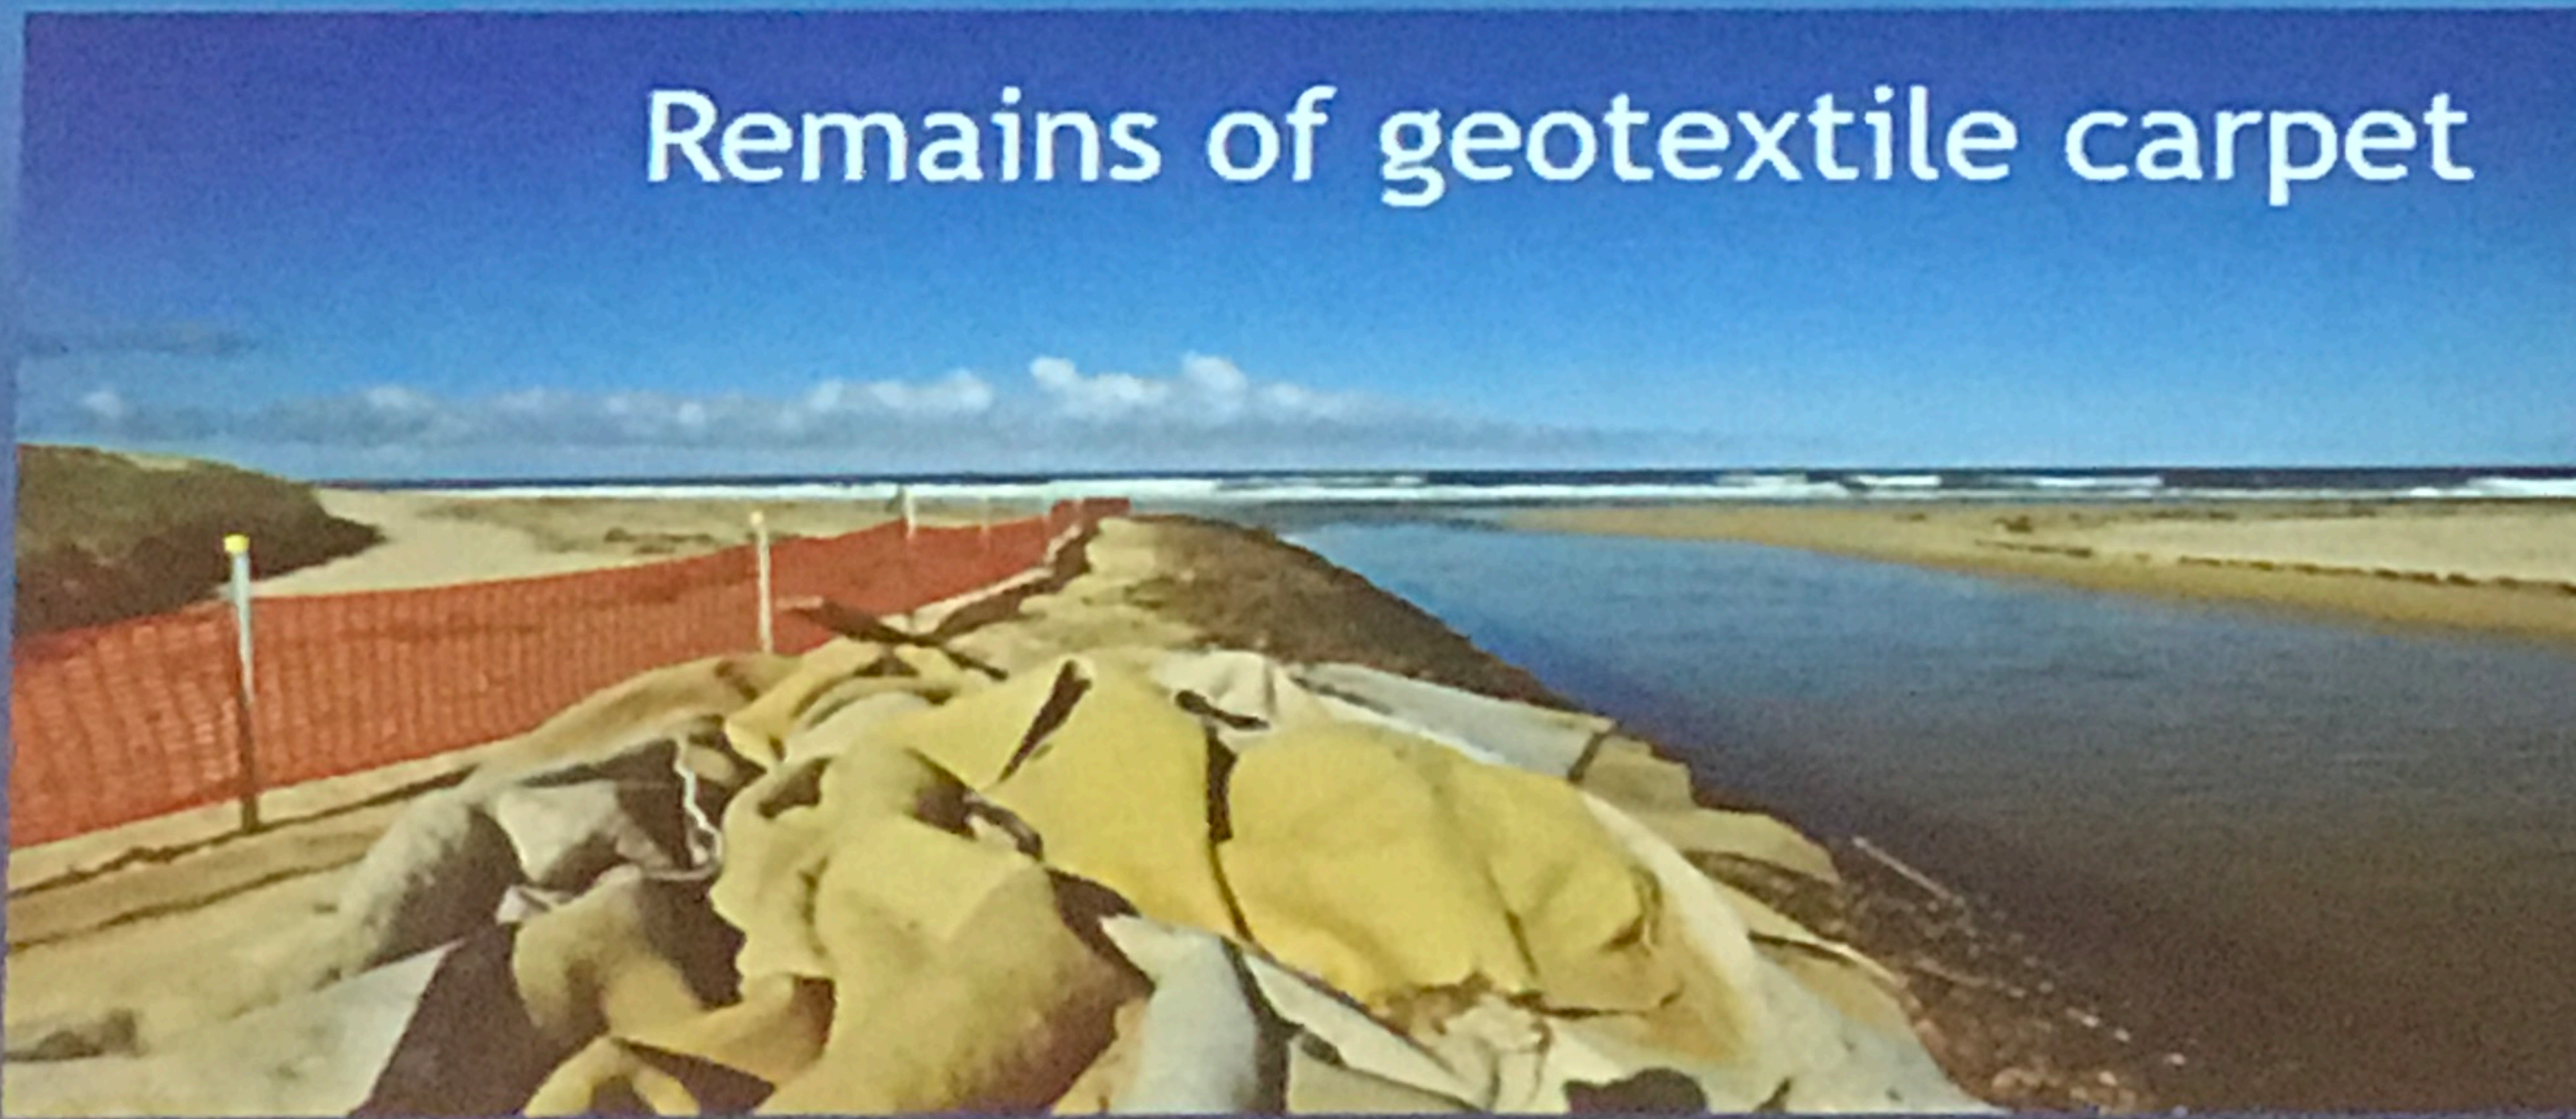
Remains of geotextile carpet

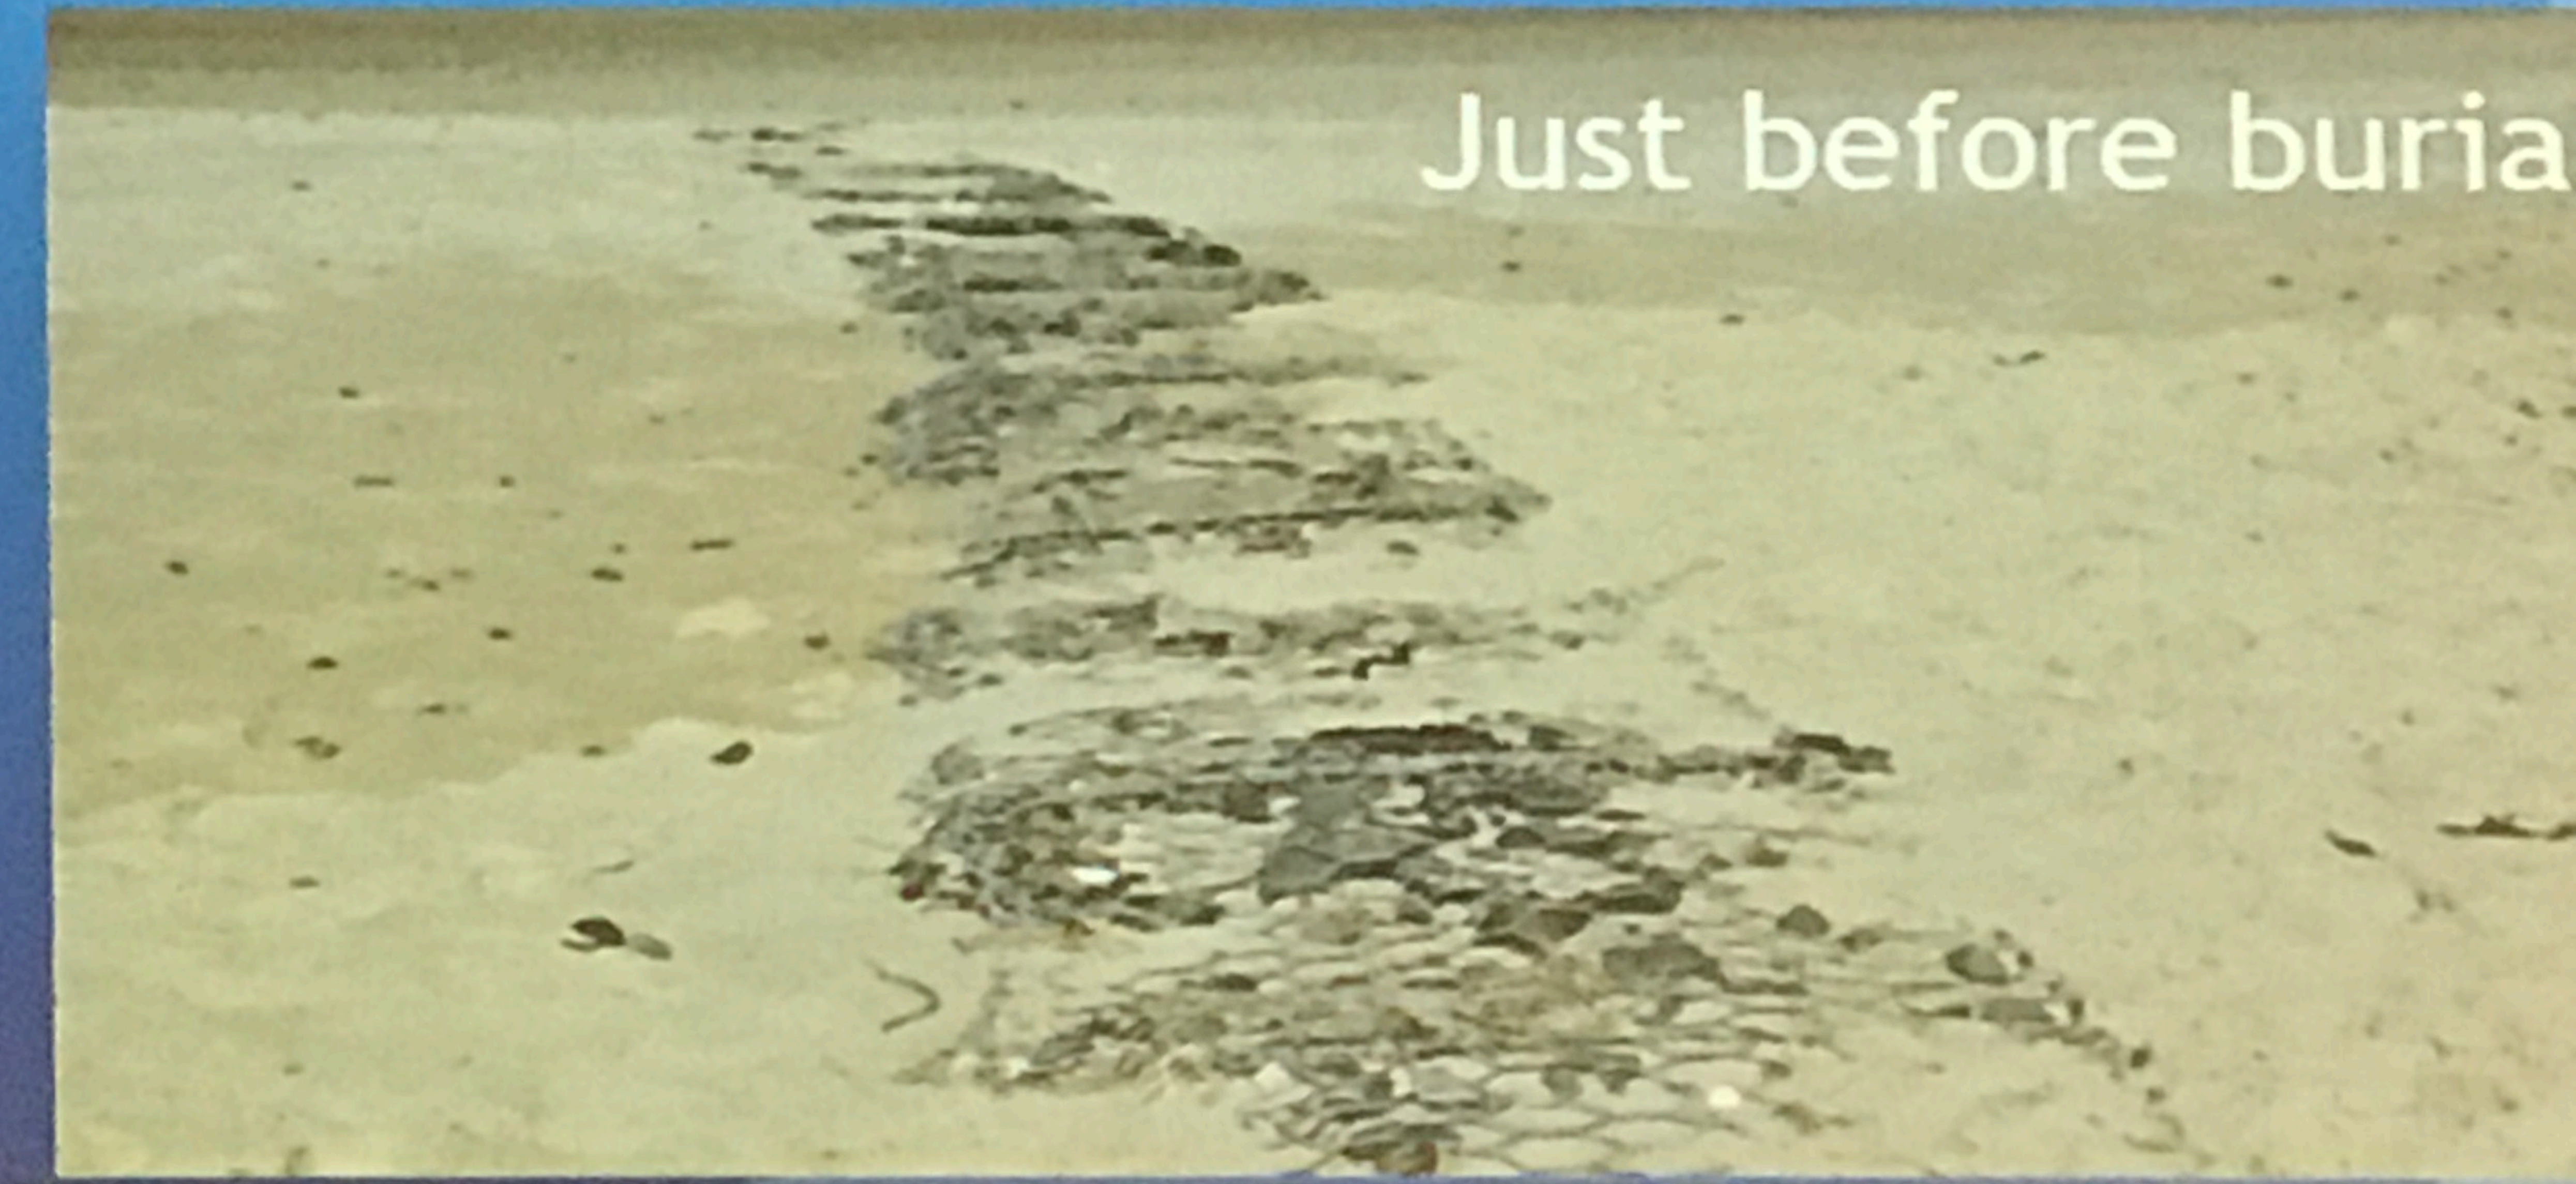
Just before burial
