Floodplain Management Advisory Committee Meeting

Stage 1 – Options Assessment

Federation Bridge Debris Control – Stage 1 Options Assessment – Draft

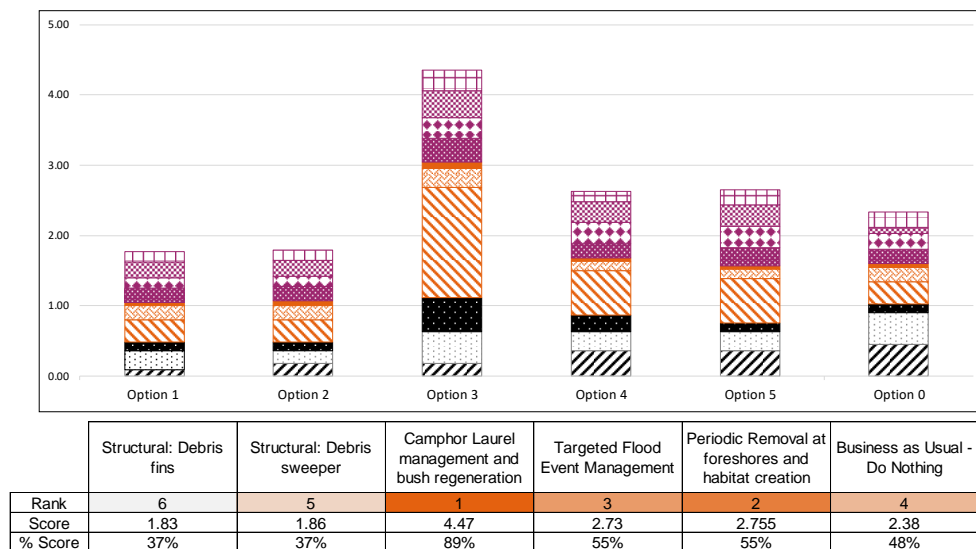
The outcomes of the MCA are outlined in the graph below.

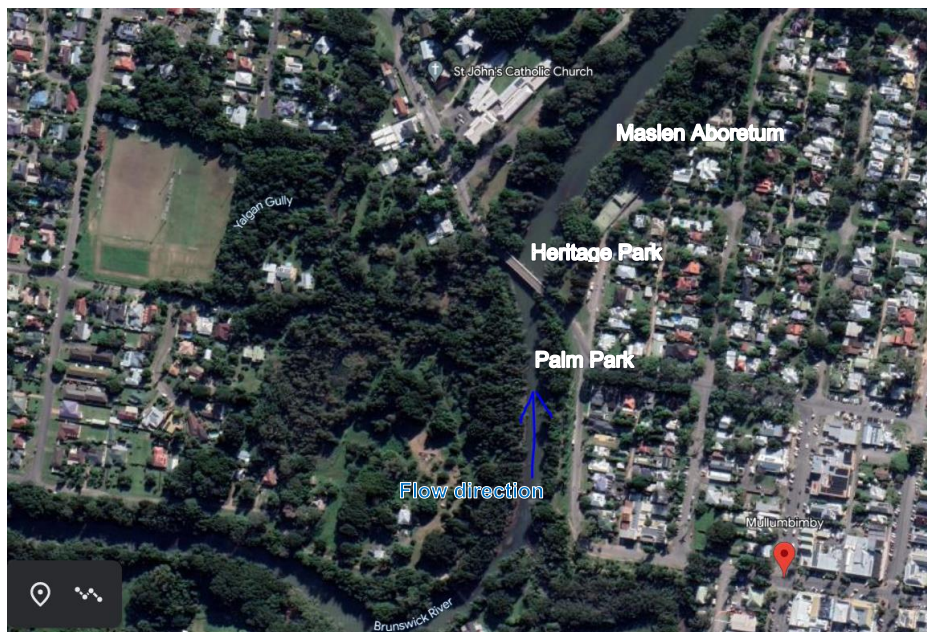
Figure 2.4.1 Site Visit – Observed Locations

A site visit was conducted on the Brunswick River within the estuarine section, around Mullumbimby approximately 400m upstream and downstream of the Federation Bridge. The purpose of this visit was to inspect the foreshores in the study area, to ascertain source and type of the debris load. The Figure below provides a locality of the site visit.

Federation Bridge is situated on a slight bend of Brunswick River and is skewed. It was observed that the bridge piers are not aligned directly parallel to the flow of the river, resulting in a higher chance of snagging or accumulation of debris.

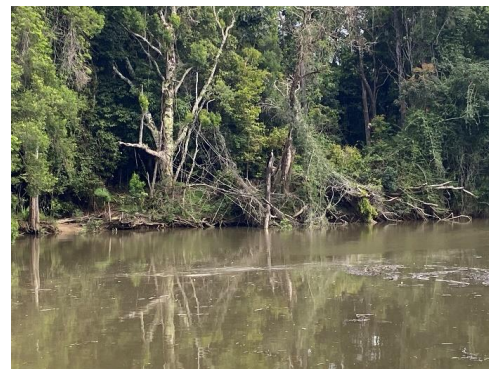
Figure 2.2.4 Downstream of Federation Bridge on the eastern side of Brunswick River looking at the western bank

The western side of the river holds significant flood storage with several layers or “steps” leading to the river bank, allowing for significant forest growth below the bridge level but above the Highest Astronomical Tide (HAT). This would allow for significant debris accumulation during dry times, then release during high water levels of the river. Large woody debris, mainly trees, were sighted falling into the river on this side.

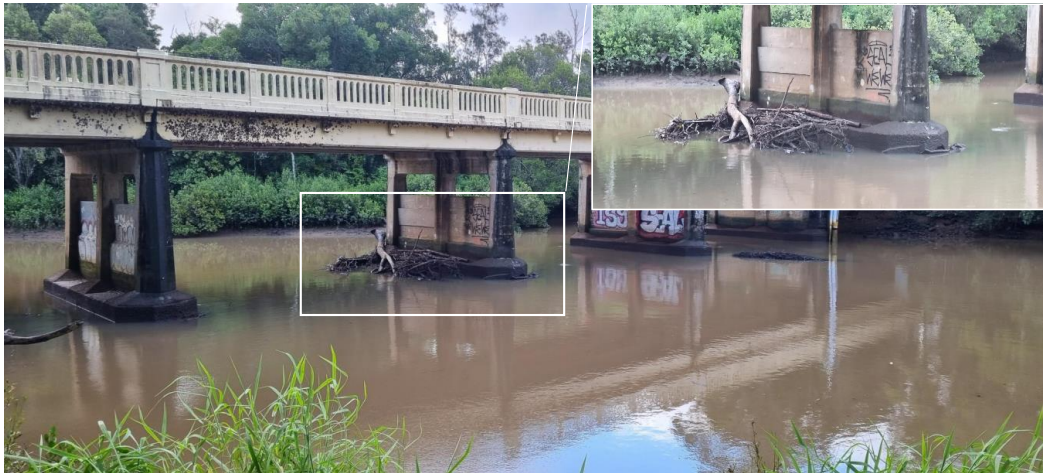
The observed debris accumulating under Federation Bridge is predominantly woody debris reported by the local community. **Figure 2.5.1** shows picture supplied by local community member which is typical of what is observed.

Figure 2.5.1 Debris Accumulation under Federation Bridge (Local Community Member, 2022)

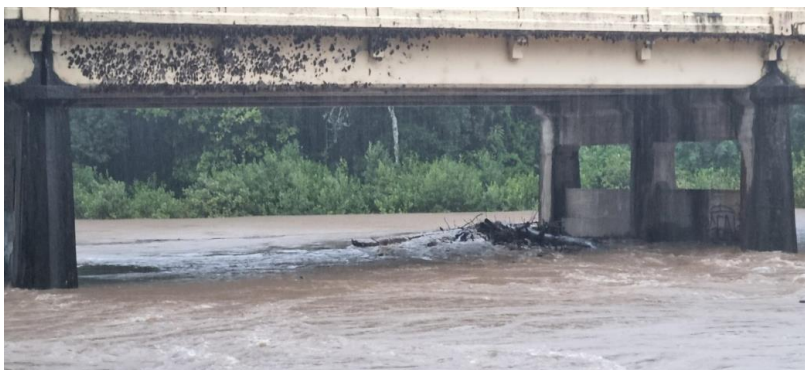
Figure 2.5.2 Debris Accumulation under Federation Bridge during 2022 Flood Event (Local Community Member, 2022)

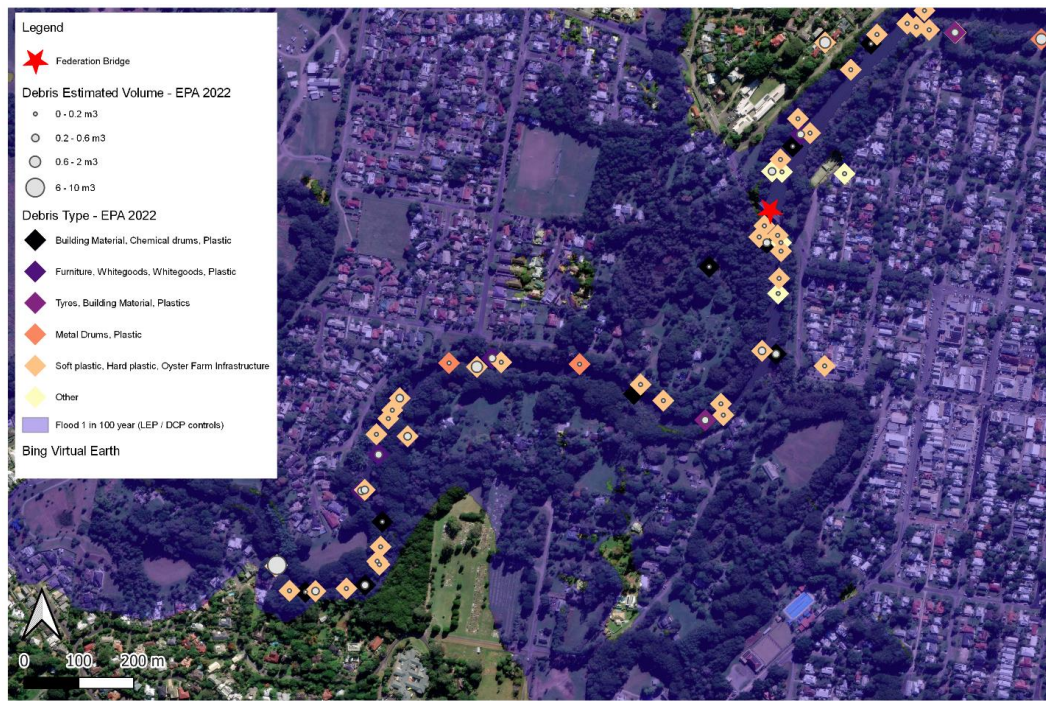
Figure 2.5.3 2022 debris collection data (EPA, 2022) (Debris type categorisations include overlaps in types; the largest items have been listed first in the description)

Figure 2.5.3 shows approximate locations of debris collected and cleared from the Study Area, also showing type and volume of the debris collected. As expected, larger debris items have been predominately on the outer bends of Brunswick River. Larger items were predominately building material and chemical drums. Smaller items were mainly small and hard plastic.

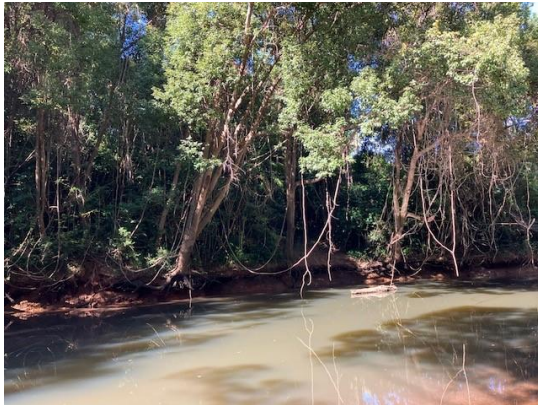
Extensive invasive flora species have been identified with Camphor Laurel dominating much of the foreshore as seen in **Figure 2.6.1**. There is also significant erosion along the banks Brunswick River and Mullumbimby Creek (BSC, 2018), where Camphor Laurel is causing undercutting due to their shallow root system (DPI, 2023), seen in **Figure 2.6.2**.

Figure 2.6.2 Camphor Laurel undercutting banks on Brunswick River in the Study Area

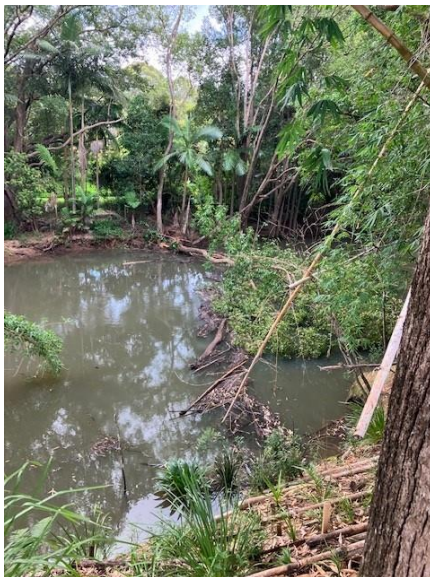
Recent ground truthing (work undertaken separate to this study) show a number of dead Camphor Laurel adult trees on the foreshore of Brunswick River, either already entering or on the verge of entering Brunswick River, contributing to the debris loads (**Figure 2.6.3**, approximately 2.5km upstream of Federation Bridge). It is suspected that poisoning Camphor Laurel has been undertaken as an effort to remove Camphor Laurel. Additionally, the Figure also demonstrates other invasive species such as bamboo entering Brunswick River.

Figure 2.6.3 Dead Camphor Laurel and bamboo logs in Brunswick River (ground truthed by BSC 2023)

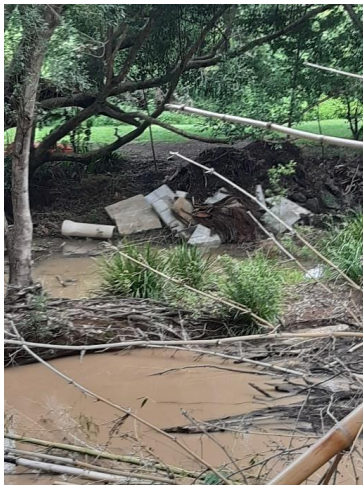
Illegal dumping regularly occurs upstream of Federation Bridge, contributing to anthropogenic debris loads. Two problem areas have been identified as Riverside Drive and Azelea Street. An example of accumulated debris, which has the potential to reach Federation Bridge can be seen in **Figure 2.6.4**. This is currently being managed by BSC through signage and fine enforcement.

Figure 2.6.4 Illegal Dumping on Azalea Street (BSC, January 2023)

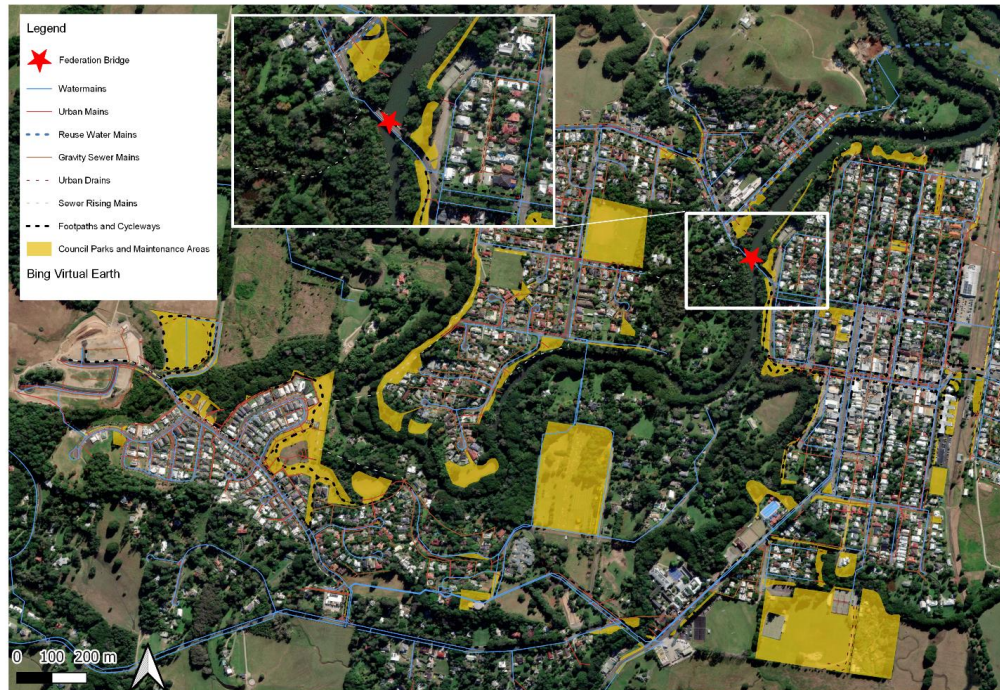
- Critical council services (water main) are located on the upstream side of Federation Bridge, extending along the span of the Bridge.
- Footpaths and cycleways are also located on the eastern foreshore of Brunswick River in Palm Park.
- Palm Park is Council managed open space.
- Although not Council's operational responsibility, Federation Bridge also includes a footpath and cycleway.

Figure 2.6.5 shows Council managed utilities and areas

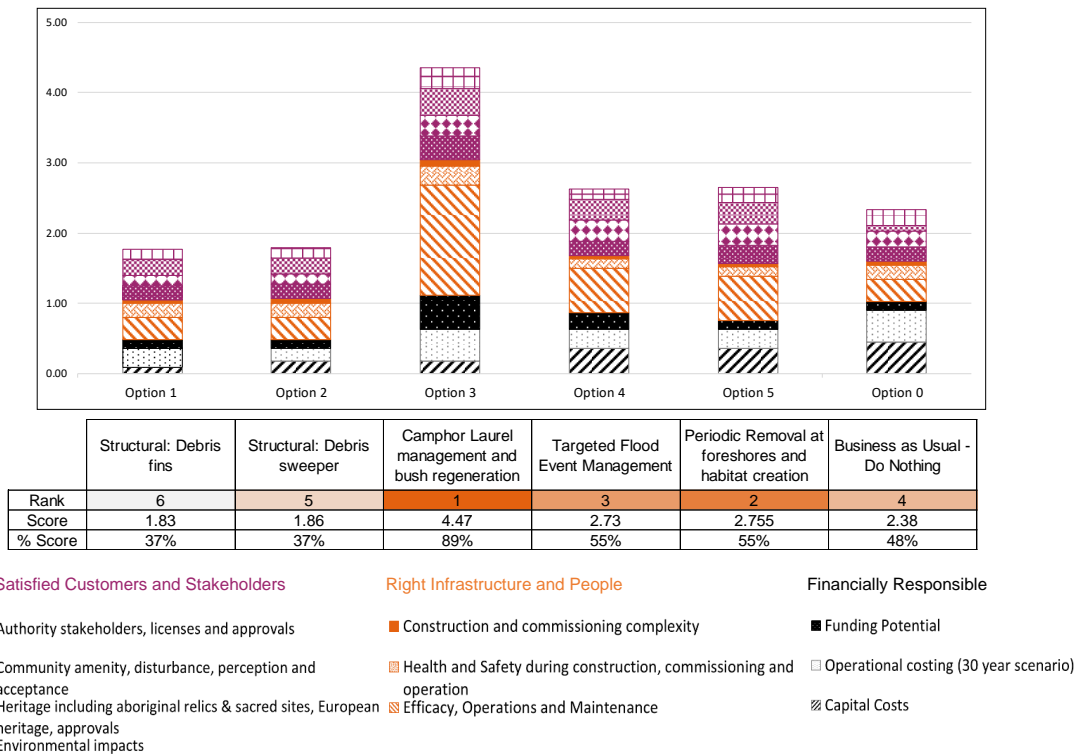
Figure 4.3.1 Short List Options MCA - Results Graph

As seen in the Figure above, *Option 3 Camphor Laurel Management and Bush Regeneration* has scored the highest out of the five options and the Business and Usual (do nothing) solution. Although this option has a high initial cost outlay, the likelihood of securing funding is high. Additionally, this solution scored the highest out all solutions for its effectiveness – addressing the woody debris at the source, preventing debris loads entering Brunswick River, which would help all bridge structures downstream of the source control point. It also provided significant environmental benefit by removing an invasive flora species allowing for further regeneration and bank stabilisation (through replacement of Camphor Laurels with native floras)

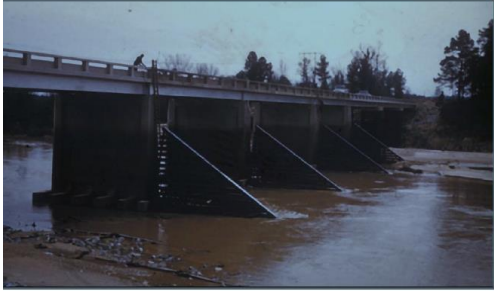
<p>https://www.elastec.com/products/floating-boom-barriers/trash-debris-boom/</p>
S.3	Debris fins

Option 1 Structural: Debris Fins	Score	Assessment
Financially Responsible		
Opinion of Initial outlay / Capital costs	1	Circa \$1,000,000 Assumes structural works are required to reinforce the Bridge due to the age and condition. Assumes 2 concrete fins on middle piers (where debris tends to accumulate) are constructed. Environmental impact assessment, heritage assessment and bridge condition assessments, river flow assessments will be required prior to any design works and construction.
Opinion of operational costing (30 year scenario)	3	Circa \$900,000 Due to the skew of the bridge and reports from existing debris fins, clearing and maintenance will likely be required. (Sheeder and Johnson, 2008 cited by Bridge Engineering Center, 2012).
Funding Potential	1	TfNSW is the asset owner of Federation Bridge and is responsible for the operational maintenance. Additional structural elements which increase maintenance cost will likely not be funded by TfNSW, due to their asset maintenance programme and the priority given to Federation Bridge in the region.

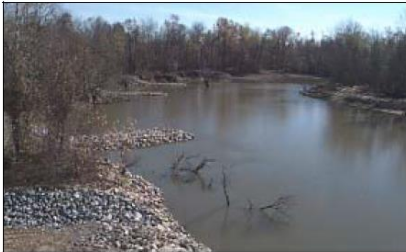
<p>Figure 5.41. Bendway weirs on outer bank of Hatchie River looking upstream (TDOT).</p> <p>U.S. Department of Transportation (2005),</p>
S.5	Debris sweeper

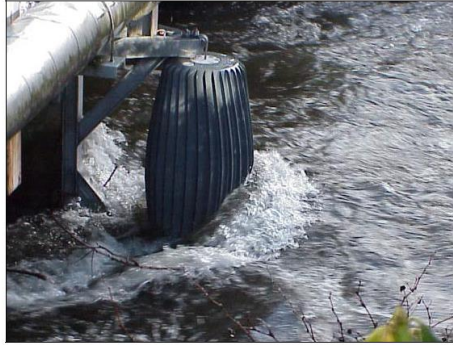
<p>Figure 5.45. Close up of a debris sweeper installed on the Cedar Creek in Washington.</p>

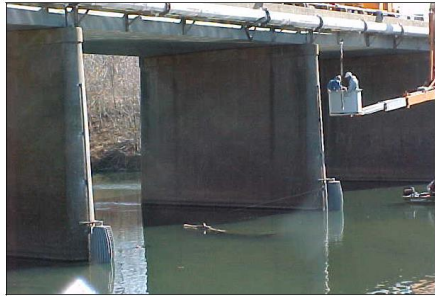
<p>Figure 5.44. Debris sweeper being installed on a bridge over Staunton River in Altavista, Virginia.</p> <p>U.S. Department of Transportation (2005)</p>
S.6	Debris deflectors
