Banaglaow Rd - Pedestrian refuge and enhancement of existing pedestrian crossing at roundabout

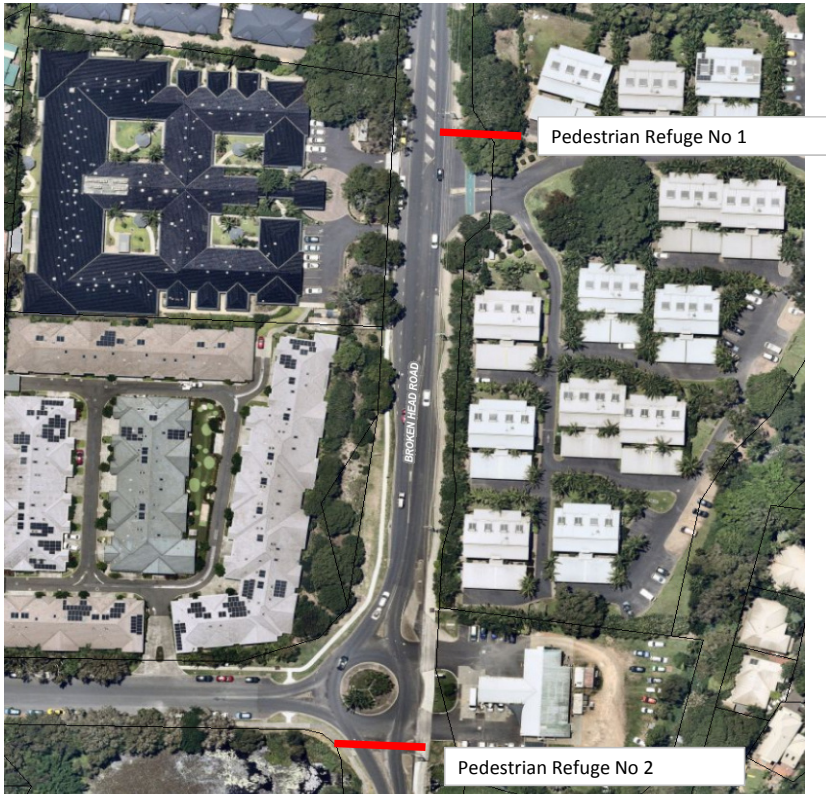
Pedestrian refuge No 1

Best suitable location near RSL age care centre and bus stops. Further south or north pedestrian refuge will clash with auxiliary lanes and driveways

Pedestrian refuge to be as per AS1742.10 and RMS TDT 2011/01a

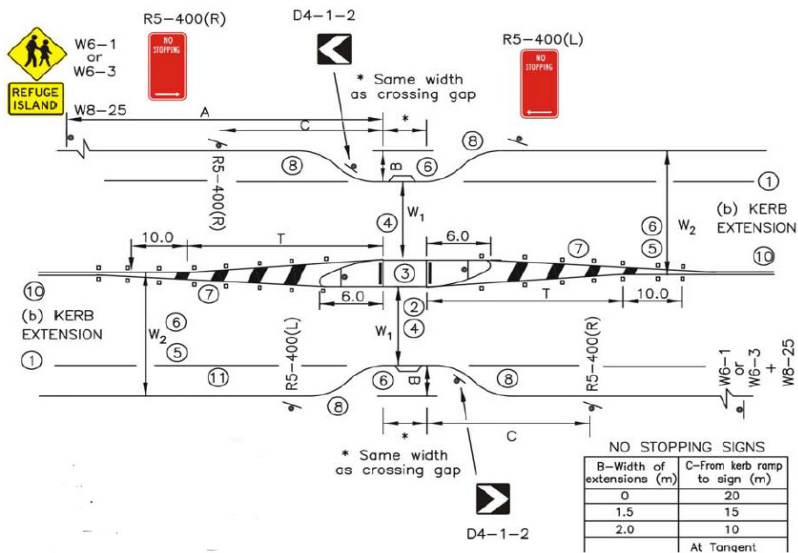
Pedestrian refuge No 2

Existing crossing is lacking hand rail, delineation, reflective markers, warning signage, line marking and raised reflective markers.

Install all of the above to enhance safety on existing crossing
